BP's Deepwater Intervention Techniques for Maintaining Integrity in Subsea Wells

Author: Daniel Gutierrez, BP Subsea Maintenance Engineer

**Subsea Rio Conference 2004
Rio De Janeiro, Brazil**

BP Subsea Integrity Management Seal-Tite Casing Pressure Communication Repair U.S. Operations / Gulf of Mexico

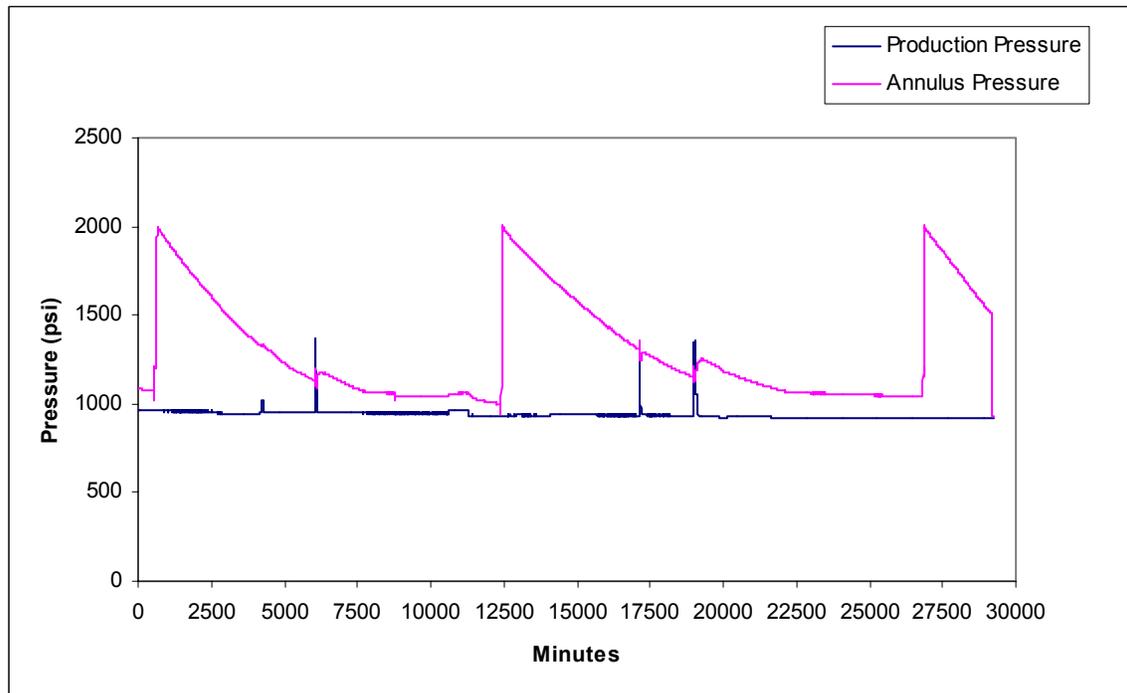
In late 2002, BP identified a pressure anomaly in one of its subsea tieback wells. Pressure data acquired from the subsea well indicated slight pressure communication between the production tubing string and the production annulus. Preliminary diagnostics focused on the subsea tree and several isolation gate valves as the potential source of the pressure integrity problem. Using specialized testing procedures; BP was able to confirm that the subsea tree valves were sealing and that the source of the pressure communication was in a down-hole component. BP was able to also determine that the source of communication was above the surface controlled subsurface safety valve (SCSSV). The preliminary testing operations were able to isolate the location the communication to approximately 2500 ft. (760 m) of production tubing. Figure 1.1 illustrates the pressure communication seen between the production tubing and the annulus.

Figure 1.1 - Tubing Pressure Communication

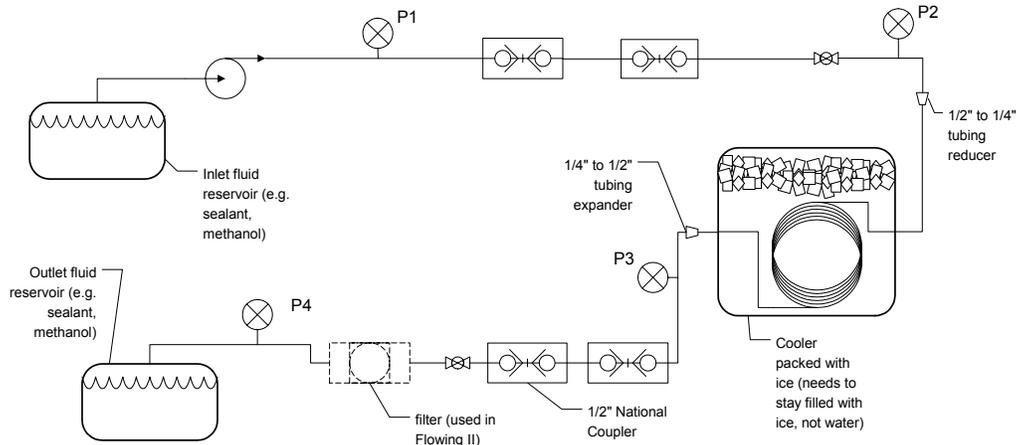
would be generated from the repair operation. Testing would cover chemical compatibility, low temperature behavior, and flow assurance of the sealant material. Figure 1.2 illustrates the testing mock-up to prove the sealant could be delivered to the subsea well without incident.

Figure 1.2 – Sealant Delivery Testing Operation

The testing operation was systematically arranged to mimic actual conditions that would be encountered during the repair operation. The tests proved to BP that the sealant material could effectively be delivered to the subsea well through the existing umbilical system without risk to the subsea system.

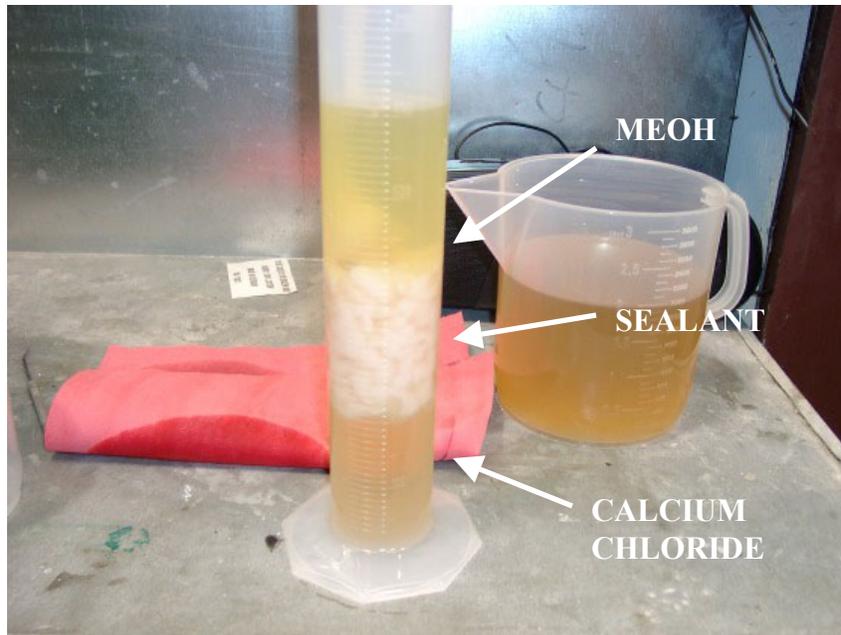
Knowing that there was very likely an interface of methanol (6.6 PPG) and calcium chloride (10.5 PPG) at or near the leak location, Seal-Tite proposed placement of the sealant utilizing a special weighted mixture of sealant. Once injected into the annular space, the weighted sealant (9.9 PPG) would sink through any methanol in the system and stop once it reaches the heavier calcium chloride interface. Theoretically, this would place the sealant at or near the leak location. BP and Seal-Tite International now had the critical answer to placing the sealant material at the source of the pressure communication.

Figure 1.3 – Sealant Development
