BELZONA 2141 ANTI-CAVITATION

Unit:- Hick Hargreaves SHR22500
Water/Sugar

Industry:- Sugar Pumped media:

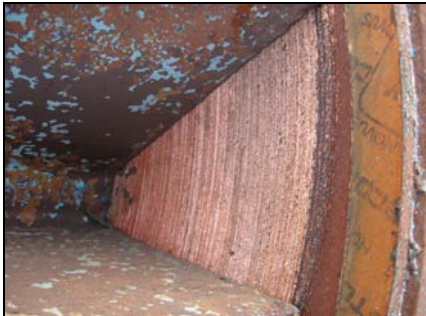
Unit as received

- The gland area was in poor condition with shaft wear found
- Both impellers and bodies had glass flake coating applied which was heavily worn
- Heavy wear due to cavitation and erosion was apparent to the leading and trailing edges of the suction impeller. Similar wear was also found to the and delivery impeller and bodies
- All plates were scored due to contact from the impellers and were worn due to erosion
- The Non drive shaft bearing location was worn

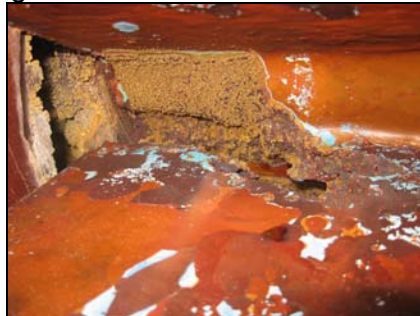
Scoring to intermediate plates

- The gland packing sleeves were grit blasted to SA 2 ½ @ 75 Microns and the rebuilt with Belzona 1131 bearing metal and then machined to size
- The NDE worn Bearing location were grit blasted to SA 2 ½ @ 75 microns and then rebuilt with Belzona 1311 ceramic and then machined to size
- The shaft diameters were polished and threads cleaned
- All four plates were undercut and prepared for Belzona application by machining
- The plates were rebuilt with Belzona 1311 ceramic r
- All plates were machined to original size
- Both Suction and delivery bodies were then Grit blasted to SA 2 ½ @75 microns
- The suction body was rebuilt with Belzona 1311 ceramic r metal where wear due to product wash was apparent
- Both bodies were coated with Belzona 1321 ceramic s to protect against future wear
- Both bodies were machined so correct clearance is established against the impellers

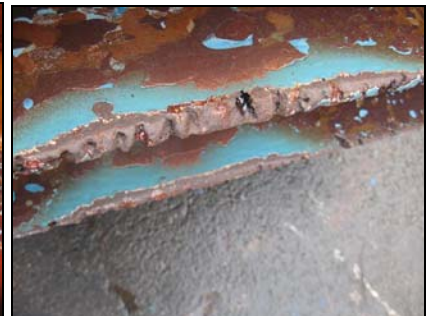
Cavitation to impellers

- The impellers were be hydraulically pressed from the shaft
- Both impellers were grit blasted to SA 2 ½ to remove existing coating, surface impurities and so incorrect surface profile is achieved
- The areas on the suction impeller which had been subjected to cavitation were rebuilt with Belzona 1311 Ceramic r metal and formed back to profile

Both impellers were coated with Belzona 2141 anti cavitations coating to protect against further wear. This replaced the previous glass flake coating which had not protected the base metal

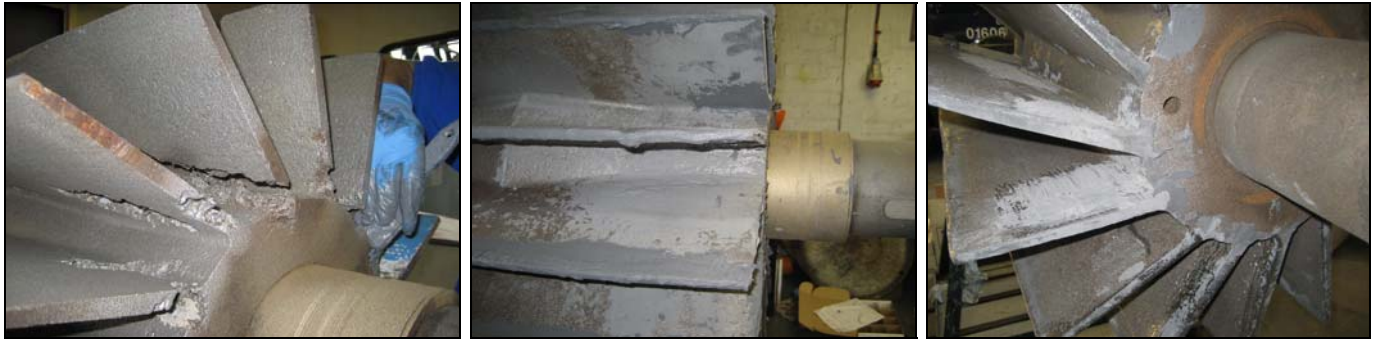
Suction impeller after grit blast - after application of 1311 - after being ground to profile

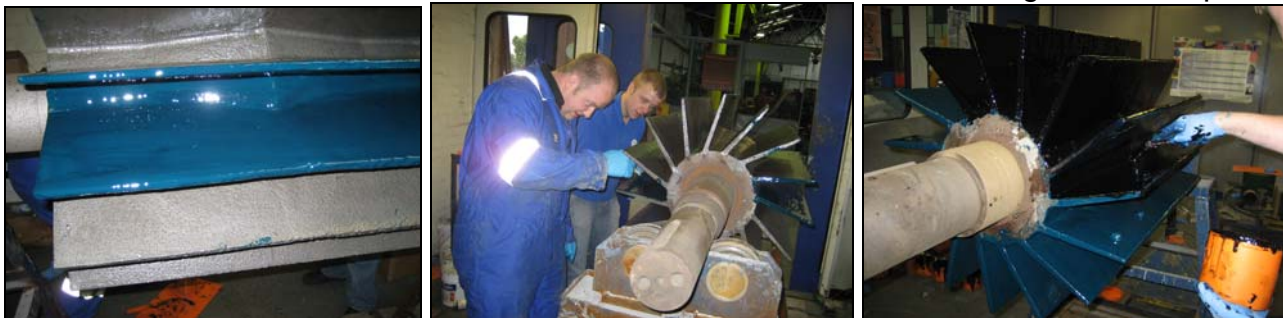
First coat of 214 - Impeller being coated - Applying second coat 2141
