EFFICIENCY OF STREAMLINED HUB INCREASED

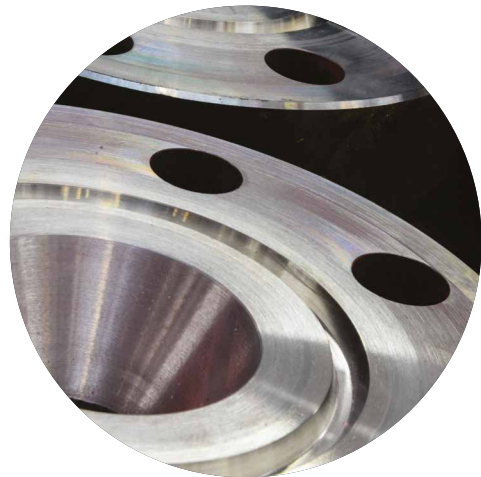
An oilfield service company approached Probe to complete a full visual and dimensional inspection on a 6" GR-52 streamlined hub c/w 90-degree cushion elbow. The component was badly corroded on all sealing areas and internals.

"As part of the refurbishment, all the sealing surfaces were rough machined to oversize allowing an Inconel weld inlay to be installed over the sealing area," said Dave Good. "Once this operation was completed the Inconel inlay was machined back to the specification required for the sealing face which ensured that the component still met with the required manufacturing tolerances. The internal areas were then inlaid with Inconel to help prevent further corrosion for when the component will be used in extreme environments."

Once the refurbishment had been completed the item was revalidated with third party certification and pressure tested to the required test pressure. This specification was in accordance with API 6A (20th Edition, NACE MR-01-75) and the client's requirements.
