Case Study – Major Component Repair

- ❖ Location: Magherafelt, Northern Ireland
- ❖ Turbine: Bonus B23 150kW
- ❖ Client: JE Wind

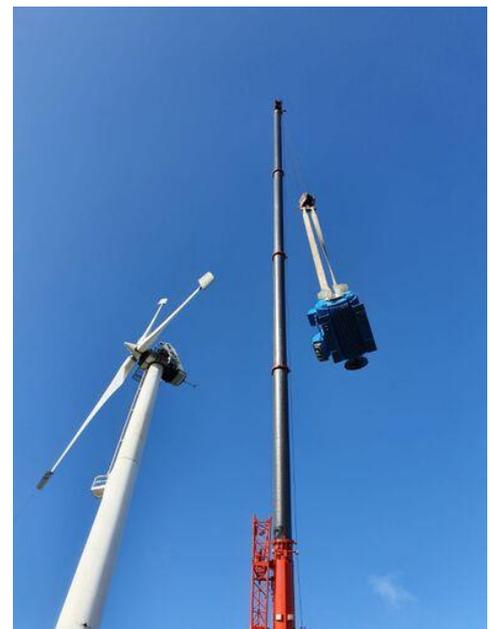
Prior to the arranged inspection taking place we were informed by the turbine owner that it had experienced a major breakdown, and, at the owner's request, a service team was dispatched to site to investigate the fault. On inspecting the generator, it was found that the insulation on the generator windings had suffered a failure and, as a result, the windings and terminals had suffered considerable heat damage rendering the generator inoperable. It was subsequently found that the cause of this failure was due to a major failure where the windings had been overloaded and had, as a result, burnt out. With storm conditions ongoing at the time of the failure and a number of grid spikes, it is likely that the cause of this failure will have been due to a storm event causing a generator overload and subsequent burnout. Our engineers provided the owner with a detailed inspection report and Realise Energy Services were asked to quote for the removal, repair and re-installation of the generator.

The Generator was removed from the turbine and delivered to an accredited generator repair facility. It was completely stripped down, rewound with new windings, new bearings, seals and terminal block. The windings were dipped in the epoxy resin primer for protection and rebuilt. On completion, the generator was fully tested, passing all tests successfully.
