### Managed Water Services – Cooling Tower Pack Endoscope Inspection

Example Site Example Site

#### **Cooling Tower Endoscopic Inspection Report**

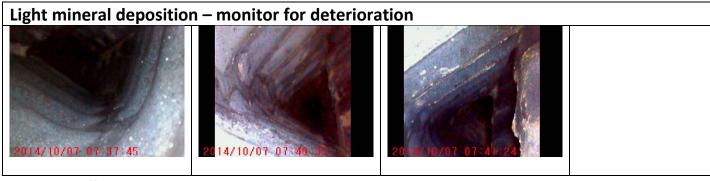
Tower 3 Cell A

- 1. Breakage- none / minimal
- 2. Biofilms none observed
- 3. Deposits some light deposition on tower 3 cells A, B & C that will require further monitoring.

Pack on tower 3 was shown to have light deposition and will require further monitoring in six months. All other packs were found to be in a good condition.

<sup>\*</sup>Identification of these deposits would help to diagnose the cause/source. Their composition is mineral, possibly carbonate and/or phosphate compounds of Calcium and/or Magnesium. There is a possibility it could be process contamination This can only be confirmed by laboratory analysis

Tower 3 should be inspected again at the next shutdown opportunity, using the endoscope method, to examine the condition of the pack for comparison with the images in this report and to ascertain whether any deterioration has occurred and whether a pack out clean is necessary at that time. Acid foam cleaning can prove effective in removing residual light mineral deposits.

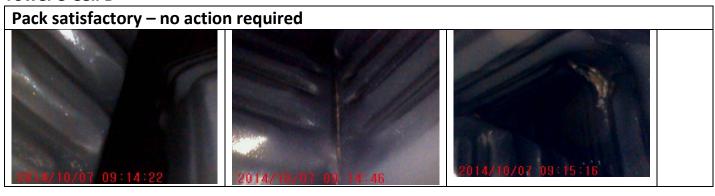
#### **Tower 5 Cell B**

## Pack satisfactory – no action required

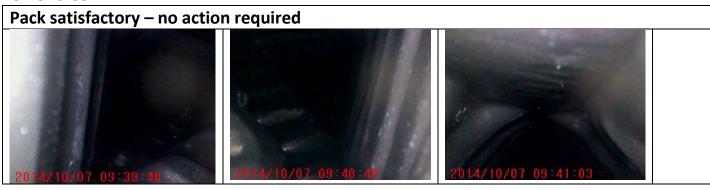
#### **Tower 6 Cell B**

## Pack satisfactory – no action required
