Indicative fire test

332065

**Hoody Speakerhoods Ltd C/O
Intumescent Systems Ltd**

Indicative Fire Test

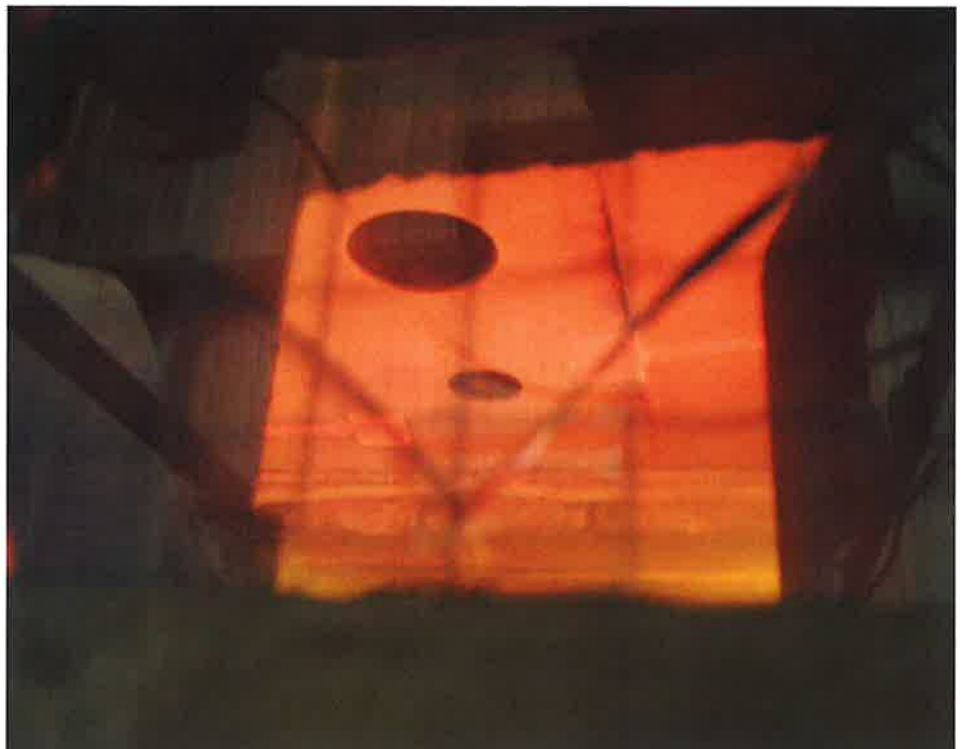
**The exposed face
of the ceiling after
a test duration of
30 minutes**

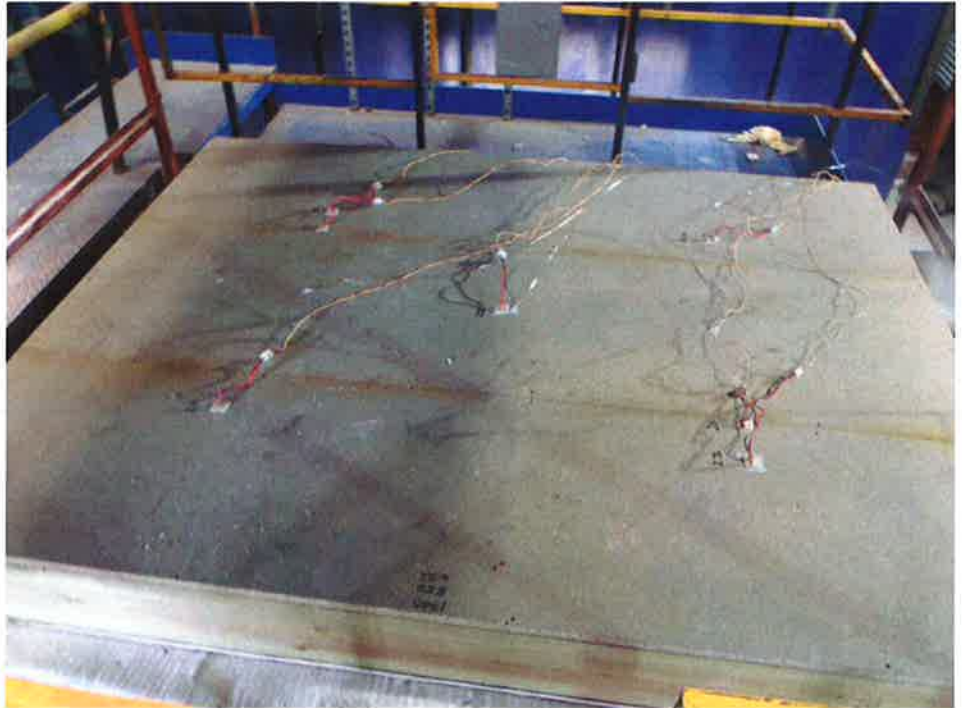
The unexposed face of the ceiling after a test duration of 60 minutes

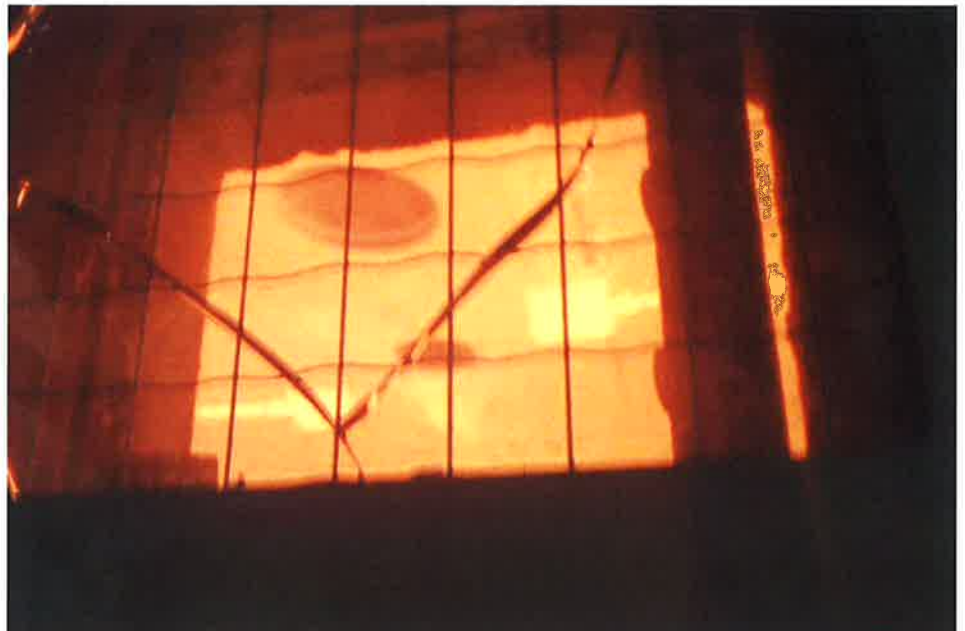
50	00	The board joints within the first layer of ceiling board have opened up by approximately 20 – 25 mm.
58	40	Viewed from the exposed face, a large section of the first layer of ceiling board has dropped downwards by approximately 30 – 35 mm as it begins to detach from the ceiling along the joint.
62	10	Smoke release from the joints within the timber floor has increased slightly. Discolouration has become more evident at the same location.
64	30	Viewed from the exposed face, flames issue from the circular openings within the ceiling. The first layer of the ceiling board has dropped down further along the joint now by approximately 50 mm.
71	30	Smoke release from the joints within the timber deck has increased further.
72	10	Viewed from the exposed face, a large section of the first layer of ceiling board continued to pull away from the ceiling now by approximately 150 – 200 mm.
73	10	A large section of the first layer of ceiling board has detached and fallen into the furnace chamber.

The exposed face of the ceiling after a test duration of 60 minutes

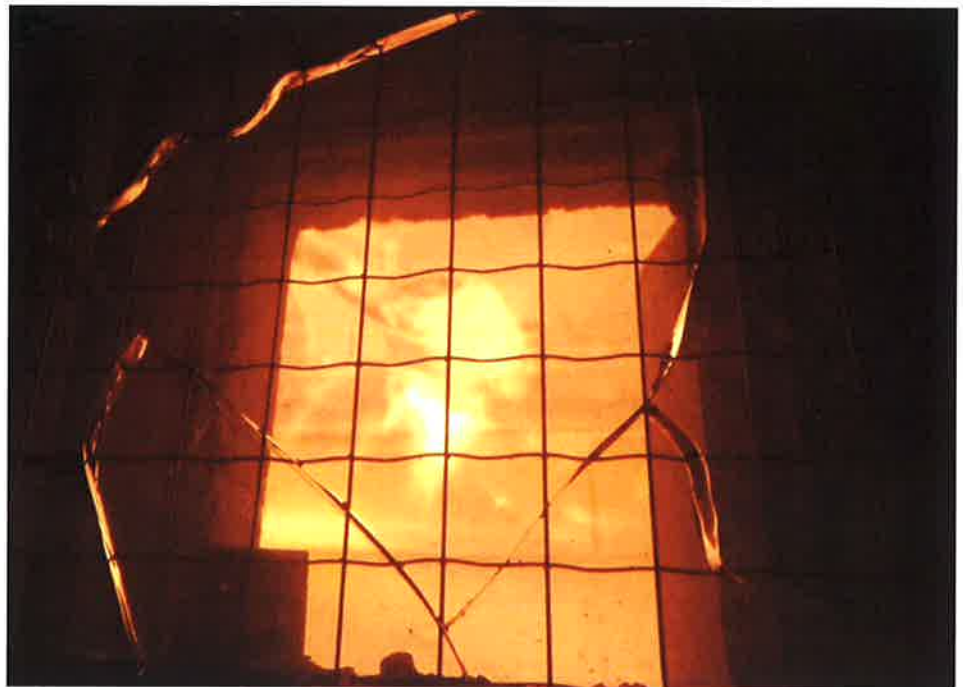
75	00	Smoke release has increased further along the timber deck joints.
78	55	A cotton pad is applied at the mid span of a timber deck joint but fails to ignite.
83	20	Viewed from the exposed face, large amounts of flaming issue from the circular apertures within the ceiling.

| 89 | 50 | A large section of the second layer of board begins to drop downwards at the approximate centre of the ceiling. |

The exposed face of the ceiling after a test duration of 90 minutes
