“Launch Support to a Major UK Tier 1 Automotive Supplier”

Case Study

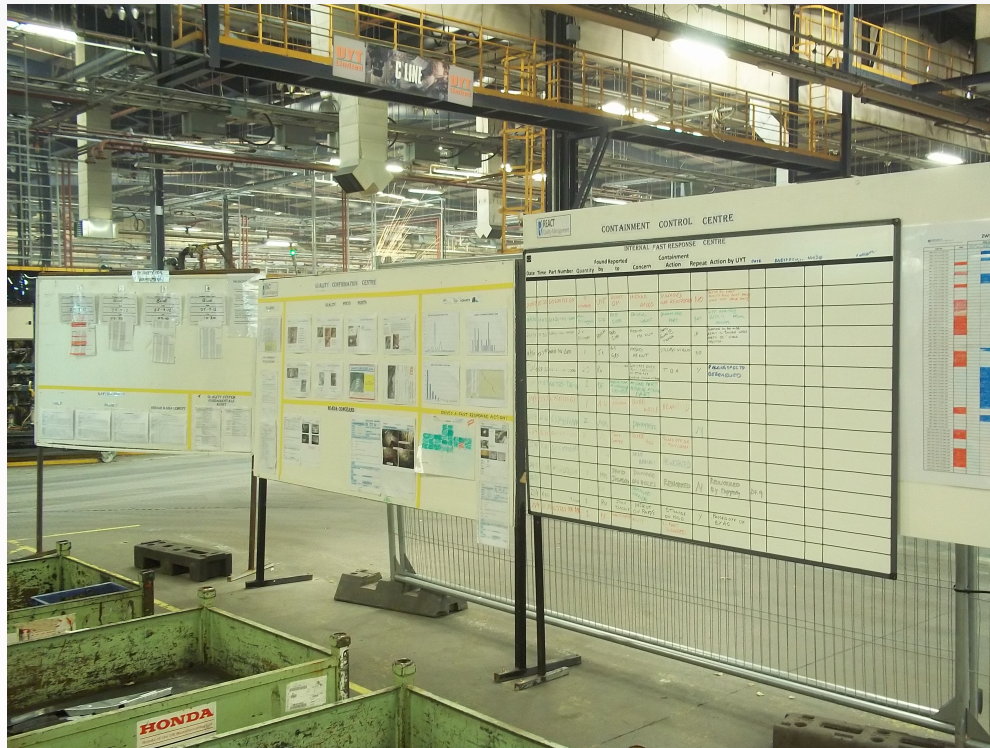
A communication centre was instigated into the area for both the REACT Inspectors and Company X associates to see the results of the DAM checks and to control and improve the results

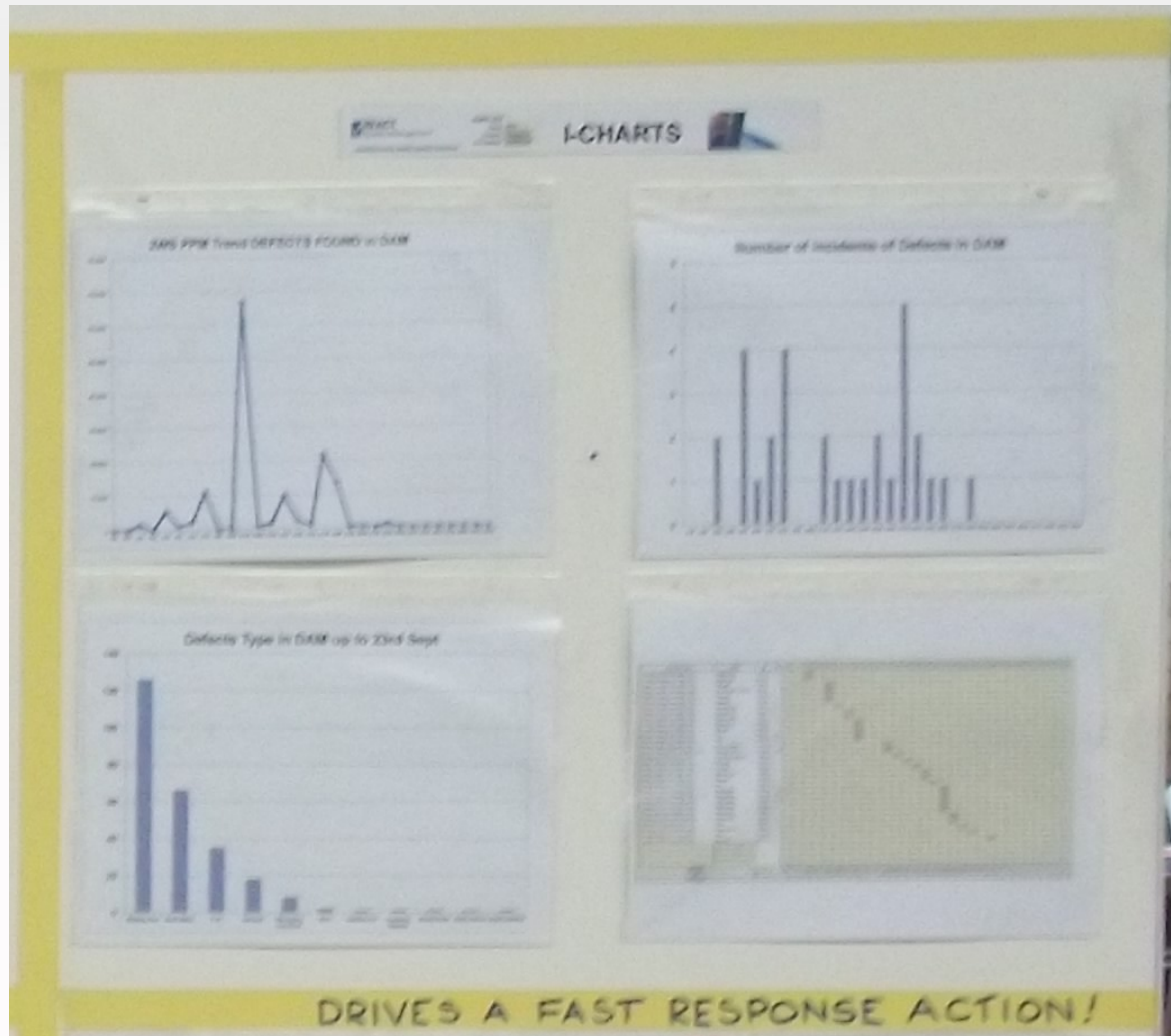
Results of DAM checks ,PPM, Defect type etc.
