BUILDING SURVEY REPORT

SURVEY DATE 23 Jan 2018

Etna Road, St. Albans

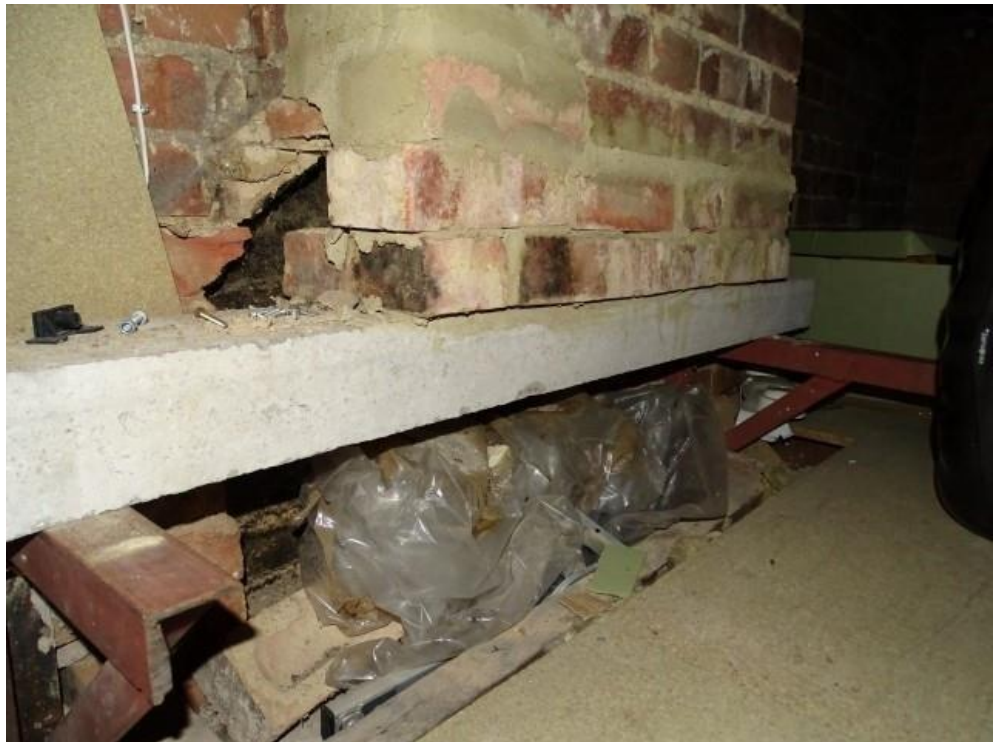
Condition	<p>All flashings, brickwork and pointing seen were in a fair condition.</p> <p>The pots are mostly uncapped and open to the elements. If any potsis left uncapped then rain can penetrate the flues and damp can appear inside the property on the breasts. Providing fireplaces are regularly used then any penetrating moisture will dry out, however if fireplaces are used infrequently then it would be prudent to provide rain cowls to allow flue gases to escape but prevent moisture ingress to the flue.</p>		
Action Required	<p>Some capping of the pots is required to prevent water penetration to the flues</p> <p>The chimney stack should be regularly monitored for any indications of damage, instability or other defects. Missing, loose or defective mortar should be re-pointed as necessary.</p>		
Additional Information	<p>The chimney breast has been removed in the bedroom above the dining room and as the loft has been converted I can not see how the chimney has been supported.</p>

Chimney stack supported in loft

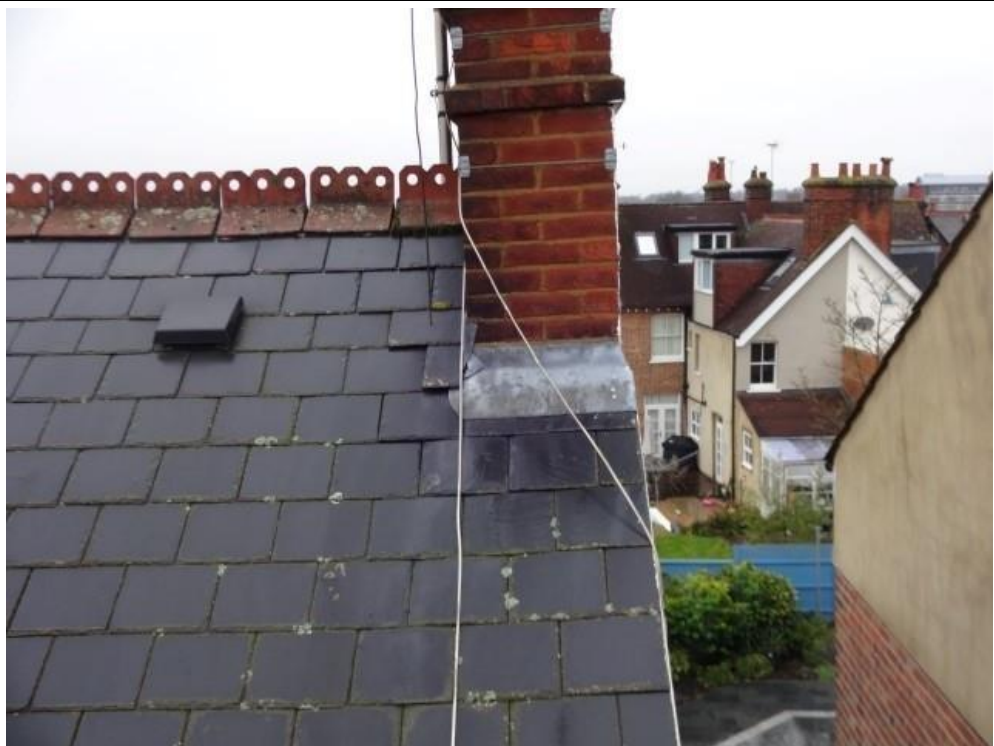
Front chimney

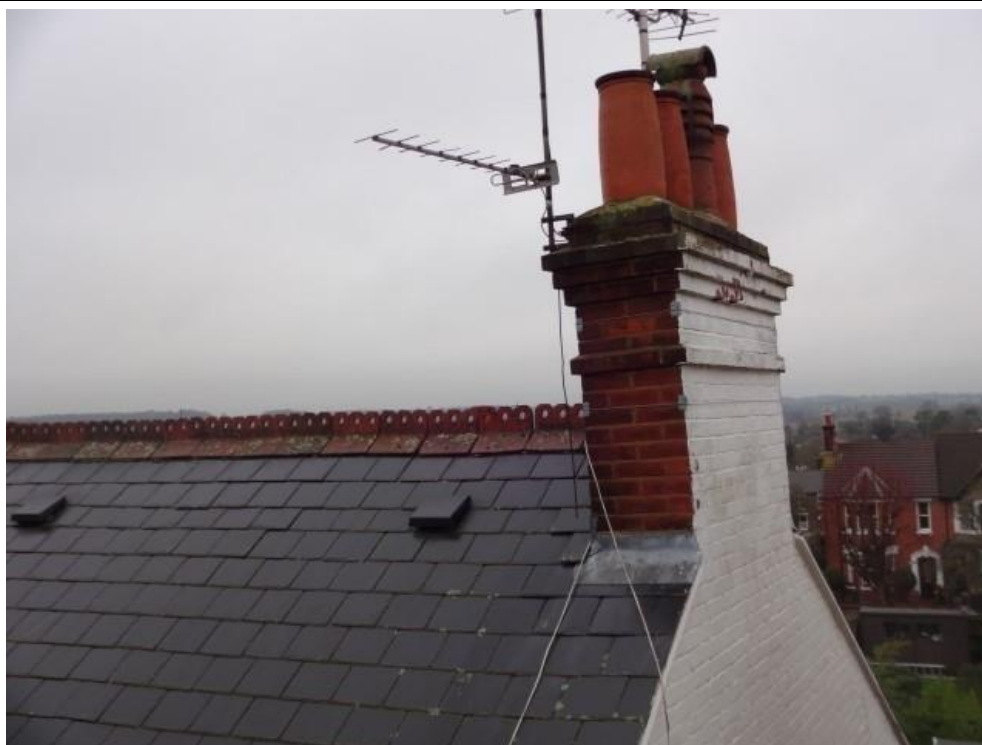
Front chimney stack

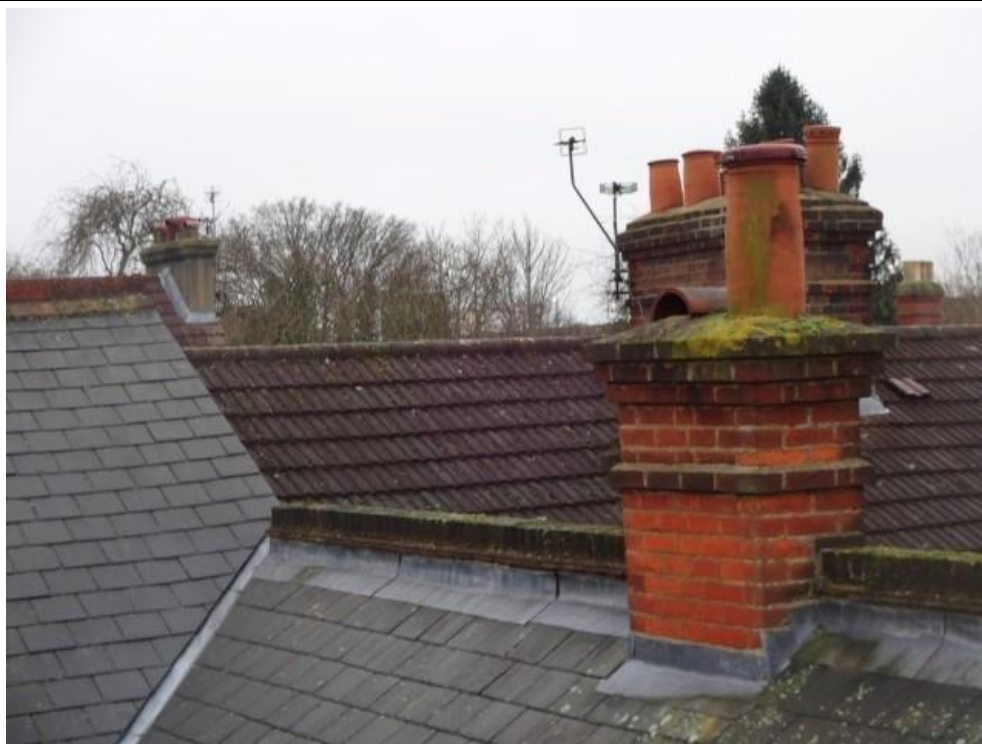
Rear redundant chimney stack

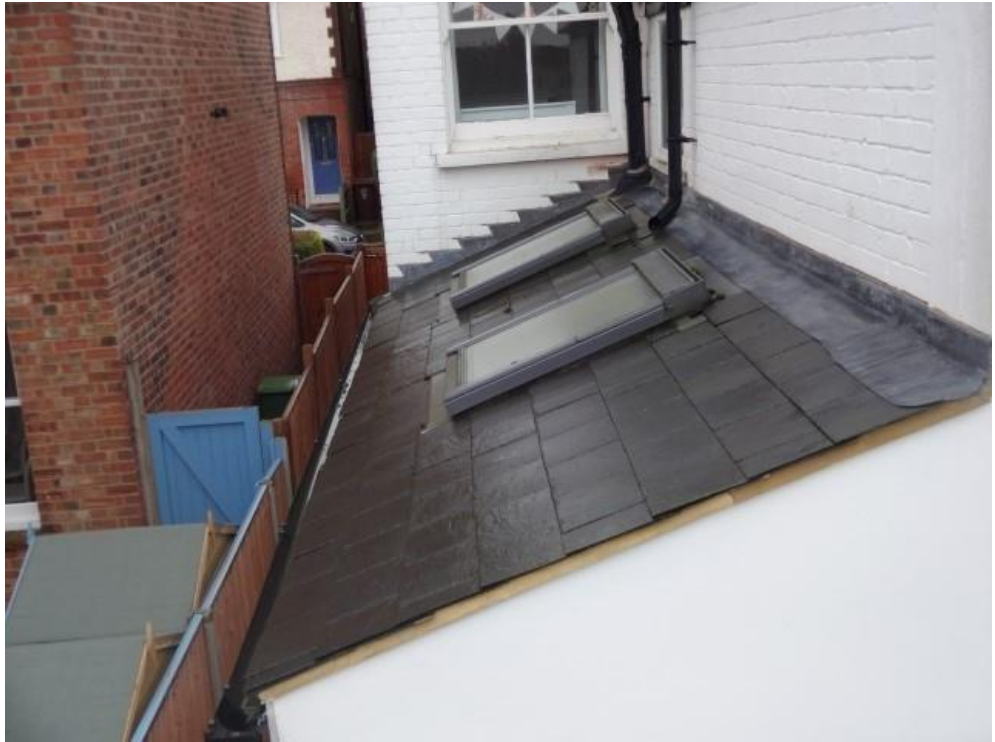
4.2 Roof Coverings	Condition rating	3
Construction & Type	The main roof slopes are pitched and covered with artificial tiles. All ridge tiles are clay, the valley gutters are swept and lined with lead.		
Nature of inspection and Limitations	The roof pitches were examined from ground level with the aid of binoculars and using a pole camera, where necessary for possible defects including sagging, collapse, broken/missing/damaged tiles, holes, and other evidence of failure.		
Condition	<p>Pitched Sections</p> <p>The majority of the slates seen were in a fair condition with no evidence of any major failures or defects. The mortar at the verges (side most run of tiles) is complete and intact with no evidence of any major weathering. The top line of ridge tiles is even with no evidence of any undue levels of flexing or bowing.</p> <p>The slates to the rear round the loft velux windows have slipped and are missing these will need to be replaced.</p>

Roof over kitchen

Action Required	<p>Pitched Sections: Carry out normal maintenance including removal of moss build-up.</p> <p>There are slipped and missing slates round the rear velux windows to the loft conversion these need to be replaced.</p> <p>Any slipped, missing or broken slates on the roof pitches should be repaired and replaced.</p> <p>You should carry out a thorough visual inspection at least once a year, ideally in the Spring to identify and repair any damage that could have been caused by winter weather. Any missing mortar at the verges and beneath any hip or ridge tiles should be replaced. Any moss or other accumulated plant matter should be cleared</p>

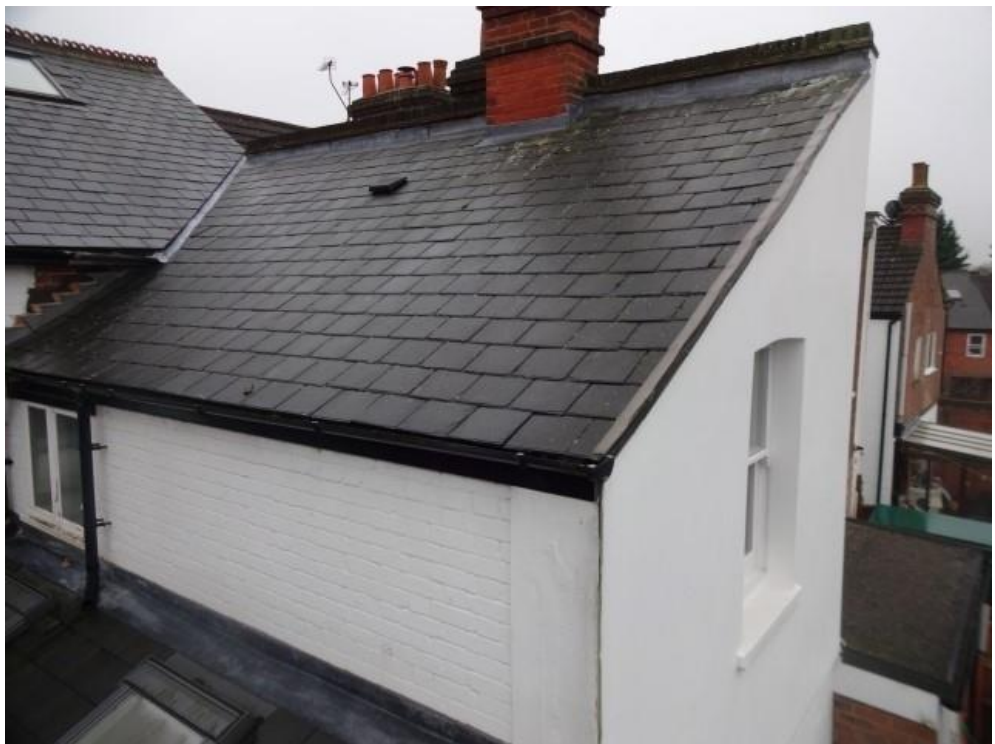
Roof over bathroom bedroom 3

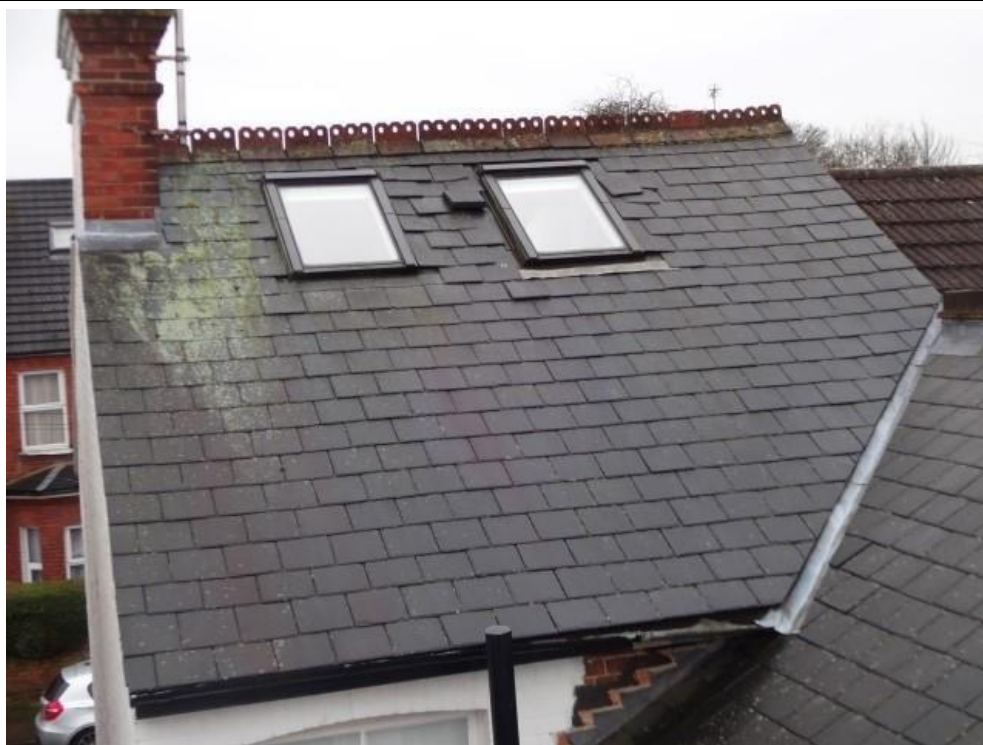
Roof over bedroom 2

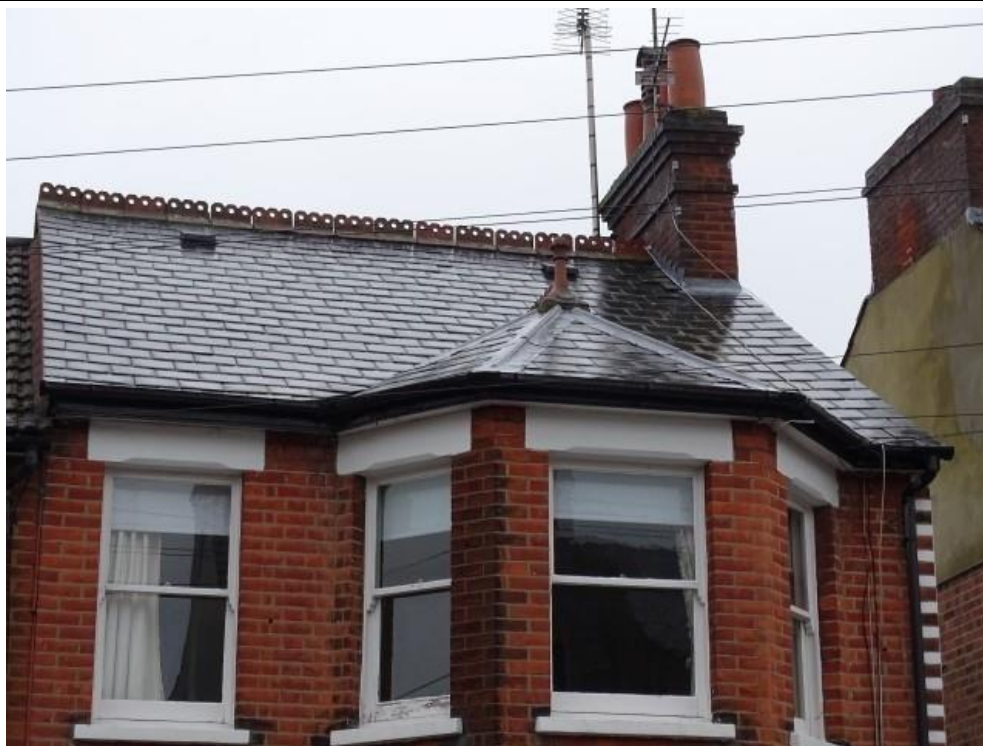
Front roof

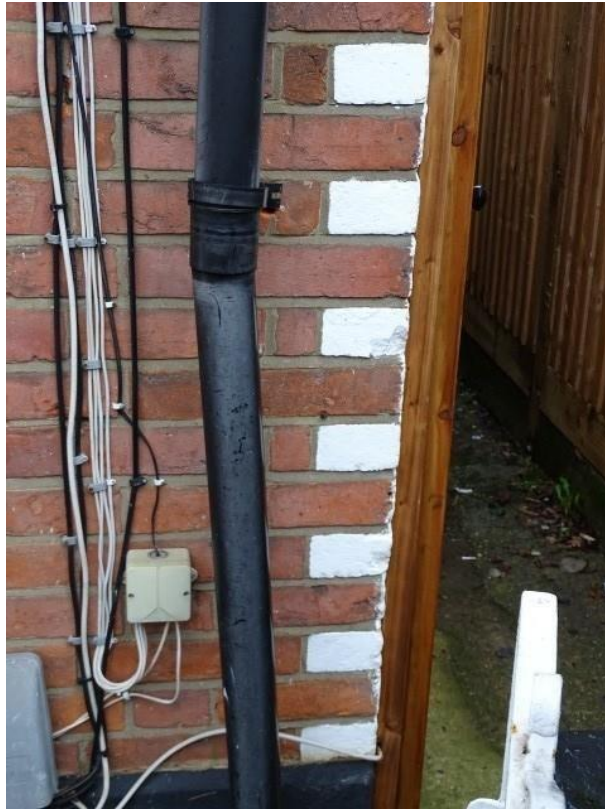
Condition	<p>The gutters are currently in fair condition and alignment. There were no significant leaks noted but all gutters require examining periodically and clearing of moss, leaves and silt which will inevitably accumulate.</p>		
Action Required	<p>Gutters and downpipes should be cleaned and inspected regularly to ensure that they are free from blockages and leaks. If it is noted during any heavy rain, that gutters or down pipe joints are leaking, then these must be fixed as soon as possible to prevent water penetration to the property and damage to the foundations.</p> <p>The front gutter down pipe needs refixing to the front wall.</p>

Front gutter down pipe

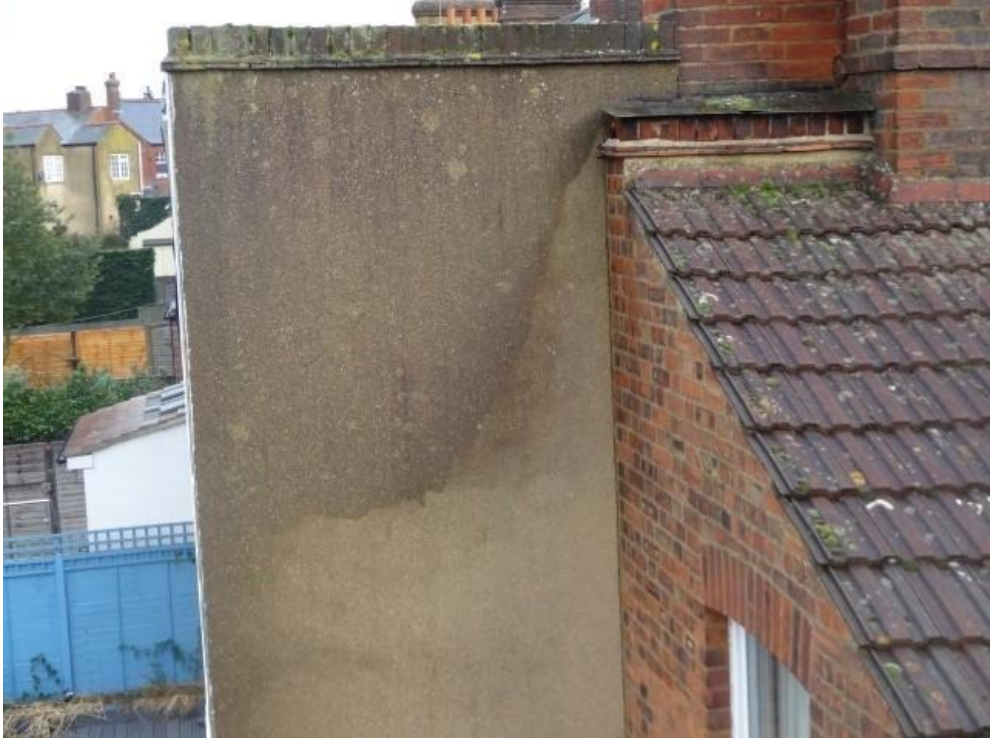
<p>Rear wall of Bedroom 3</p>

<p>Action Required</p>	<p>Walls should be examined regularly to inspect for changes in the nature of any cracking or other defects that may become apparent. The side rear wall of bedroom 3 is wet and soaking through the wall there is a crack in the render this render should be made water proof possibly by matching the render on the rear of the property.</p>

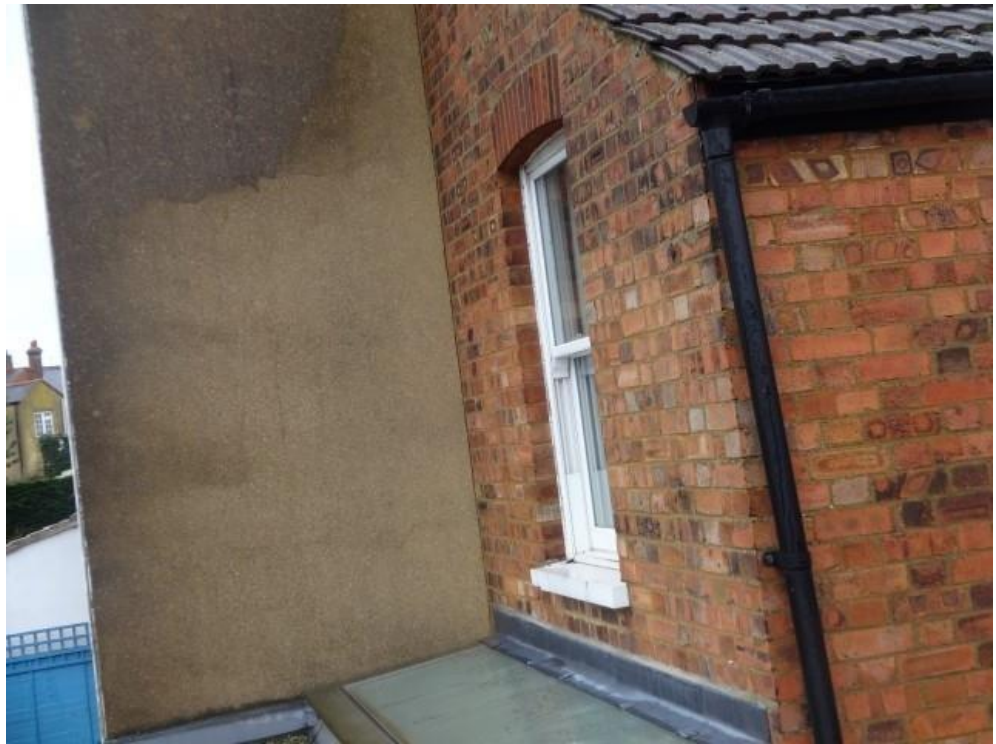
Next door in relation to rear bedroom 3 external wall

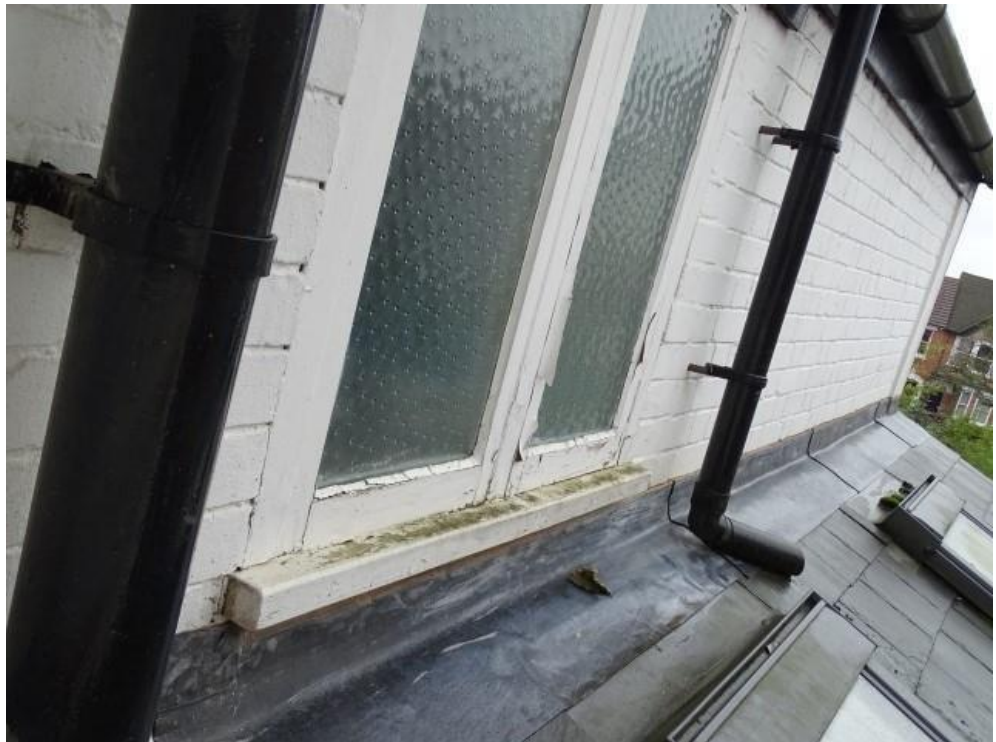
Bathroom fixed casement rotten

Action Required	<p>The bathroom fixed casement window is rotten and the opening casement needs easing, it would be better to replace this window. There is rot to the bottom frame of the right hand bay window in bedroom</p> <p>one. Normal maintenance of frames, hinges and locks is required.</p> <p>Be aware that previous owners may have distributed multiple sets of keys for the windows and doors to individuals not known to you. When purchasing a property, you should consider the cost of replacing all of the door and window locks as soon as possible after you take up occupation. When doing this you should consult your insurers to ensure that you meet their requirements for security, and obtain any discounts that may be available by improving the security of the property.</p>

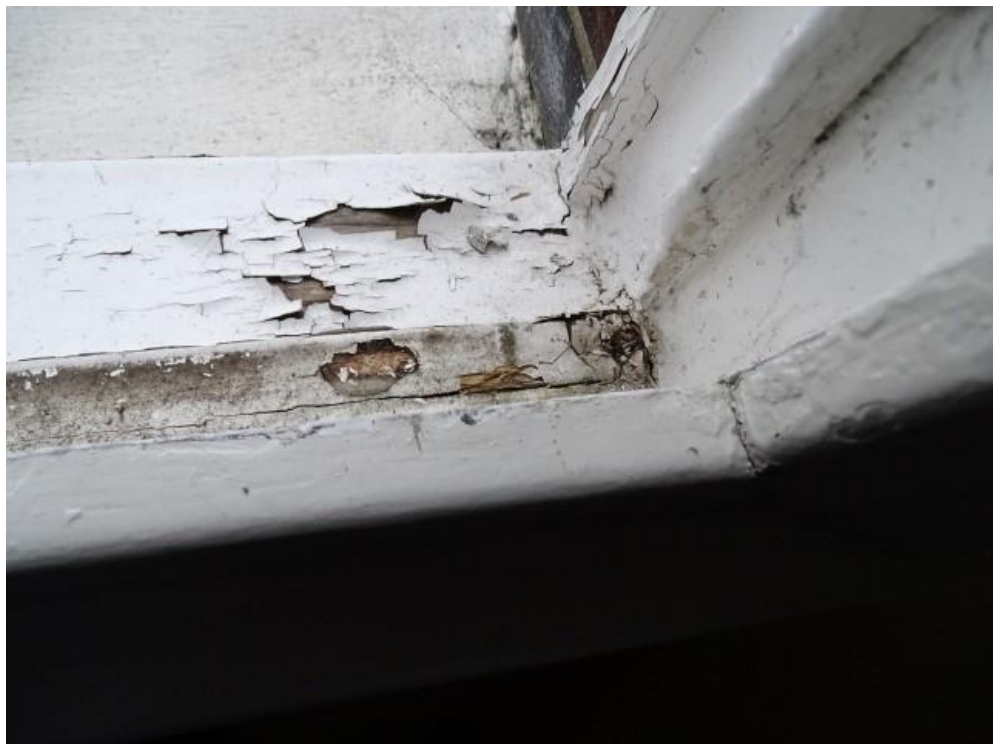
Bedroom 1 bottom sash frame rotten

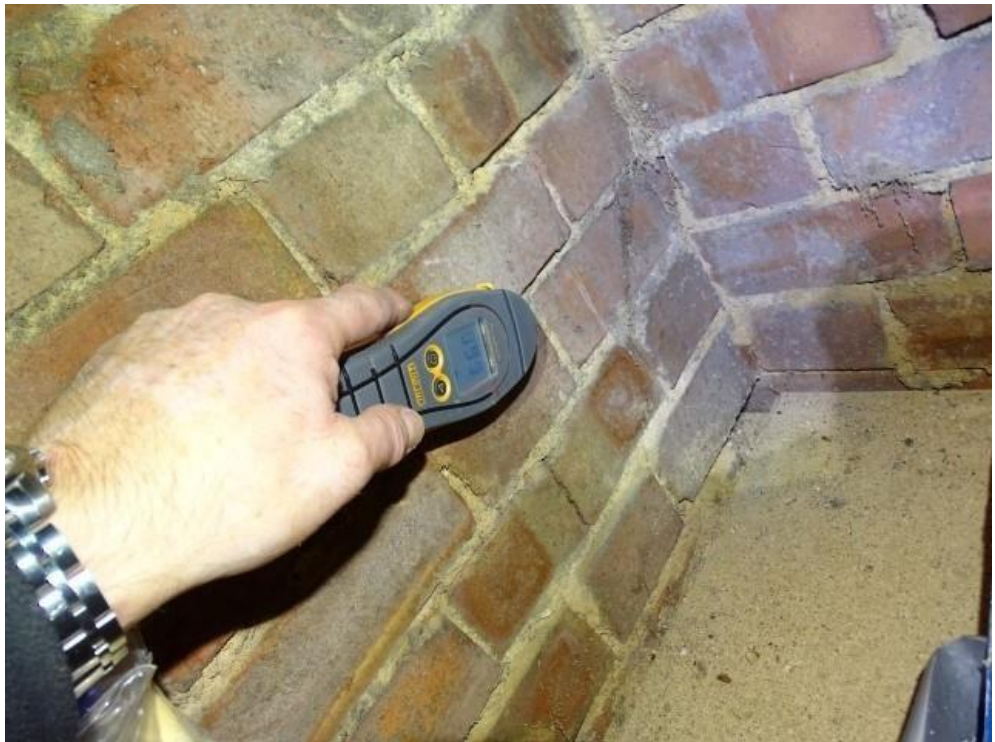
Wet wall in loft above bedroom 3

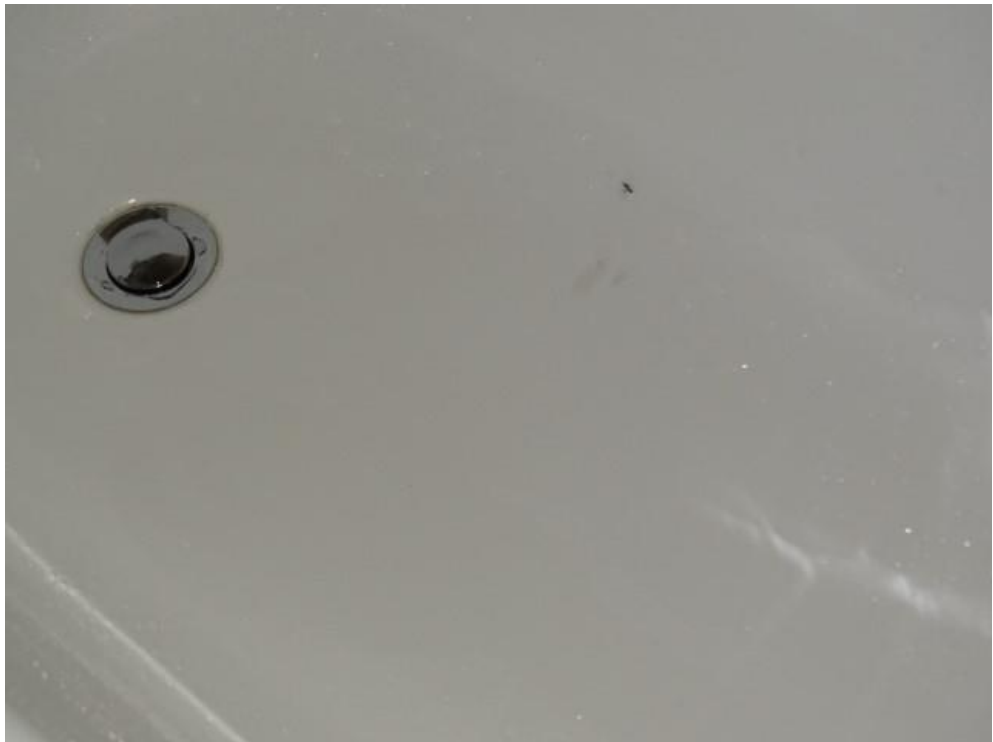
Chip in bath enamel

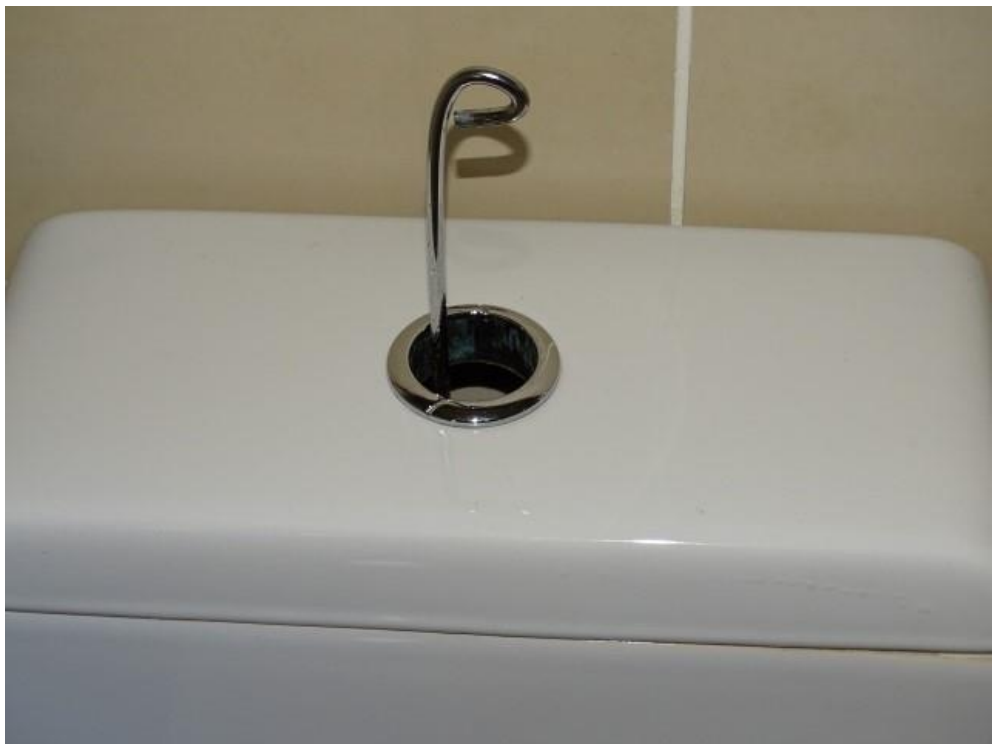
Flush mechanism button broken
