**Project Information**Project Name  
**Brunel House**

Date:  
**04/05/2017**

# Site Report

We attended site to conduct a CCTV drain survey of all underground drains, to provide drawings outlining their locations and to provide recommendations for remedial works that may be required.

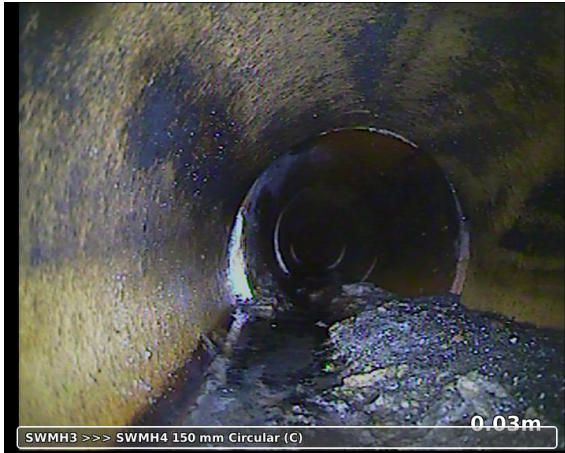
, 00:00:21, 0.03m  
Attached deposits other from/at 4 o'clock to 7 o'clock 20 % cross-sectional area loss

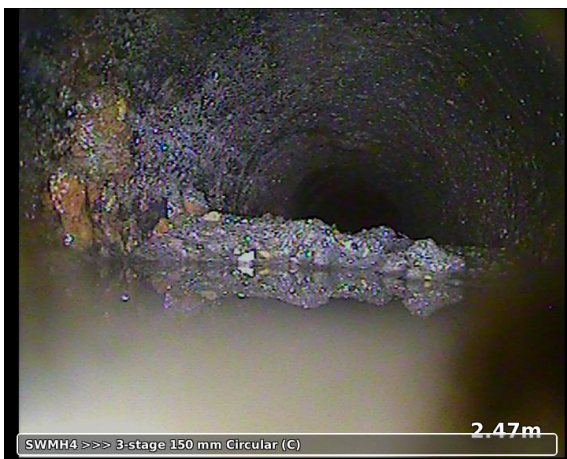
Three stage petrol interceptor requires emptying using tanker as sludge build-up is blocking the discharge of the first pit.

, 00:00:32, 2.47m  
Survey abandoned / Water level in interceptor too high

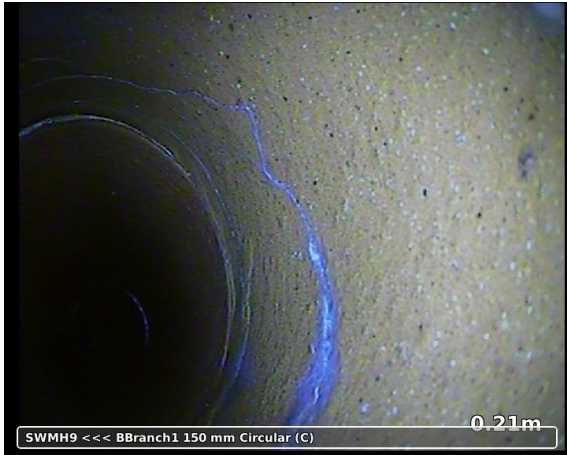
150mm drain run taking gully is fractured in two separate places and requires relining to prevent future damage approx. 8 metres in length.

, 00:00:12, 0.21m  
Fracture circumferential at joint from/at 1 o'clock to 12 o'clock

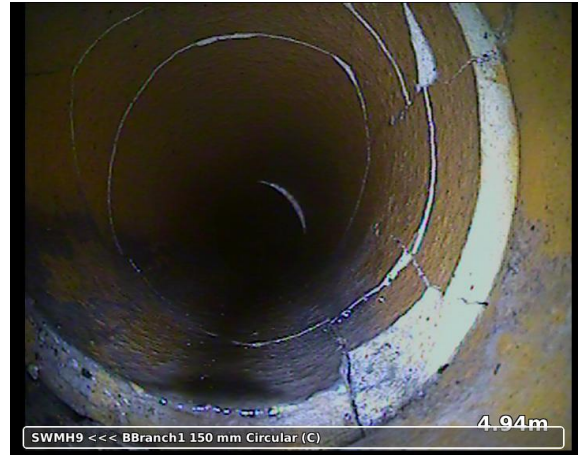
<table><tr> <td style="width: 10%;">0.00</td> <td style="width: 10%;">MH</td> <td style="width: 45%;">Start node type manhole reference number: SWMH9</td> <td style="width: 10%;">00:00:01</td> <td style="width: 10%;"></td> <td style="width: 10%;">0</td> </tr><tr> <td>4.94</td> <td>CM</td> <td>Cracks multiple from/at 1 o'clock to 12 o'clock</td> <td>00:00:35</td> <td></td> <td>1</td> </tr></table>

, 00:00:35, 4.94m  
Cracks multiple from/at 1 o'clock to 12 o'clock

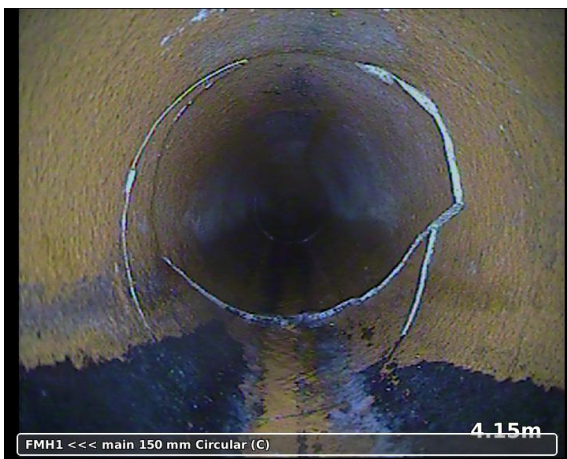
150mm Main run is fractured at 4.15metres and requires a patch liner.

, 00:00:47, 4.15m  
Cracks multiple from/at 1 o'clock to 12 o'clock

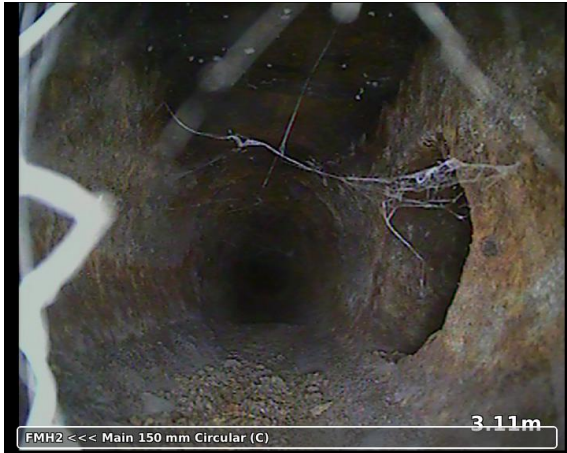
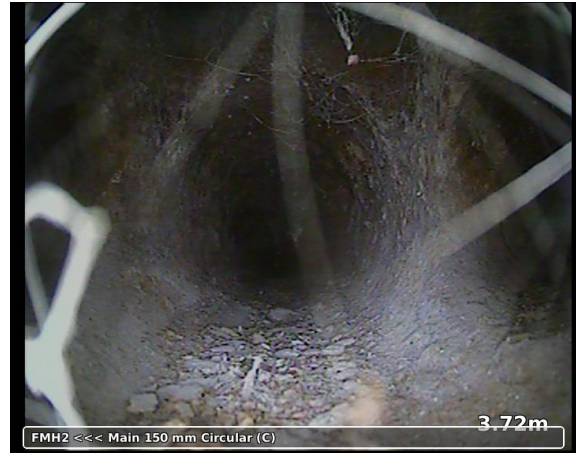
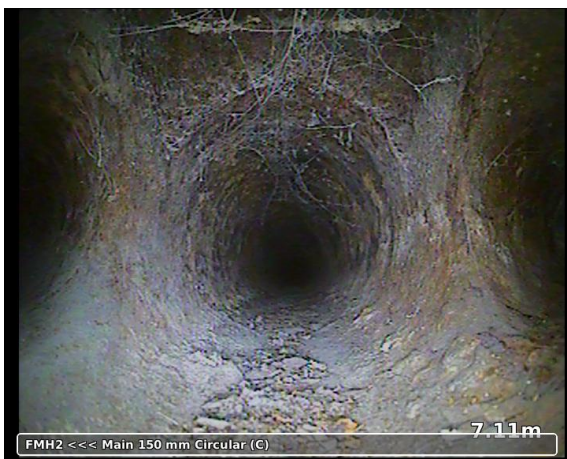
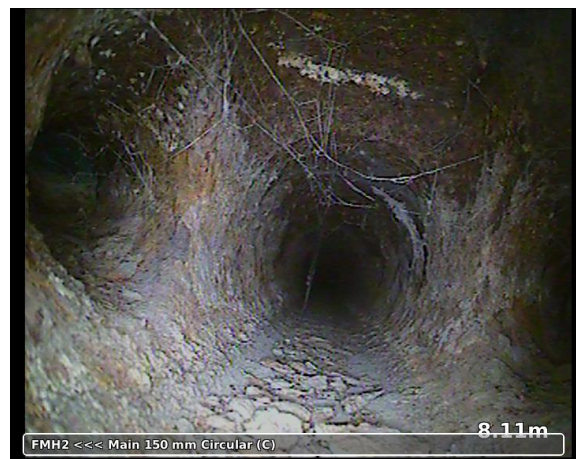
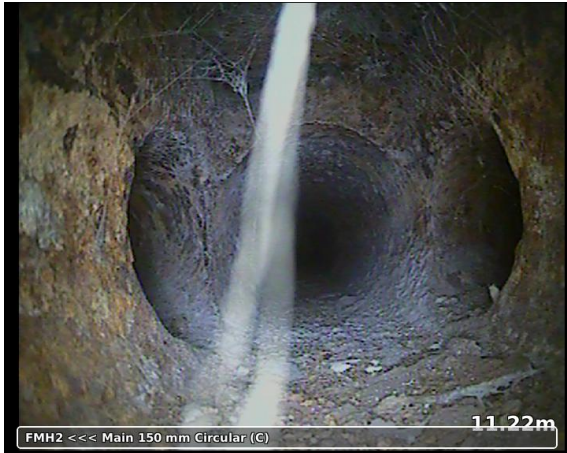
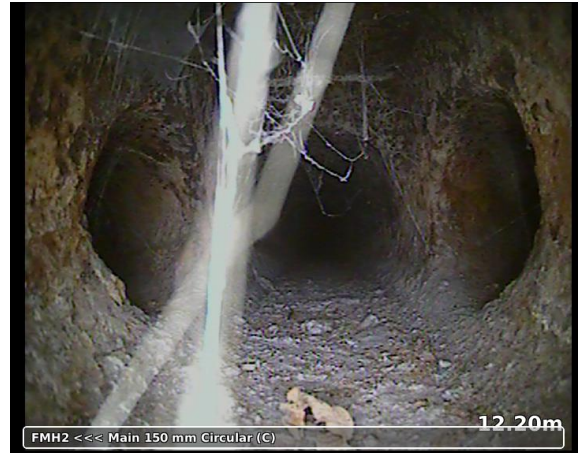
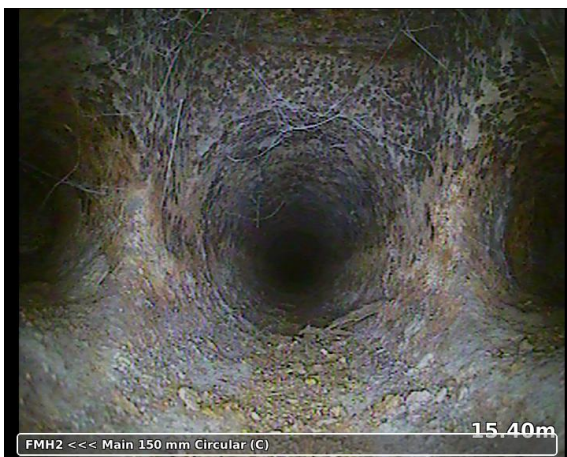
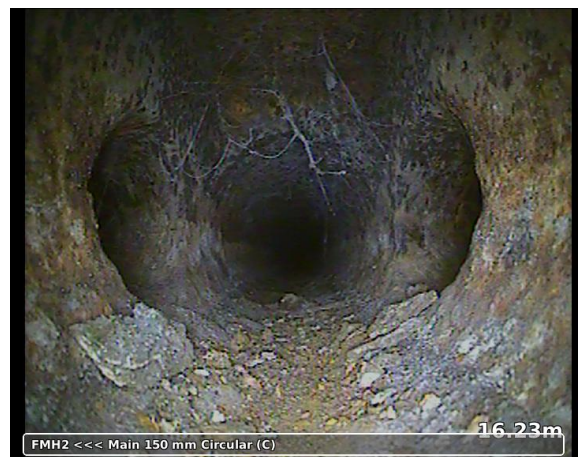
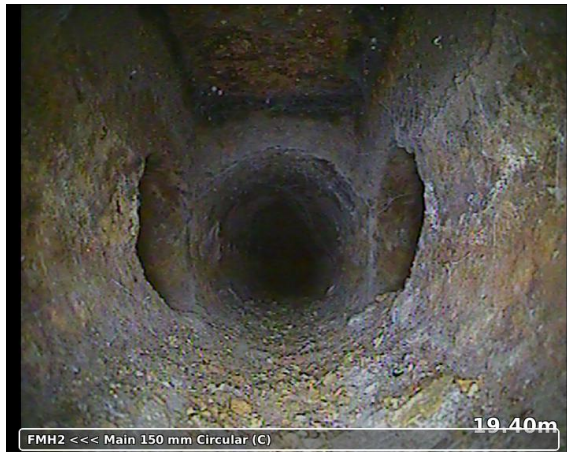
The internal foul drainage system is made of cast iron, access to some internal junctions are via burns chambers although only one chamber is accessible via an inspection cover, others appear to have been covered over with cement/screed (see drawing).

, 00:00:27, 3.11m  
General remark / Enters hidden burns chamber

, 00:00:41, 3.72m  
General remark / Enters hidden burns chamber

, 00:01:06, 7.11m  
General remark / enters hidden burns chamber

, 00:01:14, 8.11m  
General remark / enters hidden burns chamber

, 00:01:28, 11.22m  
General remark / Enters hidden burns chamber

, 00:01:36, 12.20m  
General remark / Enters hidden burns chamber

, 00:01:51, 15.40m  
General remark / Enters hidden burns chamber

, 00:01:59, 16.23m  
General remark / Enters hidden burns chamber

, 00:02:11, 19.40m  
General remark / Enters hidden burns chamber

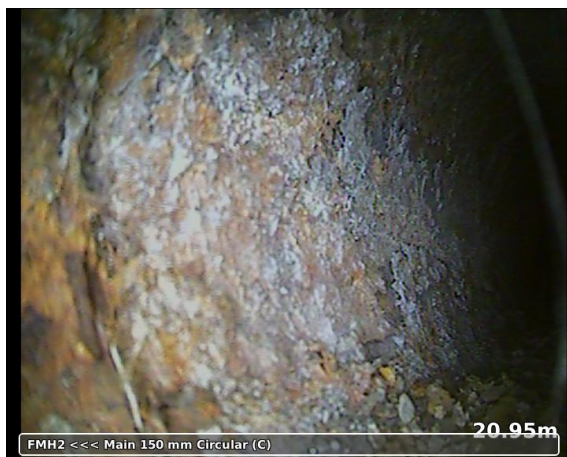
, 00:02:43, 20.95m  
Survey abandoned / Unable to push past bend
