MANAGEMENT ASBESTOS SURVEY REPORT

SURVEY REPORT WITH MATERIAL ASSESSMENT

Survey Type: Management Survey

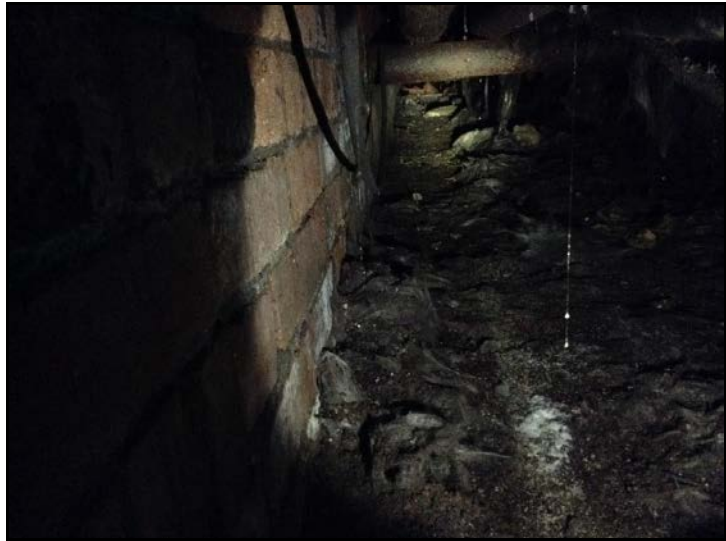
Site ID xxxxxx
 Location ID 003
 Building/Unit Site Name
 Floor -1 (Basement)
 Room / Area Void
 Description Paper Lining Debris
 Surveyed Yes
 Source of Information Name of Surveyor
 Last Inspection Date Xx/xx/xxxx
 Lab Reference Xxxxxx/xxxxxx
 Survey Type Management
 Sample Number xxxxxx/S09

MATERIAL ASSESSMENT = 7

Recommendations **The paper lining debris needs to be removed by a licensed removal company under controlled conditions as a priority.**

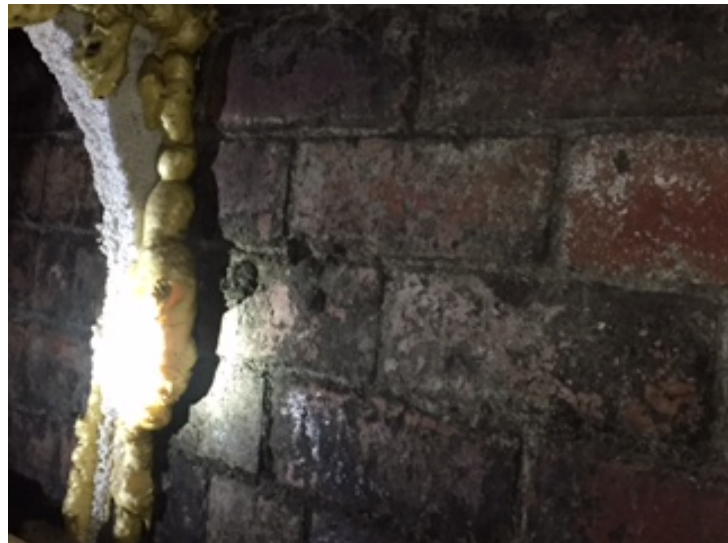
Site ID xxxxxx
Location ID 003
Building/Unit Site Name
Floor -1 (Basement)
Room / Area Void
Description Residue to Wall
Surveyed Yes
Source of Information Name of Surveyor
Last Inspection Date Xx/xx/xxxx
Lab Reference Xxxxxx/xxxxxx
Survey Type Management
Sample Number xxxxxx/S10

MATERIAL ASSESSMENT = 11

Building / Unit	Floor	Location	Item Description	Recommendations
Site Name	-1 (Basement)	003 - Void	Residue to Wall - Insulation	REMOVE / ENVIRONMENTAL CLEAN (RESIDUE) - The insulation residue needs to be removed and the area environmentally cleaned by a licensed removal company prior to the commencement of any works on site.
Site Name	-1 (Basement)	003 - Void	Paper Lining Debris - Paper Product	REMOVE - The paper lining debris needs to be removed by a licensed removal company under controlled conditions as a priority.
Site Name	-1 (Basement)	003 - Void	Paper Lining Remnants to Pipes - Paper Product	REMOVE (PAPER LINING) - The paper lining remnants need to be removed by a licensed removal company under controlled conditions as a priority.
Site Name	-1 (Basement)	004 - Compressor Room	Gasket Remnants to Pipe - Gaskets (Compressed)	REMOVE (GASK TO PIPE) - The pipe gasket remnants need to be removed by suitably trained persons under controlled conditions using HSE Guidelines prior to the commencement of any works.

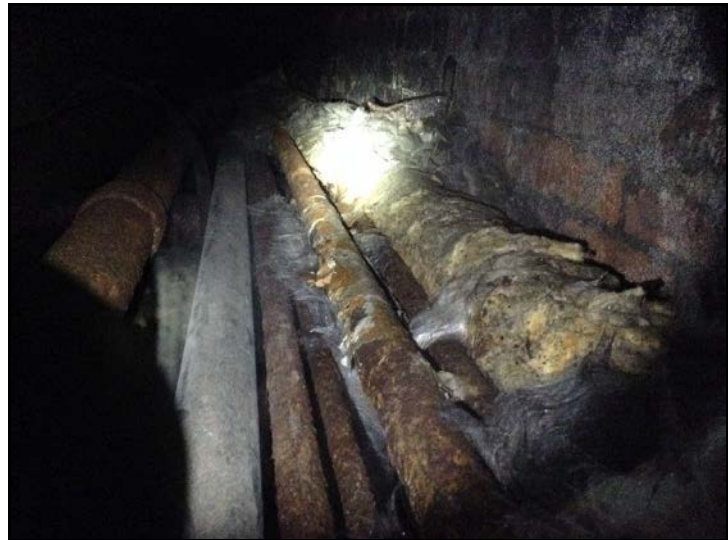
Site ID xxxxxx
Location ID 003
Building/Unit Site Name
Floor -1 (Basement)
Room / Area Void
Description Paper Lining Remnants to Pipes
Surveyed Yes
Source of Information Name of Surveyor
Last Inspection Date Xx/xx/xxxx
Lab Reference Xxxxxx/xxxxxx
Survey Type Management
Sample Number xxxxxx/S08

MATERIAL ASSESSMENT = 7

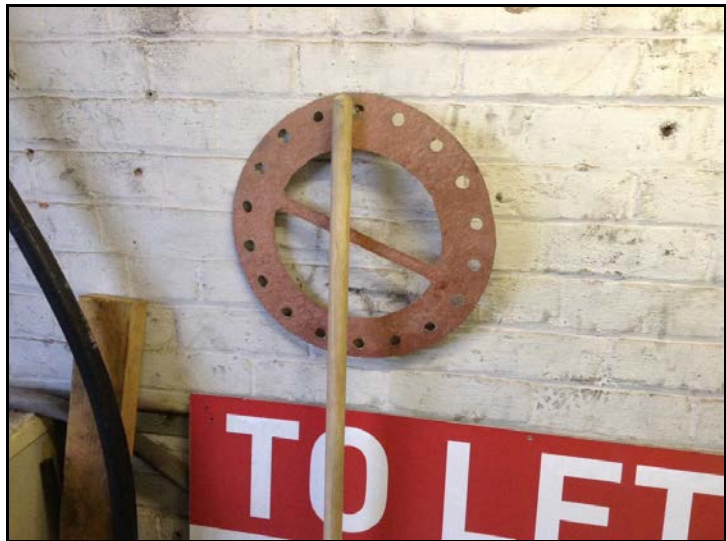
Site ID xxxxxx
 Location ID 004
 Building/Unit Site Name
 Floor -1 (Basement)
 Room / Area Compressor Room
 Description Loose Gasket
 Surveyed Yes
 Source of Information Luke Poston
 Last Inspection Date Xx/xx/xxxx
 Lab Reference Xxxxxx/xxxxxx
 Survey Type Management
 Sample Number xxxxxx/S02

MATERIAL ASSESSMENT = 4

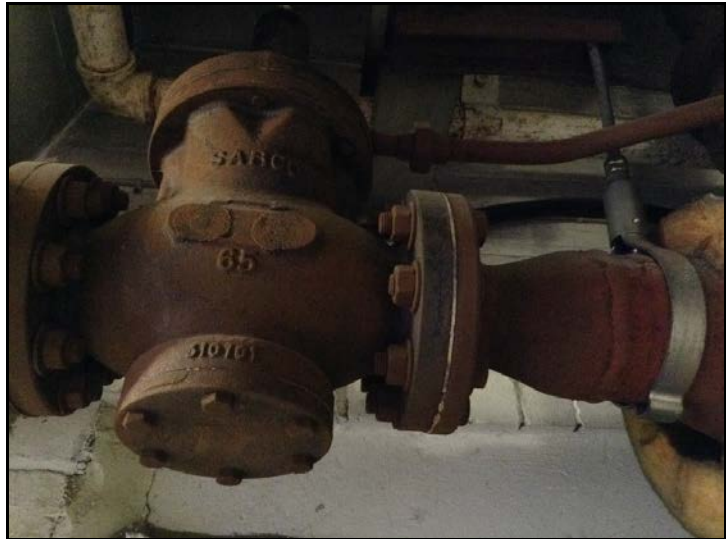
Site ID xxxxxx
 Location ID 004
 Building/Unit Site Name
 Floor -1 (Basement)
 Room / Area Compressor Room
 Description Gaskets to Pipes
 Surveyed Yes
 Source of Information Name of Surveyor
 Last Inspection Date Xx/xx/xxxx
 Lab Reference
 Survey Type Management
 Sample Number xxxxxx/X01

MATERIAL ASSESSMENT = 4

Site Name	-1 (Basement)	004 - Compressor Room	Gaskets to Pipes - Gaskets (Compressed)	MANAGE (GASK TO PIPE) - The gaskets to the pipework are in good condition and can remain in-situ if required. A management plan needs to be put in place to monitor the gaskets on a regular basis for any signs of deterioration or damage. Should any damage occur then the gaskets need to be repaired or removed by suitably trained persons under controlled conditions using HSE Guidelines.
Site Name	-1 (Basement)	004 - Compressor Room	Loose Gasket - Gaskets (Compressed)	REMOVE - The loose gasket needs to be removed by suitably trained persons under controlled conditions using HSE Guidelines prior to the commencement of any works.

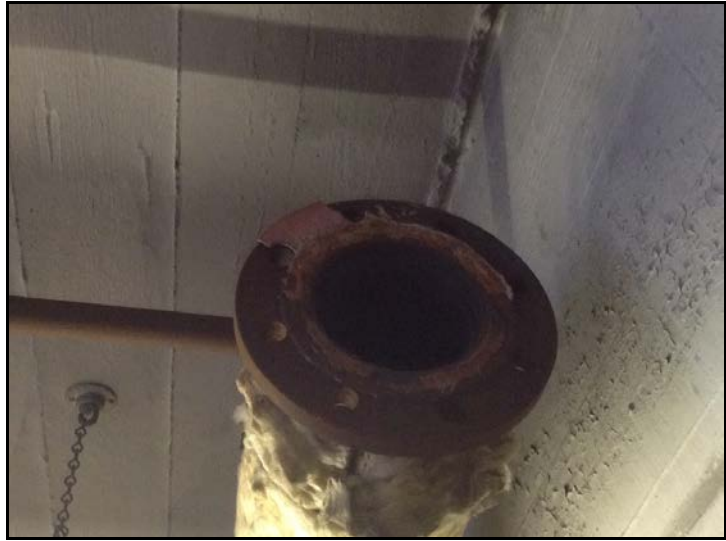
Site ID xxxxxx
Location ID 004
Building/Unit Site Name
Floor -1 (Basement)
Room / Area Compressor Room
Description Gasket Remnants to Pipe
Surveyed Yes
Source of Information Name of Surveyor
Last Inspection Date Xx/xx/xxxx
Lab Reference Xxxxxx/xxxxxx
Survey Type Management
Sample Number xxxxxx/S01

MATERIAL ASSESSMENT = 6

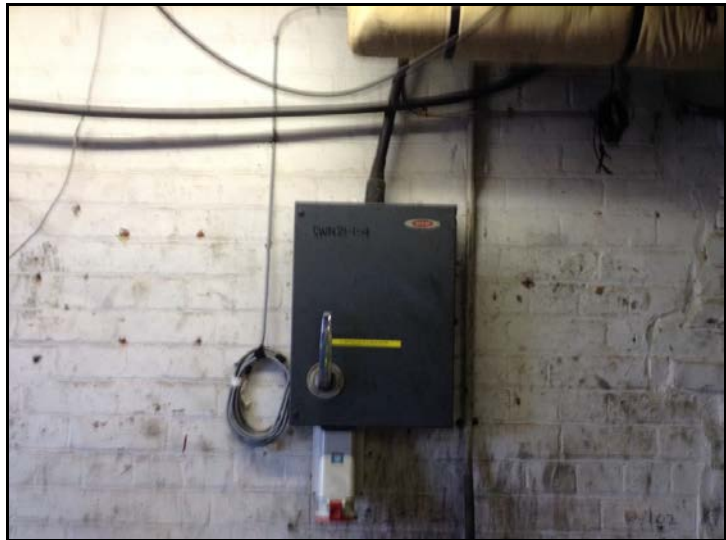
Site ID xxxxxx
 Location ID 004
 Building/Unit Site Name
 Floor -1 (Basement)
 Room / Area Compressor Room
 Description Fuse Box "Flash Pads"
 Surveyed Yes
 Source of Information Name of Surveyor
 Last Inspection Date Xx/xx/xxxx
 Lab Reference
 Survey Type Management
 Sample Number xxxxxx/X06

MATERIAL ASSESSMENT = 4

Building / Unit	Floor	Location	Item Description	Recommendations
Site Name	-1 (Basement)	004 - Compressor Room	Fuse Box "Flash Pads" - Woven Product	MANAGE (FLASH PADS) - The fuse box 'flash pads' appear to be in good condition and can remain in-situ if required. A management plan needs to be put in place to monitor the flash pads on a regular basis for any signs of deterioration or damage. Should any damage occur then the fuse box along with the internal flash pads will need to be removed complete by suitably trained persons under controlled conditions using HSE Guidelines.
Site Name	-1 (Basement)	005 - Compressor Room	Fuse Box "Flash Pads" - Woven Product	MANAGE (FLASH PADS) - The fuse box 'flash pads' appear to be in good condition and can remain in-situ if required. A management plan needs to be put in place to monitor the flash pads on a regular basis for any signs of deterioration or damage. Should any damage occur then the fuse box along with the internal flash pads will need to be removed complete by suitably trained persons under controlled conditions using HSE Guidelines.

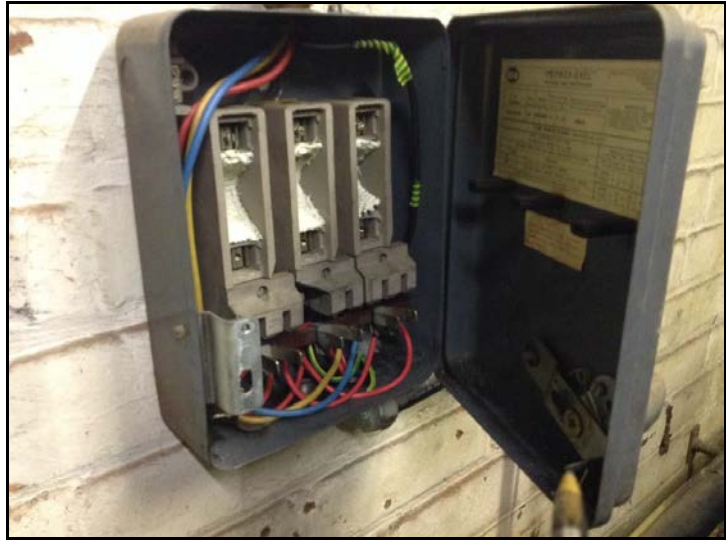
Site ID xxxxxx
 Location ID 005
 Building/Unit Site Name
 Floor -1 (Basement)
 Room / Area Compressor Room
 Description Fuse Box "Flash Pads"
 Surveyed Yes
 Source of Information Name of Surveyor
 Last Inspection Date Xx/xx/xxxx
 Lab Reference Xxxxxx/xxxxxx
 Survey Type Management
 Sample Number xxxxxx/S06

MATERIAL ASSESSMENT = 4

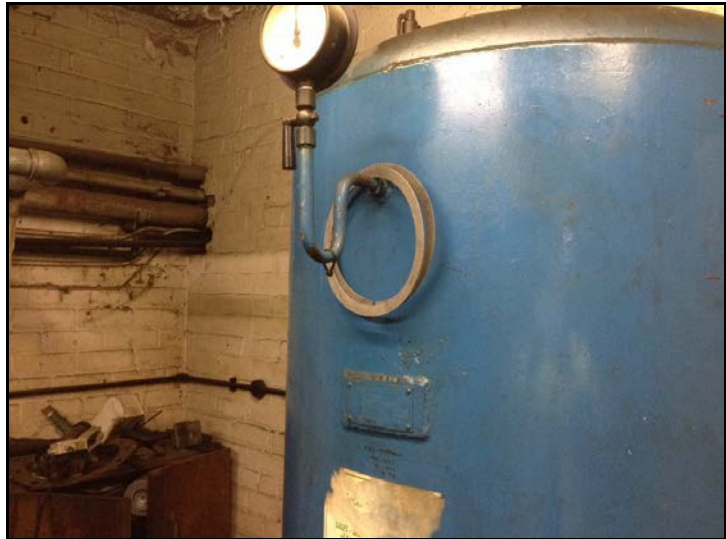
Site ID xxxxxx
Location ID 005
Building/Unit Site Name
Floor -1 (Basement)
Room / Area Compressor Room
Description Loose Gaskets
Surveyed Yes
Source of Information Name of Surveyor
Last Inspection Date Xx/xx/xxxx
Lab Reference Xxxxxx/xxxxxx
Survey Type Management
Sample Number xxxxxx/S04

MATERIAL ASSESSMENT = 4

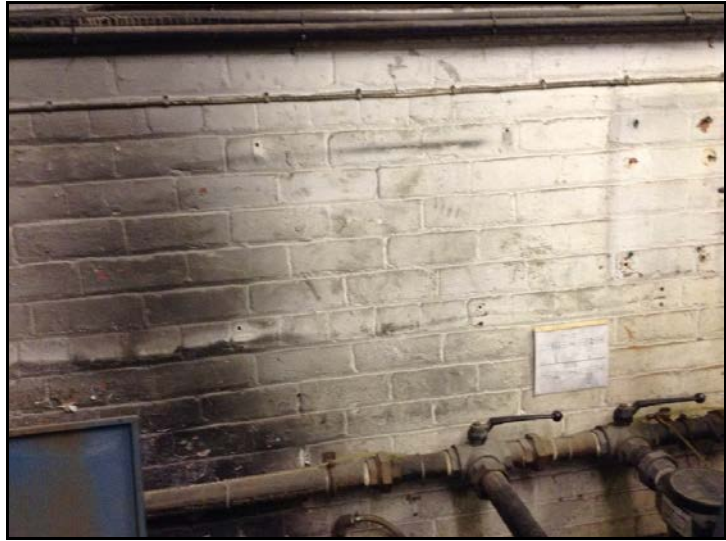
Site ID xxxxxx
 Location ID 005
 Building/Unit Site Name
 Floor -1 (Basement)
 Room / Area Compressor Room
 Description Insulation Residue to Walls
 Surveyed Yes
 Source of Information Name of Surveyor
 Last Inspection Date Xx/xx/xxxx
 Lab Reference Xxxxxx/xxxxxx
 Survey Type Management
 Sample Number xxxxxx/S07

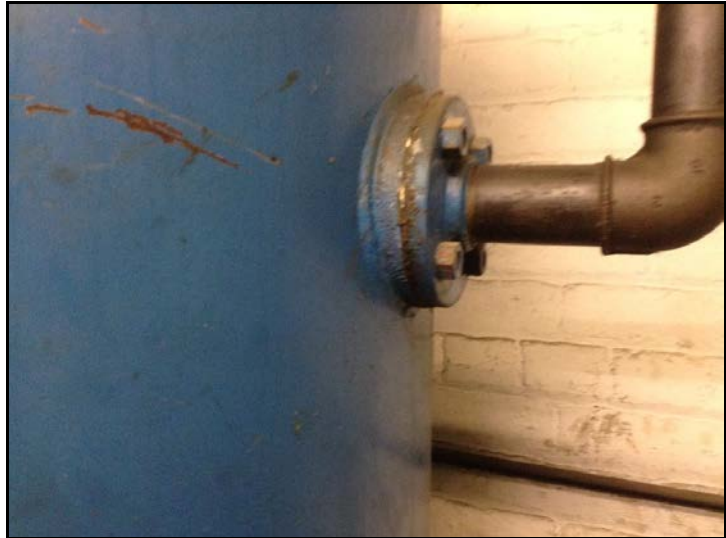
Site ID xxxxxx
 Location ID 005
 Building/Unit Site Name
 Floor -1 (Basement)
 Room / Area Compressor Room
 Description Gaskets to Pressure Vessel
 Surveyed Yes
 Source of Information Name of Surveyor
 Last Inspection Date Xx/xx/xxxx
 Lab Reference Xxxxxx/xxxxxx
 Survey Type Management
 Sample Number xxxxxx/S05

MATERIAL ASSESSMENT = 4

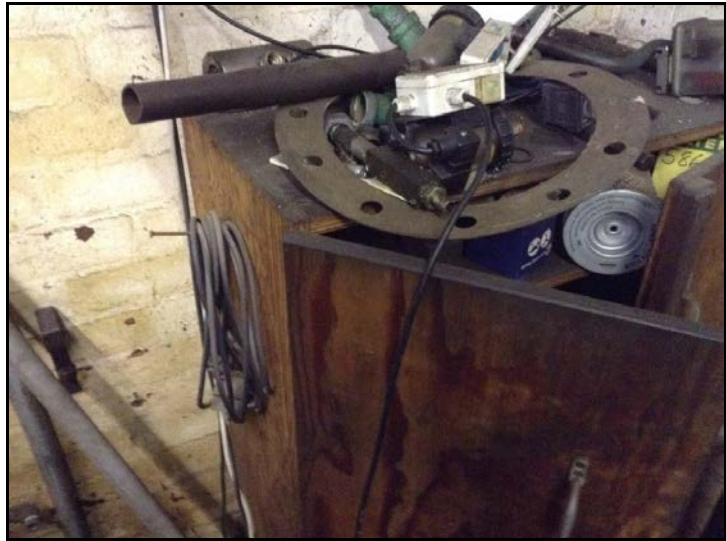
Site ID xxxxxx
 Location ID 005
 Building/Unit Site Name
 Floor -1 (Basement)
 Room / Area Compressor Room
 Description Loose Gasket
 Surveyed Yes
 Source of Information Name of Surveyor
 Last Inspection Date Xx/xx/xxxx
 Lab Reference Xxxxxx/xxxxxx
 Survey Type Management
 Sample Number xxxxxx/S03

MATERIAL ASSESSMENT = 4

Site Name	-1 (Basement)	005 - Compressor Room	Loose Gasket - Gaskets (Compressed)	REMOVE - The loose gasket needs to be removed by suitably trained persons under controlled conditions using HSE Guidelines prior to the commencement of any works.
Site Name	-1 (Basement)	005 - Compressor Room	Loose Gaskets - Gaskets (Compressed)	REMOVE - The loose gaskets need to be removed by suitably trained persons under controlled conditions using HSE Guidelines prior to the commencement of any works.
Site Name	-1 (Basement)	005 - Compressor Room	Gaskets to Pressure Vessel - Gaskets (Compressed)	MANAGE - The gaskets need to be removed by suitably trained persons under controlled conditions using HSE Guidelines prior to the commencement of any works.
Site Name	0 (Ground)	007 - Offices Ceiling Void	Ceiling Boards & Cladding - Insulating Board	ENCAPSULATE/ MANAGE/ LABEL (AIB) - The asbestos boards are in a damaged condition. They need to be repaired and encapsulated by a licensed removal company. A management plan should then be put in place to monitor the boards on a regular basis for any signs of further deterioration or damage. Should any further damage occur then the boards will need to be repaired or removed by a licensed removal company as a priority. Labelling of the boards left in-situ is also recommended.

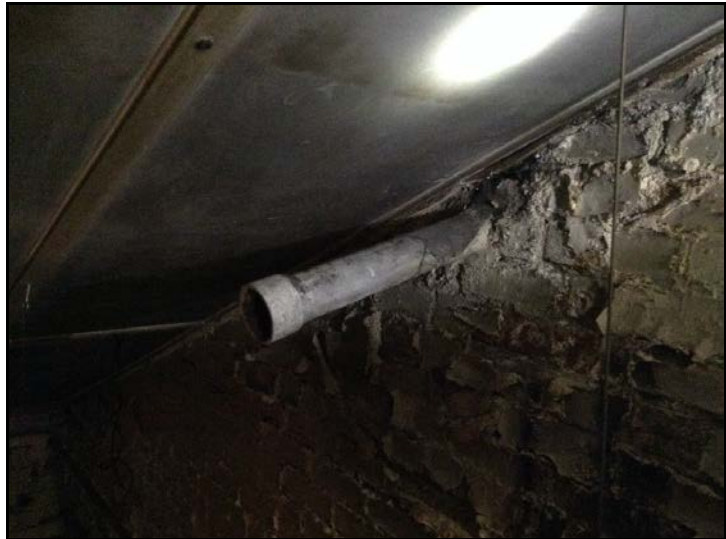
Site ID xxxxxx
Location ID 007
Building/Unit Site Name
Floor 0 (Ground)
Room / Area Offices Ceiling Void
Description Flue Pipe
Surveyed Yes
Source of Information Name of Surveyor
Last Inspection Date Xx/xx/xxxx
Lab Reference Xxxxxx/xxxxxx
Survey Type Management
Sample Number xxxxxx/S12

MATERIAL ASSESSMENT = 4

Building / Unit	Floor	Location	Item Description	Recommendations
Site Name	0 (Ground)	007 - Offices Ceiling Void	Flue Pipe - Cement Product	MANAGE (AC) - GOOD - The asbestos cement is in a good condition and can remain in-situ if required. A management plan needs to be put in place to monitor the cement on a regular basis for any signs of deterioration or damage. Should any damage occur, then repair or removal by suitably trained persons under controlled conditions should be considered.
Site Name	0 (Ground)	025 - Loading	Patch Board - Insulating Board	MANAGE (AIB BOARD - SINGULAR) - The asbestos board is in good condition and can remain in-situ if required. A management plan needs to be put in place to monitor the board on a regular basis for any signs of deterioration or damage. Should any damage occur then repair or removal by a licensed removal company should be considered.
Site Name	1 (1st Floor)	031 - Lift Motor Room	Lining to Cabinet - Cement Product	MANAGE (AC) - GOOD - The asbestos cement is in a good condition and can remain in-situ if required. A management plan needs to be put in place to monitor the cement on a regular basis for any signs of deterioration or damage. Should any damage occur, then repair or removal by suitably trained persons under controlled conditions should be considered.

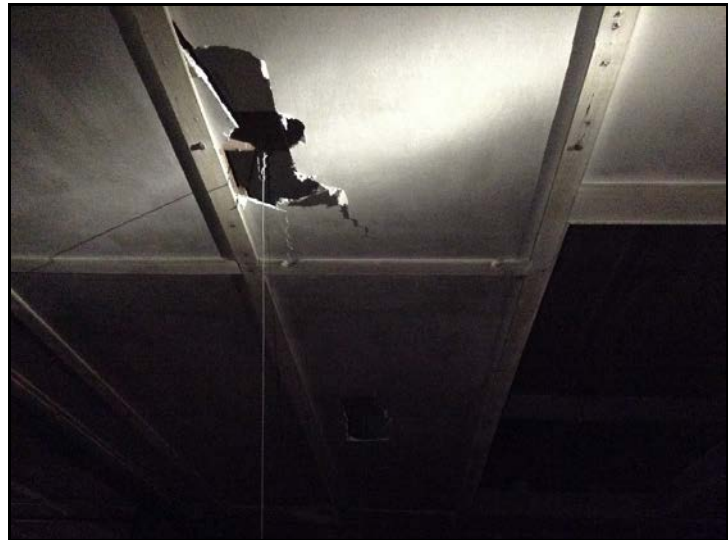
Site ID xxxxxx
Location ID 007
Building/Unit Site Name
Floor 0 (Ground)
Room / Area Offices Ceiling Void
Description Ceiling Boards & Cladding
Surveyed Yes
Source of Information Name of Surveyor
Last Inspection Date Xx/xx/xxxx
Lab Reference Xxxxxx/xxxxxx
Survey Type Management
Sample Number xxxxxx/S11

MATERIAL ASSESSMENT = 9

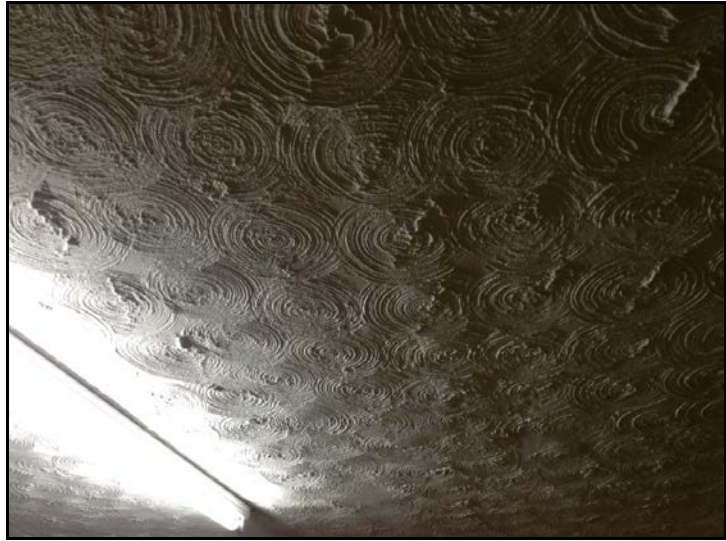
Site ID xxxxxx
Location ID 011
Building/Unit Site Name
Floor 0 (Ground)
Room / Area Staff Room
Description Textured Coating to Office
Surveyed Yes
Source of Information Name of Surveyor
Last Inspection Date xx/xx/xxxx
Lab Reference Xxxxxx/xxxxxx
Survey Type Management
Sample Number xxxxxx/S13

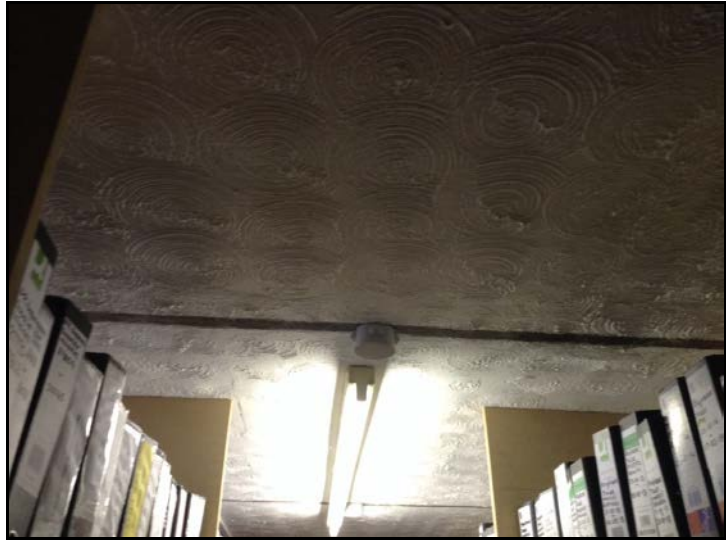
Site ID xxxxxx
 Location ID 012
 Building/Unit Site Name
 Floor 0 (Ground)
 Room / Area File Store
 Description Textured Coating to Office
 Surveyed Yes
 Source of Information Name of Surveyor
 Last Inspection Date Xx/xx/xxxx
 Lab Reference
 Survey Type Management
 Sample Number xxxxxx/X13

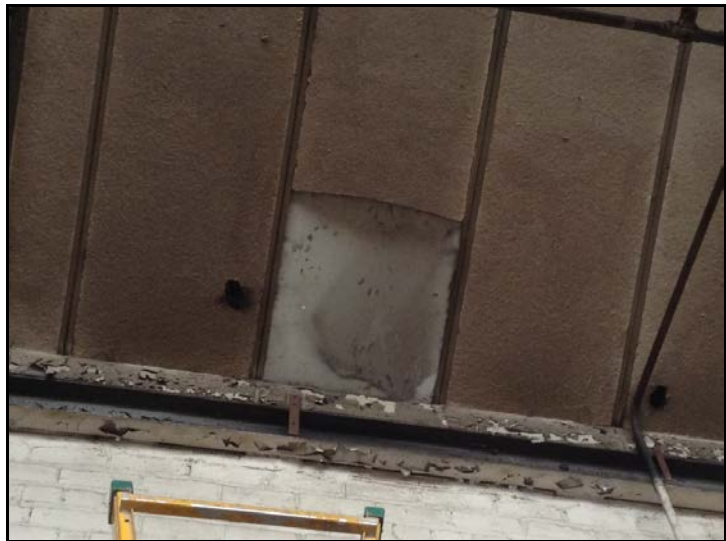
Site ID xxxxxx
 Location ID 025
 Building/Unit Site Name
 Floor 0 (Ground)
 Room / Area Loading
 Description Patch Board
 Surveyed Yes
 Source of Information Name of Surveyor
 Last Inspection Date Xx/xx/xxxx
 Lab Reference Xxxxxx/xxxxxx
 Survey Type Management
 Sample Number xxxxxx/S28

MATERIAL ASSESSMENT = 4

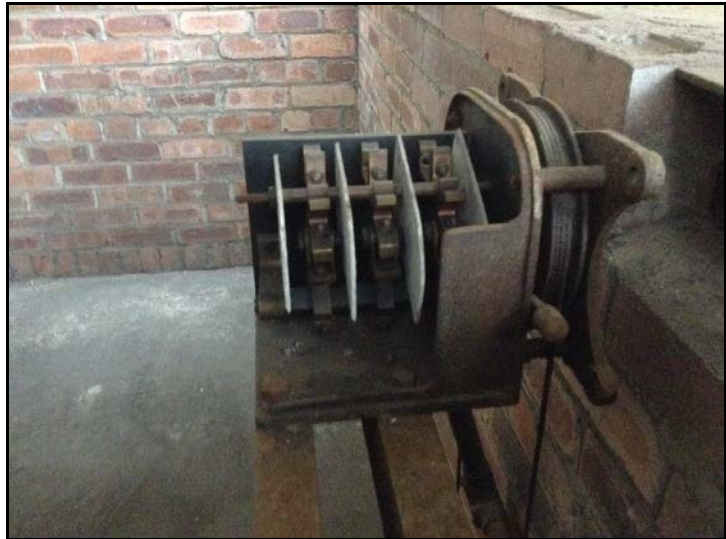
Site ID xxxxxx
Location ID 031
Building/Unit Site Name
Floor 1 (1st Floor)
Room / Area Lift Motor Room
Description Insulation Plates
Surveyed Yes
Source of Information Name of Surveyor
Last Inspection Date Xx/xx/xxxx
Lab Reference
Survey Type Management
Sample Number xxxxxx/X16

MATERIAL ASSESSMENT = 4

Site Name	1 (1st Floor)	031 - Lift Motor Room	Insulation Plates - Cement Product	MANAGE (AC) - GOOD - The asbestos cement is in a good condition and can remain in-situ if required. A management plan needs to be put in place to monitor the cement on a regular basis for any signs of deterioration or damage. Should any damage occur, then repair or removal by suitably trained persons under controlled conditions should be considered.
Site Name	0 (Ground)	032 - Store	Flue Pipe Remnant - Cement Product	MANAGE (AC) - GOOD - The asbestos cement is in a good condition and can remain in-situ if required. A management plan needs to be put in place to monitor the cement on a regular basis for any signs of deterioration or damage. Should any damage occur, then repair or removal by suitably trained persons under controlled conditions should be considered.

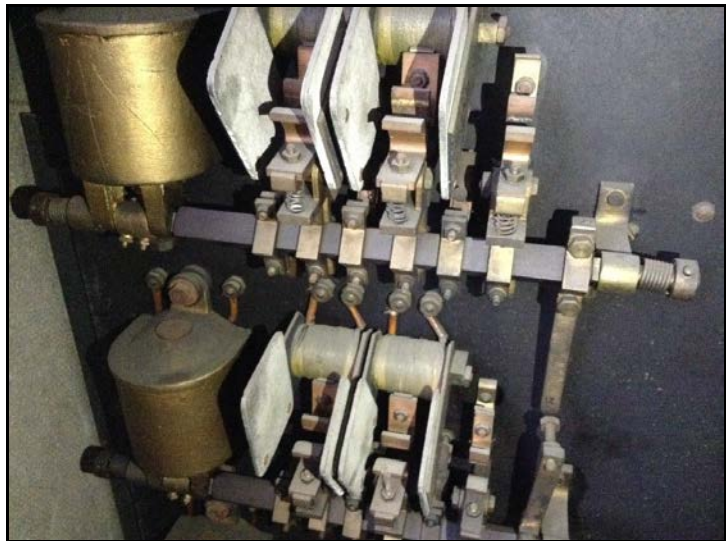
Site ID xxxxxx
 Location ID 031
 Building/Unit Site Name
 Floor 1 (1st Floor)
 Room / Area Lift Motor Room
 Description Insulation Plates
 Surveyed Yes
 Source of Information Name of Surveyor
 Last Inspection Date Xx/xx/xxxx
 Lab Reference Xxxxxx/xxxxxx
 Survey Type Management
 Sample Number xxxxxx/S16

MATERIAL ASSESSMENT = 4

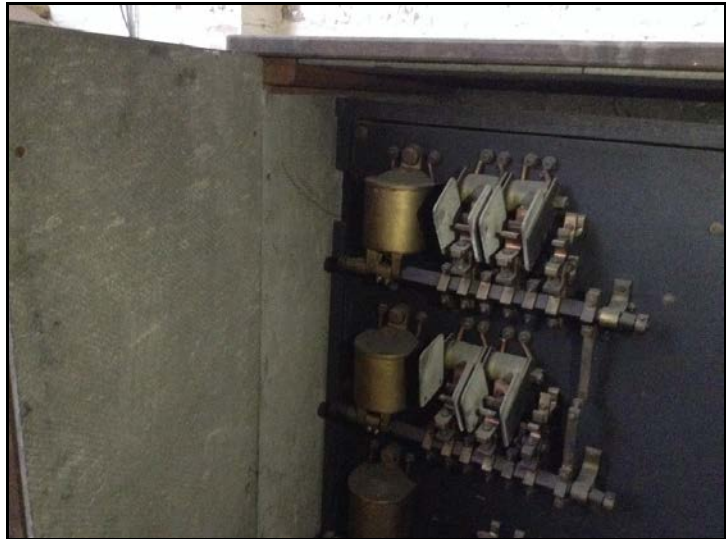
Site ID xxxxxx
Location ID 031
Building/Unit Site Name
Floor 1 (1st Floor)
Room / Area Lift Motor Room
Description Lining to Cabinet
Surveyed Yes
Source of Information Name of Surveyor
Last Inspection Date Xx/xx/xxxx
Lab Reference Xxxxxx/xxxxxx
Survey Type Management
Sample Number xxxxxx/S15

MATERIAL ASSESSMENT = 4

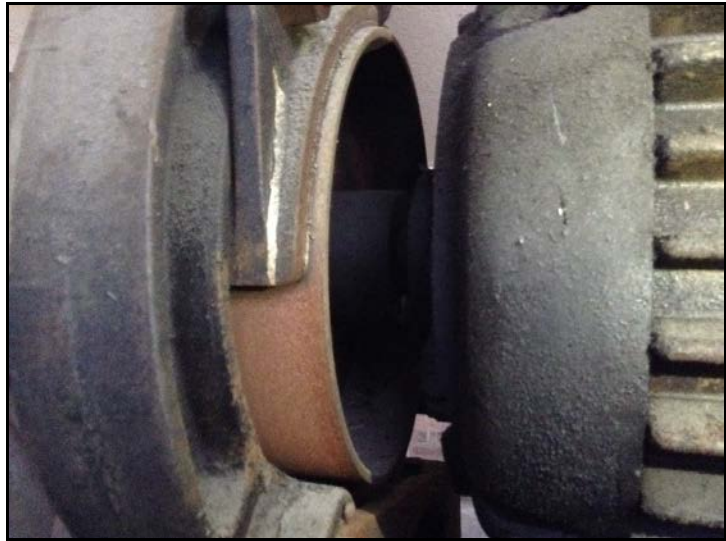
Site ID xxxxxx
 Location ID 031
 Building/Unit Site Name
 Floor 1 (1st Floor)
 Room / Area Lift Motor Room
 Description Brake Pads
 Surveyed Yes
 Source of Information Name of Surveyor
 Last Inspection Date Xx/xx/xxxx
 Lab Reference Xxxxxx/xxxxxx
 Survey Type Management
 Sample Number xxxxxx/S14

MATERIAL ASSESSMENT = 2

Site Name	1 (1st Floor)	031 - Lift Motor Room	Brake Pads - Friction Material	MANAGE (BRAKE PAD) - The brake pad is a low risk item and can remain in-situ if required. However the brake pad should be removed and replaced with a non-asbestos alternative when the lift is next serviced. In the meantime a management plan needs to be put in place to monitor the brake pad on a regular basis for any signs of damage. Should any damage occur, then removal should be considered.

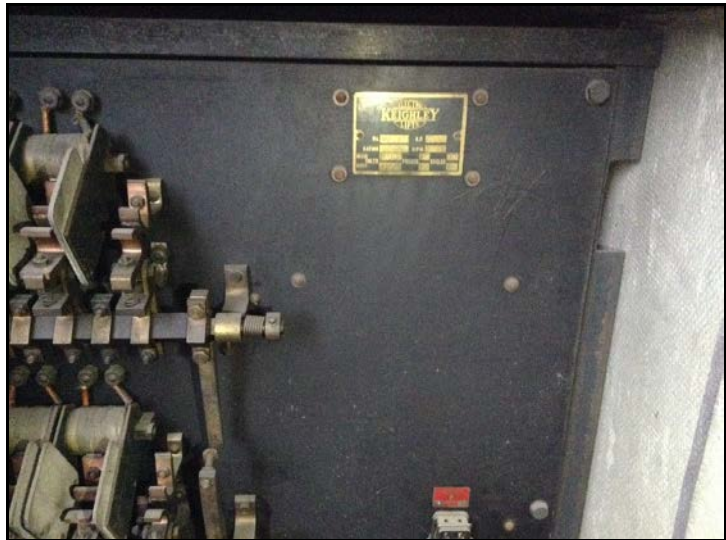
Site ID xxxxxx
 Location ID 031
 Building/Unit Site Name
 Floor 1 (1st Floor)
 Room / Area Lift Motor Room
 Description Board behind
 Electrics
 Surveyed Yes
 Source of Information Name of Surveyor
 Last Inspection Date Xx/xx/xxxx
 Lab Reference Xxxxxx/xxxxxx
 Survey Type Management
 Sample Number xxxxxx/S17

MATERIAL ASSESSMENT = 2

Building / Unit	Floor	Location	Item Description	Recommendations
Site Name	1 (1st Floor)	031 - Lift Motor Room	Board behind Electrics - Bakelite	MANAGE - The asbestos containing Bakelite board is in a good condition and can remain in-situ if required. A management plan needs to be put in place to monitor the Bakelite on a regular basis for any signs of deterioration or damage. Should any damage occur, then repair or removal by suitably trained persons under controlled conditions should be considered.
Site Name	1 (1st Floor)	031 - Lift Motor Room	Insulation Plates - Cement Product	MANAGE (AC) - GOOD - The asbestos cement is in a good condition and can remain in-situ if required. A management plan needs to be put in place to monitor the cement on a regular basis for any signs of deterioration or damage. Should any damage occur, then repair or removal by suitably trained persons under controlled conditions should be considered.

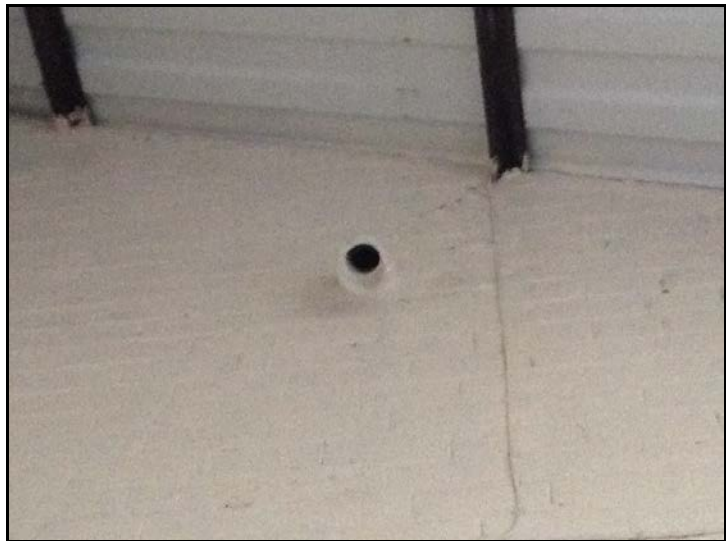
Site ID xxxxxx
 Location ID 032
 Building/Unit Site Name
 Floor 0 (Ground)
 Room / Area Store
 Description Flue Pipe Remnant
 Surveyed Yes
 Source of Information Name of Surveyor
 Last Inspection Date Xx/xx/xxxx
 Lab Reference Xxxxxx/xxxxxx
 Survey Type Management
 Sample Number xxxxxx/S18

MATERIAL ASSESSMENT = 4

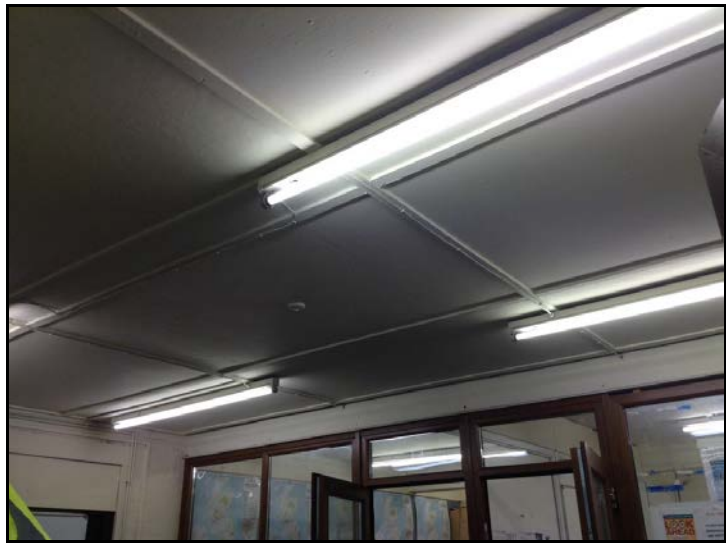
Site ID xxxxxx
 Location ID 033
 Building/Unit Site Name
 Floor 0 (Ground)
 Room / Area Offices
 Description Ceiling Boards
 Surveyed Yes
 Source of Information Surveyor Name
 Last Inspection Date Xx/xx/xxxx
 Lab Reference Xxxxxx/xxxxxx
 Survey Type Management
 Sample Number xxxxxx/S20

MATERIAL ASSESSMENT = 4

Building / Unit	Floor	Location	Item Description	Recommendations
Site Name	0 (Ground)	033 - Offices	Ceiling Boards - Cement Product	MANAGE (AC) - GOOD - The asbestos cement is in a good condition and can remain in-situ if required. A management plan needs to be put in place to monitor the cement on a regular basis for any signs of deterioration or damage. Should any damage occur, then repair or removal by suitably trained persons under controlled conditions should be considered.
Site Name	1 (1st Floor)	037 - Old Canteen	Boiler - Internal Asbestos Materials	MANAGE (BOILER PRESUMED) - The boiler should be assumed to contain asbestos materials until proven otherwise by either intrusive sampling or contacting the manufacturer. Any future works must be carried out under controlled conditions by suitably trained persons using HSE guidelines. A management plan should be put in place to monitor for any signs of damage on a regular basis. Should any internal damage occur, then the removal of the boiler should be considered.

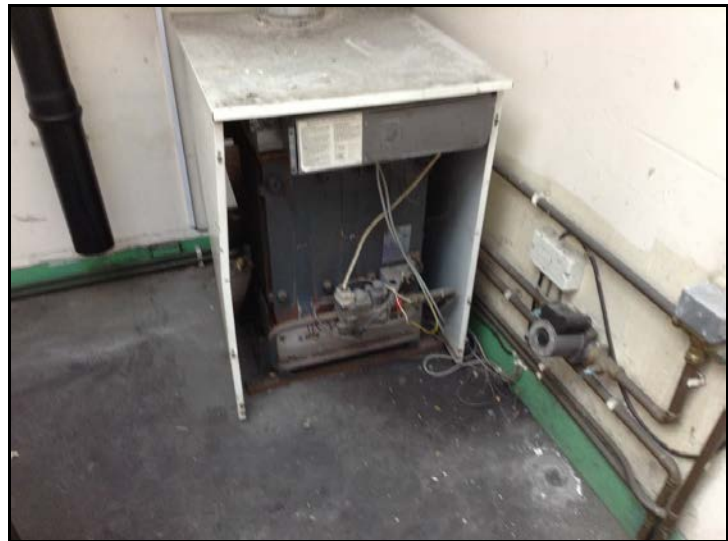
Site ID xxxxxx
 Location ID 037
 Building/Unit Site Name
 Floor 1 (1st Floor)
 Room / Area Old Canteen
 Description Boiler
 Surveyed Yes
 Source of Information Name of Surveyor
 Last Inspection Date Xx/xx/xxxx
 Lab Reference
 Survey Type Management
 Sample Number xxxxxx/P

MATERIAL ASSESSMENT = 6

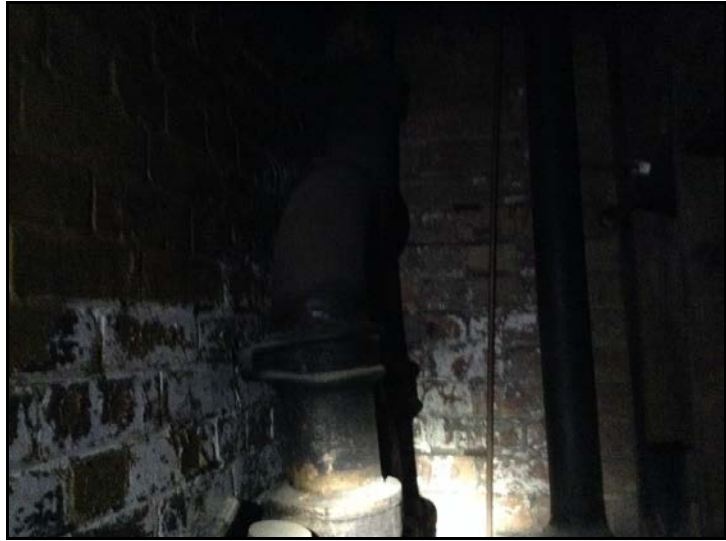
Site ID xxxxxx
 Location ID 037
 Building/Unit Site Name
 Floor 1 (1st Floor)
 Room / Area Old Canteen
 Description Insulation between Sections of Pipes
 Surveyed Yes
 Source of Information Name of Surveyor
 Last Inspection Date Xx/xx/xxxx
 Lab Reference Xxxxxx/xxxxxx
 Survey Type Management
 Sample Number xxxxxx/S22

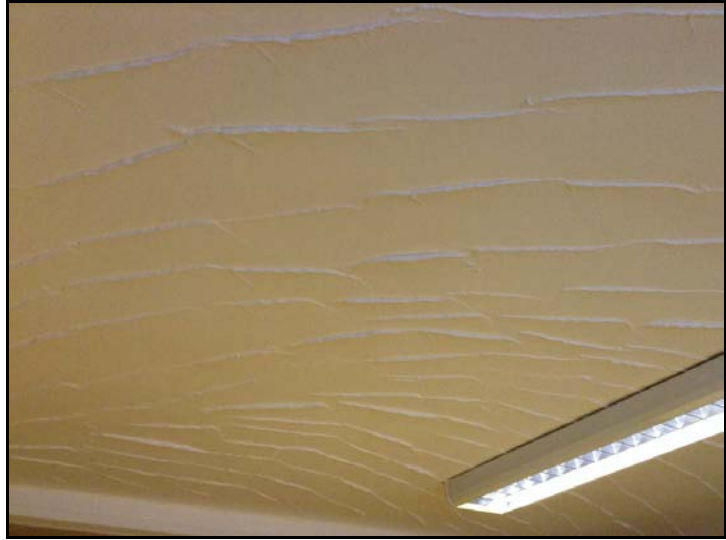
Site ID xxxxxx
Location ID 040
Building/Unit Site Name
Floor 1 (1st Floor)
Room / Area Meeting Rooms/Corridor
Description Textured Coating to Ceiling
Surveyed Yes
Source of Information Name of Surveyor
Last Inspection Date Xx/xx/xxxx
Lab Reference Xxxxxx/xxxxxx
Survey Type Management
Sample Number xxxxxx/S19

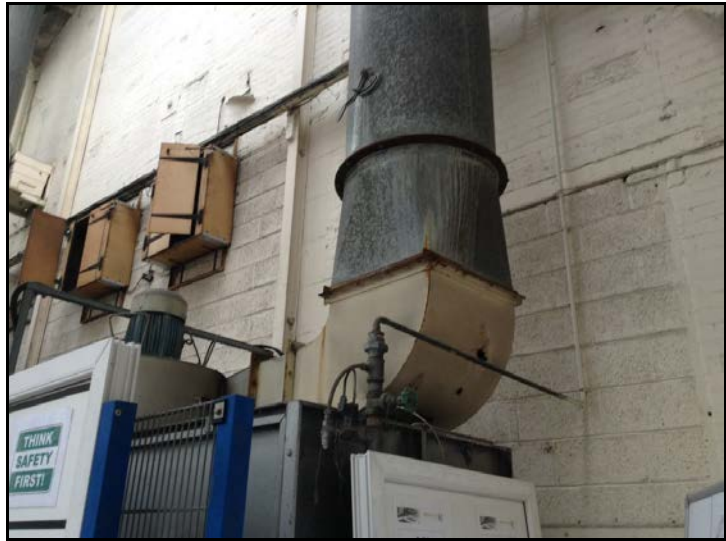
Site ID xxxxxx
 Location ID 041
 Building/Unit Site Name
 Floor 0 (Ground)
 Room / Area Workshop
 Description Sealant to Venting
 Surveyed Yes
 Source of Information Name of Surveyor
 Last Inspection Date 31/03/2017
 Lab Reference Xxxxxx/xxxxxx
 Survey Type Management
 Sample Number xxxxxx/S21

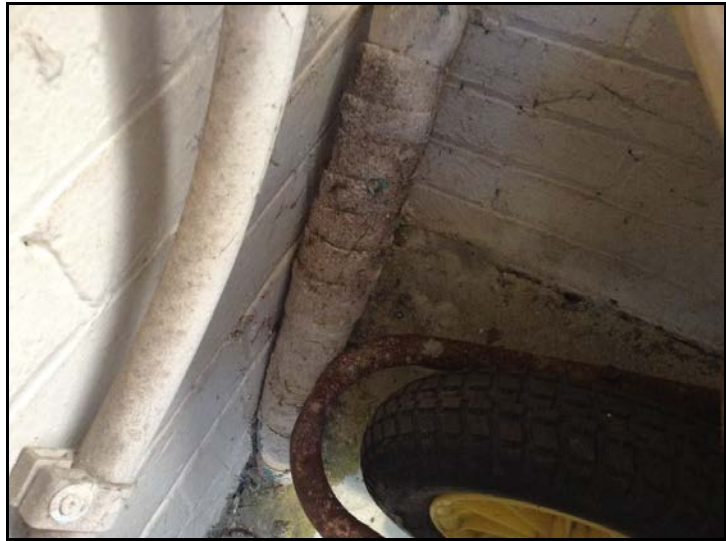
Site ID xxxxxx
 Location ID 044
 Building/Unit Site Name
 Floor 0 (Ground)
 Room / Area Maintenance Stores
 Description Wrap to Cable
 Surveyed Yes
 Source of Information Name of Surveyor
 Last Inspection Date Xx/xx/xxxx
 Lab Reference Xxxxxx/xxxxxx
 Survey Type Management
 Sample Number Xxxxxx/S23

MATERIAL ASSESSMENT = 4

Site Name	0 (Ground)	044 - Maintenance Stores	Wrap to Cable - Woven Product	REMOVE - The woven fabric wrap needs to be removed by suitably trained persons under controlled conditions, and be disposed of at a licensed disposal facility as a priority. Please note that this product needs to be notified to the HSE by way of an ASB1 form, prior to the works commencing.
Site Name	0 (Ground)	046 - W.C	Internal Roof Sheets - Cement Product	MANAGE (AC) - GOOD - The asbestos cement is in a good condition and can remain in-situ if required. A management plan needs to be put in place to monitor the cement on a regular basis for any signs of deterioration or damage. Should any damage occur, then repair or removal by suitably trained persons under controlled conditions should be considered.

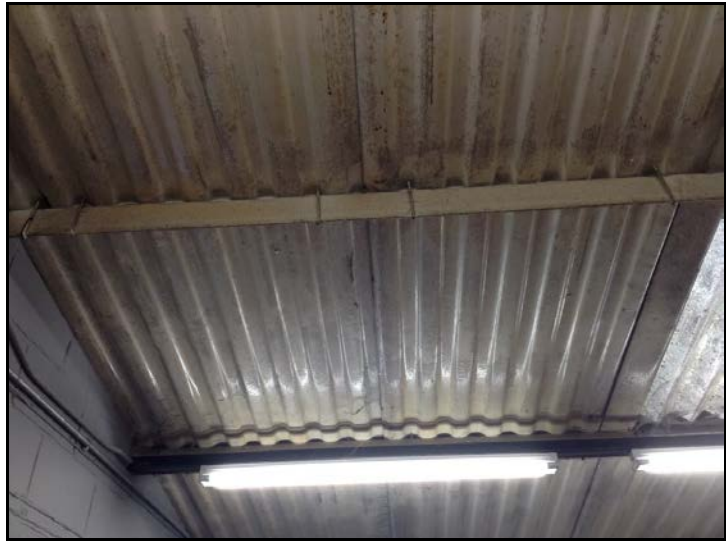
Site ID xxxxxx
Location ID 046
Building/Unit Site Name
Floor 0 (Ground)
Room / Area W.C
Description Internal Roof Sheets
Surveyed Yes
Source of Information Name of Surveyor
Last Inspection Date Xx/xx/xxxx
Lab Reference Xxxxxx/xxxxxx
Survey Type Management
Sample Number xxxxxx/S25

MATERIAL ASSESSMENT = 4

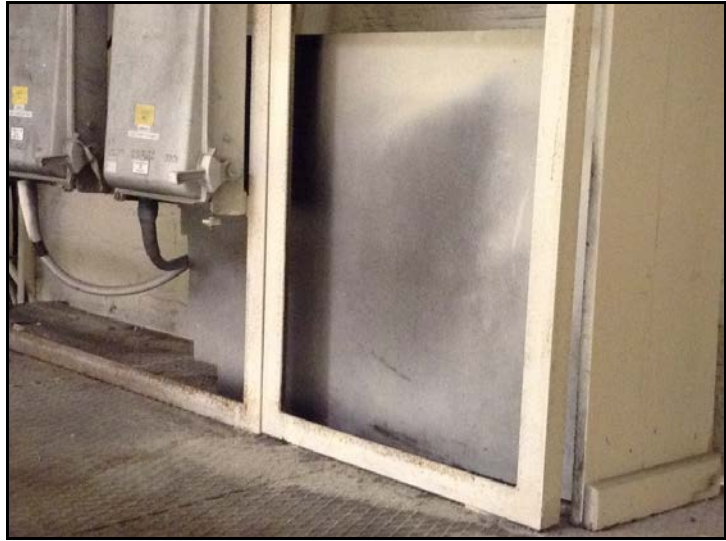
Site ID xxxxxx
Location ID 047
Building/Unit Site Name
Floor 0 (Ground)
Room / Area Workshop
Description Board behind
 Electrics
Surveyed Yes
Source of Information Name of Surveyor
Last Inspection Date 31/03/2017
Lab Reference Xxxxxx/xxxxxx
Survey Type Management
Sample Number xxxxxx/S24

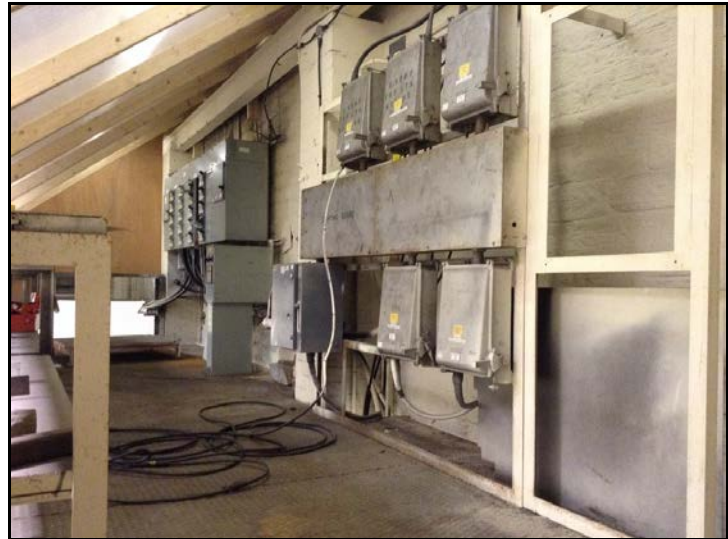
Site ID xxxxxx
Location ID 047
Building/Unit Site Name
Floor 0 (Ground)
Room / Area Workshop
Description Electrical Equipment
Surveyed Yes
Source of Information Name of Surveyor
Last Inspection Date Xx/xx/xxxx
Lab Reference
Survey Type Management
Sample Number xxxxxx/SP

MATERIAL ASSESSMENT = 6

Building / Unit	Floor	Location	Item Description	Recommendations
Site Name	0 (Ground)	047 - Workshop	Electrical Equipment - Internal Asbestos Materials	MANAGE (ELECTRICAL EQUIPMENT) - The electrical equipment appears to be in good condition and can remain in-situ if required. A management plan needs to be put in place to monitor the electrical equipment on a regular basis for any signs of deterioration or damage. Should any damage occur, then the electrical equipment should be removed complete without any disturbance to the internal materials by suitably trained persons under controlled conditions using HSE Guidelines, and be disposed of at a licensed disposal facility.
Site Name	0 (Ground)	048 - Sub Station	Electrical Equipment - Internal Asbestos Materials	MANAGE (ELECTRICAL EQUIPMENT) - The electrical equipment appears to be in good condition and can remain in-situ if required. A management plan needs to be put in place to monitor the electrical equipment on a regular basis for any signs of deterioration or damage. Should any damage occur, then the electrical equipment should be removed complete without any disturbance to the internal materials by suitably trained persons under controlled conditions using HSE Guidelines, and be disposed of at a licensed disposal facility.

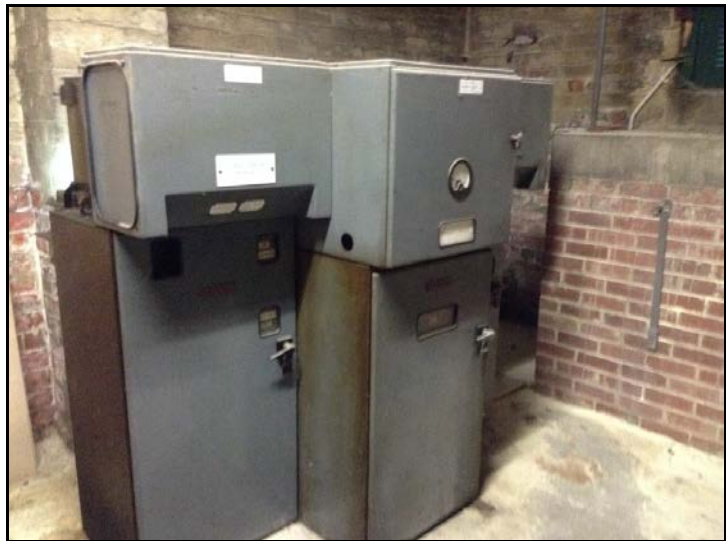
Site ID xxxxxx
 Location ID 048
 Building/Unit Site Name
 Floor 0 (Ground)
 Room / Area Sub Station
 Description Electrical Equipment
 Surveyed Yes
 Source of Information Name of Surveyor
 Last Inspection Date Xx/xx/xxxx
 Lab Reference
 Survey Type Management
 Sample Number xxxxxx/SP

MATERIAL ASSESSMENT = 6

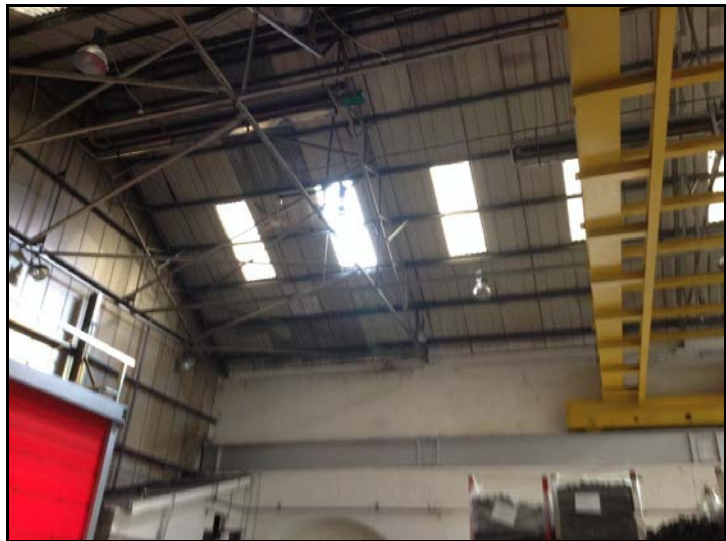
Site ID xxxxxx
Location ID 049
Building/Unit Site Name
Floor 0 (Ground)
Room / Area Workshop
Description Internal Roof Sheets
Surveyed Yes
Source of Information Name of Surveyor
Last Inspection Date Xx/xx/xxxx
Lab Reference Xxxxxx/xxxxxx
Survey Type Management
Sample Number xxxxxx/S26

MATERIAL ASSESSMENT = 5

Site Name	0 (Ground)	049 - Workshop	Internal Roof Sheets - Cement Product	MANAGE (AC) - REASONABLE - The asbestos cement is in reasonable condition, and as it is classed as a low risk item it can remain in-situ if required. A management plan needs to be put in place to monitor the cement on a regular basis for any further signs of deterioration or damage. Should any damage occur, then repair or removal by suitably trained persons under controlled conditions should be considered.

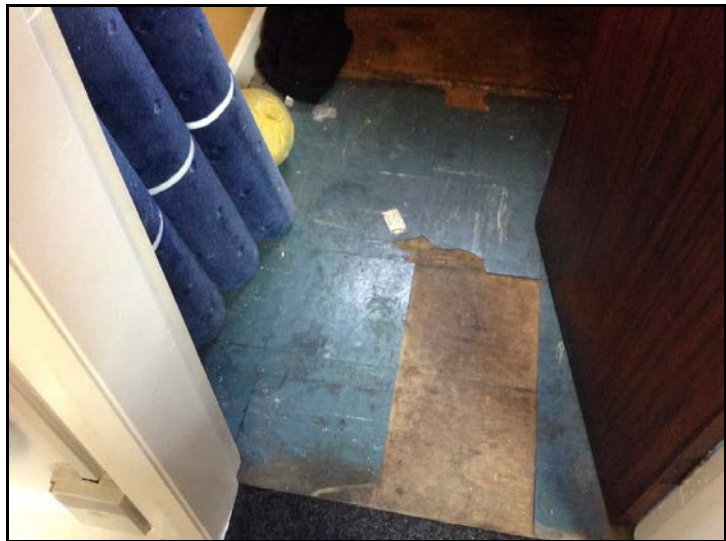
Site ID xxxxxx
Location ID 051
Building/Unit Site Name
Floor 0 (Ground)
Room / Area Offices
Description Floor Tiles
Surveyed Yes
Source of Information Name of Surveyor
Last Inspection Date Xx/xx/xxxx
Lab Reference Xxxxxx/xxxxxx
Survey Type Management
Sample Number xxxxxx/S27

MATERIAL ASSESSMENT = 3

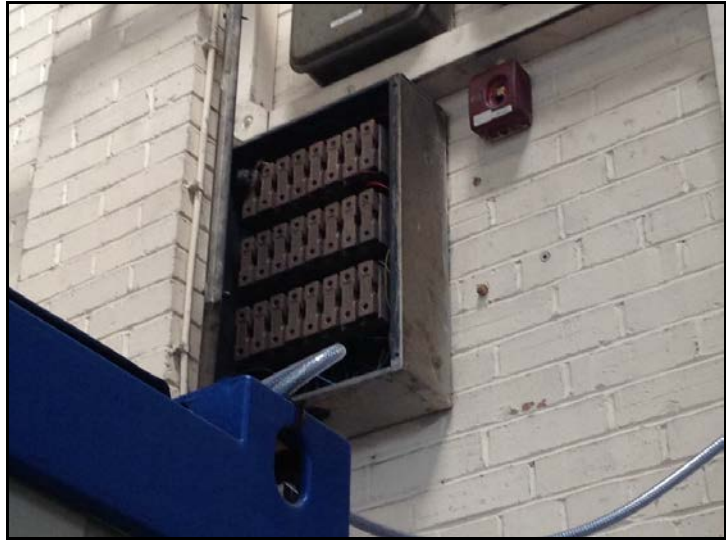
Site ID xxxxxx
 Location ID 052
 Building/Unit Site Name
 Floor 0 (Ground)
 Room / Area Throughout
 Description Fuse Box "Flash Pads"
 Surveyed Yes
 Source of Information Name of Surveyor
 Last Inspection Date Xx/xx/xxxx
 Lab Reference
 Survey Type Management
 Sample Number xxxxxx/X06

MATERIAL ASSESSMENT = 4

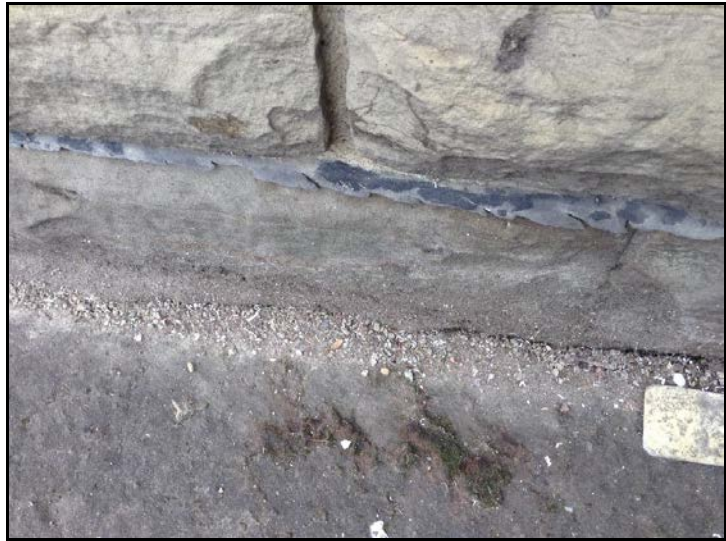
Site ID xxxxxx
 Location ID 053
 Building/Unit Site Name
 Floor 0 (Ground)
 Room / Area External Areas
 Description Damp Proof Course
 Surveyed Yes
 Source of Information Name of Surveyor
 Last Inspection Date 31/03/2017
 Lab Reference Xxxxxx/xxxxxx
 Survey Type Management
 Sample Number xxxxxx/S33

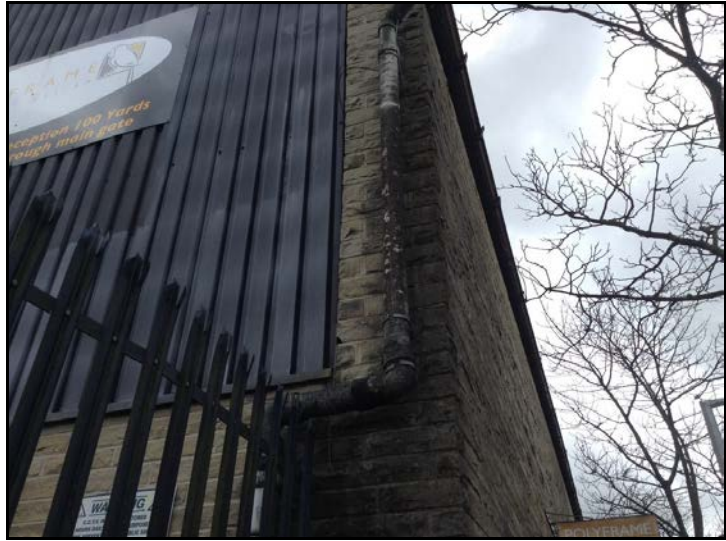
Site ID xxxxxx
 Location ID 053
 Building/Unit Site Name
 Floor 0 (Ground)
 Room / Area External Areas
 Description Fall Pipe Sections
 Surveyed Yes
 Source of Information Name of Surveyor
 Last Inspection Date Xx/xx/xxxx
 Lab Reference Xxxxxx/xxxxxx
 Survey Type Management
 Sample Number xxxx/S34

MATERIAL ASSESSMENT = 4

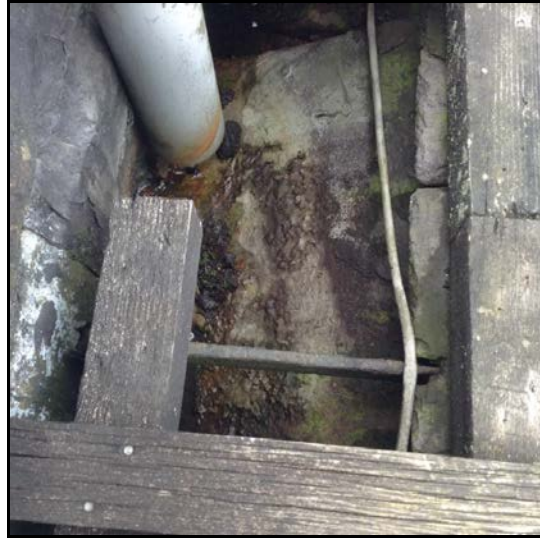
Site ID xxxxxx
 Location ID 053
 Building/Unit Site Name
 Floor 0 (Ground)
 Room / Area External Areas
 Description Bitumen Coating to Gutters
 Surveyed Yes
 Source of Information Name of Surveyor
 Last Inspection Date Xx/xx/xxxx
 Lab Reference Xxxxxx/xxxxxx
 Survey Type Management
 Sample Number xxxxxx/S32

MATERIAL ASSESSMENT = 2

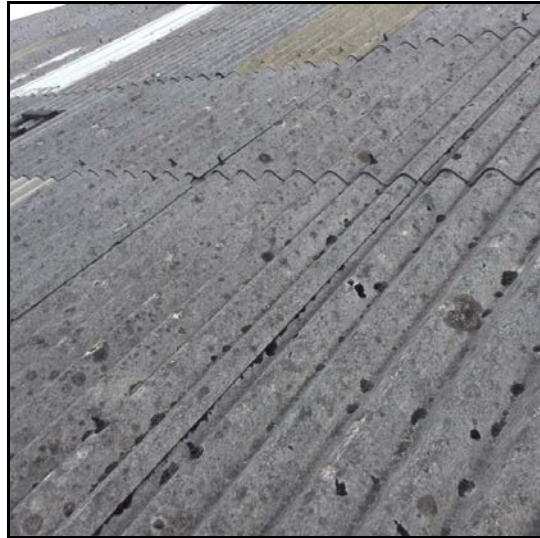
Site ID xxxxxx
 Location ID 053
 Building/Unit Site Name
 Floor 0 (Ground)
 Room / Area External Areas
 Description External Roof Sheets
 Surveyed Yes
 Source of Information Name of Surveyor
 Last Inspection Date Xx/xx/xxxx
 Lab Reference Xxxxxx/xxxxxx
 Survey Type Management
 Sample Number xxxxxx/S31

MATERIAL ASSESSMENT = 4

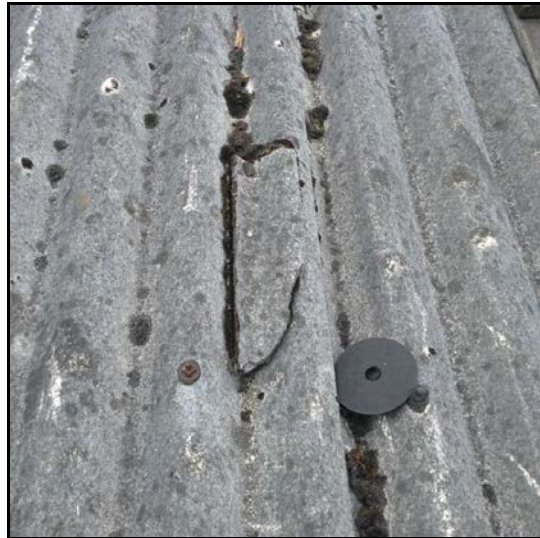
Site ID xxxxxx
 Location ID 053
 Building/Unit Site Name
 Floor 0 (Ground)
 Room / Area External Areas
 Description Cement Debris on Roof
 Surveyed Yes
 Source of Information Name of Surveyor
 Last Inspection Date Xx/xx/xxxx
 Lab Reference
 Survey Type Management
 Sample Number xxxxxx/X31

MATERIAL ASSESSMENT = 5
