MANAGEMENT ASBESTOS SURVEY REPORT

SURVEY REPORT WITH MATERIAL ASSESSMENT

Survey Type: Management Survey

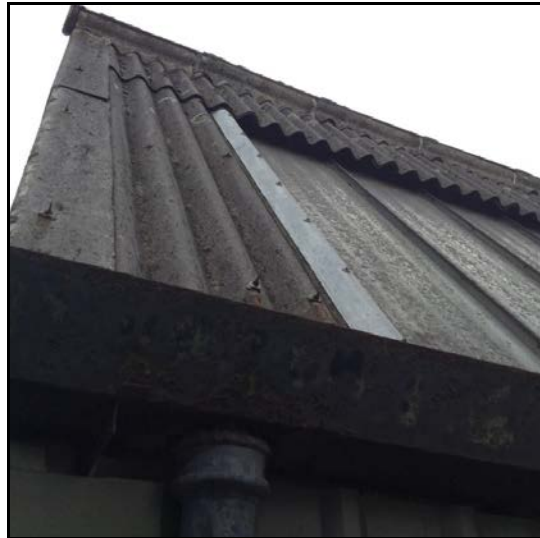
Site ID xxxxxx
 Location ID 053
 Building/Unit Site Name
 Floor 0 (Ground)
 Room / Area External Areas
 Description Roof Sheets & Barge Boards
 Surveyed Yes
 Source of Information Name of Surveyor
 Last Inspection Date xx/xx/xxxx
 Lab Reference Xxxxxx/xxxxxx
 Survey Type Management
 Sample Number xxxxxx/S29

MATERIAL ASSESSMENT = 4

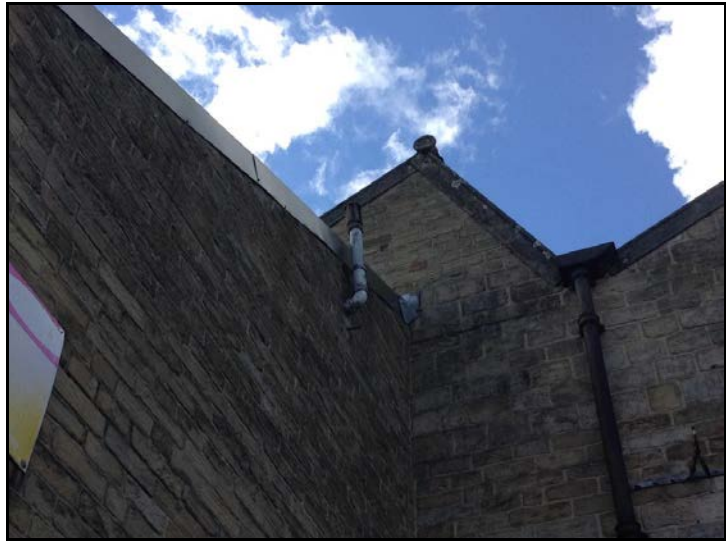
Site ID xxxxxx
 Location ID 053
 Building/Unit Site Name
 Floor 0 (Ground)
 Room / Area External Areas
 Description Flue Pipe
 Surveyed Yes
 Source of Information Name of Sureyor
 Last Inspection Date Xx/xx/xxxx
 Lab Reference
 Survey Type Management
 Sample Number xxxxxx/X18

MATERIAL ASSESSMENT = 4
