REFURBISHMENT/DEMOLITION ASBESTOS SURVEY REPORT

SURVEY REPORT WITH MATERIAL ASSESSMENT

Survey Type: Refurbishment and Demolition Survey

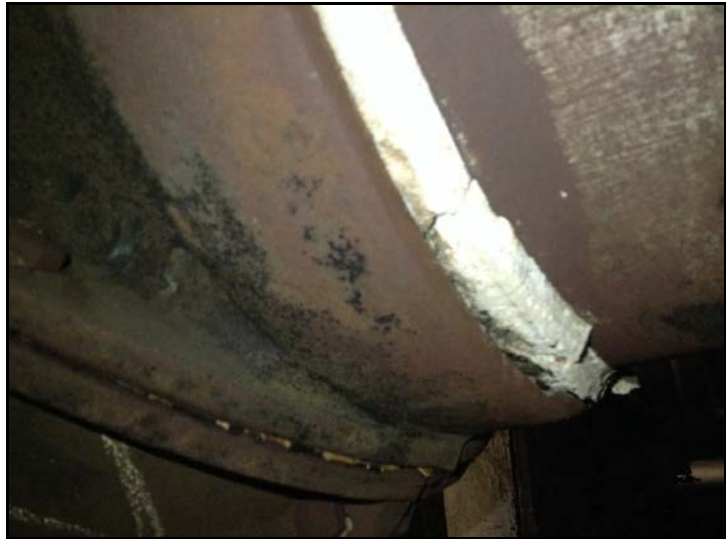
Site ID xxxxxx
 Location ID 001
 Building/Unit Site Name
 Floor -1 (Basement)
 Room / Area Boiler Room
 Description Rope Gaskets between Flue Sections
 Surveyed Yes
 Source of Information Name of Surveyor
 Last Inspection Date Xx/xx/xxxx
 Lab Reference Xxxxxx/xxxxxx
 Survey Type Refurbishment Demolition
 Sample Number xxxxxx/S24

MATERIAL ASSESSMENT = 5

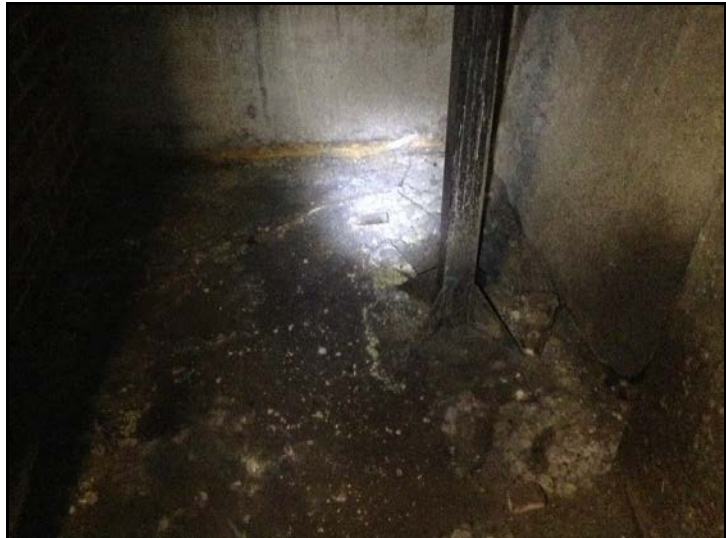
Site ID xxxxxx
Location ID 001
Building/Unit Site Name
Floor -1 (Basement)
Room / Area Boiler Room
Description Board Debris
Surveyed Yes
Source of Information Name of Surveyor
Last Inspection Date xx/xx/xxxx
Lab Reference
Survey Type Refurbishment
 Demolition
Sample Number xxxxxx/X27

MATERIAL ASSESSMENT = 8

Recommendations The insulation board debris needs to be removed and the area environmentally cleaned by a licensed removal company as a priority.

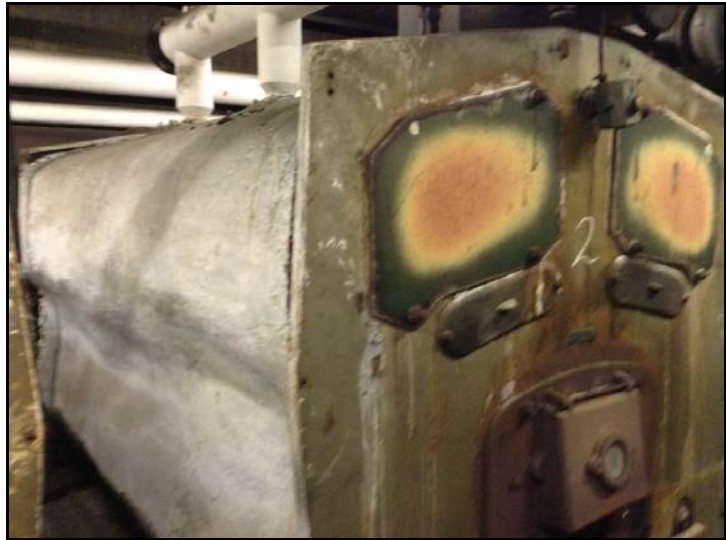
Site ID xxxxxx
 Location ID 001
 Building/Unit Site Name
 Floor -1 (Basement)
 Room / Area Boiler Room
 Description Lagging to Boiler 2
 Surveyed Yes
 Source of Information Name of Surveyor
 Last Inspection Date Xx/xx/xxxx
 Lab Reference Xxxxxx/xxxxxx
 Survey Type Refurbishment
 Demolition
 Sample Number xxxxxx/S20

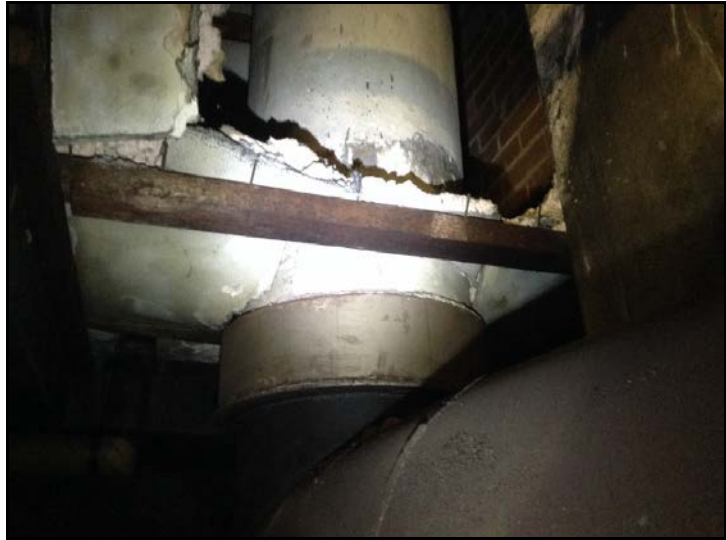
Site ID xxxxxx
 Location ID 001
 Building/Unit Site Name
 Floor -1 (Basement)
 Room / Area Boiler Room
 Description Insulation around Chimney
 Surveyed Yes
 Source of Information Name of Surveyor
 Last Inspection Date Xx/xx/xxxx
 Lab Reference Xxxxxx/xxxxxx
 Survey Type Refurbishment
 Demolition
 Sample Number xxxxxx/S28

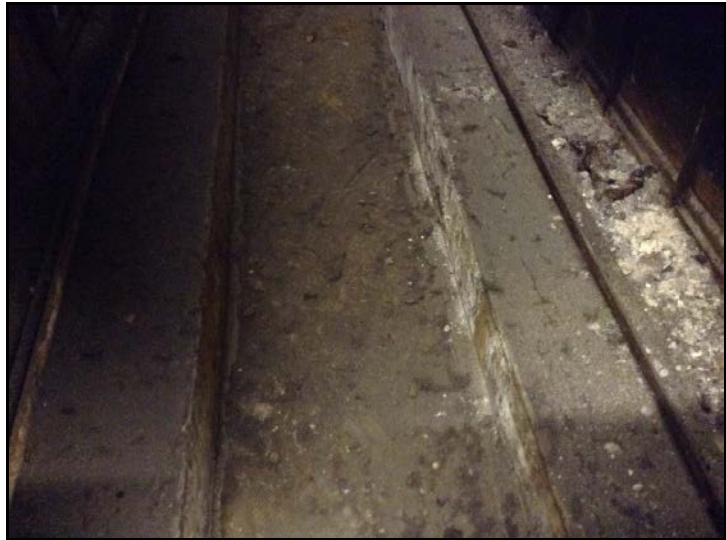
Site ID xxxxxx
 Location ID 001
 Building/Unit Site Name
 Floor -1 (Basement)
 Room / Area Boiler Room
 Description Debris to Floor
 Surveyed Yes
 Source of Information Name of Surveyor
 Last Inspection Date Xx/xx/xxxx
 Lab Reference
 Survey Type Refurbishment
 Demolition
 Sample Number xxxxxx/X19

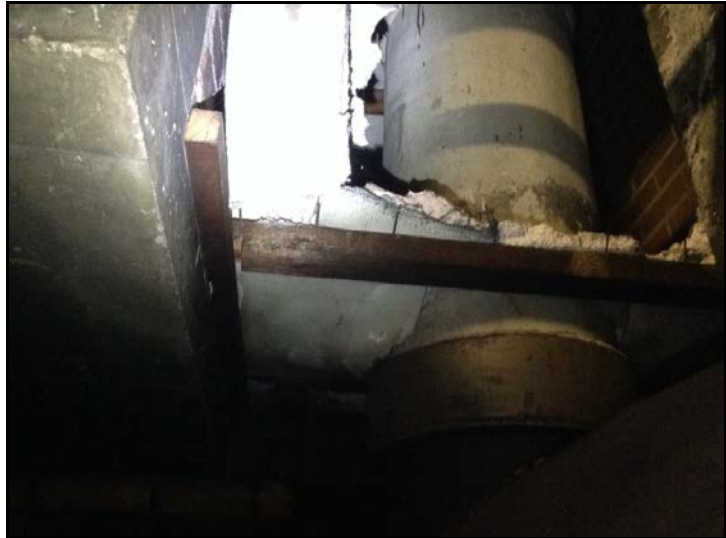
Site ID xxxxxx
Location ID 001
Building/Unit Site Name
Floor -1 (Basement)
Room / Area Boiler Room
Description Lining around Chimney
Surveyed Yes
Source of Information Name of Surveyor
Last Inspection Date xx/xx/xxxx
Lab Reference Xxxxxx/xxxxxx
Survey Type Refurbishment
 Demolition
Sample Number xxxxxx/S27

MATERIAL ASSESSMENT = 8

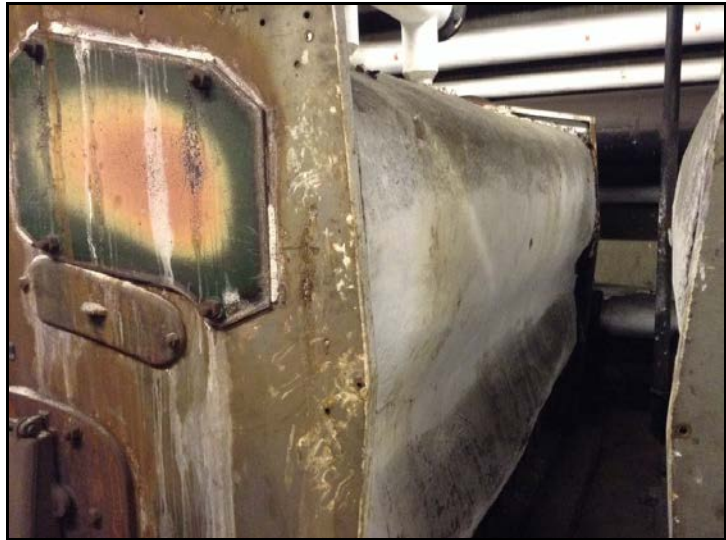
Site ID xxxxxx
 Location ID 001
 Building/Unit Site Name
 Floor -1 (Basement)
 Room / Area Boiler Room
 Description Lagging to Boiler 1
 Surveyed Yes
 Source of Information Name of Surveyor
 Last Inspection Date Xx/xx/xxxx
 Lab Reference Xxxxxx/xxxxxx
 Survey Type Refurbishment
 Demolition
 Sample Number xxxxxx/S19

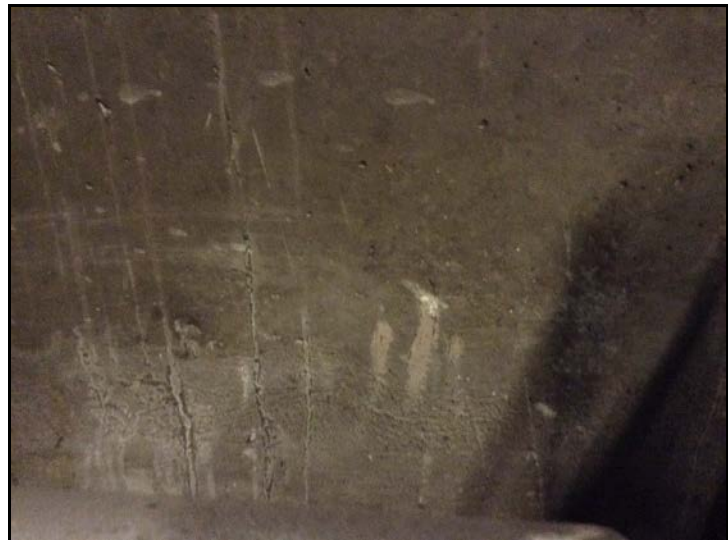
Site ID xxxxxx
Location ID 001
Building/Unit Site Name
Floor -1 (Basement)
Room / Area Boiler Room
Description Residue to Walls
Surveyed Yes
Source of Information Name of Surveyor
Last Inspection Date Xx/xx/xxxx
Lab Reference Xxxxxx/xxxxxx
Survey Type Refurbishment
 Demolition
Sample Number xxxxxx/S26

MATERIAL ASSESSMENT = 11

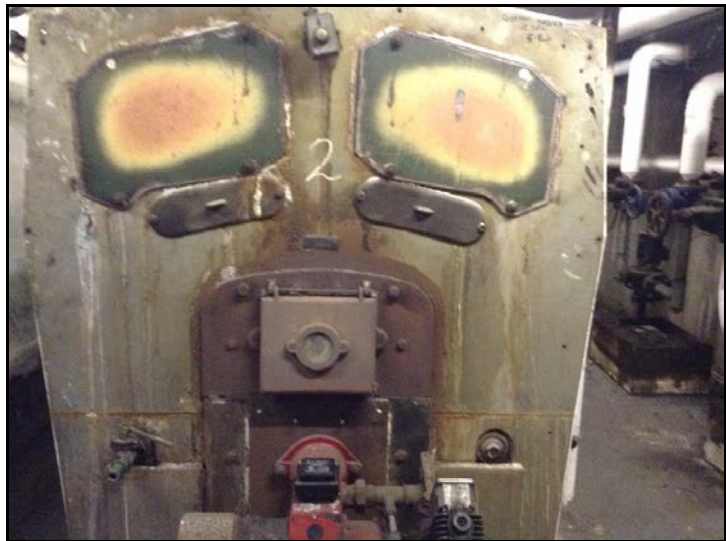
Site ID xxxxxx
 Location ID 001
 Building/Unit Site Name
 Floor -1 (Basement)
 Room / Area Boiler Room
 Description Seal between Sections of Boilers
 Surveyed Yes
 Source of Information Name of Surveyor
 Last Inspection Date Xx/xx/xxxx
 Lab Reference Xxxxxx/xxxxxx
 Survey Type Refurbishment
 Demolition
 Sample Number xxxxxx/S25

MATERIAL ASSESSMENT = 4

Site Name	-1 (Basement)	001 - Boiler Room	Seal between Sections of Boilers - Putty	REMOVE - The asbestos containing seals need to be removed by suitably trained persons under controlled conditions using HSE Guidelines prior to the commencement of any works.
Site Name	-1 (Basement)	001 - Boiler Room	Residue to Walls - Insulation	REMOVE / ENVIRONMENTAL CLEAN (INSULATION DEBRIS) - The insulation debris needs to be removed and the area environmentally cleaned by a licensed removal company prior to the commencement of any works.
Site Name	-1 (Basement)	001 - Boiler Room	Lining around Chimney - Millboard	REMOVE (AIB) - The asbestos boards need to be removed by a licensed removal company prior to the commencement of any works.

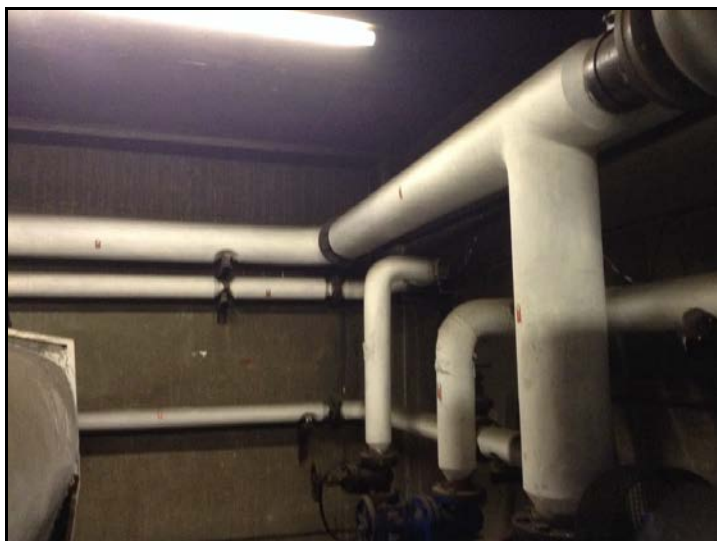
Site ID xxxxxx
Location ID 001
Building/Unit Site Name
Floor -1 (Basement)
Room / Area Boiler Room
Description Lagging to Pipes
Surveyed Yes
Source of Information Name of Surveyor
Last Inspection Date Xx/xx/xxxx
Lab Reference Xxxxxx/xxxxxx 21-23
Survey Type Refurbishment
 Demolition
Sample Number xxxxxx/S21 - 23

MATERIAL ASSESSMENT = 7

Building	Floor	Location	Item Description	Recommendations
Site Name	-1 (Basement)	001 - Boiler Room	Lagging to Pipes - Insulation	REMOVE (LAGGING) - The lagging needs to be removed by a licensed removal company prior to the commencement of any works.
Site Name	-1 (Basement)	001 - Boiler Room	Board Debris - Millboard	REMOVE / ENVIRONMENTAL CLEAN (AIB) - The insulation board debris needs to be removed and the area environmentally cleaned by a licensed removal company as a priority.
Site Name	-1 (Basement)	001 - Boiler Room	Fuse Box "Flash Pads" - Woven Product	REMOVE (FUSE BOX) - The fuse boxes need to be removed complete without any disturbance to the internal materials by suitably trained persons under controlled conditions using HSE Guidelines, and be disposed of at a licensed disposal facility prior to the commencement of any works.
Site Name	-1 (Basement)	001 - Boiler Room	Rope Gaskets between Flue Sections - Gaskets (Rope/Woven)	REMOVE - The gaskets need to be removed by suitably trained persons under controlled conditions using HSE Guidelines prior to the commencement of any works.

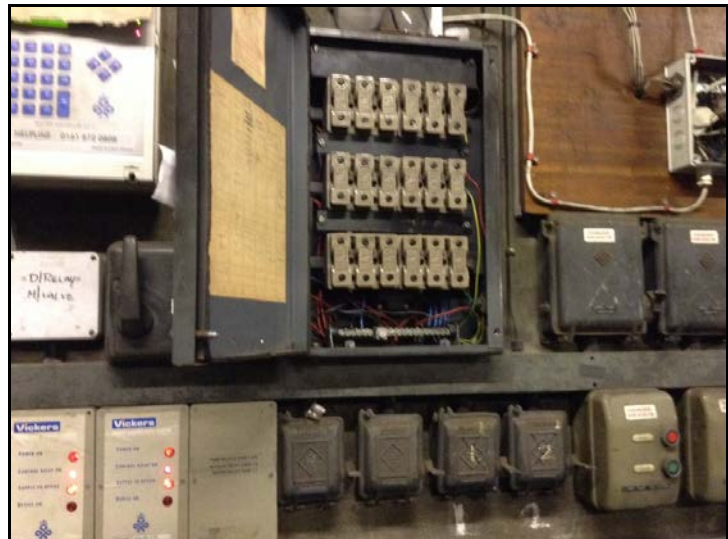
Site ID xxxxxx
 Location ID 001
 Building/Unit Site Name
 Floor -1 (Basement)
 Room / Area Boiler Room
 Description Fuse Box "Flash Pads"
 Surveyed Yes
 Source of Information Name of Surveyor
 Last Inspection Date Xx/xx/xxxx
 Lab Reference
 Survey Type Refurbishment
 Demolition
 Sample Number xxxxxx/X12

MATERIAL ASSESSMENT = 4

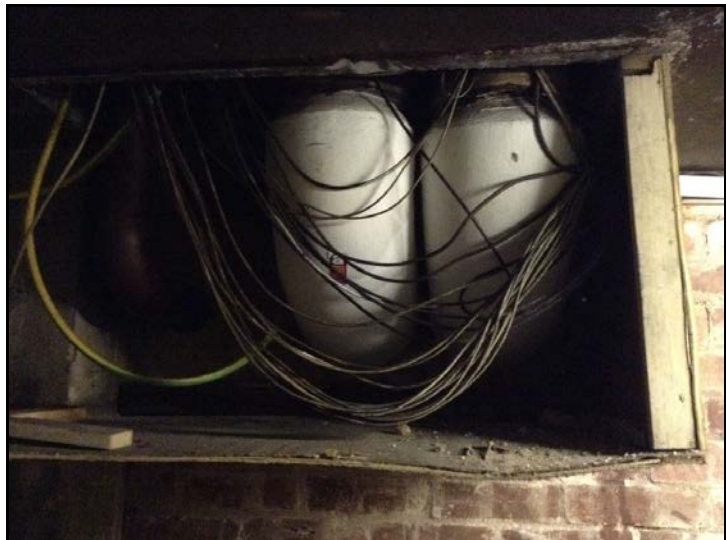
Site ID xxxxxx
Location ID 002
Building/Unit Site Name
Floor -1 (Basement)
Room / Area Gas Meter Room
Description Lagging to Pipes
Surveyed Yes
Source of Information Name of Surveyor
Last Inspection Date Xx/xx/xxxx
Lab Reference
Survey Type Refurbishment
 Demolition
Sample Number xxxxxx/X21

MATERIAL ASSESSMENT = 7

Building	Floor	Location	Item Description	Recommendations
Site Name	-1 (Basement)	002 - Gas Meter Room	Lagging to Pipes - Insulation	REMOVE (LAGGING) - The lagging needs to be removed by a licensed removal company prior to the commencement of any works.
Site Name	0 (Ground)	005 - Lobby/Stair well	Stair Nosing - PVC / Reinforced Plastics	REMOVE (NOSING) - The asbestos nosing needs to be removed by suitably trained persons under controlled conditions using HSE Guidelines, prior to the commencement of any works.
Site Name	0 (Ground)	008 - Store	Loose Boards - Insulating Board	REMOVE (AIB) - The asbestos boards need to be removed by a licensed removal company prior to the commencement of any works.
Site Name	0 (Ground)	008 - Store Ceiling Void	Loose Pipes - Cement Product	REMOVE (AC DEBRIS) - The cement debris needs to be removed. It should be picked and bagged and disposed of as hazardous waste by suitably trained persons under controlled conditions using HSE Guidelines, prior to the commencement of any works. An updated search for any additional cement debris should also be carried out during the course of the removal works.

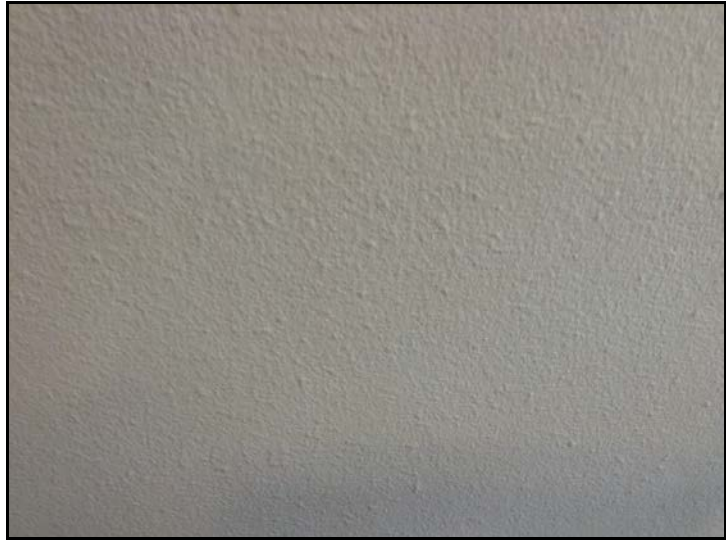
Site ID xxxxxx
 Location ID 003
 Building/Unit Site Name
 Floor 0 (Ground)
 Room / Area Entrance Lobby
 Description Textured Coating to Wall
 Surveyed Yes
 Source of Information Name of Surveyor
 Last Inspection Date Xx/xx/xxxx
 Lab Reference Xxxxxx/xxxxxx
 Survey Type Refurbishment
 Demolition
 Sample Number Xxxxxx/S32

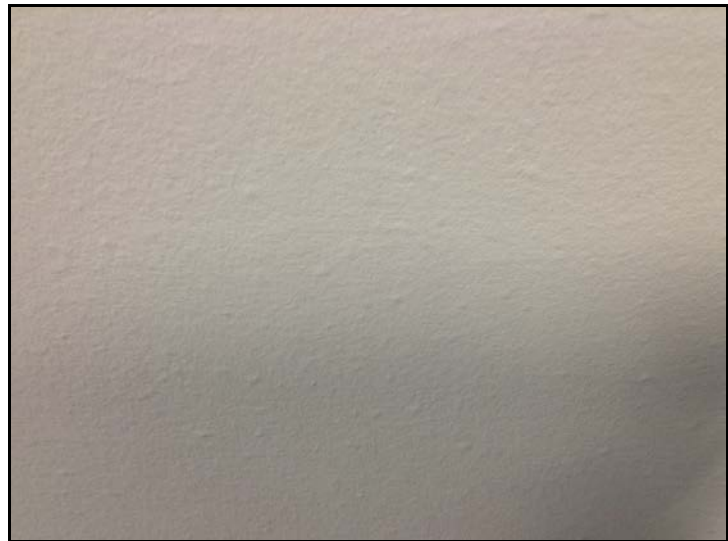
Site ID xxxxxx
Location ID 004
Building/Unit Site Name
Floor 0 (Ground)
Room / Area Office
Description Textured Coating to Walls
Surveyed Yes
Source of Information Name of Surveyor
Last Inspection Date Xx/xx/xxxx
Lab Reference Xxxxxx/xxxxxx
Survey Type Refurbishment
 Demolition
Sample Number xxxxxx/S33

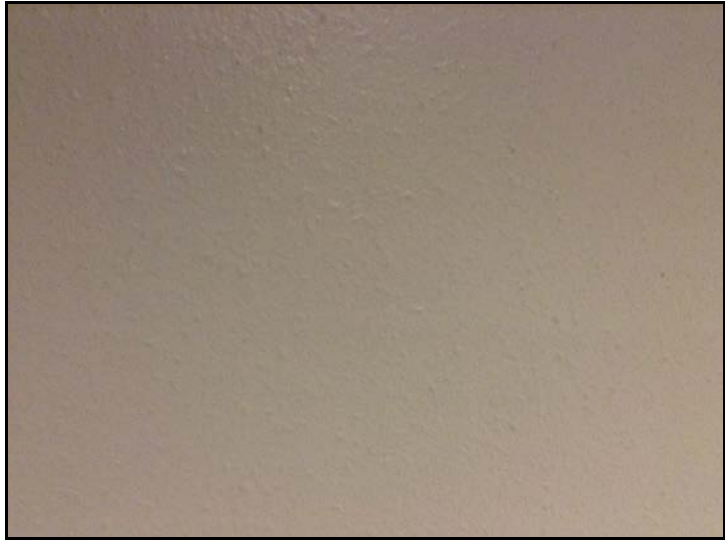
Site ID xxxxxx
 Location ID 005
 Building/Unit Site Name
 Floor 0 (Ground)
 Room / Area Lobby/Stairwell
 Description Textured Coating to Wall
 Surveyed Yes
 Source of Information Name of Surveyor
 Last Inspection Date Xx/xx/xxxx
 Lab Reference Xxxxxx/xxxxxx
 Survey Type Refurbishment
 Demolition
 Sample Number xxxxxx/S34

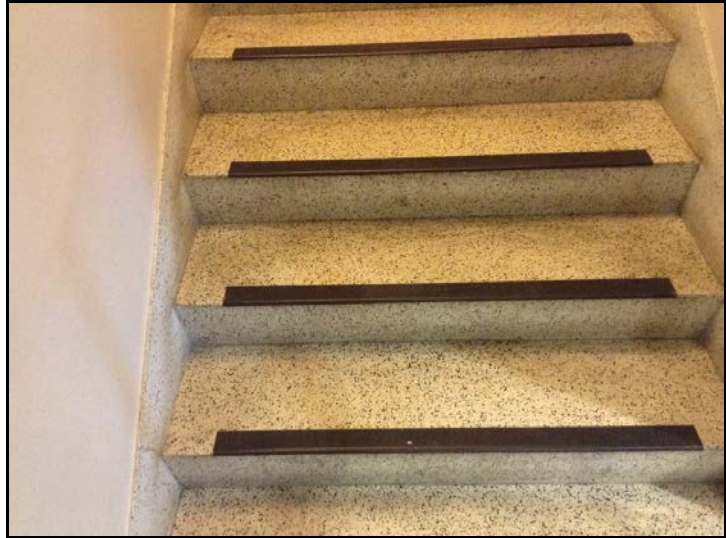
Site ID xxxxxx
 Location ID 005
 Building/Unit Site Name
 Floor 0 (Ground) - 2 (2nd Floor)
 Room / Area Lobby/Stairwell
 Description Stair Nosing
 Surveyed Yes
 Source of Information Name of Surveyor
 Last Inspection Date Xx/xx/xxxx
 Lab Reference Xxxxxx/xxxxxx
 Survey Type Refurbishment
 Demolition
 Sample Number xxxxxx/S35

MATERIAL ASSESSMENT = 2

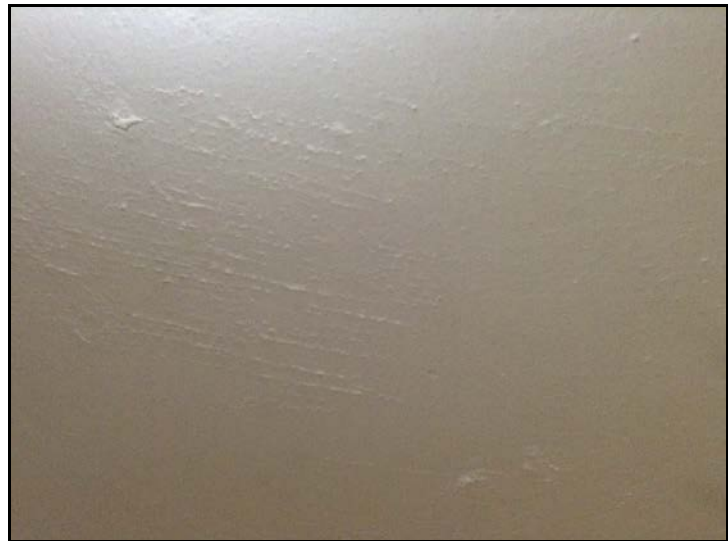
Site ID xxxxxx
 Location ID 007
 Building/Unit Site Name
 Floor 0 (Ground)
 Room / Area Store
 Description Textured Coating to Walls & Ceiling
 Surveyed Yes
 Source of Information Name of Surveyor
 Last Inspection Date Xx/xx/xxxx
 Lab Reference Xxxxxx/xxxxxx
 Survey Type Refurbishment
 Demolition
 Sample Number xxxxxx/S38

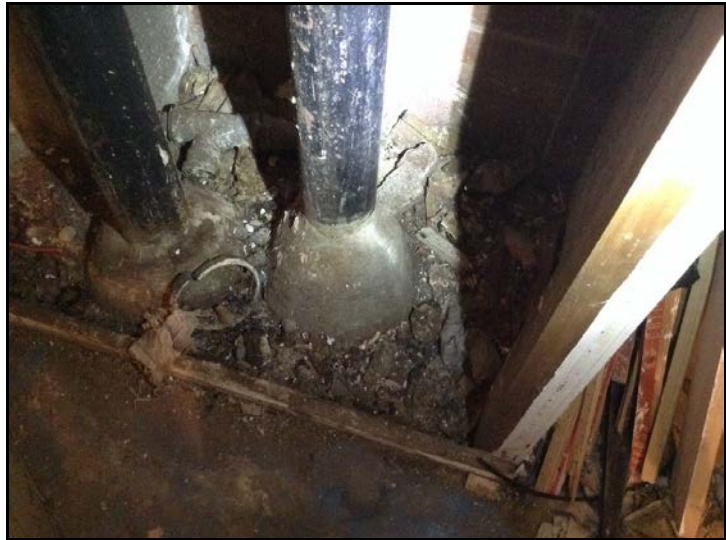
Site ID xxxxxx
 Location ID 008
 Building/Unit Site Name
 Floor 0 (Ground)
 Room / Area Store
 Description Debris in Riser
 Surveyed Yes
 Source of Information Name of Surveyor
 Last Inspection Date Xx/xx/xxxx
 Lab Reference Xxxxxx/xxxxxx
 Survey Type Refurbishment
 Demolition
 Sample Number xxxxxx/S29

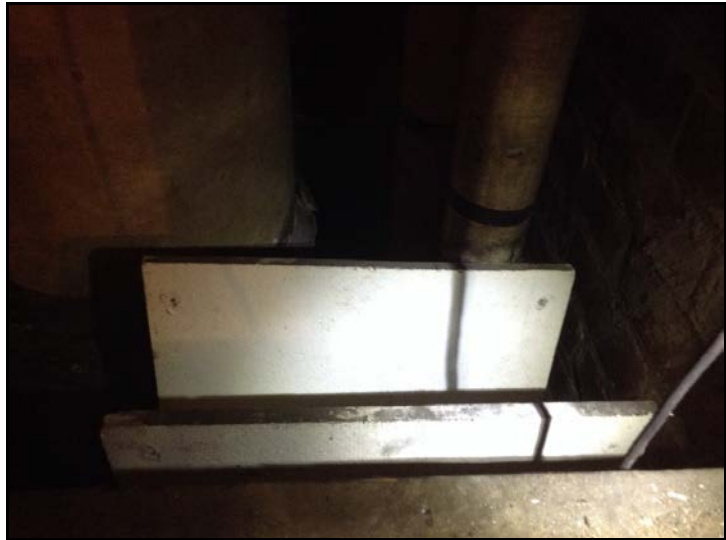
Site ID xxxxxx
 Location ID 008
 Building/Unit Site Name
 Floor 0 (Ground)
 Room / Area Store
 Description Loose Boards
 Surveyed Yes
 Source of Information Name of Surveyor
 Last Inspection Date Xx/xx/xxxx
 Lab Reference
 Survey Type Refurbishment
 Demolition
 Sample Number xxxxxx/X30

MATERIAL ASSESSMENT = 8

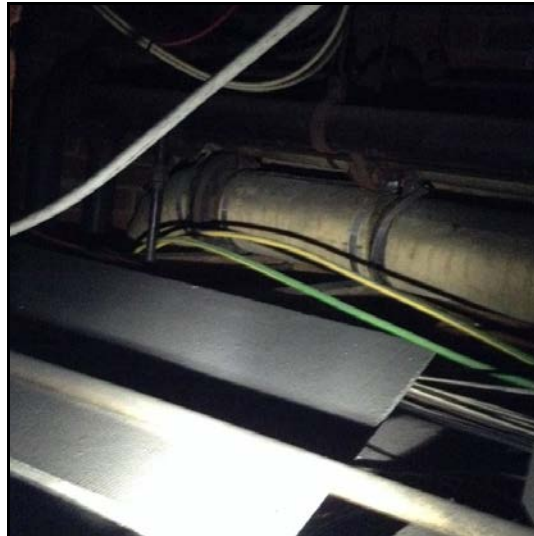
Site ID xxxxxx
Location ID 008
Building/Unit Site Name
Floor 0 (Ground)
Room / Area Store Ceiling Void
Description Loose Boards & Debris
Surveyed Yes
Source of Information Name of Surveyor
Last Inspection Date Xx/xx/xxxx
Lab Reference
Survey Type Refurbishment
 Demolition
Sample Number xxxxxx/X30

MATERIAL ASSESSMENT = 9

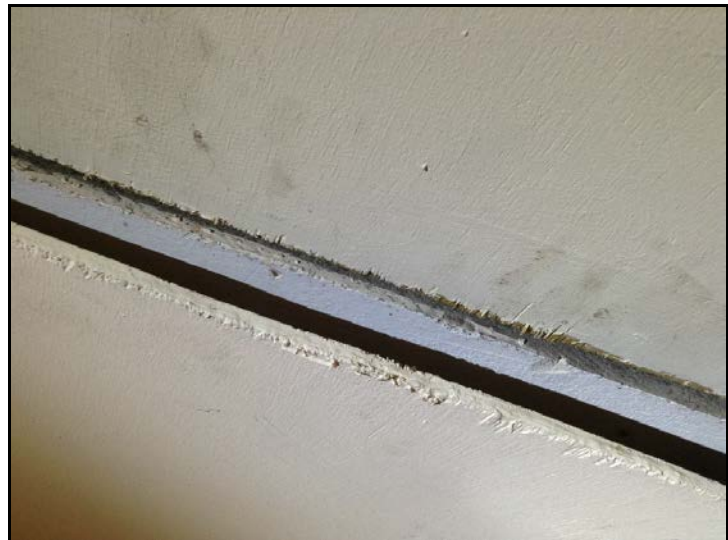
Site ID xxxxxx
Location ID 008
Building/Unit Site Name
Floor 0 (Ground)
Room / Area Store
Description Ceiling Boards
Surveyed Yes
Source of Information Name of Surveyor
Last Inspection Date Xx/xx/xxxx
Lab Reference Xxxxxx/xxxxxx
Survey Type Refurbishment
 Demolition
Sample Number xxxxxx/S31

MATERIAL ASSESSMENT = 8

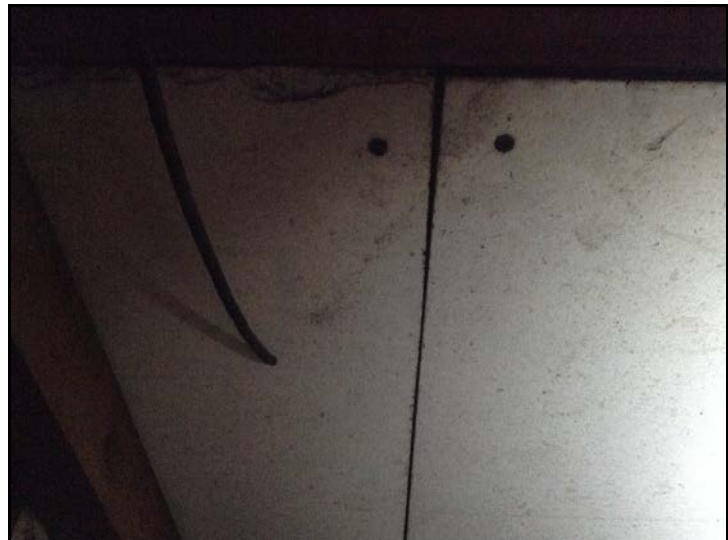
Site ID xxxxxx
Location ID 008
Building/Unit Site Name
Floor 0 (Ground)
Room / Area Store
Description Lining to Riser
Surveyed Yes
Source of Information Name of Surveyor
Last Inspection Date Xx/xx/xxxx
Lab Reference Xxxxxx/xxxxxx
Survey Type Refurbishment
 Demolition
Sample Number xxxxxx/S30

MATERIAL ASSESSMENT = 8

Site Name	0 (Ground)	008 - Store	Lining to Riser - Insulating Board	REMOVE (AIB) - The asbestos boards need to be removed by a licensed removal company prior to the commencement of any works.
Site Name	0 (Ground)	008 - Store	Ceiling Boards - Insulating Board	REMOVE (AIB) - The asbestos boards need to be removed by a licensed removal company prior to the commencement of any works.
Site Name	0 (Ground)	008 - Store Ceiling Void	Loose Boards & Debris - Insulating Board	REMOVE / ENVIRONMENTAL CLEAN (AIB DEBRIS) - The insulation board debris needs to be removed and the area environmentally cleaned by a licensed removal company as a priority.
Site Name	0 (Ground)	008 - Store	Flue Pipe in Riser - Cement Product	REMOVE (AC) - The asbestos cement needs to be removed by suitably trained persons under controlled conditions, and disposed of at a licensed disposal facility prior to the commencement of any works.

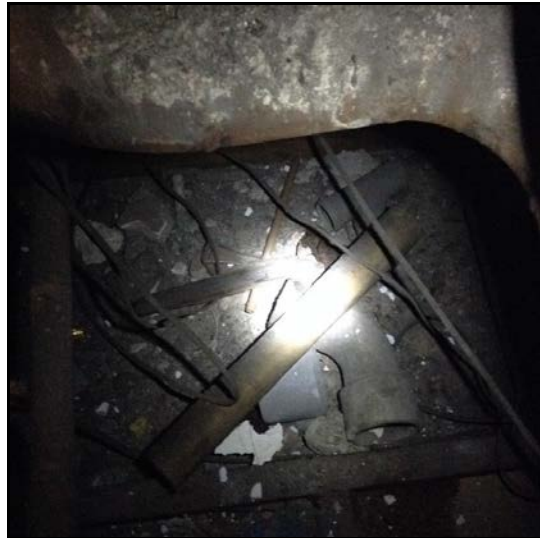
Site ID xxxxxx
 Location ID 008
 Building/Unit Site Name
 Floor 0 (Ground)
 Room / Area Store Ceiling Void
 Description Loose Pipes
 Surveyed Yes
 Source of Information Name of Surveyor
 Last Inspection Date Xx/xx/xxxx
 Lab Reference
 Survey Type Refurbishment
 Demolition
 Sample Number xxxxxx/X03

MATERIAL ASSESSMENT = 5

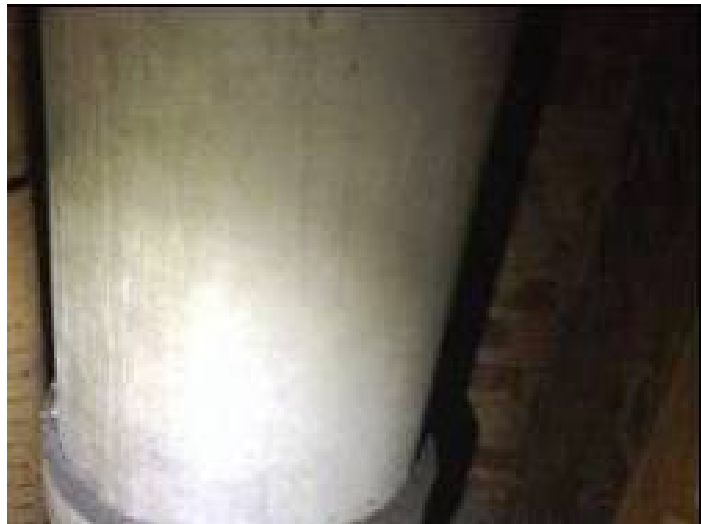
Site ID xxxxxx
Location ID 008
Building/Unit Site Name
Floor 0 (Ground)
Room / Area Store
Description Flue Pipe in Riser
Surveyed Yes
Source of Information Name of Surveyor
Last Inspection Date Xx/xx/xxxx
Lab Reference
Survey Type Refurbishment
 Demolition
Sample Number xxxxxx/X10

MATERIAL ASSESSMENT = 4

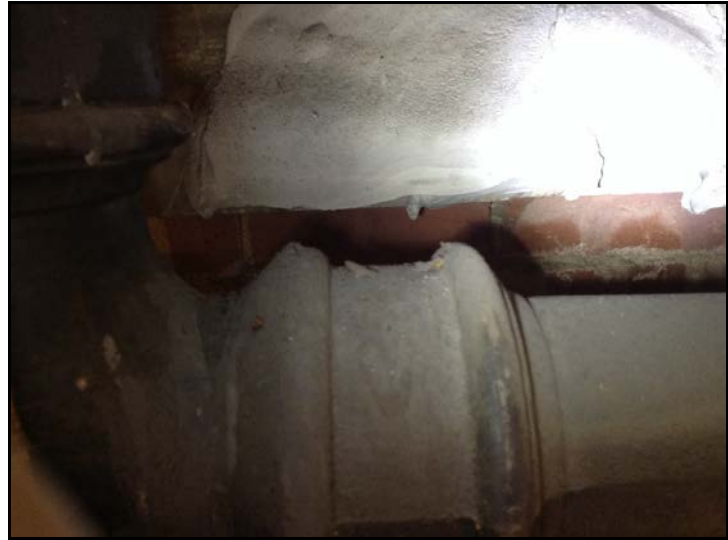
Site ID xxxxxx
 Location ID 009
 Building/Unit Site Name
 Floor 0 (Ground)
 Room / Area Gents W.C & Throughout
 Description Lagging between Sections of Waste Pipe
 Surveyed Yes
 Source of Information Name of Surveyor
 Last Inspection Date Xx/xx/xxxx
 Lab Reference Xxxxxx/xxxxxx
 Survey Type Refurbishment Demolition
 Sample Number xxxxxx/S36

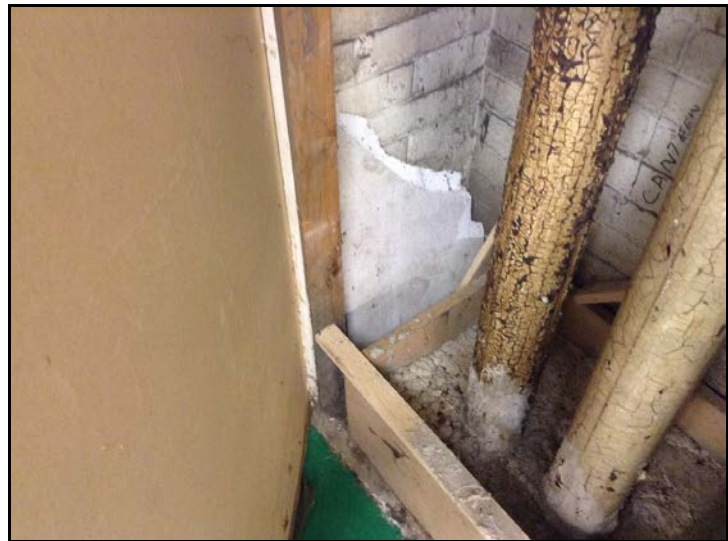
Site ID xxxxxx
Location ID 010
Building/Unit Site Name
Floor 0 (Ground)
Room / Area Warehouse
Description Loose Board & Debris
Surveyed Yes
Source of Information Name of Surveyor
Last Inspection Date Xx/xx/xxxx
Lab Reference
Survey Type Refurbishment
 Demolition
Sample Number xxxxxx/X37

MATERIAL ASSESSMENT = 8

Building	Floor	Location	Item Description	Recommendations
Site Name	0 (Ground)	010 - Warehouse	Loose Board & Debris - Insulating Board	REMOVE / ENVIRONMENTAL CLEAN (AIB DEBRIS) - The insulation board debris needs to be removed and the area environmentally cleaned by a licensed removal company as a priority.
Site Name	0 (Ground)	010 - Warehouse	Lining to Riser - Insulating Board	REMOVE (AIB) - The asbestos boards need to be removed by a licensed removal company prior to the commencement of any works.
Site Name	0 (Ground)	010 - Warehouse	Ceiling Panels - Insulating Board	REMOVE (AIB) - The asbestos boards need to be removed by a licensed removal company prior to the commencement of any works.
Site Name	0 (Ground)	010 - Warehouse	Gaskets to Pipes - Gaskets (Compressed)	REMOVE (GASK TO PIPE) - The pipe gaskets need to be removed by suitably trained persons under controlled conditions using HSE Guidelines prior to the commencement of any works.

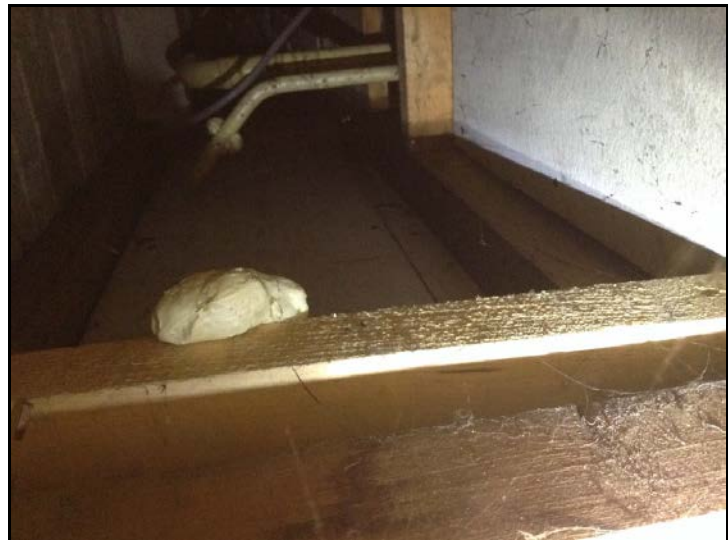
Site ID xxxxxx
 Location ID 010
 Building/Unit Site Name
 Floor 0 (Ground)
 Room / Area Warehouse
 Description Lining to Riser
 Surveyed Yes
 Source of Information Name of Surveyor
 Last Inspection Date Xx/xx/xxxx
 Lab Reference Xxxxxx/xxxxxx
 Survey Type Refurbishment
 Demolition
 Sample Number xxxxxx/S37

MATERIAL ASSESSMENT = 8

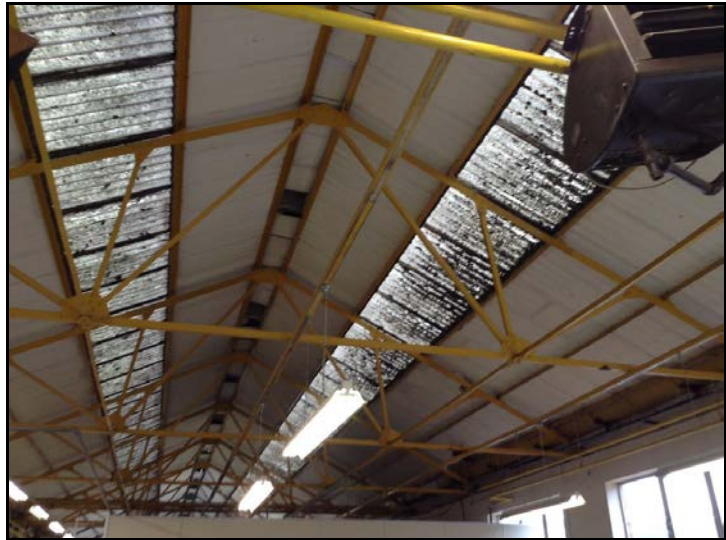
Site ID xxxxxx
 Location ID 010
 Building/Unit Site Name
 Floor 0 (Ground)
 Room / Area Warehouse
 Description Ceiling Panels
 Surveyed Yes
 Source of Information Name of Surveyor
 Last Inspection Date Xx/xx/xxxx
 Lab Reference Xxxxxx/xxxxxx
 Survey Type Refurbishment
 Demolition
 Sample Number xxxxxx/S39-40

MATERIAL ASSESSMENT = 5

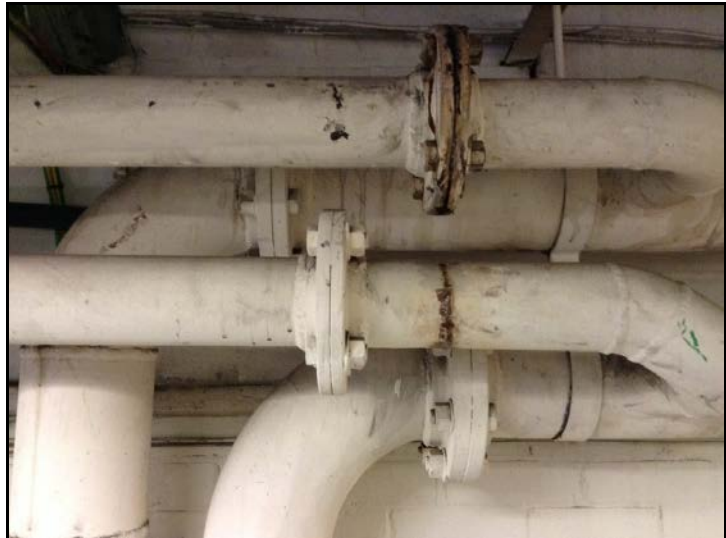
Site ID xxxxxx
Location ID 010
Building/Unit Site Name
Floor 0 (Ground)
Room / Area Warehouse
Description Gaskets to Pipes
Surveyed Yes
Source of Information Name of Surveyor
Last Inspection Date Xx/xx/xxxx
Lab Reference Xxxxxx/xxxxxx
Survey Type Refurbishment
 Demolition
Sample Number xxxxxx/S41

MATERIAL ASSESSMENT = 4

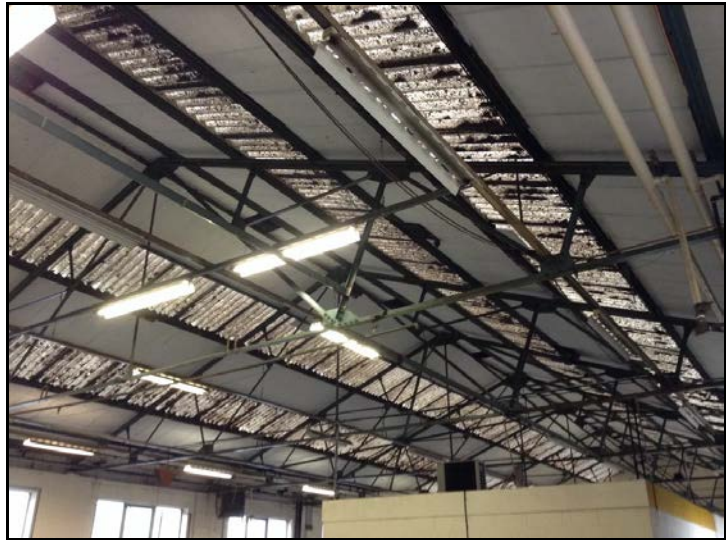
Site ID xxxxxx
 Location ID 015
 Building/Unit Site Name
 Floor 0 (Ground)
 Room / Area Warehouse
 Description Ceiling Panels
 Surveyed Yes
 Source of Information Name of Surveyor
 Last Inspection Date Xx/xx/xxxx
 Lab Reference Xxxxxx/xxxxxx
 Survey Type Refurbishment
 Demolition
 Sample Number xxxxxx/S42-S43

MATERIAL ASSESSMENT = 5

Site Name	0 (Ground)	015 - Warehouse	Ceiling Panels - Insulating Board	REMOVE (AIB) - The asbestos boards need to be removed by a licensed removal company prior to the commencement of any works.
Site Name	0 (Ground)	017 - Welding Area	Ceiling Panels - Insulating Board	REMOVE (AIB) - The asbestos boards need to be removed by a licensed removal company prior to the commencement of any works.
Site Name	0 (Ground)	019 - Throughout Warehouses	Roof Vents - Cement Product	REMOVE (AC) - The asbestos cement needs to be removed by suitably trained persons under controlled conditions, and disposed of at a licensed disposal facility prior to the commencement of any works.
Site Name	0 (Ground)	019 - Throughout Warehouses	Roof Sheets - Cement Product	REMOVE (AC) - The asbestos cement needs to be removed by suitably trained persons under controlled conditions, and disposed of at a licensed disposal facility prior to the commencement of any works.

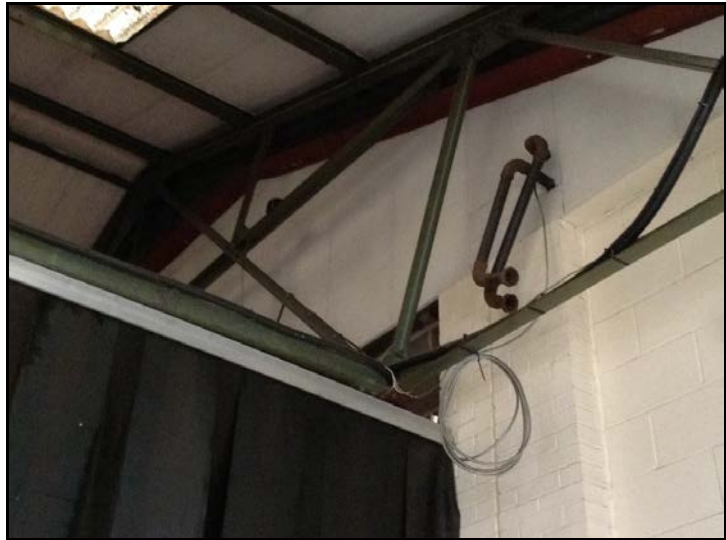
Site ID xxxxxx
 Location ID 017
 Building/Unit Site Name
 Floor 0 (Ground)
 Room / Area Welding Area
 Description Wall Boards
 Surveyed Yes
 Source of Information Name of Surveyor
 Last Inspection Date Xx/xx/xxxx
 Lab Reference Xxxxxx/xxxxxx
 Survey Type Refurbishment
 Demolition
 Sample Number xxxxxx/S44

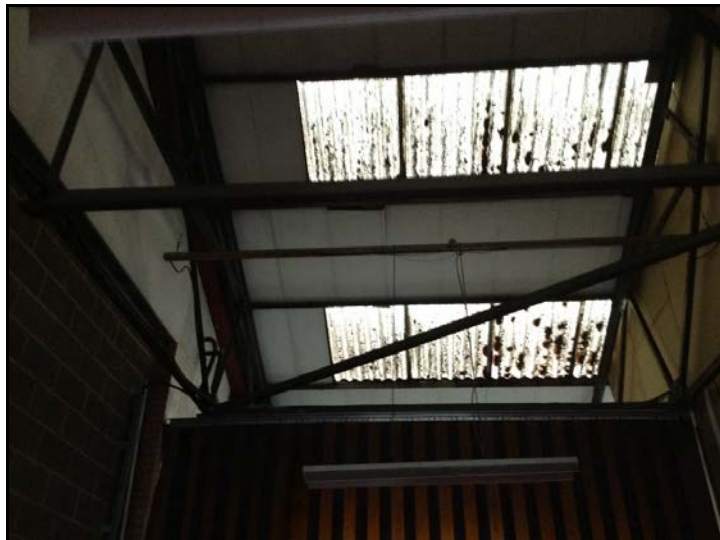
Site ID xxxxxx
Location ID 017
Building/Unit Site Name
Floor 0 (Ground)
Room / Area Welding Area
Description Ceiling Panels
Surveyed Yes
Source of Information Name of Surveyor
Last Inspection Date Xx/xx/xxxx
Lab Reference
Survey Type Refurbishment
 Demolition
Sample Number xxxxxx/X42

MATERIAL ASSESSMENT = 5

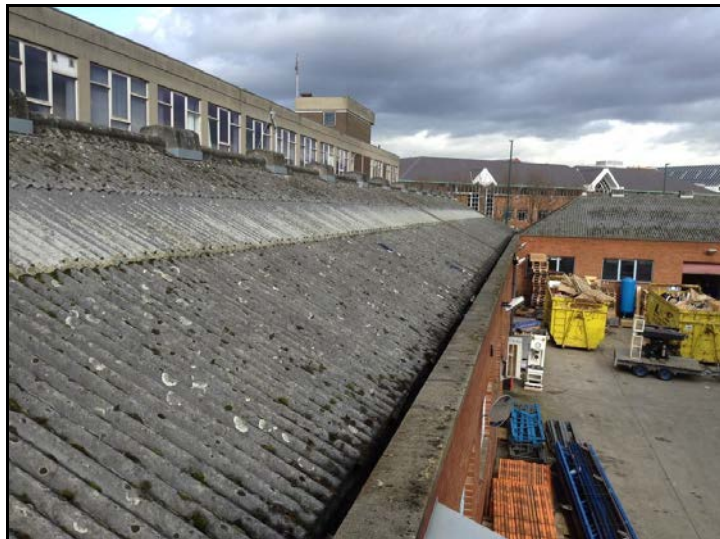
Site ID xxxxxx
Location ID 019
Building/Unit Site Name
Floor 0 (Ground)
Room / Area Throughout
 Warehouses
Description Roof Sheets
Surveyed Yes
Source of Information Name of Surveyor
Last Inspection Date Xx/xx/xxxx
Lab Reference Xxxxxx/xxxxxx
Survey Type Refurbishment
 Demolition
Sample Number xxxxxx/S45

MATERIAL ASSESSMENT = 4

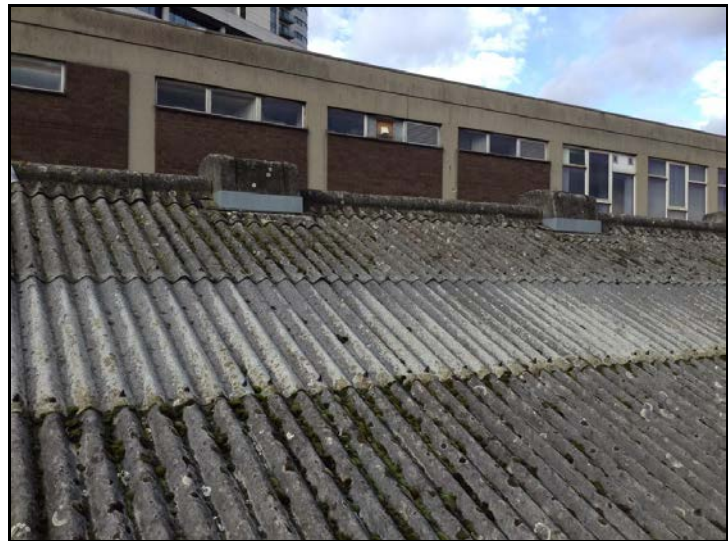
Site ID xxxxxx
Location ID 019
Building/Unit Site Name
Floor 0 (Ground)
Room / Area Throughout
 Warehouses
Description Roof Vents
Surveyed Yes
Source of Information Name of Surveyor
Last Inspection Date Xx/xx/xxxx
Lab Reference Xxxxxx/xxxxxx
Survey Type Refurbishment
 Demolition
Sample Number xxxxxx/S46

MATERIAL ASSESSMENT = 4

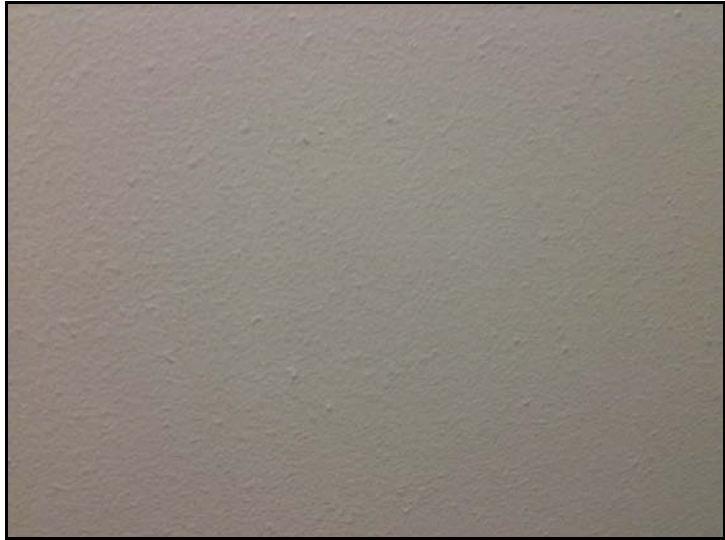
Site ID xxxxxx
 Location ID 101
 Building/Unit Site Name
 Floor 1 (1st Floor)
 Room / Area Landing
 Description Textured Coating to Walls
 Surveyed Yes
 Source of Information Name of Surveyor
 Last Inspection Date Xx/xx/xxxx
 Lab Reference Xxxxxx/xxxxxx
 Survey Type Refurbishment
 Demolition
 Sample Number xxxxxx/S14

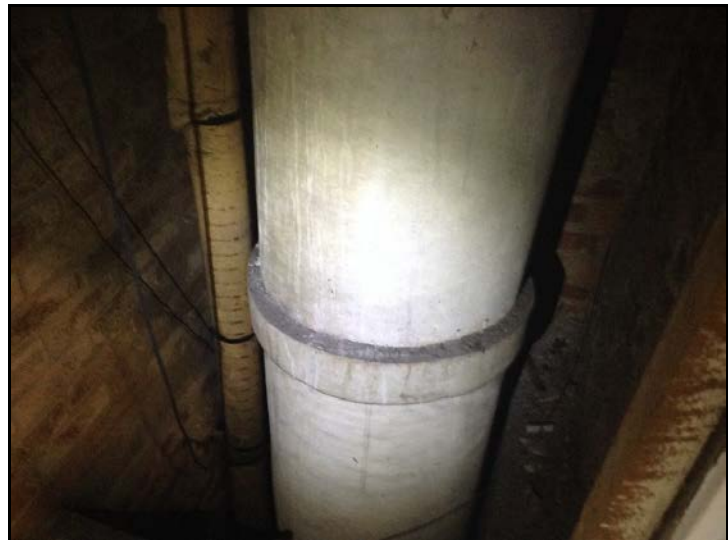
Site ID xxxxxx
Location ID 103
Building/Unit Site Name
Floor 1 (1st Floor)
Room / Area Riser
Description Flue Pipe
Surveyed Yes
Source of Information Name of Surveyor
Last Inspection Date Xx/xx/xxxx
Lab Reference
Survey Type Refurbishment
 Demolition
Sample Number xxxxxx/X10

MATERIAL ASSESSMENT = 4

Site Name	1 (1st Floor)	103 - Riser	Flue Pipe - Cement Product	REMOVE (AC) - The asbestos cement needs to be removed by suitably trained persons under controlled conditions, and disposed of at a licensed disposal facility prior to the commencement of any works.

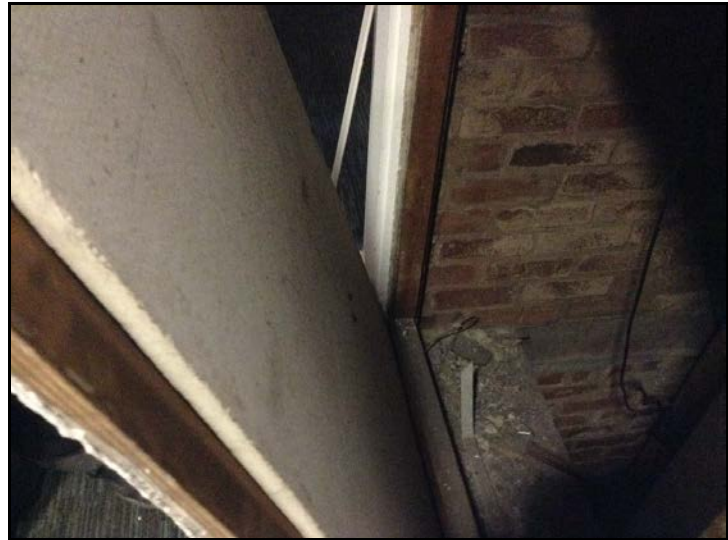
Site ID xxxxxx
Location ID 103
Building/Unit Site Name
Floor 1 (1st Floor)
Room / Area Riser
Description Lining Boards
Surveyed Yes
Source of Information Name of Surveyor
Last Inspection Date Xx/xx/xxxx
Lab Reference xxxxxx/xxxxxx
Survey Type Refurbishment
 Demolition
Sample Number xxxxxx/S15

MATERIAL ASSESSMENT = 9

Building	Floor	Location	Item Description	Recommendations
Site Name	1 (1st Floor)	103 - Riser	Lining Boards - Insulating Board	REMOVE (AIB) - The asbestos boards need to be removed by a licensed removal company prior to the commencement of any works.
Site Name	1 (1st Floor)	103 - Riser	Boards Debris - Insulating Board	REMOVE / ENVIRONMENTAL CLEAN (AIB DEBRIS) - The insulation board debris needs to be removed and the area environmentally cleaned by a licensed removal company as a priority.
Site Name	1 (1st Floor)	104 - Ladies W.C	Floor Tile Remnants & Bitumen Adhesive - Vinyl Tiles	REMOVE (FLOOR TILES & ADHESIVE) DEM - The floor tiles and bitumen adhesive need to be removed by suitably trained persons under controlled conditions using HSE Guidelines, prior to the commencement of any works.
Site Name	1 (1st Floor)	105 - Shower Room	Floor Tile Remnants & Bitumen Adhesive - Vinyl Tiles	REMOVE (FLOOR TILES & ADHESIVE) DEM - The floor tiles and bitumen adhesive need to be removed by suitably trained persons under controlled conditions using HSE Guidelines, prior to the commencement of any works.

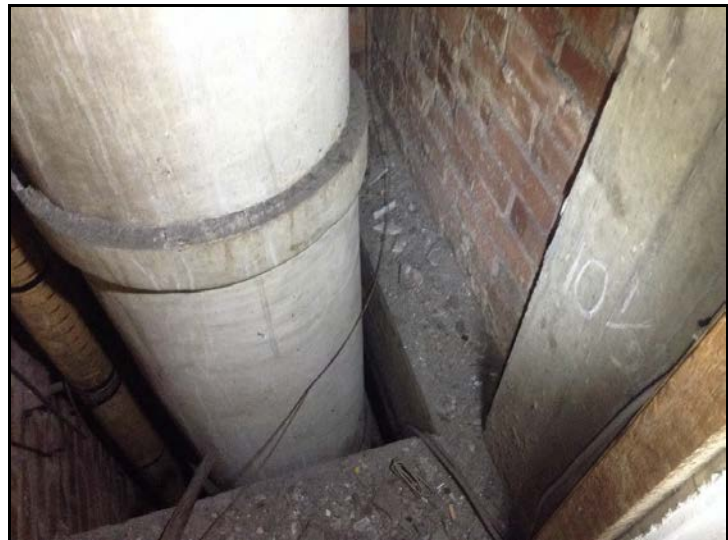
Site ID xxxxxx
 Location ID 103
 Building/Unit Site Name
 Floor 1 (1st Floor)
 Room / Area Riser
 Description Boards Debris
 Surveyed Yes
 Source of Information Luke Poston
 Last Inspection Date Xx/xx/xxxx
 Lab Reference
 Survey Type Refurbishment
 Demolition
 Sample Number xxxxxx/X15

MATERIAL ASSESSMENT = 9

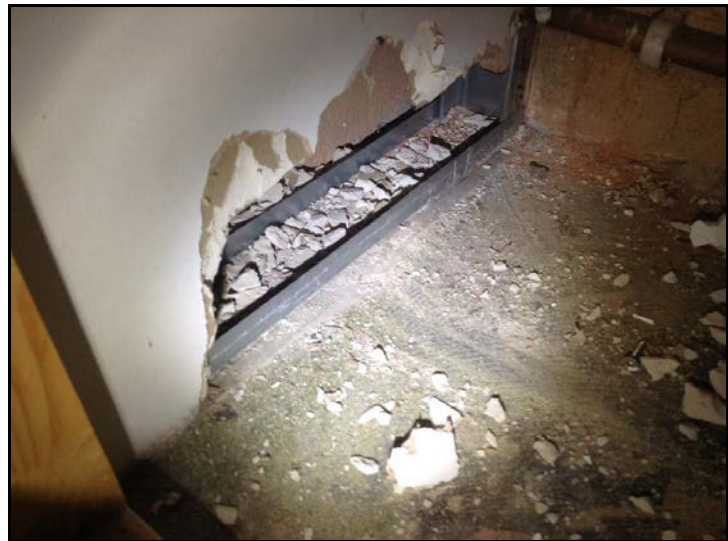
Site ID xxxxxx
Location ID 104
Building/Unit Site Name
Floor 1 (1st Floor)
Room / Area Ladies W.C
Description Floor Tile Remnants & Bitumen Adhesive
Surveyed Yes
Source of Information Luke Poston
Last Inspection Date Xx/xx/xxxx
Lab Reference Xxxxxx/xxxxxx
Survey Type Refurbishment
 Demolition
Sample Number xxxxxx/S17

MATERIAL ASSESSMENT = 3

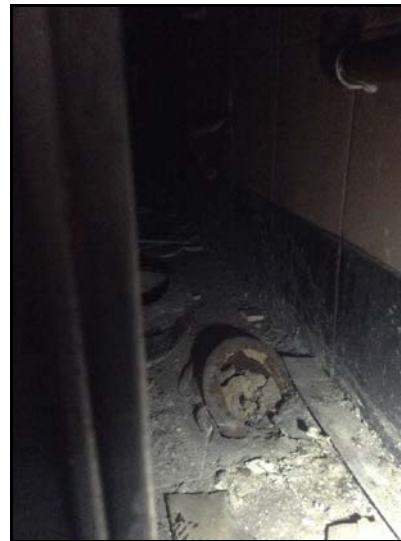
Site ID xxxxxx
Location ID 105
Building/Unit Site Name
Floor 1 (1st Floor)
Room / Area Shower Room
Description Floor Tile Remnants & Bitumen Adhesive
Surveyed Yes
Source of Information Name of Surveyor
Last Inspection Date xx/xx/xxxx
Lab Reference Xxxxxx/xxxxxx
Survey Type Refurbishment
 Demolition
Sample Number xxxxxx/S18

MATERIAL ASSESSMENT = 3
