JAPAN P&I CLUB

P&I Loss Prevention Bulletin

Dragging Anchor

- Case Studies and Preventive Measures -

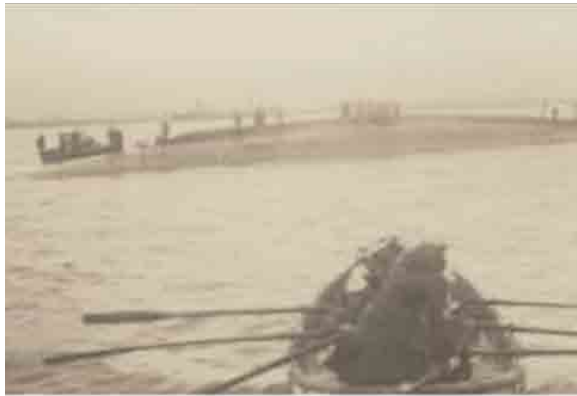
Photograph 35
"Capsized Touya Maru"

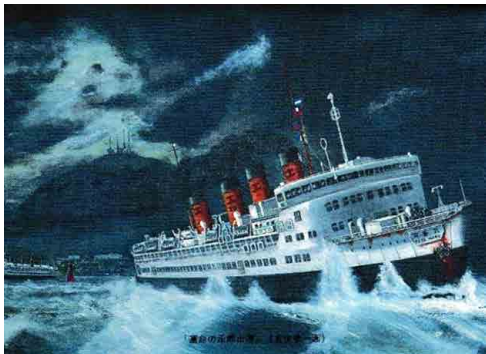
Grounded in the shallow off Nanaehama, with a 45 degree inclination to the starboard side.

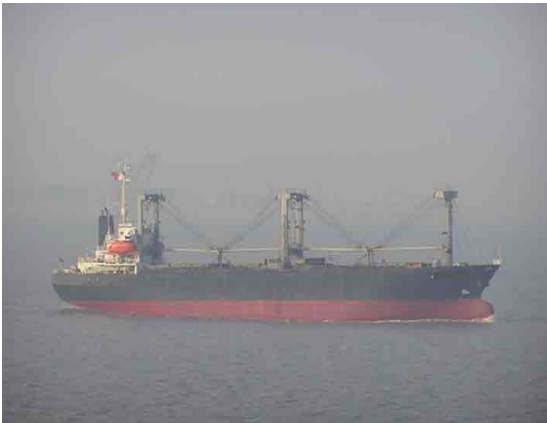
Photograph 45

deceased and three missing). The remaining 16 crew members including the Master were rescued by the helicopters of the Japan Coast Guard and the Self-Defense Force. Photograph 45, Figs. 46 and 47 show the path of Vessel B and its anchor being dragged.

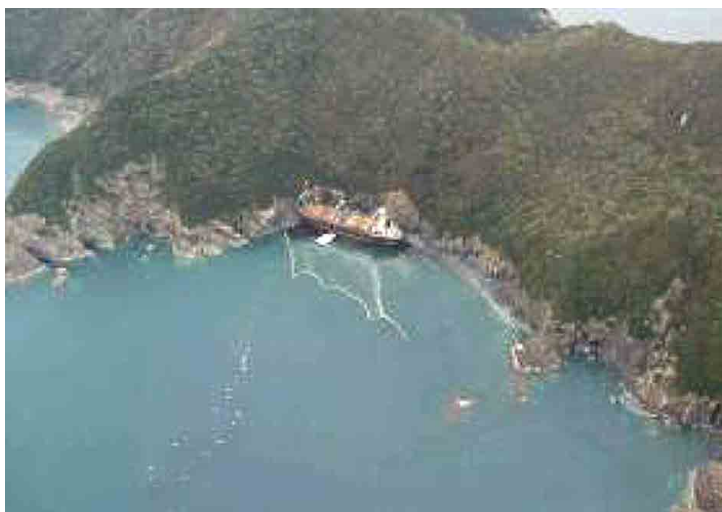
Photograph 51

<p>Grounded at the point of <066> 1,750m from Yuranohana Cape Lighthouse. At approximately 13:00, four panicked crew members left the bridge. When they climbed down the stern deck they were carried away with the waves and fell into the sea.</p>

- ▶ There were facts related to the process leading to the accident such as not obtaining the information about anchoring from the agency and only obtaining weather information by means of NAVEX. Also, not being able to use the anchor on the starboard side due to windlass failure was one of the causes of the accident.

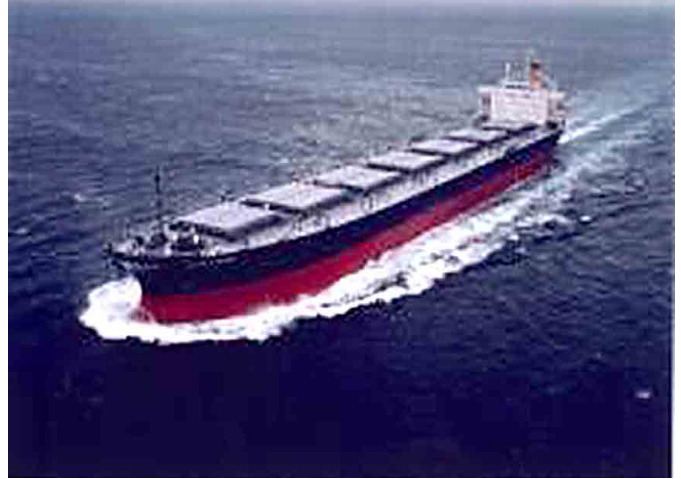
Photograph 53

Regarding dry bulk, Vessel C, the total number of crew members on board was 23 (four Indian nationals and 19 Filipino nationals) and 57, 474 tons of corn was loaded at the Port of New Orleans in North America. She entered into the Port of Shibushi, Kagoshima Prefecture, on the 23rd of July, 2002 in order to unload. At the Port, among the people disembarking were: 9 crew members (a chief officer [Indian national] and 8 others [Filipino nationals]) that disembarked and a total number of 5 crew members (the successor, a chief officer [(Indian national)] and 4 other crew members) relieved them and boarded. The crew arrangement at the time when the accident occurred was 4 Indian nationals made up of the Master, the chief officer, the chief engineer and the 1st engineer and 15 other Filipino nationals. (The number of crew members decreased by 4)

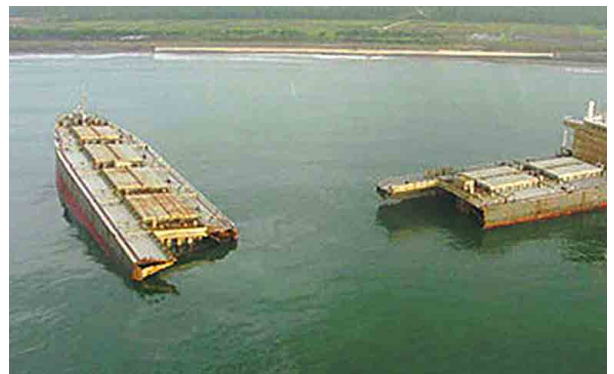
Regarding the damage, cargo holds, between No. 5 and No. 6, near the centre of the hull there was breakage and No. 2 Fuel Oil Tank under No. 5 cargo hold was damaged. Immediately, at the same time as he activated the distress signal by operating the EPIRB, the Master reported the distress to the Japan Coast Guard via international VHF radio communications.

Photograph 56 Breakage
