Specific Defect Report

Inspection Date 15 February 2021

I was asked to inspect and advise on an issue relating to building dampness which was evident on the flank wall following the application of a sand and cement render over the original brickwork. I was advised that the issue appears to worsen during periods of adverse weather. The problem extends the length of the flank wall and is visible in the lounge and the kitchen.

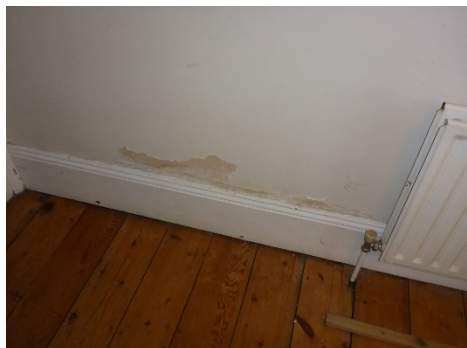
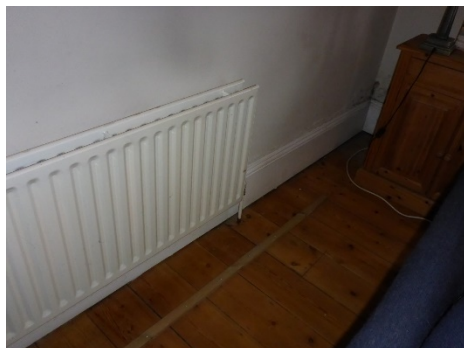
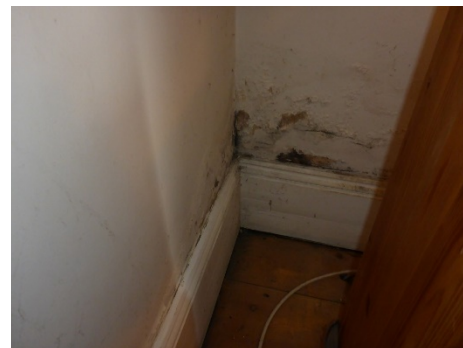
Saturation and damage at low level in the lounge

The walls at low level are showing signs of rising and penetrating moisture above the line of the skirting boards. The damage is more prevalent in the front corner to the left of the bay window and around the chimney breast in the kitchen.

Moisture readings were taken in both rooms and all of the readings were in excess of 90% on a Protimeter Mini.

The internal plaster is likely to be suffering from Hygroscopic salt contamination due to the moisture penetration, and following the replacement of the existing external render, it is likely that you will need to consider the replacement of the internal plaster in the affected areas. This will involve cutting out the plaster to a height of 1m and replacing this with a new plaster system that will complement the external finish. In this regard you will need to seek the advice of a contractor accredited to the Property Care Association (PCA) who will be best placed to advise further. This work will also involve the removal and replacement of the stringboards.

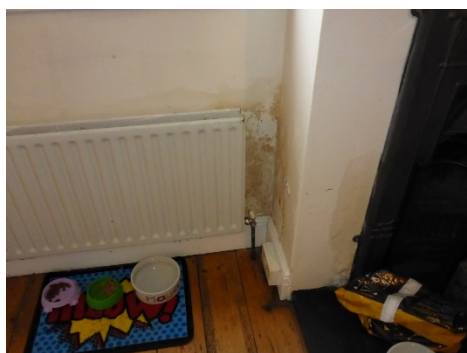
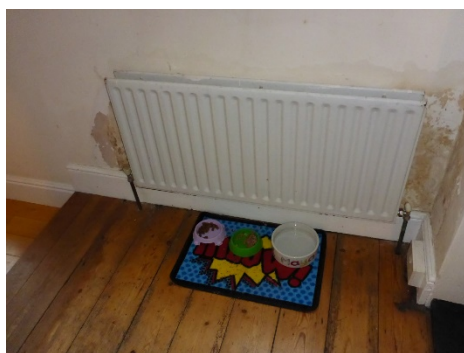
Saturation and damage at low level in the lounge

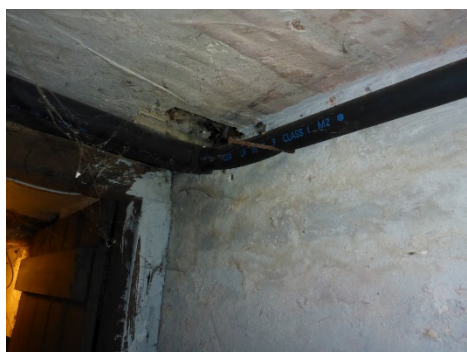
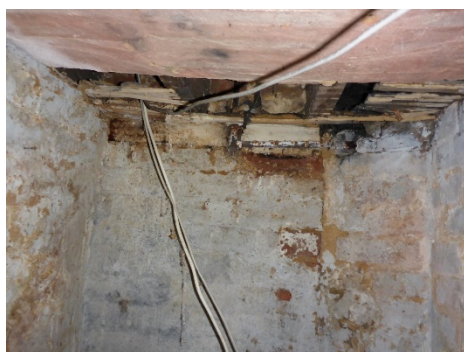
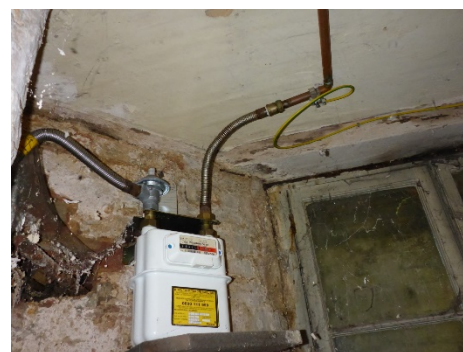
Signs of moisture penetration on the cellar walls

The walls in the cellar are lime washed brickwork which have been painted with emulsion. There is visible moisture penetration through the walls and this is more prevalent in the front walls.

In regard to the moisture penetration in the cellar around the front bay, I believe that this is the direct result of the open hopper to the front and I would recommend that this is fitted with a concrete shroud which is flaunches on four sides to direct water directly into the hopper and prevent this from draining behind the hopper and along the path.

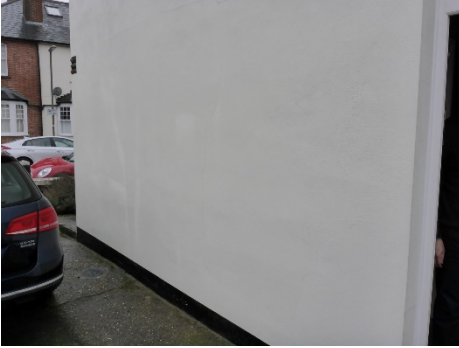
Render applied to the flank wall

The external flank wall was originally finished in fair faced brickwork and more recently a smooth sand and cement render has been applied and painted with external emulsion. I was advised that the original bricks were similar to the surrounding properties, which are red stock bricks.

The internal issues with rising and penetrating moisture are the direct result of the incorrect and poor application and finish of the render. The render is in direct contact with the ground and is causing moisture to be drawn up above the level of the DPC and where the walls do not have a cavity and the external face has been sealed with a cement based render, moisture is then being drawn inwards resulting in the internal damage.

I am, therefore, of the opinion that the rendering is not fit for purpose and will need to be removed and replaced with a material more suitable for this type of installation. A more suitable material would be a silicate based render, of which there are many manufacturers. One of the most well known is K Rend and further information can be viewed at <https://www.k-rend.co.uk/> Silicate based renders offer a more flexible and breathable solution, both of which are extremely important in a building of this age and type of construction. K Rend offer technical support and provide an approved contractor list to assist you in finding a suitable contractor.

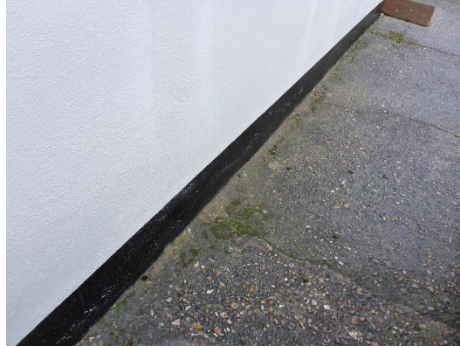
Render is in direct contact with the ground

The render to the flank wall is in direct contact with the ground and there is no bell drip installed at the base of the wall. The render is cracked and crazing in several locations and when tapped, the render produced a hollow sound, particularly around the cracking.

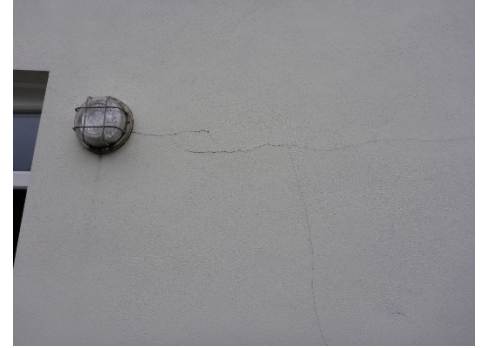
Cracks and crazing to the render

The cement based render is the incorrect material and should not have been used in this installation. The cracking is consistent with a render finish being applied over the original brickwork and due to a chemical reaction called sulphate attack where sulphates react with tricalcium aluminates found in ordinary Portland cement. This reaction causes expansion, leading to cracking.

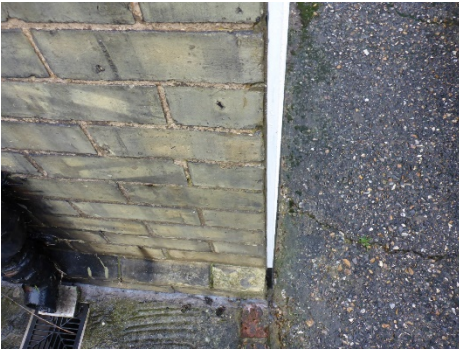
Stop bead to front corner

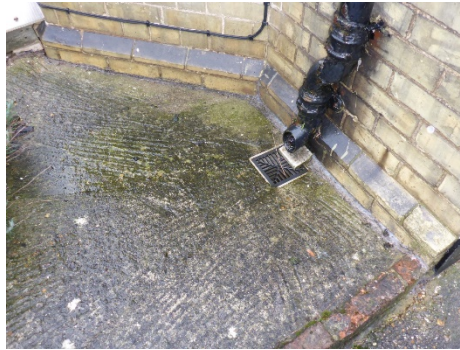
Rainwater discharge point to the front

The front elevations are finished in fair faced brickwork with fully pointed mortar joints. There is a rainwater pipe to the right of the front facing bay window which discharges to an open ground hopper. The connection and integrity of the hopper was not tested or checked at the time of my inspection.

The wall behind the rainwater hopper has been sealed with silicone at the junction between the wall and the concrete paving.
