## Case Study

**Address:** Cam Estate, Ainsworth Close, London, NW2 7ED

**Operations:** Licensed and unlicensed asbestos removal of all identified asbestos containing materials from several buildings on the estate subject to external refurbishment by our client.

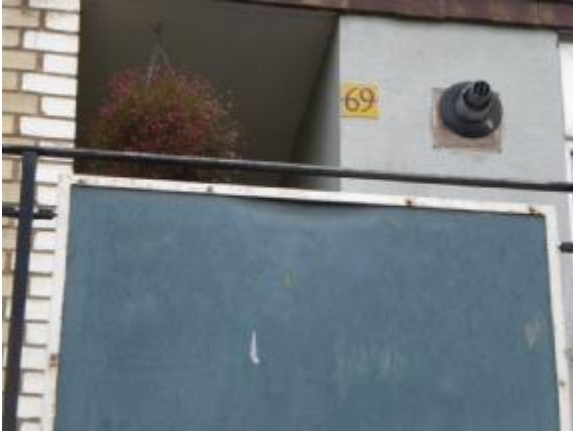
**Balustrade panels to balconies**

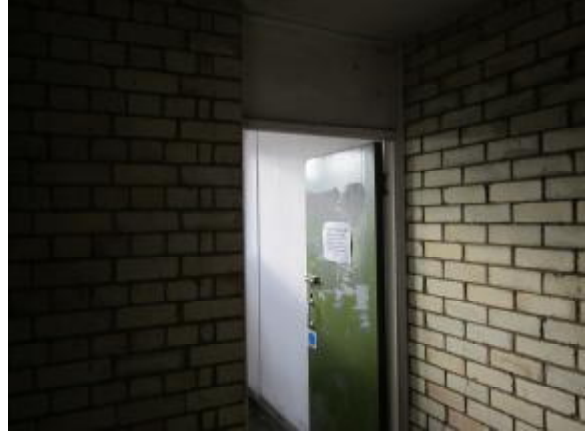
**Chute room fanlights**

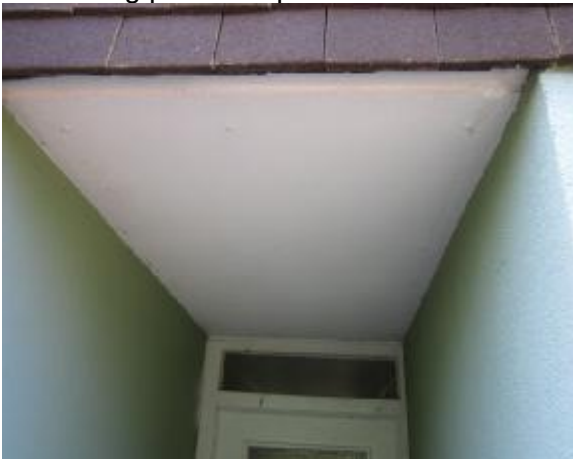
**AIB ceiling panels to porch entrances**

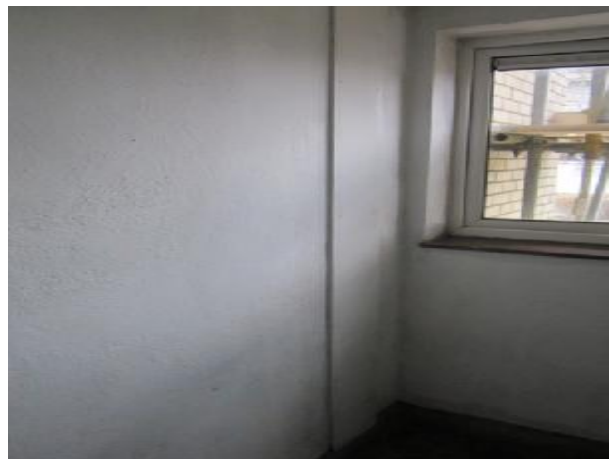
**AIB risers in communal areas**

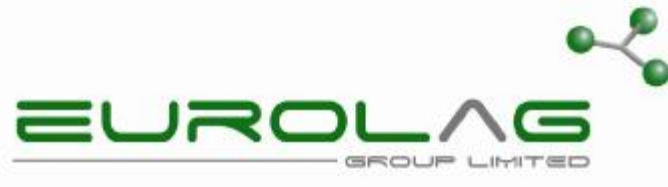
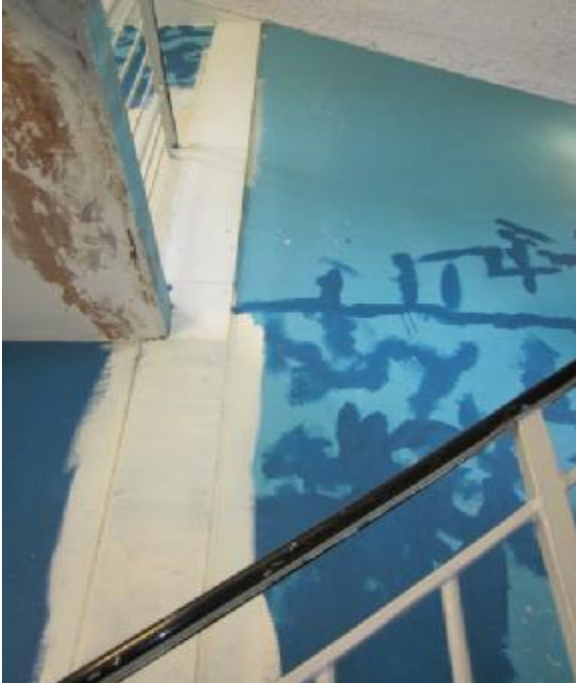
**AIB risers in communal stair areas**
