REFURBS & UPGRADES

CASE STUDY PACK

Efficiency of streamlined hub increased

Choke manifold refurbishment & recertification

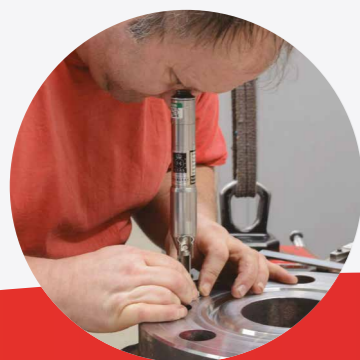
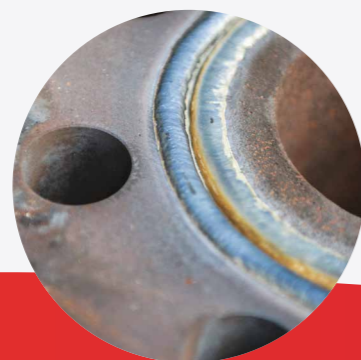
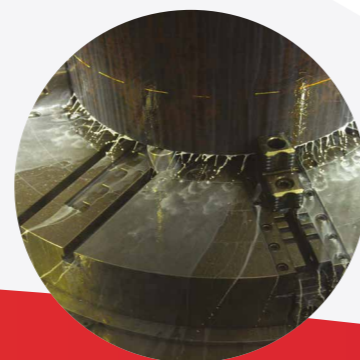
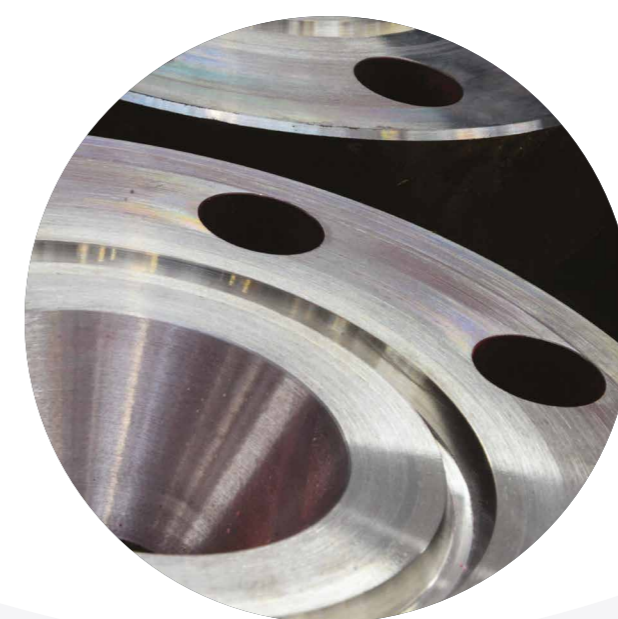
An oilfield service company approached Probe to complete a full visual and dimensional inspection on a 6" GR-52 streamlined hub c/w 90-degree cushion elbow. The component was badly corroded on all sealing areas and internals.

"As part of the refurbishment, all the sealing surfaces were rough machined to oversize allowing an Inconel weld inlay to be installed over the sealing area," said Dave Good. "Once this operation was completed the Inconel inlay was machined back to the specification required for the sealing face which ensured that the component still met with the required manufacturing tolerances. The internal areas were then inlaid with Inconel to help prevent further corrosion for when the component will be used in extreme environments."

Once the refurbishment had been completed the item was revalidated with third party certification and pressure tested to the required test pressure. This specification was in accordance with API 6A (20th Edition, NACE MR-01-75) and the client's requirements.

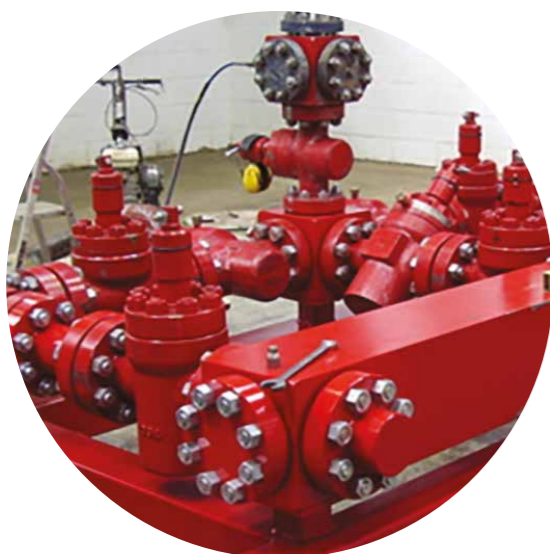
During the inspection process, it was confirmed that a vast amount of the sealing areas had corrosion/surface pitting and the actual valve seats also showed signs of pitting and corrosion. This was causing leak paths past the valves when closed.

Steven Blake, Operations Manager, Probe, said, "All the sealing surfaces were rough machined to oversize allowing an Inconel inlay to be installed over the sealing area. Once this operation was completed, the welded inlay was machined back to the specification required for the sealing face ensuring that they still met with the required manufacturing tolerances. The internal areas were then inlaid with Inconel to help prevent further corrosion.

"There was a requirement for Probe to remanufacture the choke manifold valve seats and sealing rods as we needed to ensure that the valve integrity could be achieved during operations. Having to manufacture these items separately did not compromise the project timetable. Once all refurbished and new components were made, the manifold was revalidated with third party certification and pressure tested to the required test pressure. The specification was in accordance with API 6A (20th Edition, NACE MR-01-75) and the customers' requirements."

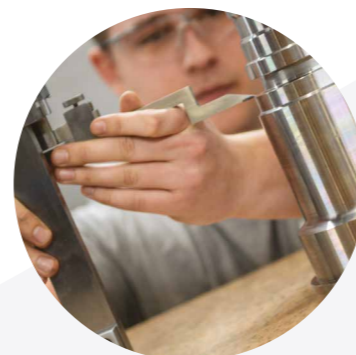
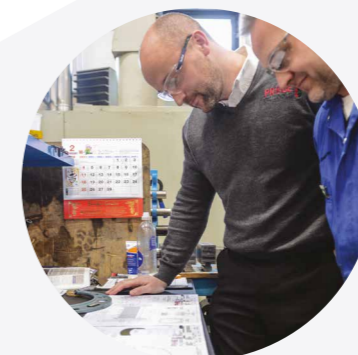
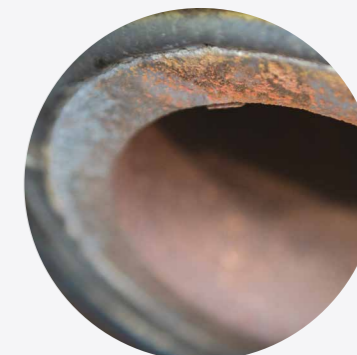
An oilfield service company approached Probe to complete a full visual and dimensional inspection on a 13 5/8" - 5000 Bowl - 7100 Tall. The component was badly corroded on all sealing areas.

"As part of the refurbishment, all the sealing surfaces were rough machined to oversize allowing an Inconel weld inlay to be installed over the sealing area," said Dave Good. "Once this operation was completed, the Inconel inlay was machined back to the specification required for the sealing face, which ensured that the component still met with the required manufacturing tolerances. The internal areas were then inlaid with Inconel to help prevent further corrosion for when the component will be used in extreme environments."

Once the refurbishment had been completed, the item was revalidated with third party certification and pressure tested to the required test pressure. This specification was in accordance with API 6A (20th Edition, NACE MR-01-75) and the client's requirements.
