# MAKING AN OLD HOME GREENER

Period properties are often criticised for being draughty and expensive to run, but this listed house has been transformed into a comfortable, cost-effective, much more eco-friendly place to live. Roger Hunt explains how this was achieved without compromising its character

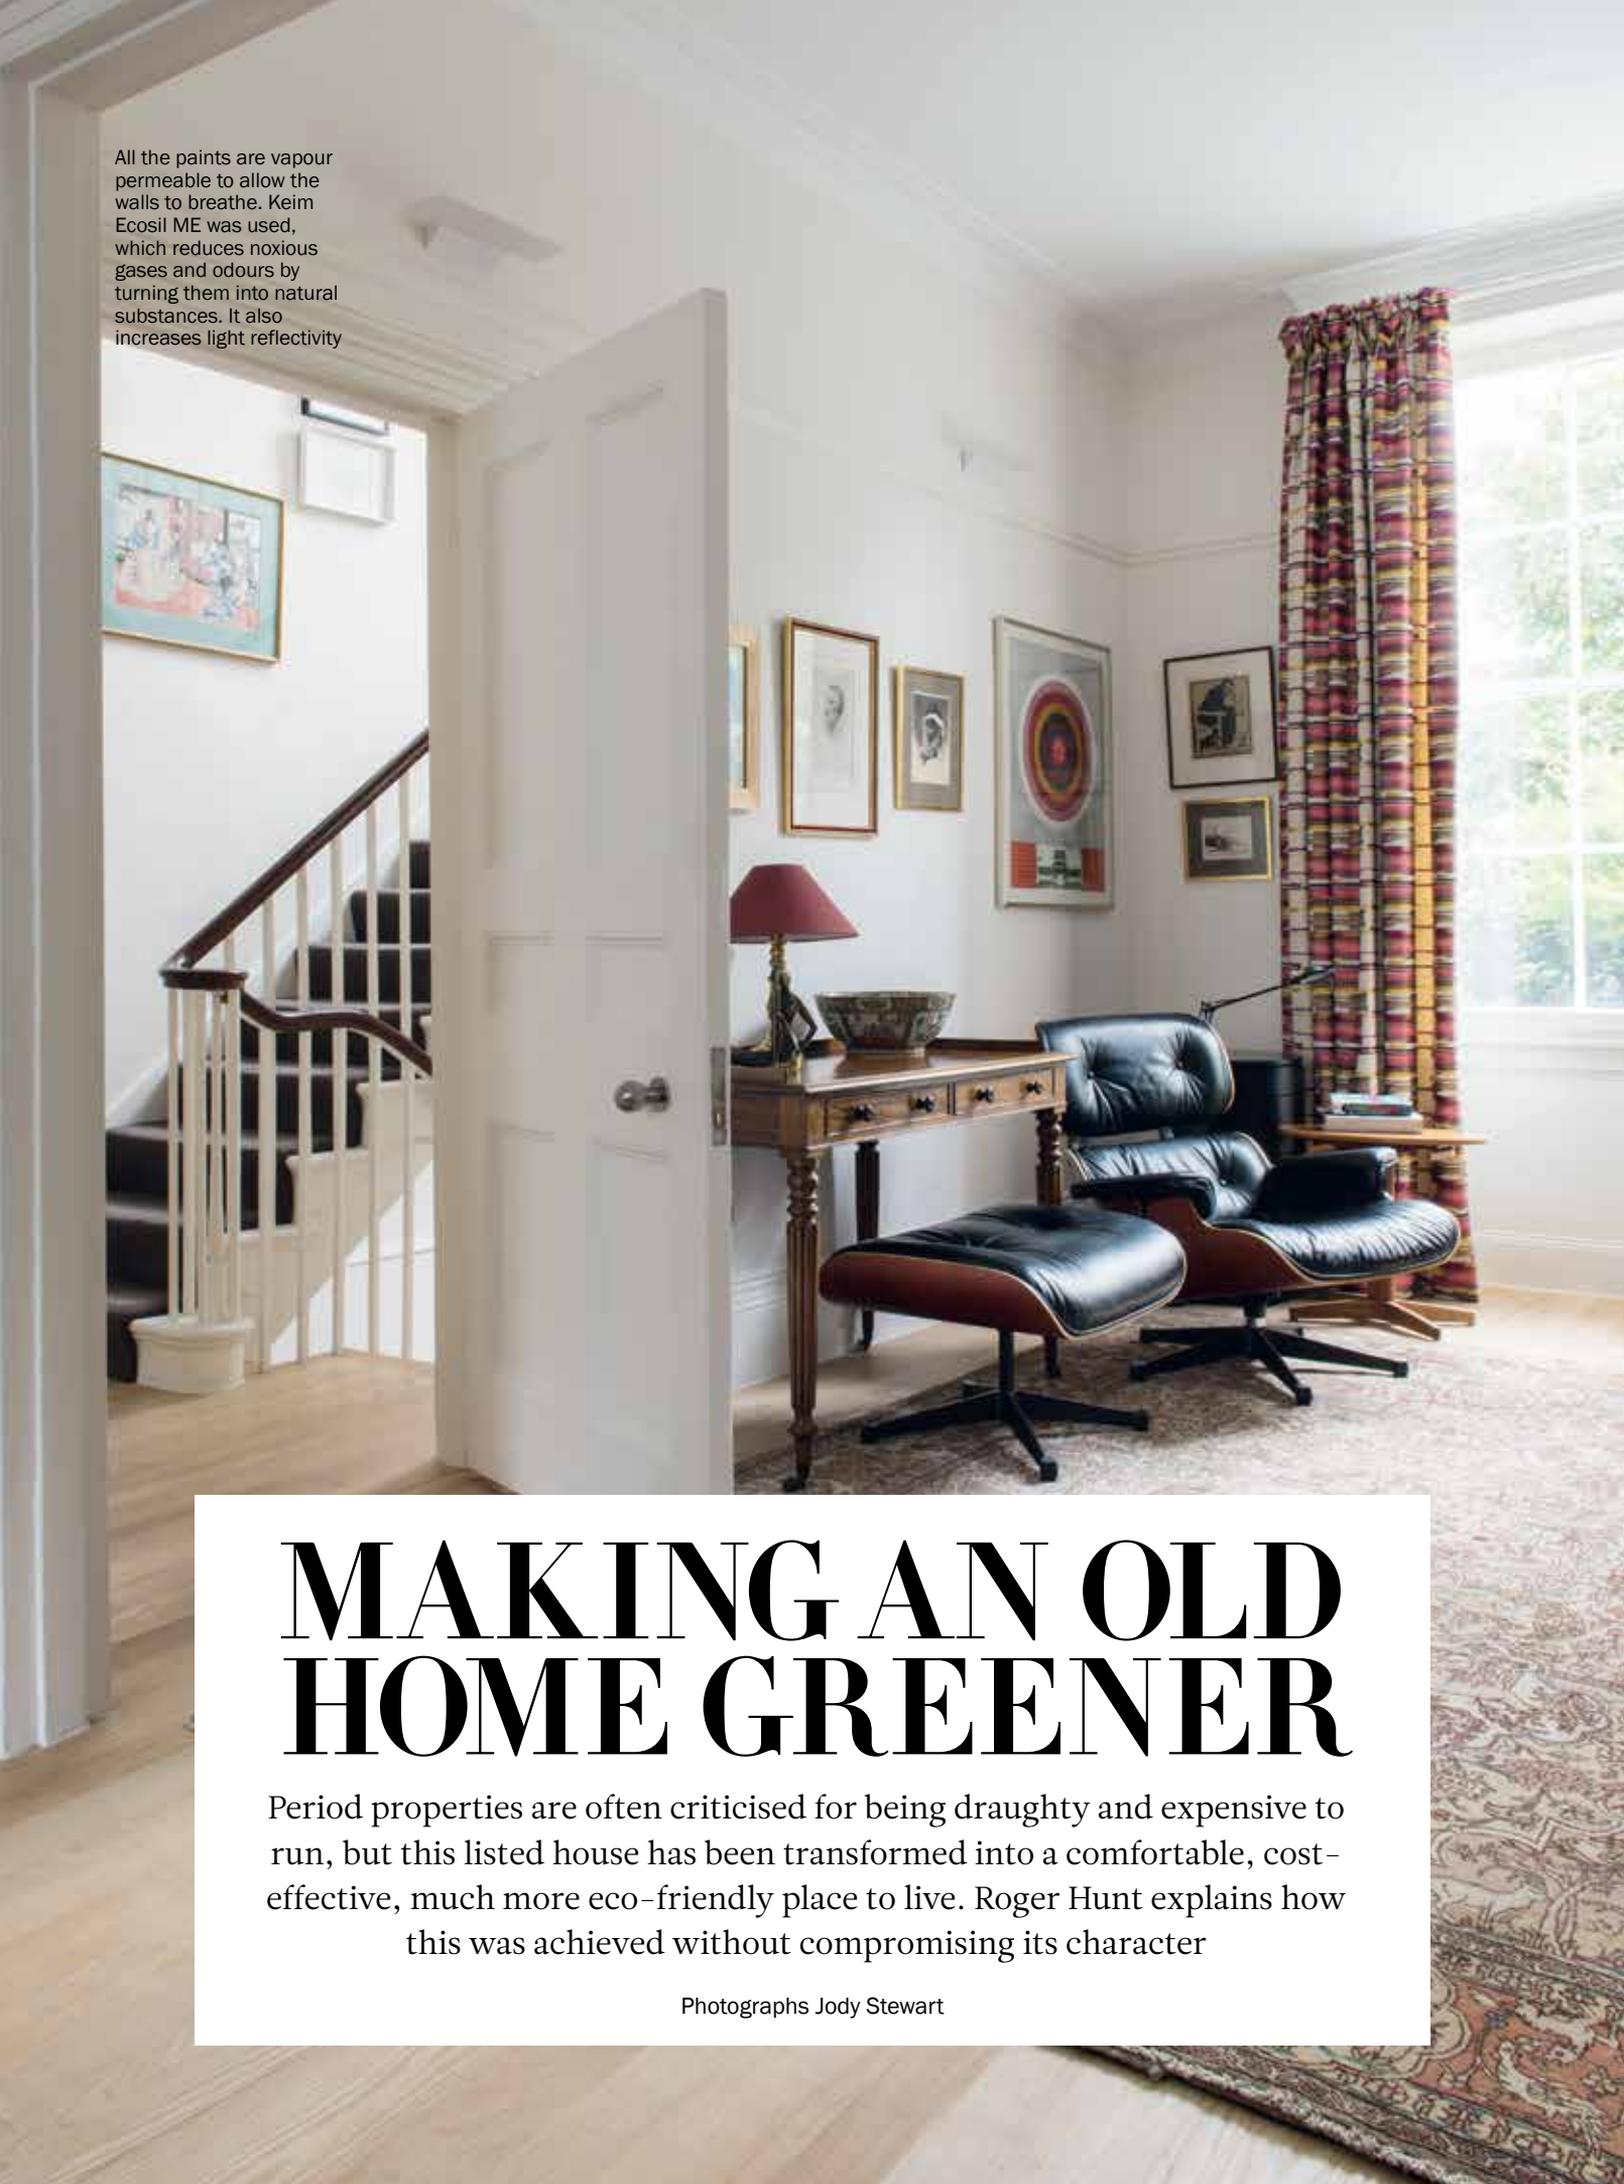
All the paints are vapour permeable to allow the walls to breathe. Keim Ecosil ME was used, which reduces noxious gases and odours by turning them into natural substances. It also increases light reflectivity

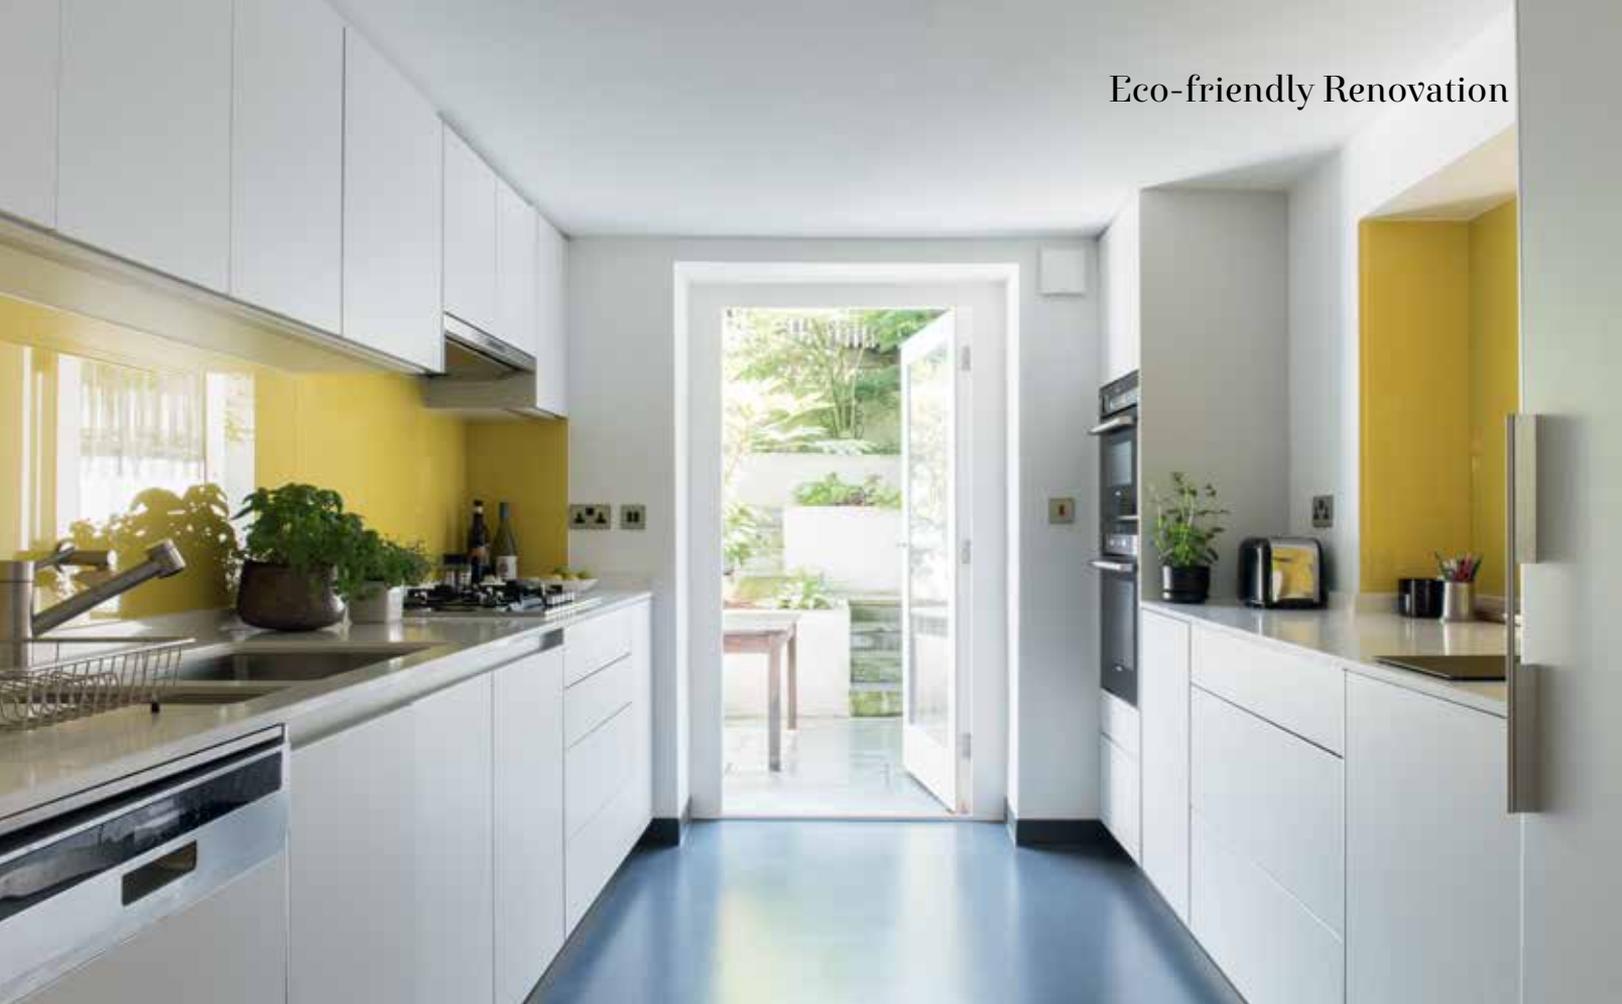
*Above:* The kitchen is where the biggest change can be seen. The garden was excavated and a patio door added. Due to the high levels of airtightness, this space is fitted with a mechanical extractor fan that runs continuously

Increasing the airtightness of the house meant that sufficient controlled ventilation had to be introduced. Installing a centrally based ducted ventilation system within the fabric of the old house would have been very invasive so separate mechanical extractor fans were installed through existing vents in each of the three bathrooms and the kitchen. These run continuously at a low extraction rate and have a boost function that the owners can activate when necessary.

Despite the huge amount of work done to the house, most of it is unseen. The biggest visible change is the transformation of the dark and cramped lower ground floor into a bright kitchen. This was achieved by excavating the back garden to create an airy sunken courtyard accessed through a glass door that allows in light. ►

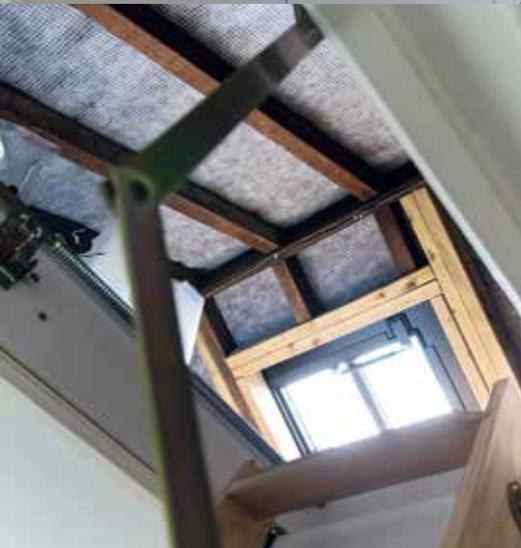
*Far left:* A breathable membrane was used in the roof space. A rooflight allows maintenance access to the valley gutter and thermal solar panels

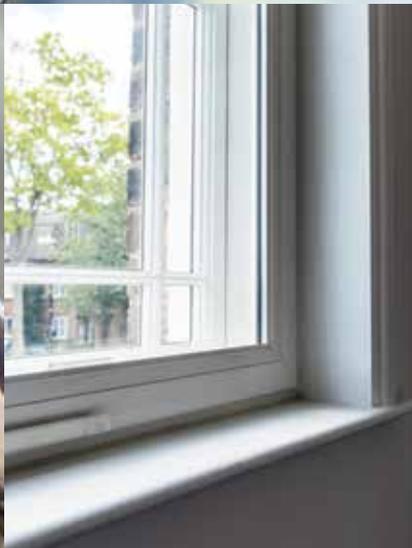
*Left:* Aluminium secondary glazing has improved the thermal performance of the original windows

The original sash windows are single glazed and had to be retained due to their historic importance but, on their own, could never provide the thermal performance required, so the decision was taken to install double-glazed secondary glazing. A further benefit of this was the reduction in road noise.

A hinged tilt and turn aluminium system from Granada Secondary Glazing was chosen that opens inwards to provide natural ventilation. This enabled a single pane of glass to be used so the sashes are obscured as little as possible. 'What's nice is that we managed to match the sightlines of the secondary glazing to the window precisely,' explains Harry.

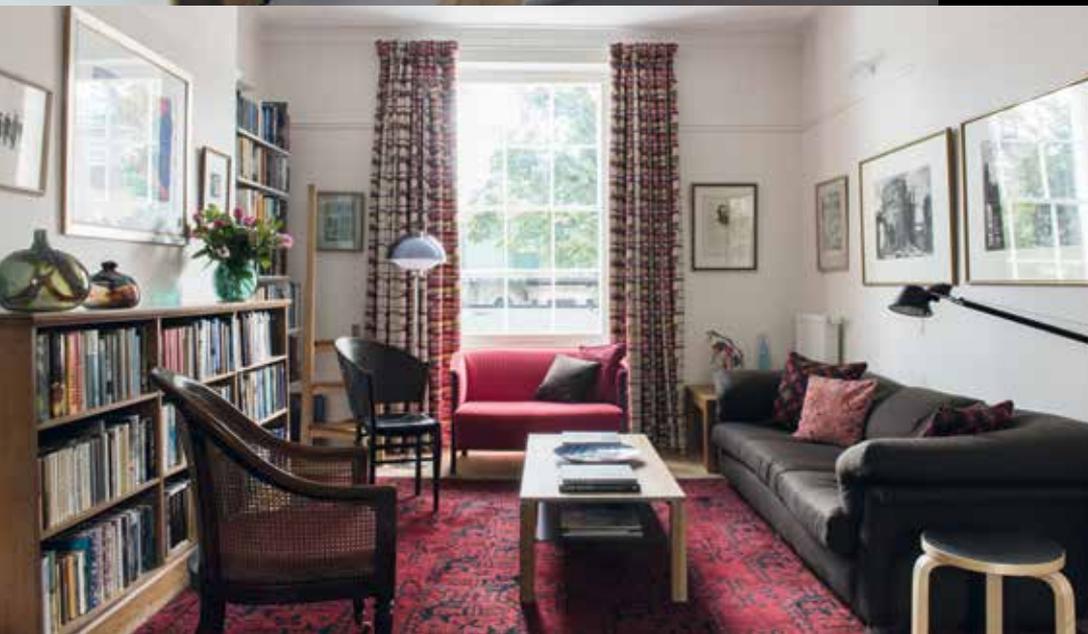
*Below:* To give the living room a focal point, and to make it extra cosy on cold winter evenings, a small 4kW Morso stove was installed in front of the original cast-iron fire surround. The owners opted for a large Welsh slate hearth

a 4kW Morso wood-burning stove was installed in the living room fireplace on a new hearth of Welsh slate in front of the original cast-iron fire surround.
