SPIRAL WELD

Re-engineering with Advanced Recovery Technology

THE FIRST NAME IN RECOVERY TECHNOLOGY

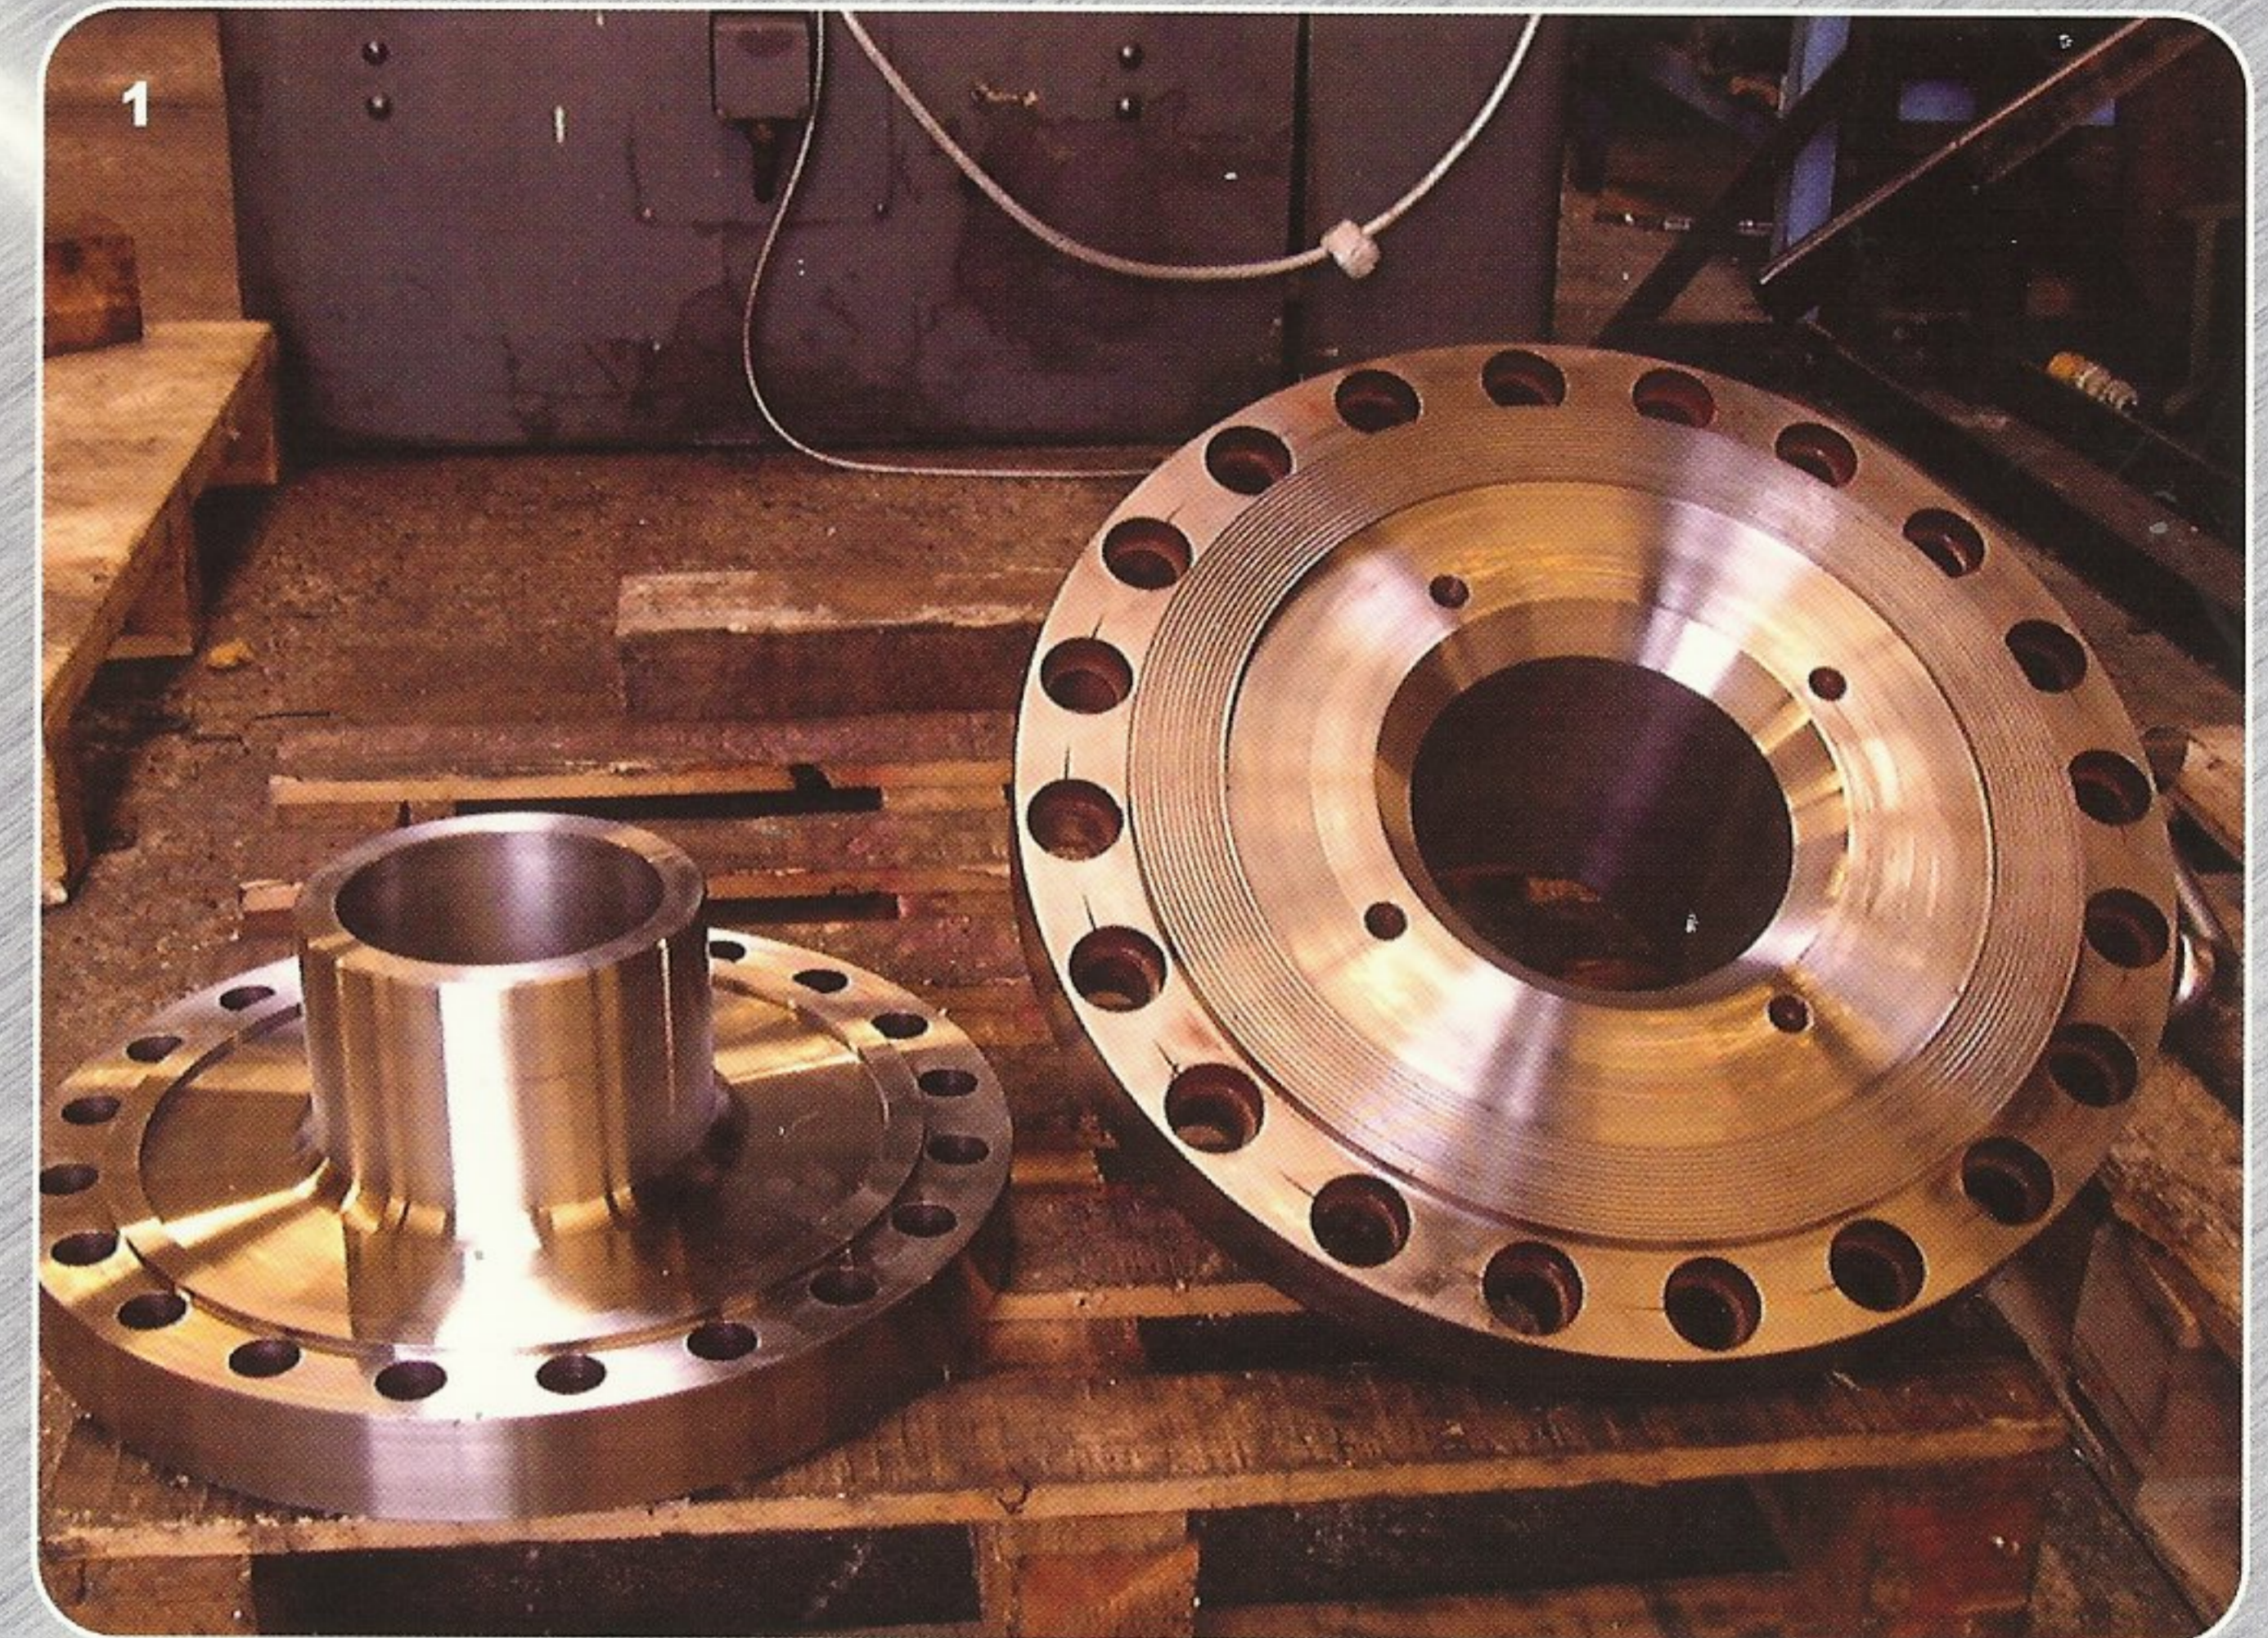
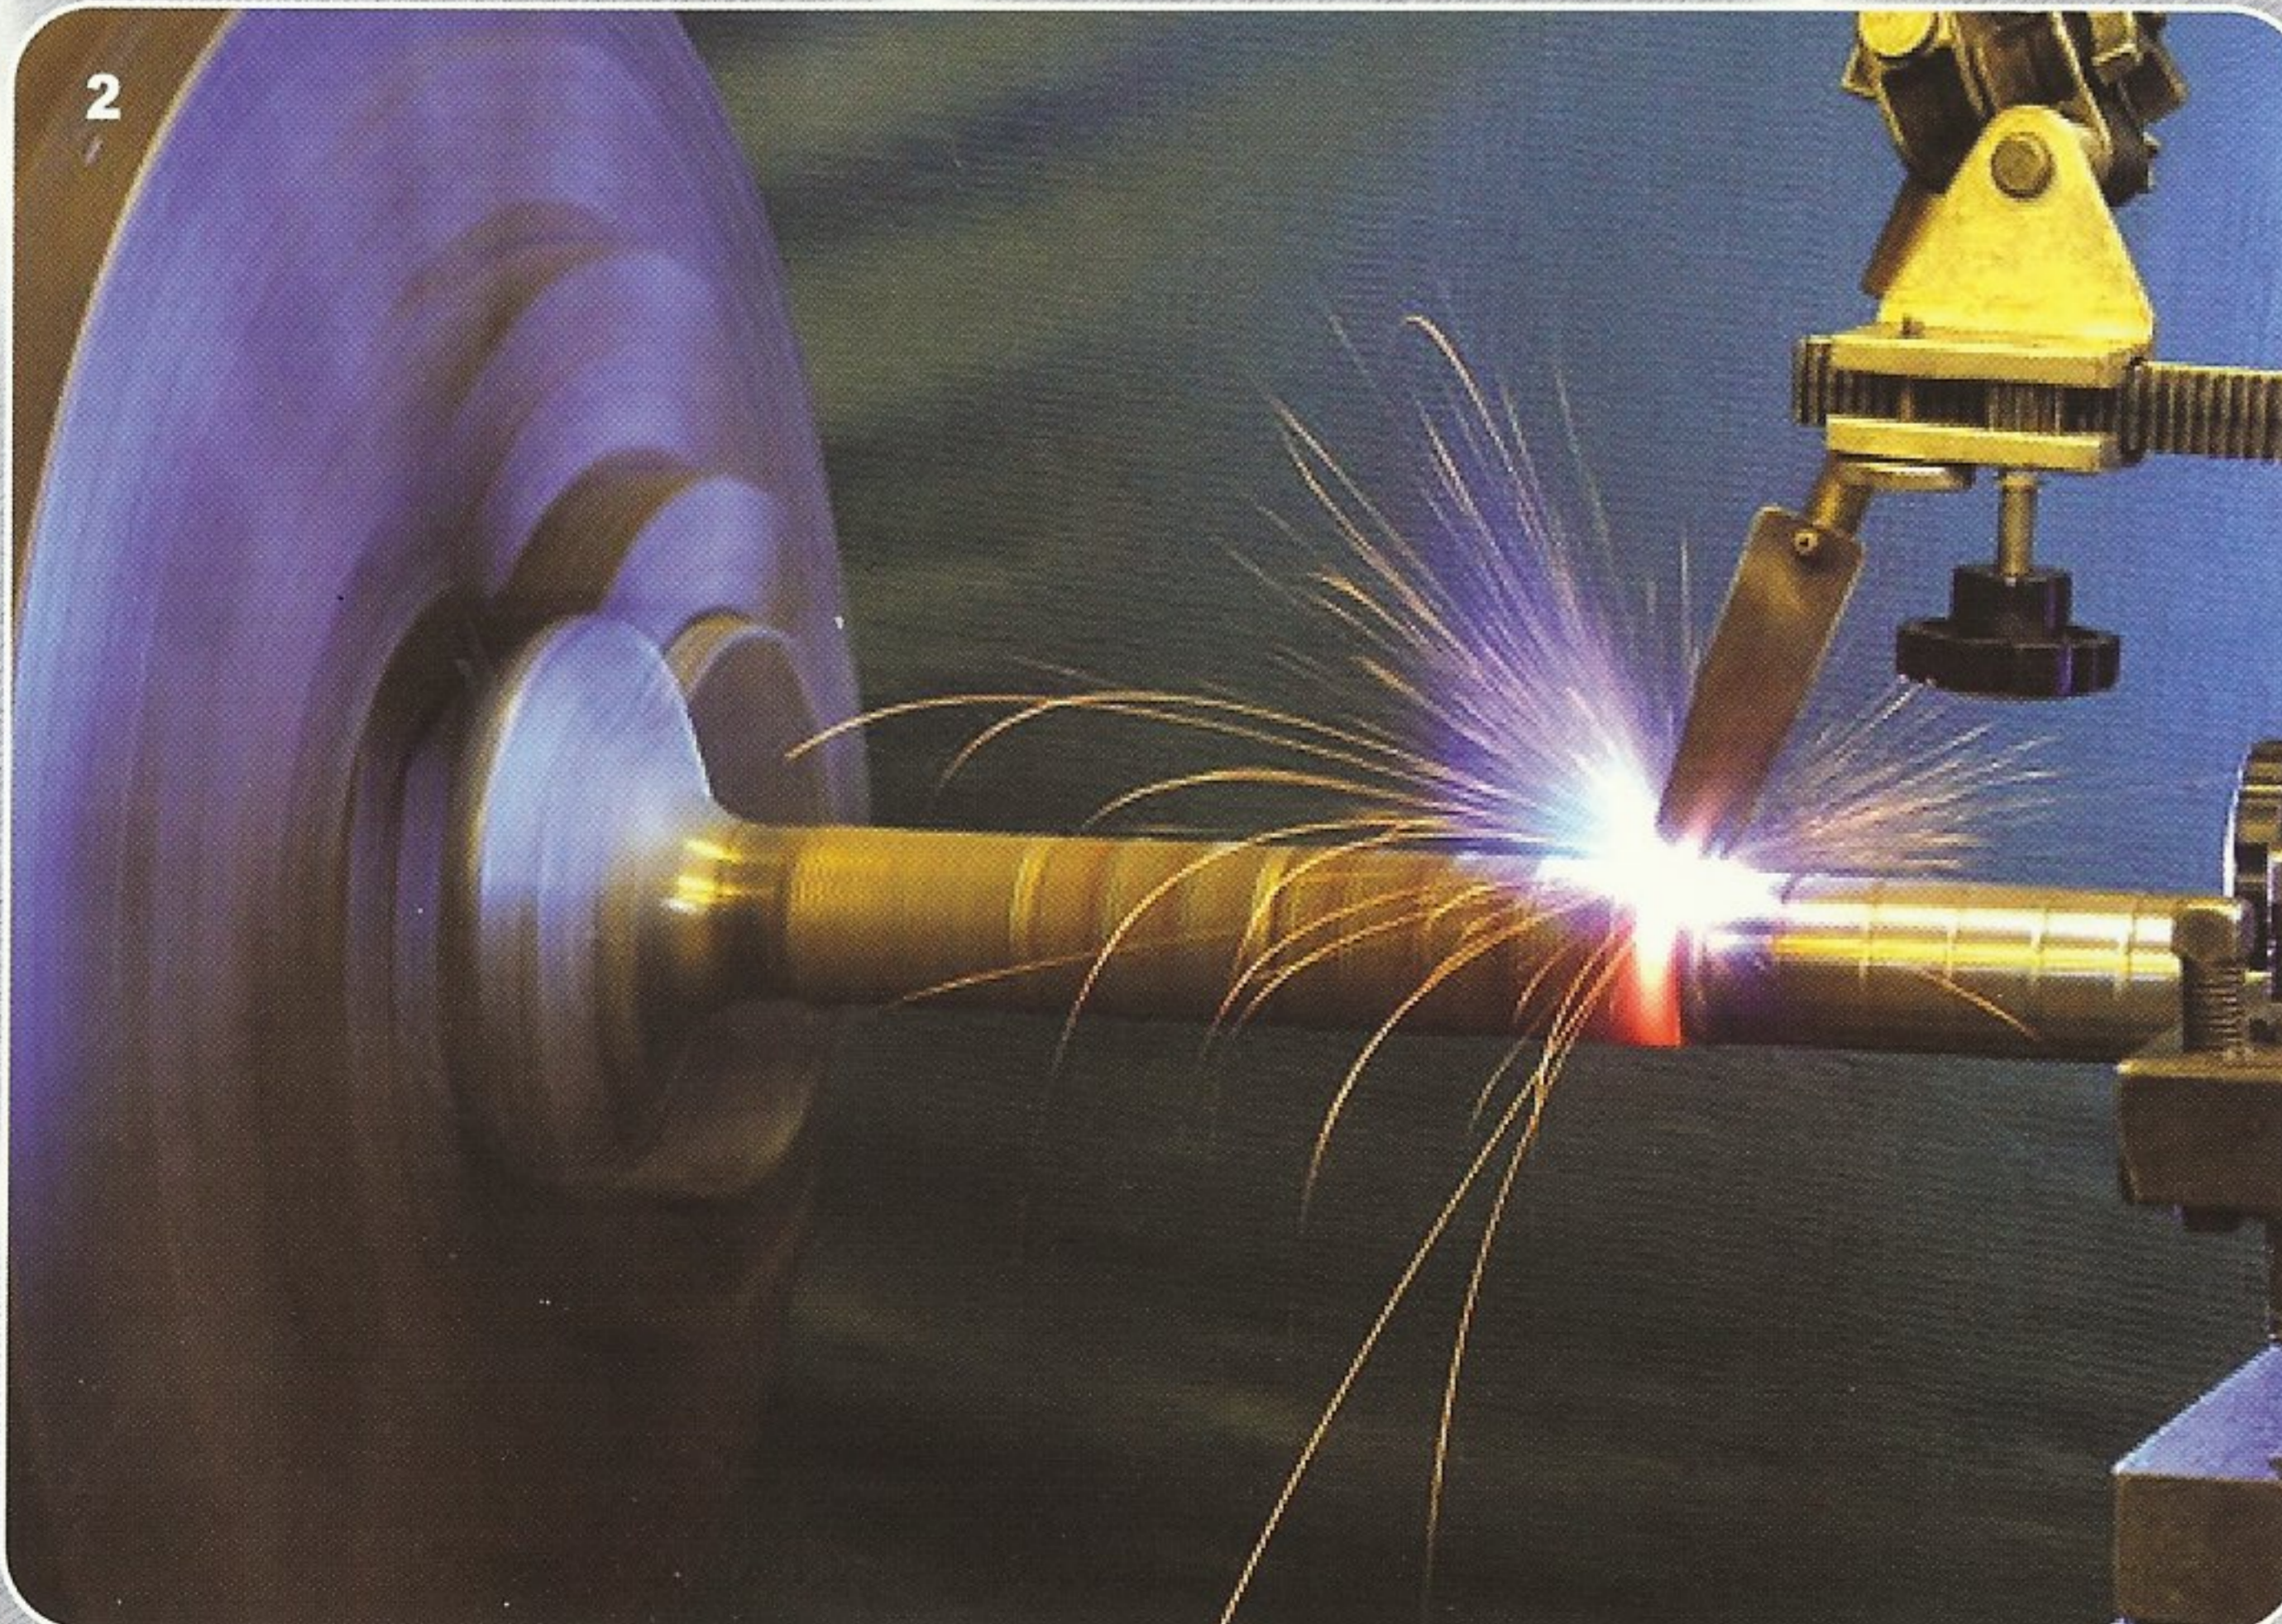
1. Recovery of worn contact areas of a main boiler feed pump and start standby boiler feed pump balance assembly.

Damaged areas are machined to sound/clean parent material, rebuilt using the Spiral Weld process and finished machined to original or customer required dimensions.

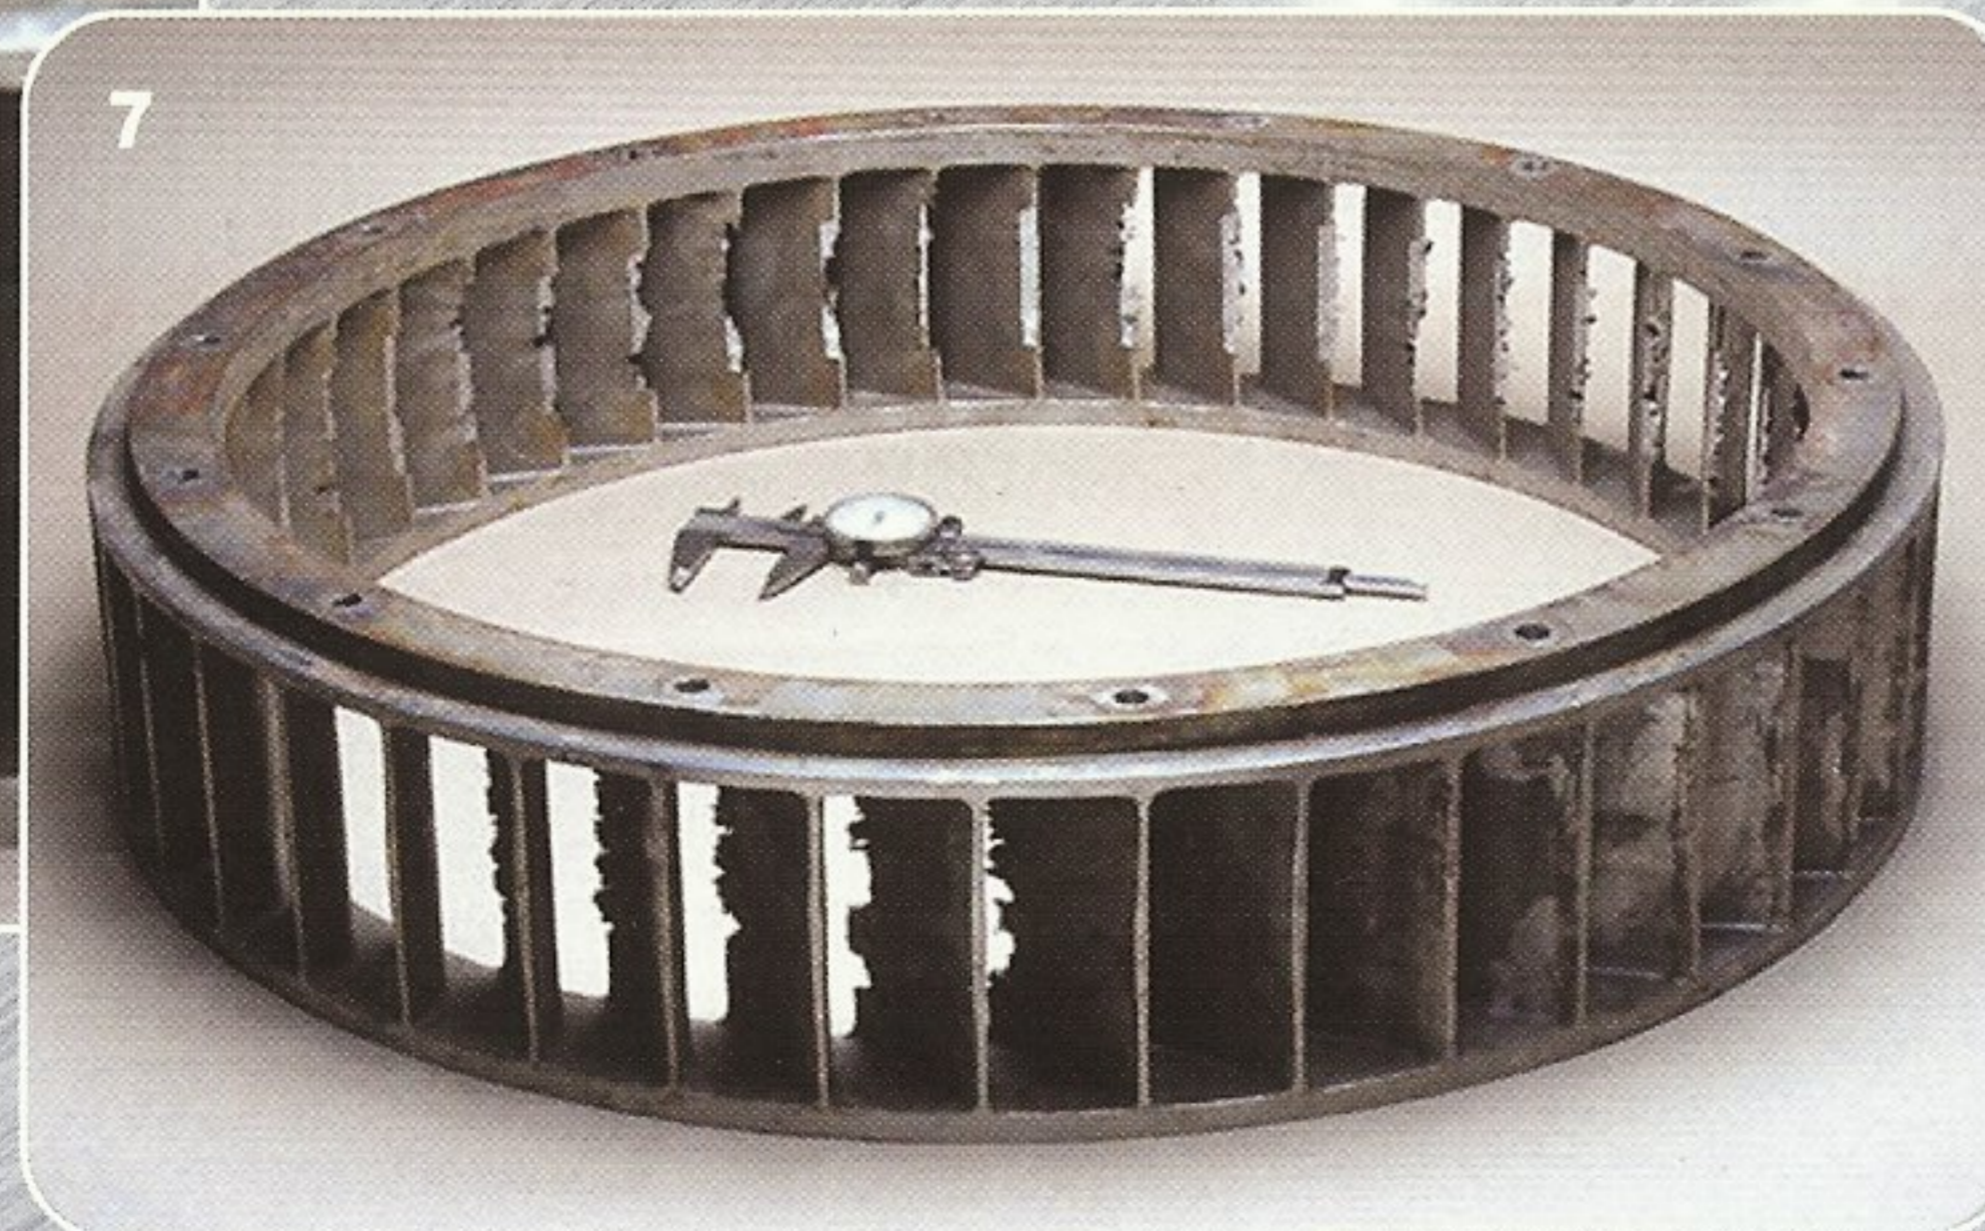
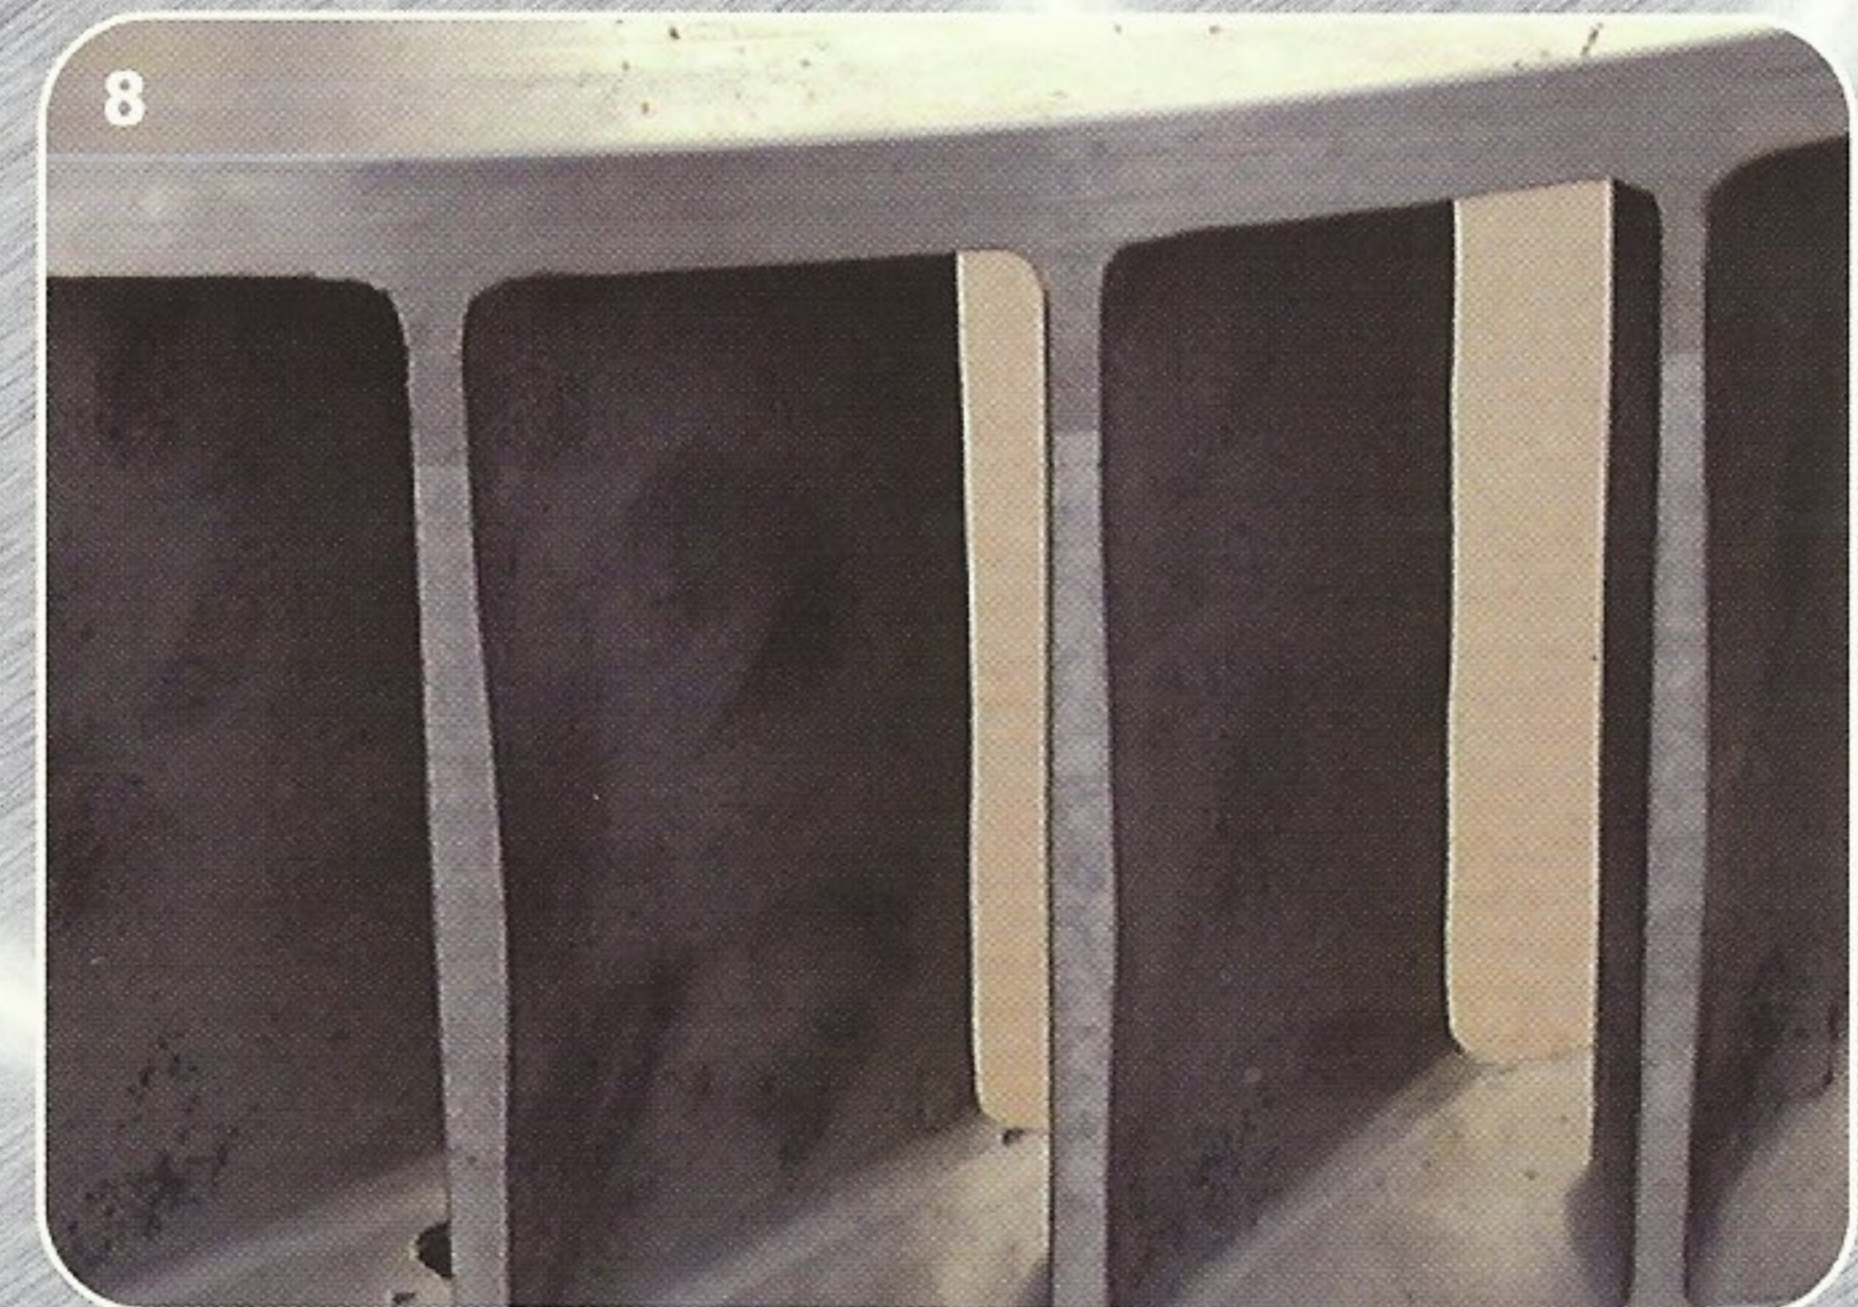
5. Control valve spindle showing eroded seat area in top half of picture and recovered seat in the bottom half. The seat was recovered with a cobalt based alloy to give the seat better wear resistance compared to the original design in parent material.

6-8. Worn rotary air pump vane wheel showing damage to vane tips caused by in-service running hours. A specially developed weld solution was created to recover the vane tips back to serviceable condition.

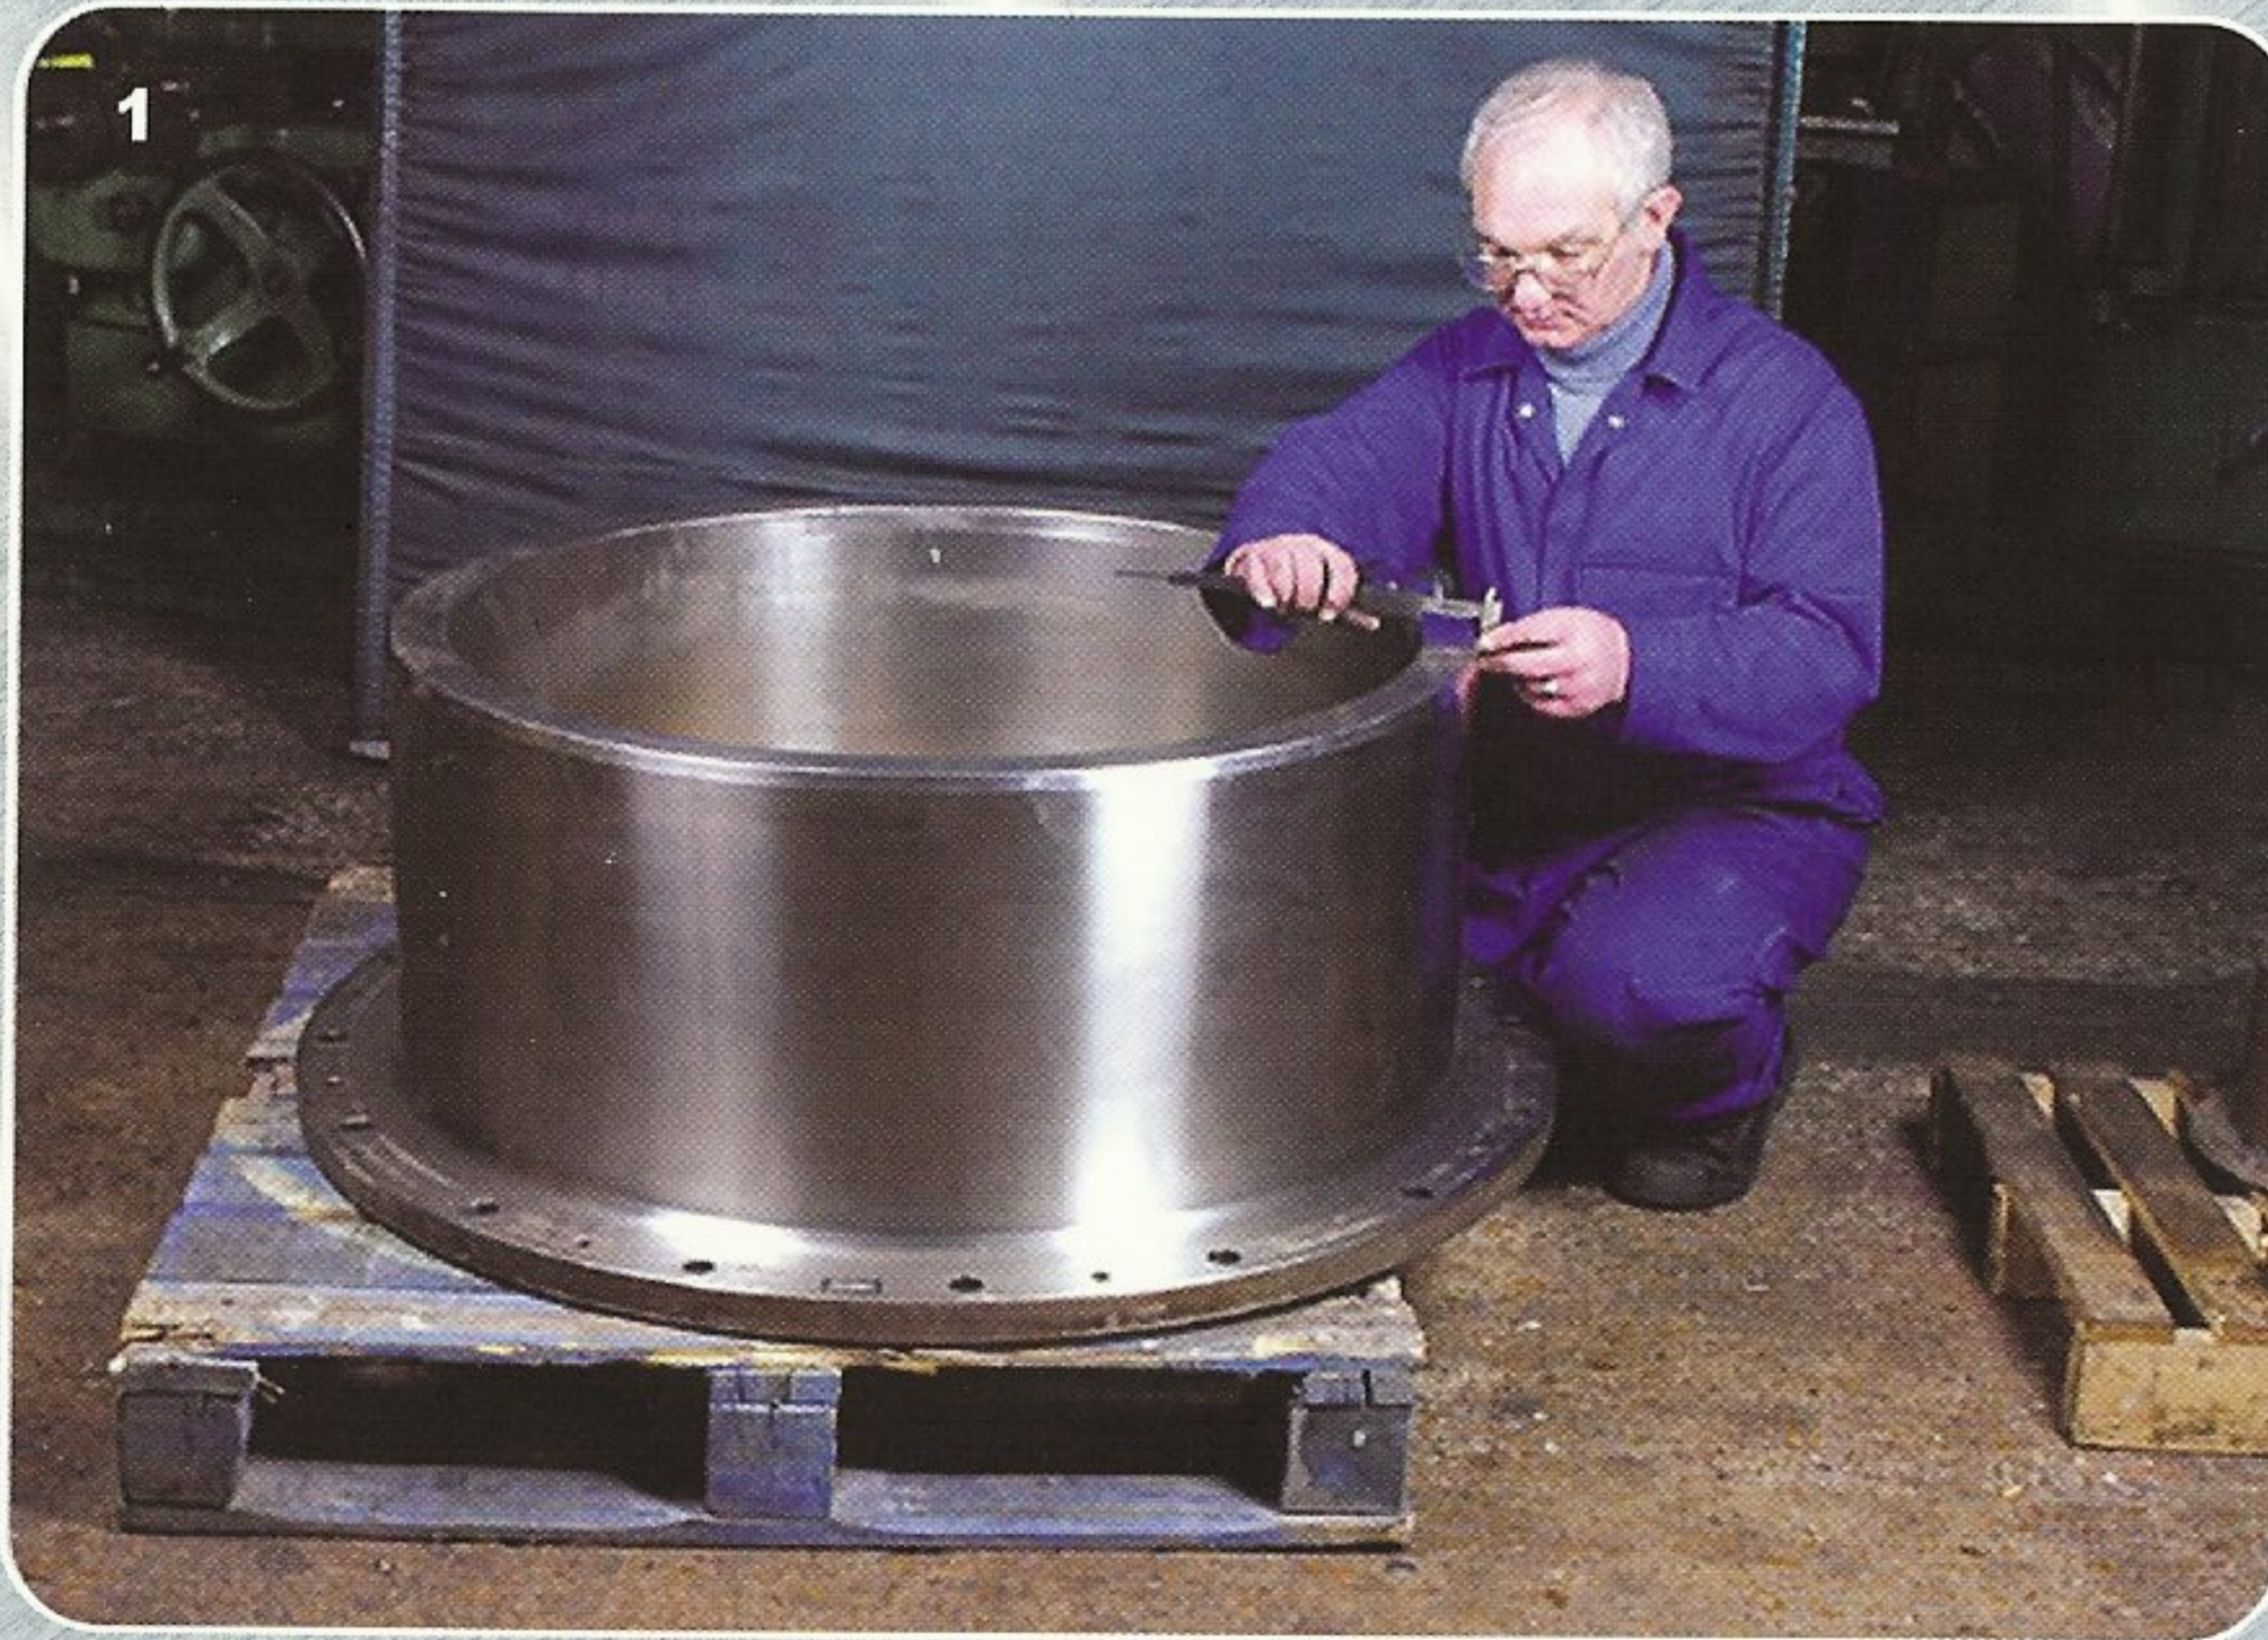
1. 900mm diameter tail shaft liner undergoing dimensional checks. Liner material is 316 stainless steel with a spiral weld overlay of Inconel 625 along the outer diameter to increase wear resistance against the seal arrangement and prolong in-service life expectancy of the liner.

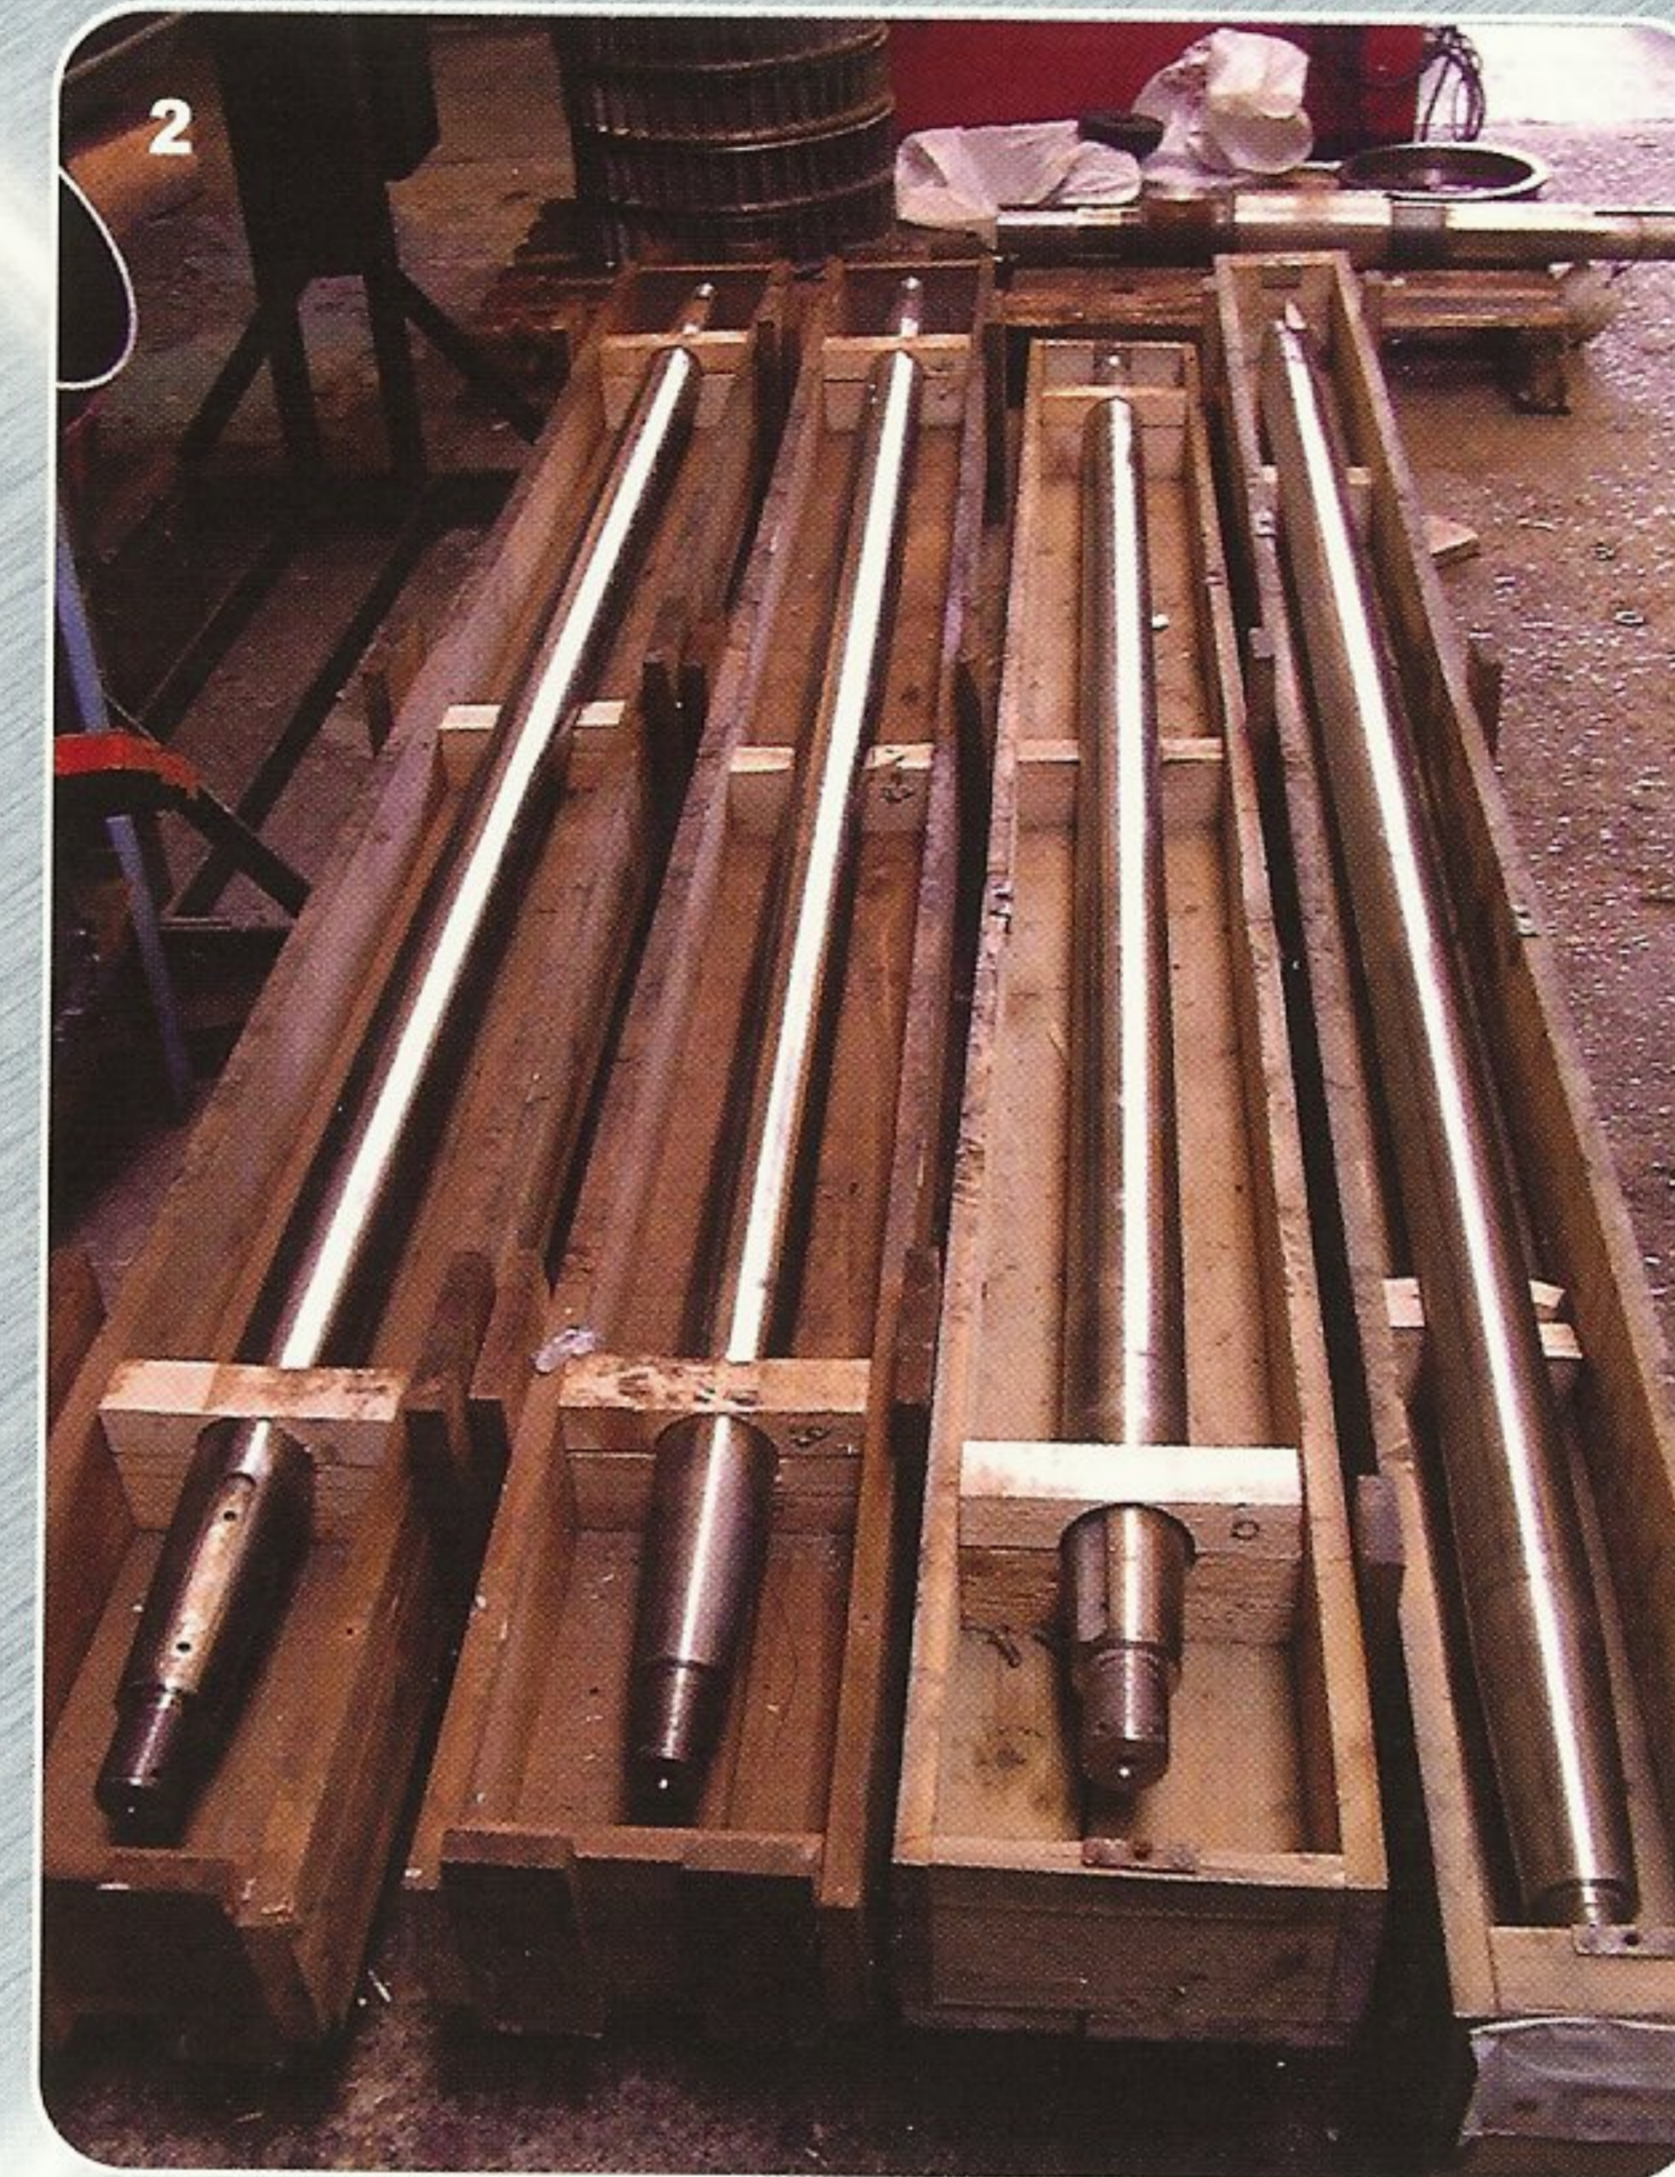
2. Prop shafts awaiting despatch following recovery of worn bearing and gland areas. We have extensive expertise in recovering carbon steels and more exotic materials such as Monel and Aquamet 22. Dissimilar overlays for improved performance are often used for the recovery using materials such as Inconel 625, Nitronic 50 and cobalt based alloys.

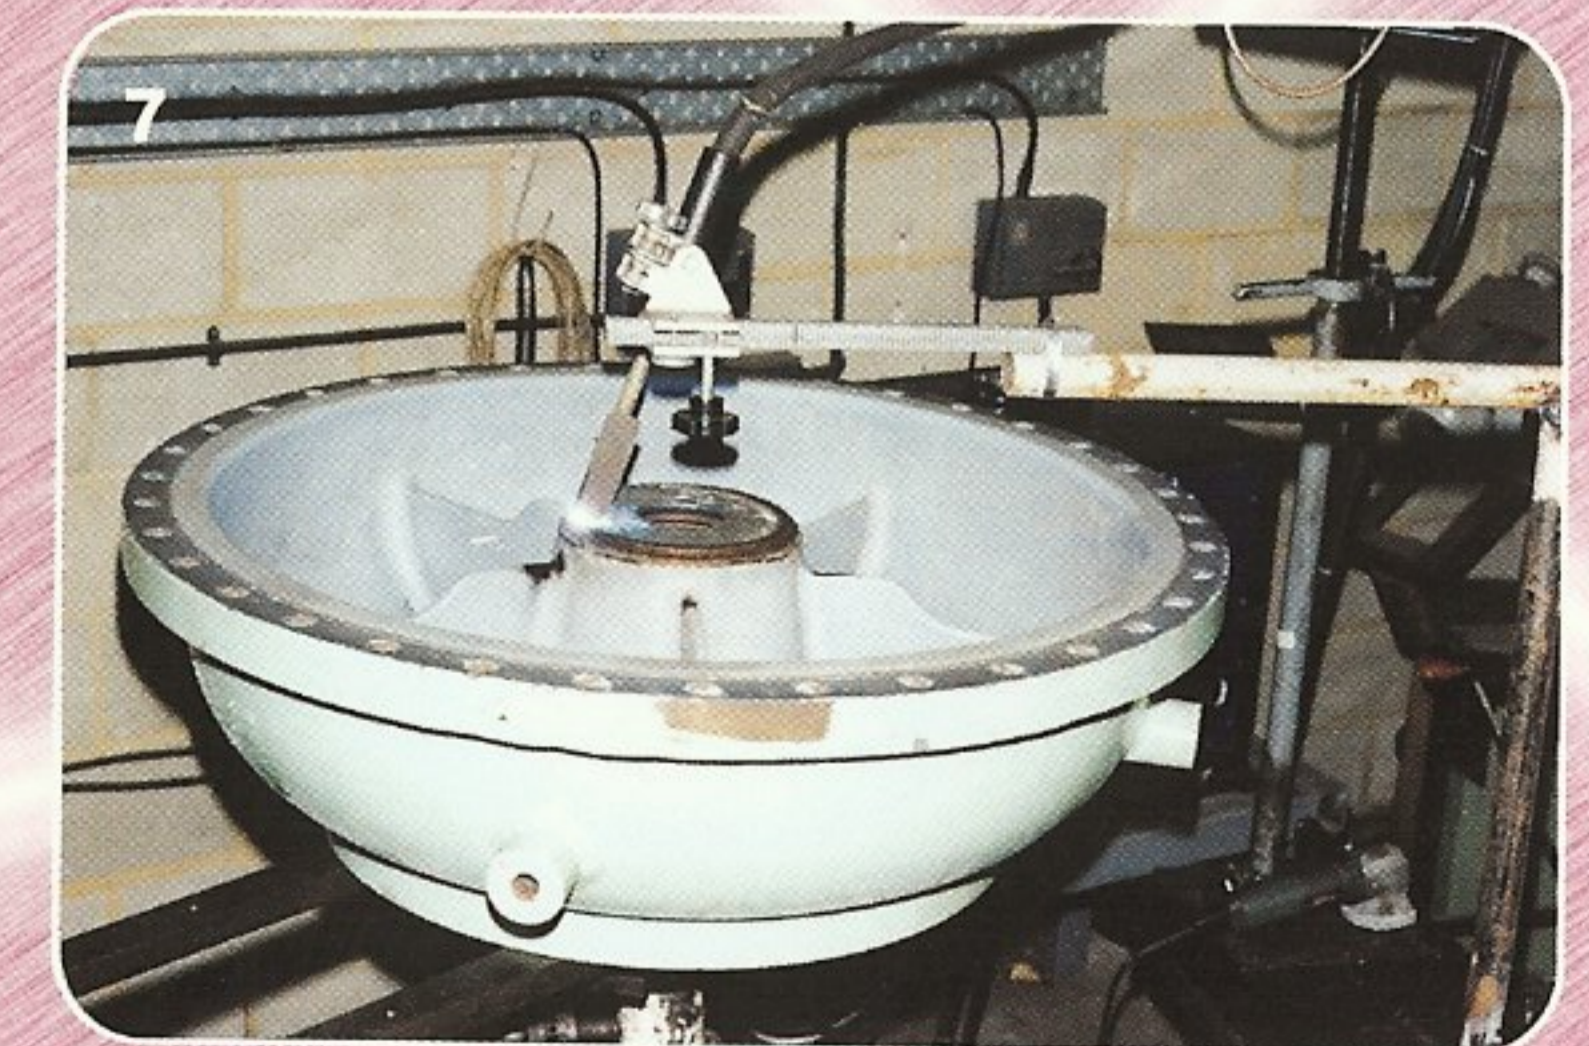
7. Carbon steel contactor head having the internal bore and seal area recovered with Hastelloy C22 to prevent corrosive attack from the process chemical.
