SPIRAL WELD

Re-engineering with Advanced Recovery Technology

THE FIRST NAME IN RECOVERY TECHNOLOGY

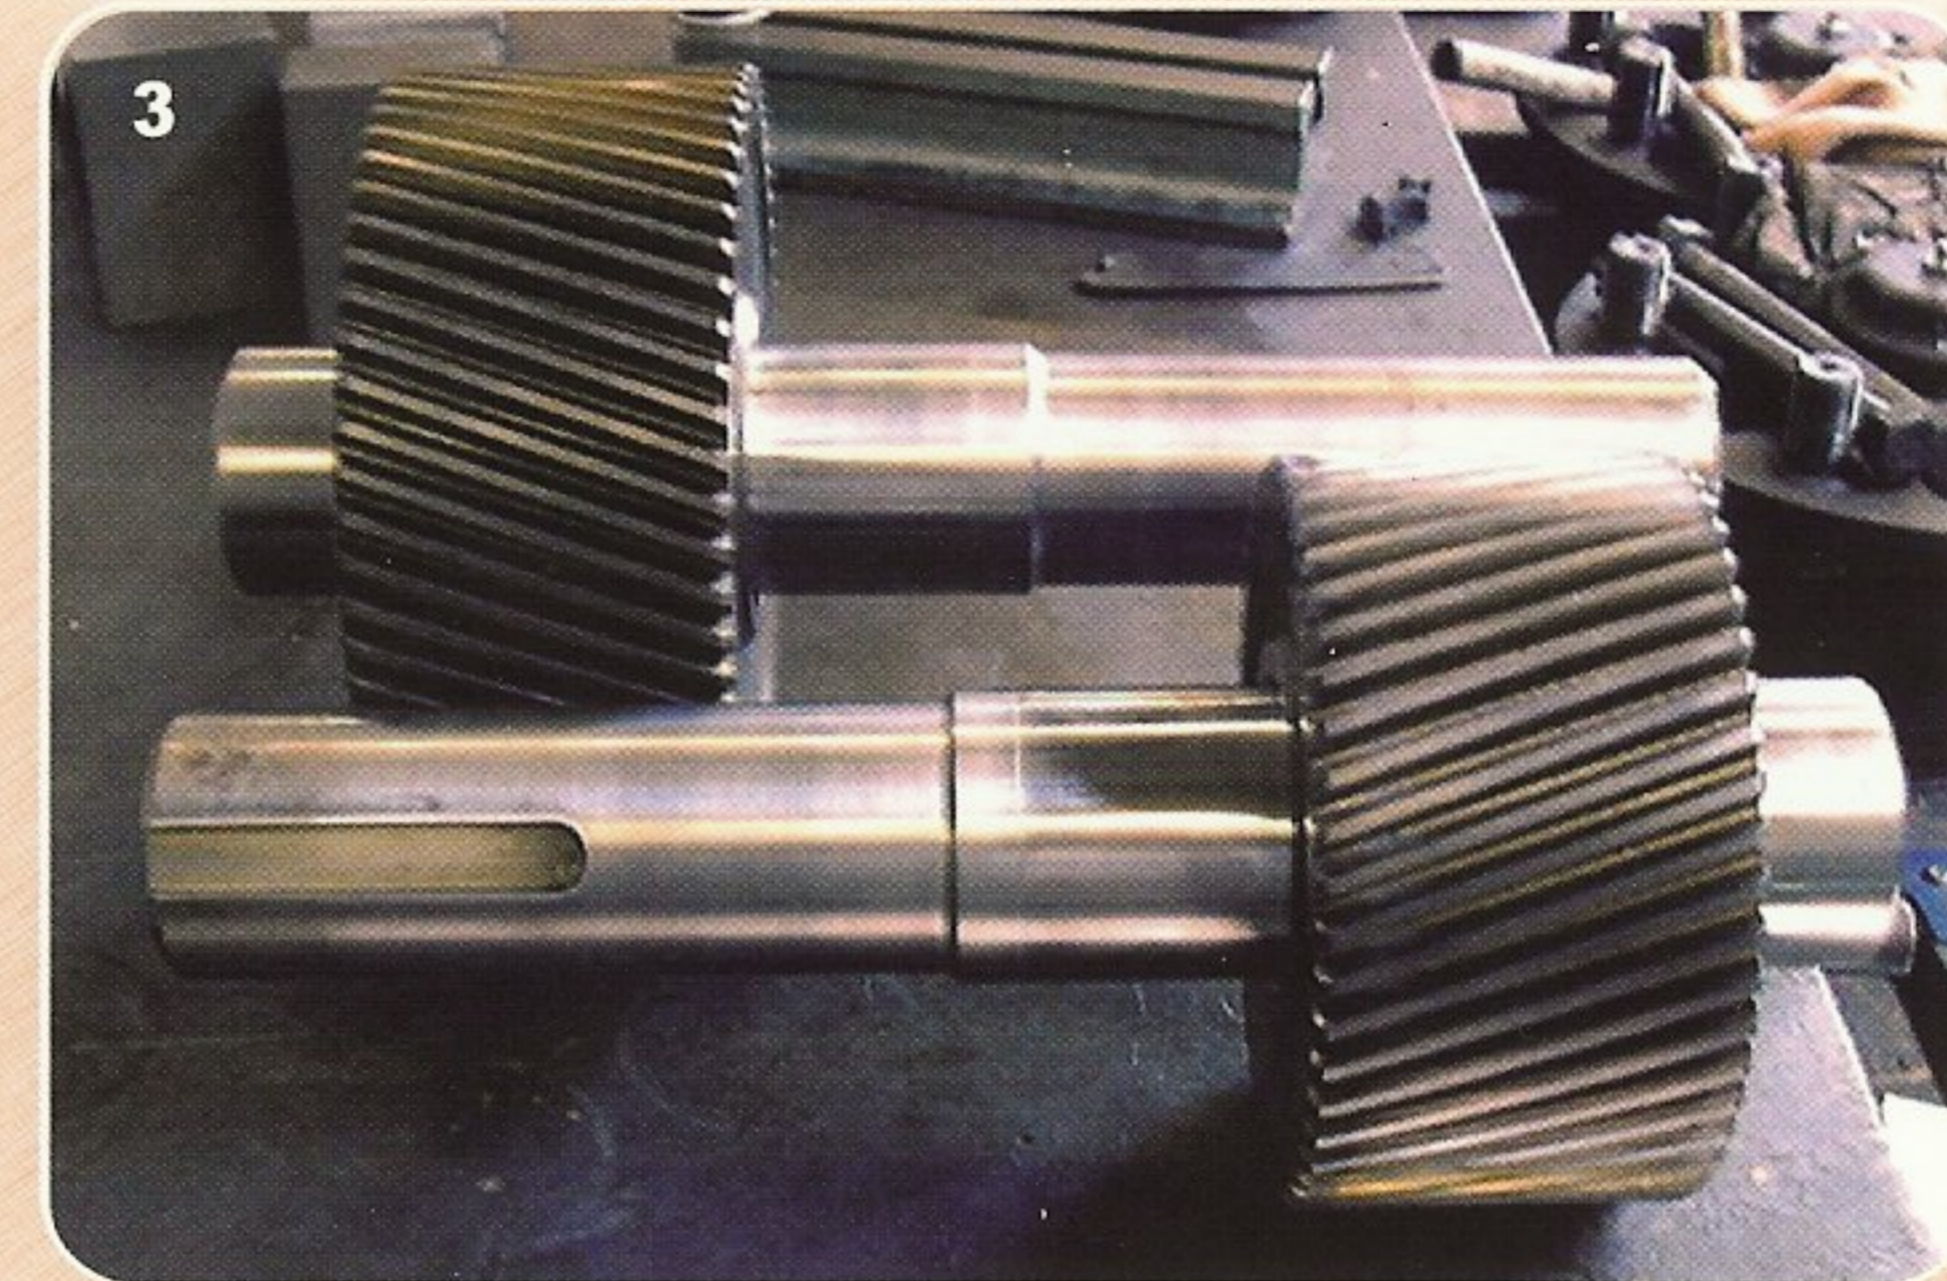
3. Typical gear wheels have had worn bearing diameters recovered either side of the gear hubs.

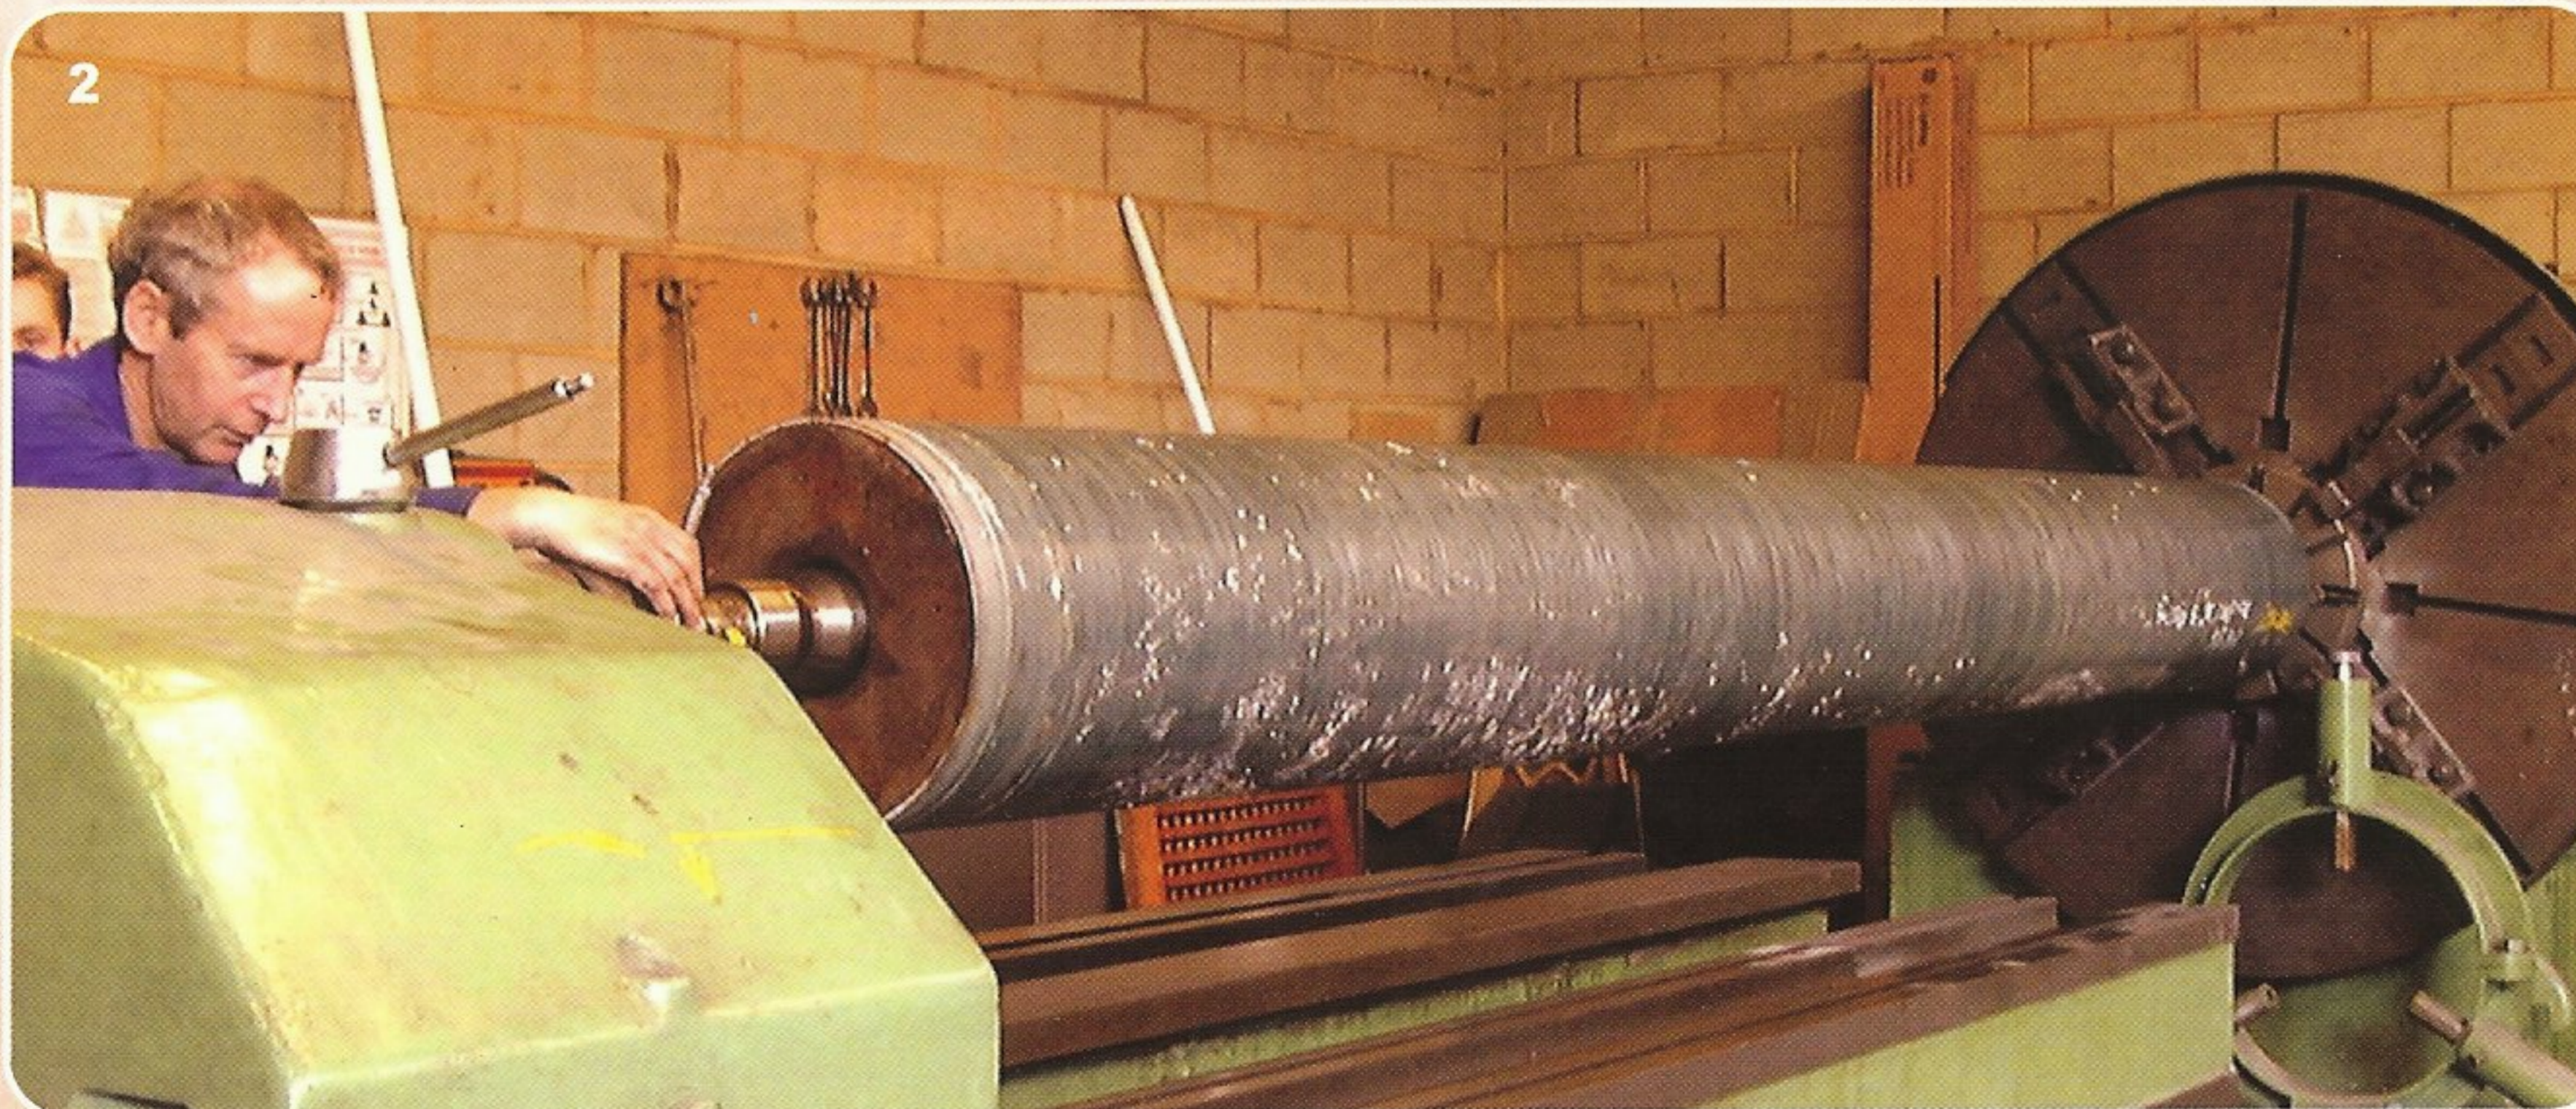
2. Process roller from a paper mill having the damaged bearing areas recovered at either end of the roller.

These areas were recovered without the need to remove the stub shafts from the roller body.

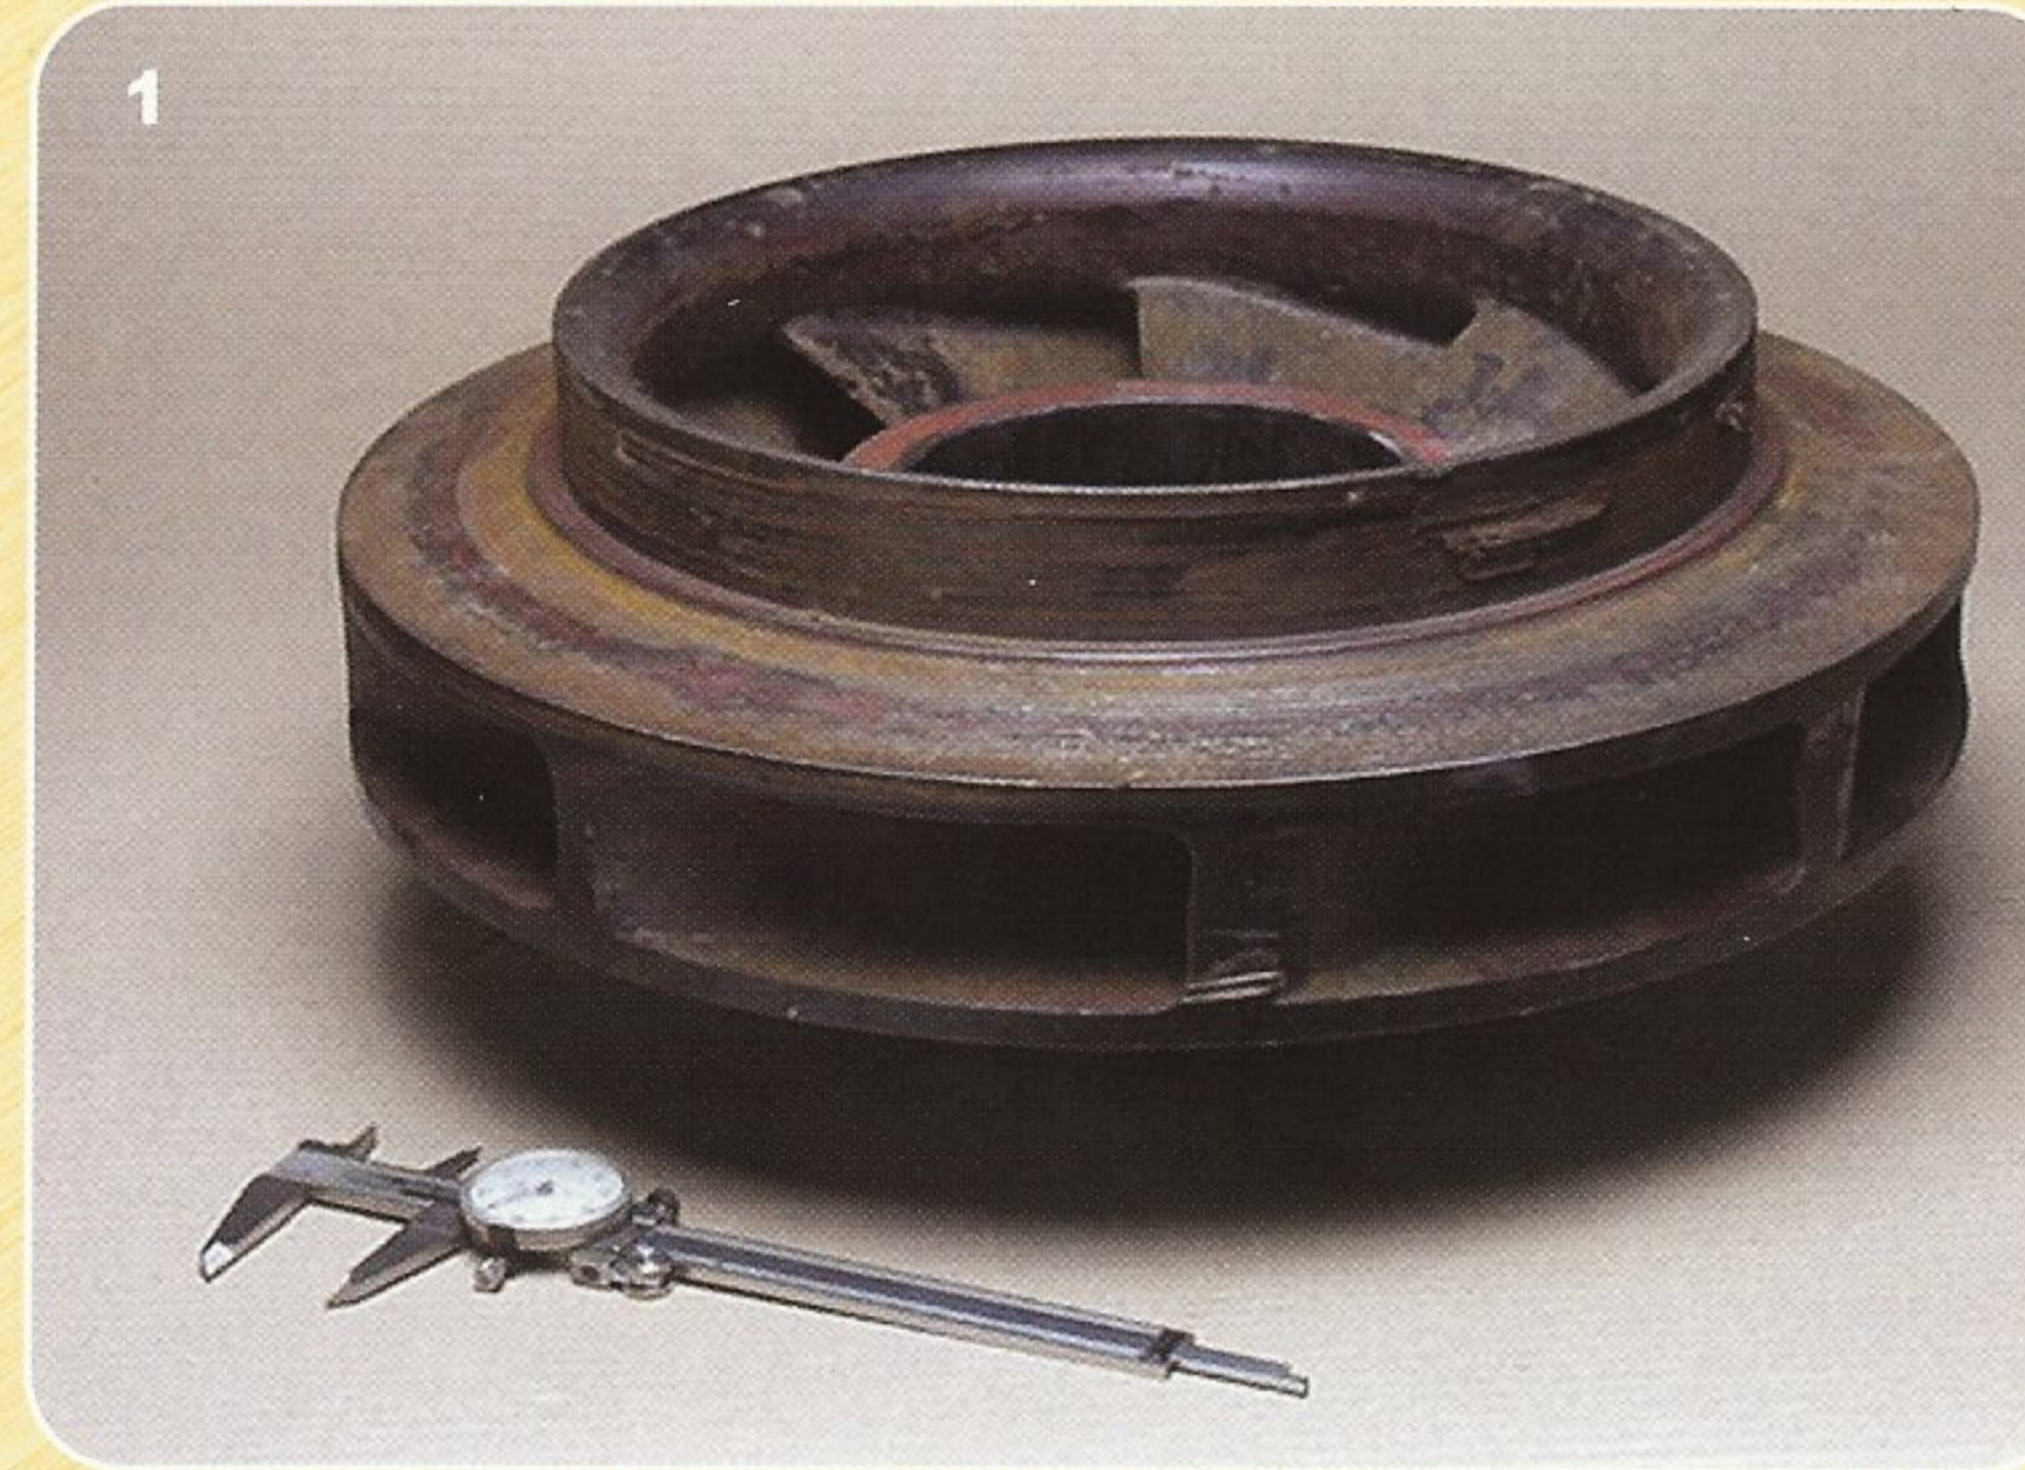
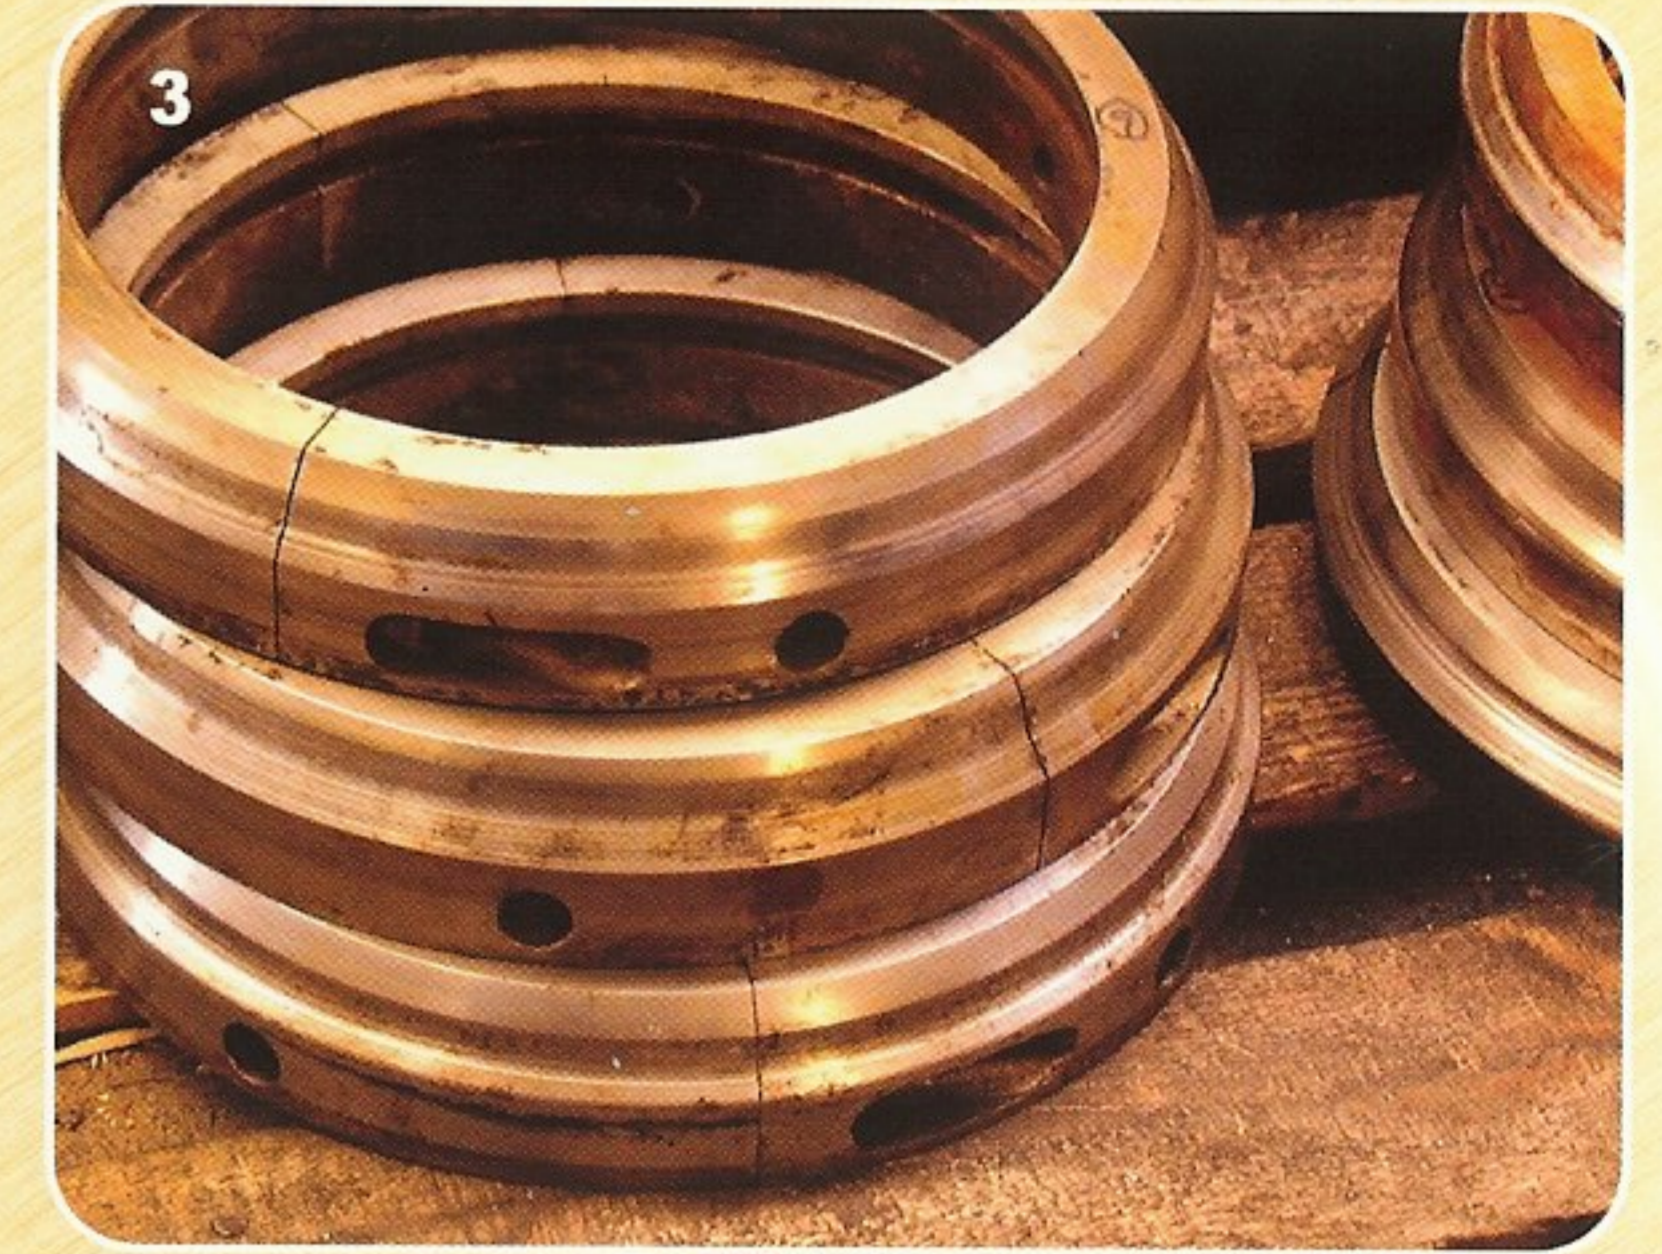
1. shows worn and corroded impeller on arrival at our service centre. The impeller required recovery of the neck ring diameter, hub and bore diameters and vane tip leading edges.

2. shows impeller following full recovery to as new condition.

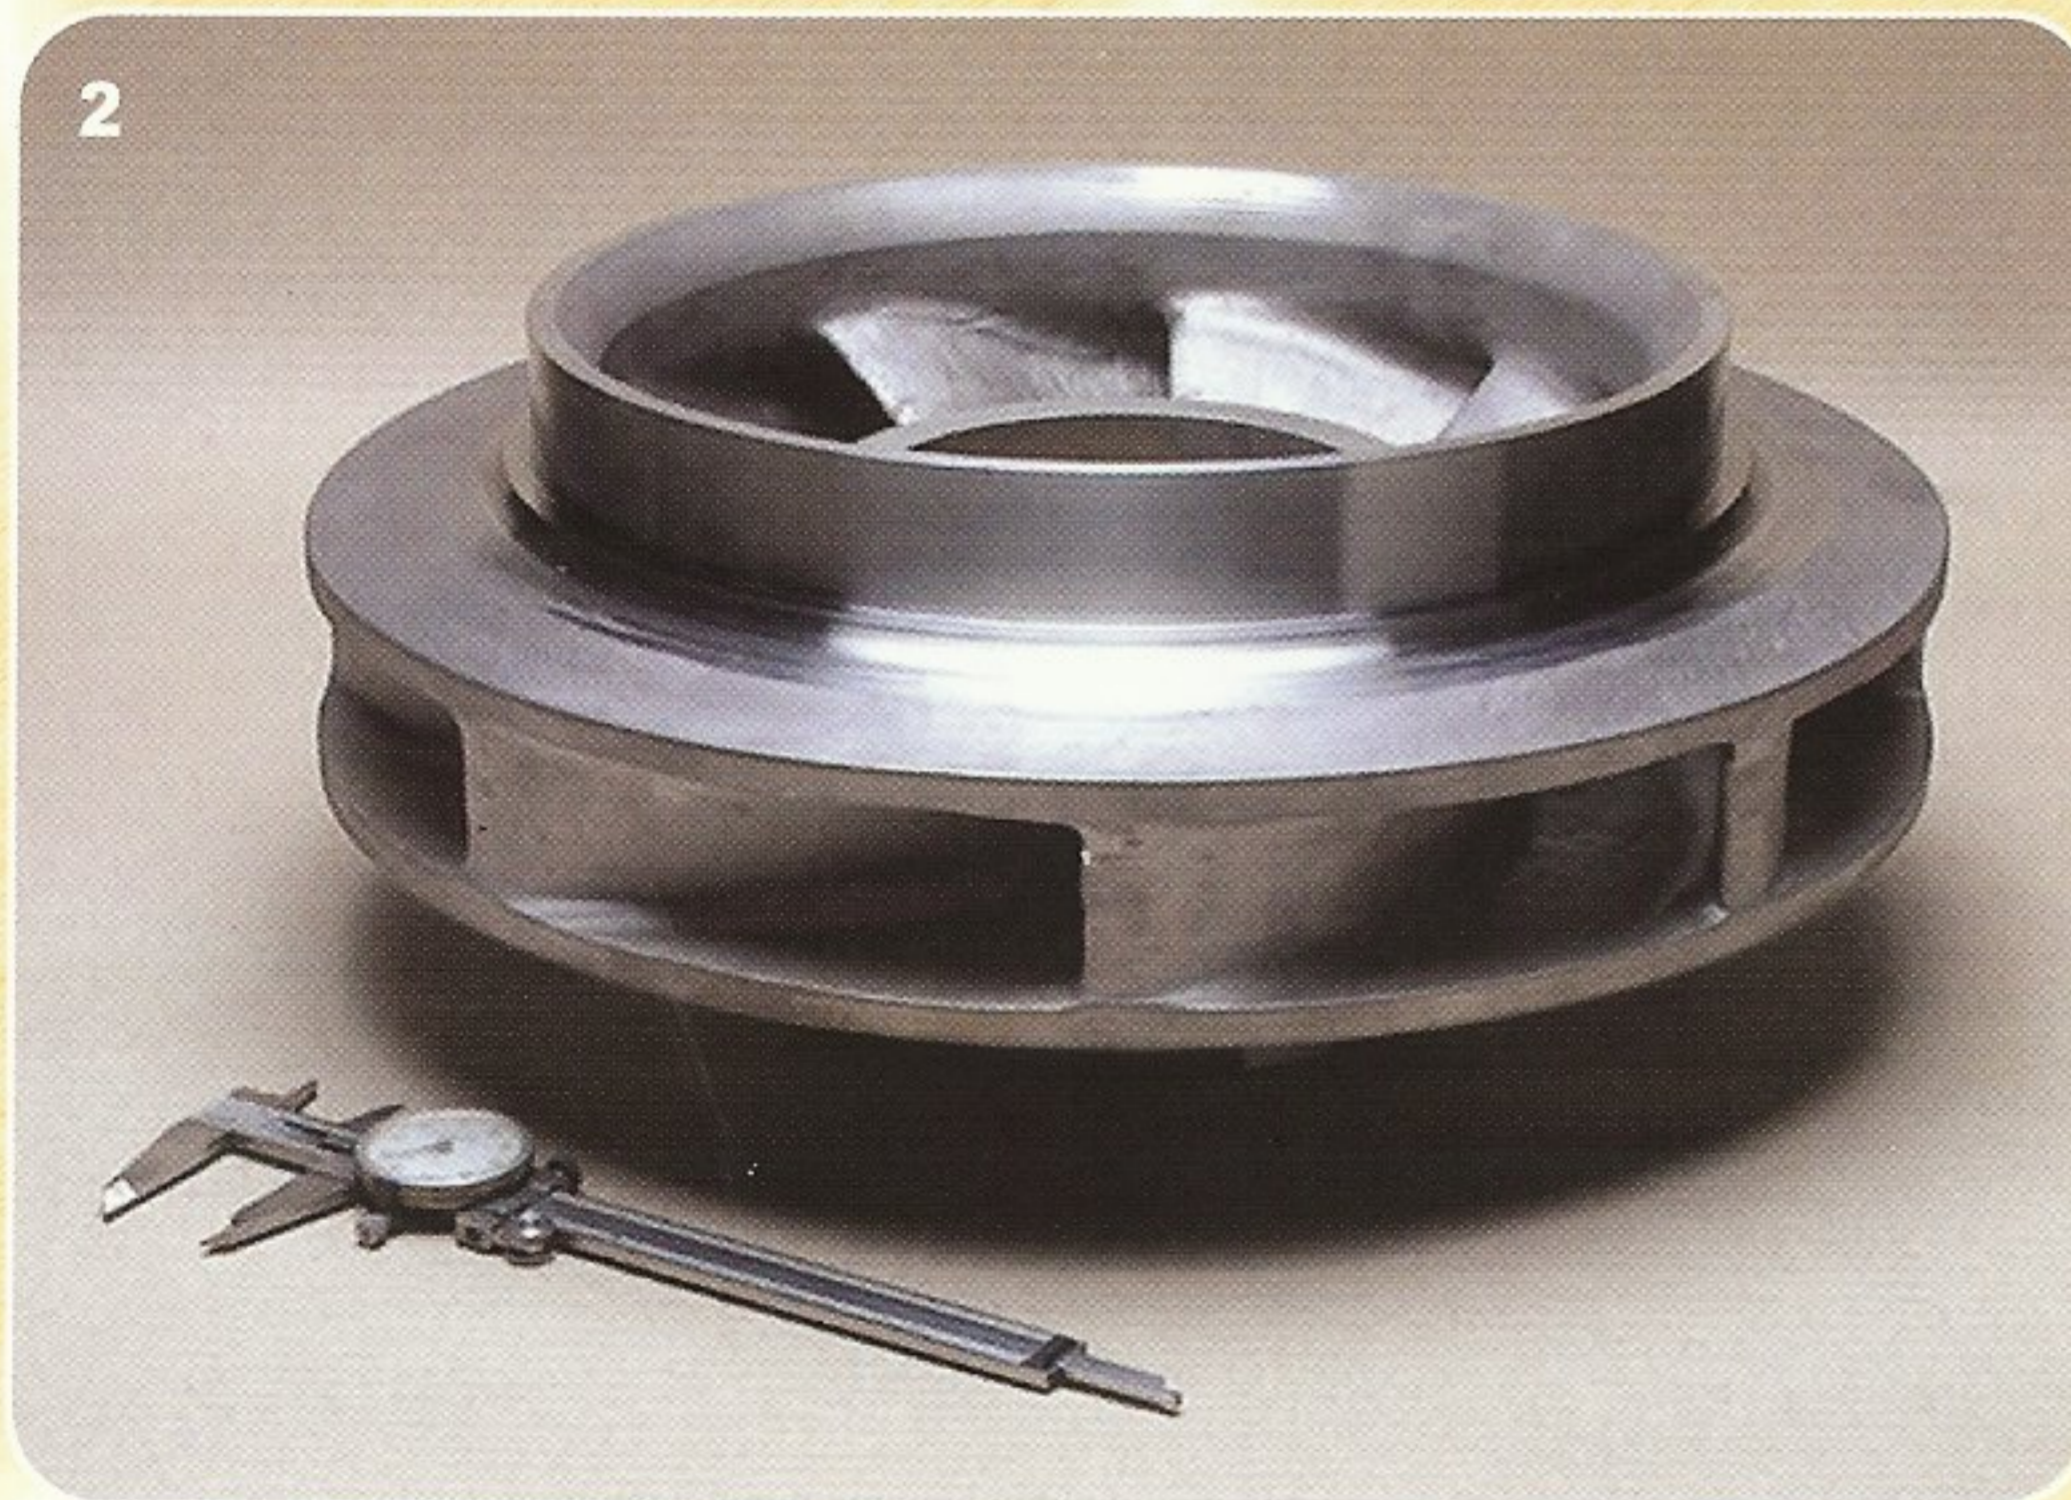
3. Cooling water pump stainless steel cone seal rings with worn sealing faces prior to repair.

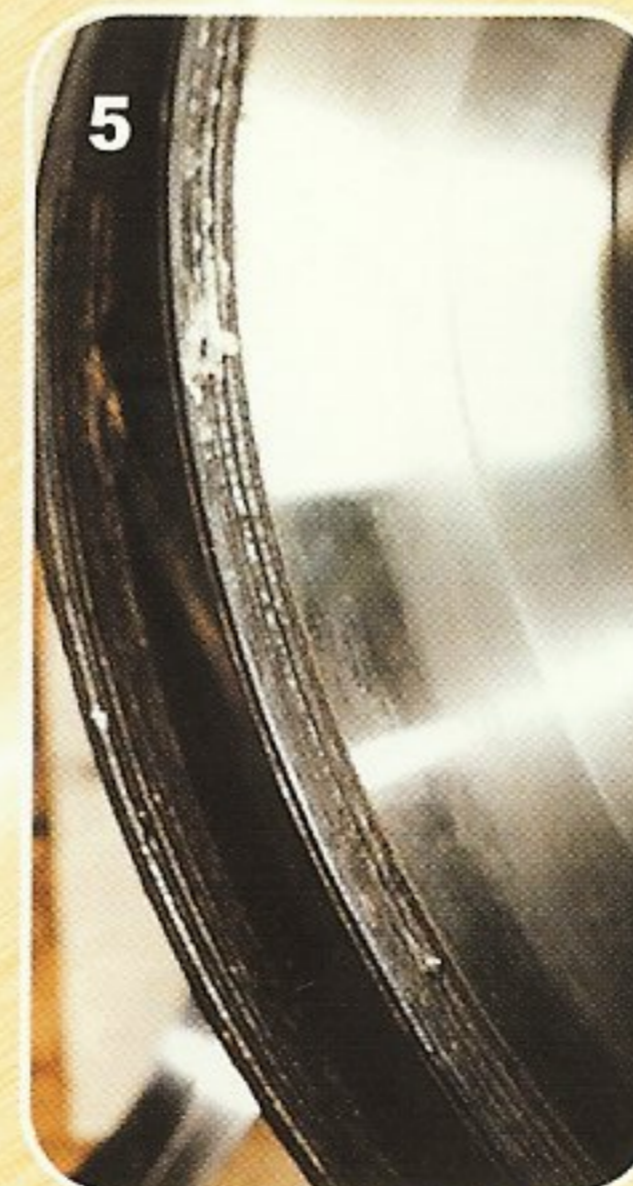
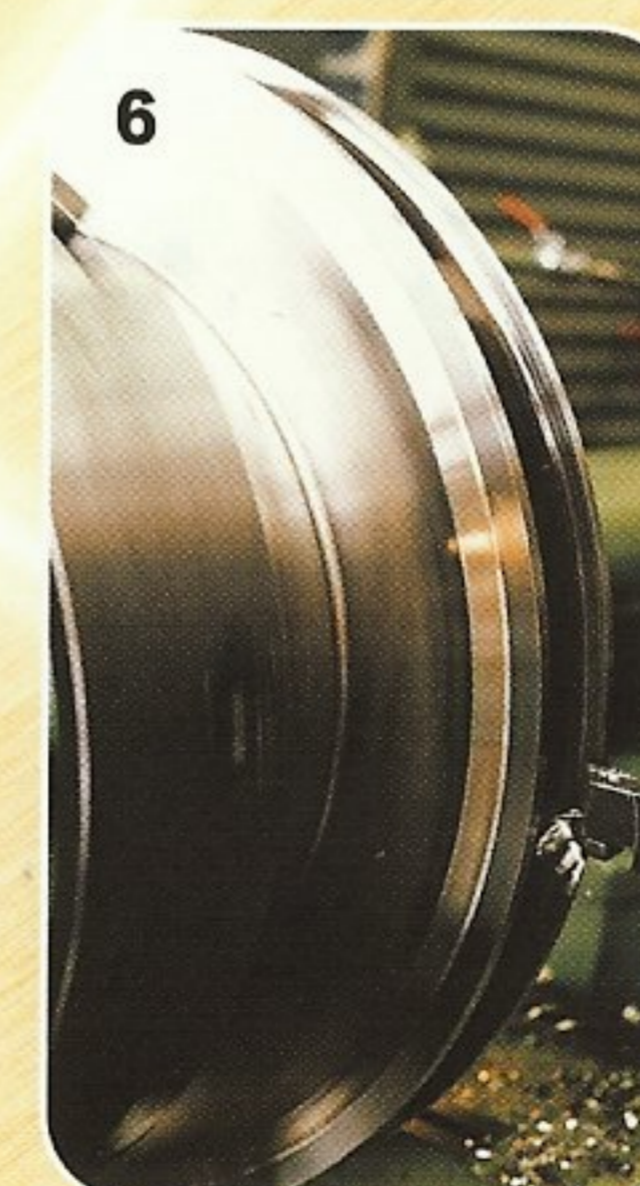
5. & 6. Increasing the diameter of a new pump impeller to meet client's need for enhanced performance.

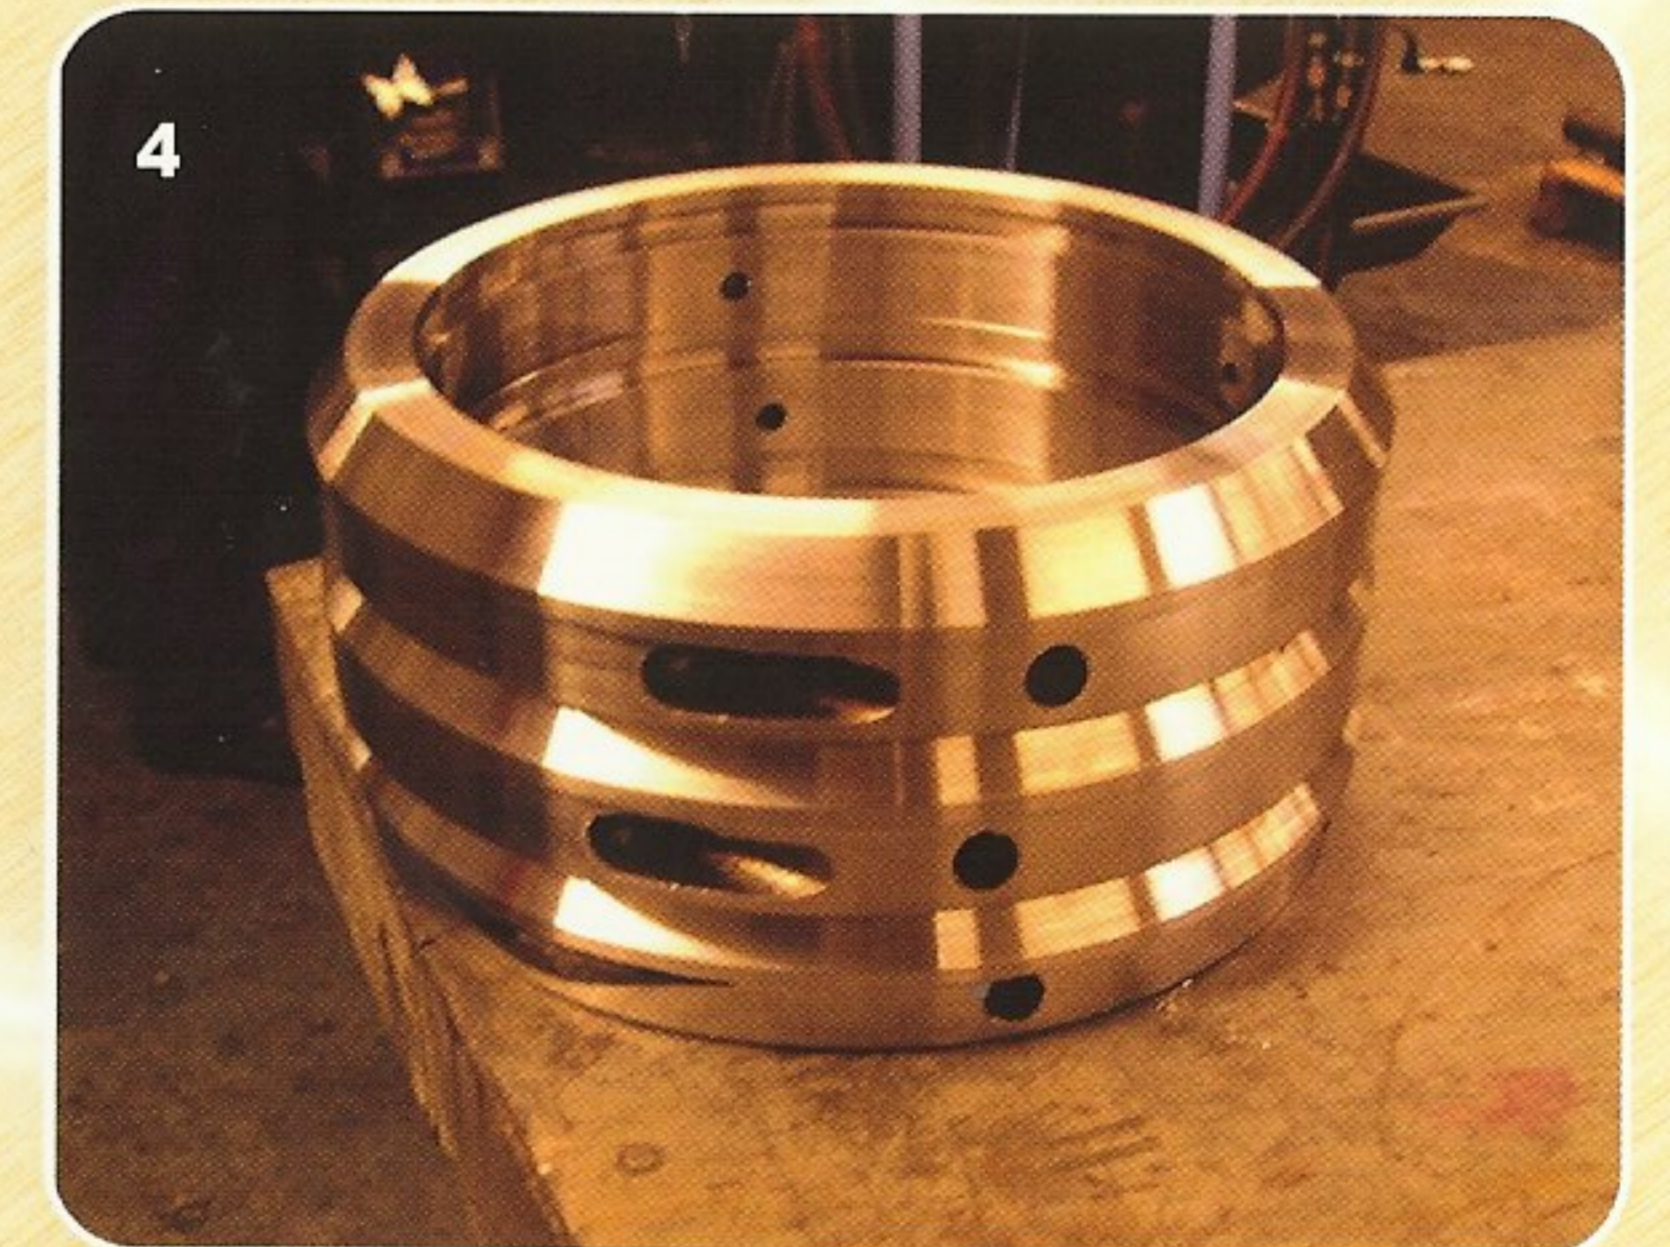
4. Fully recovered seal rings with wear faces overlaid with Inconel 625 to increase in-service wear resistance.

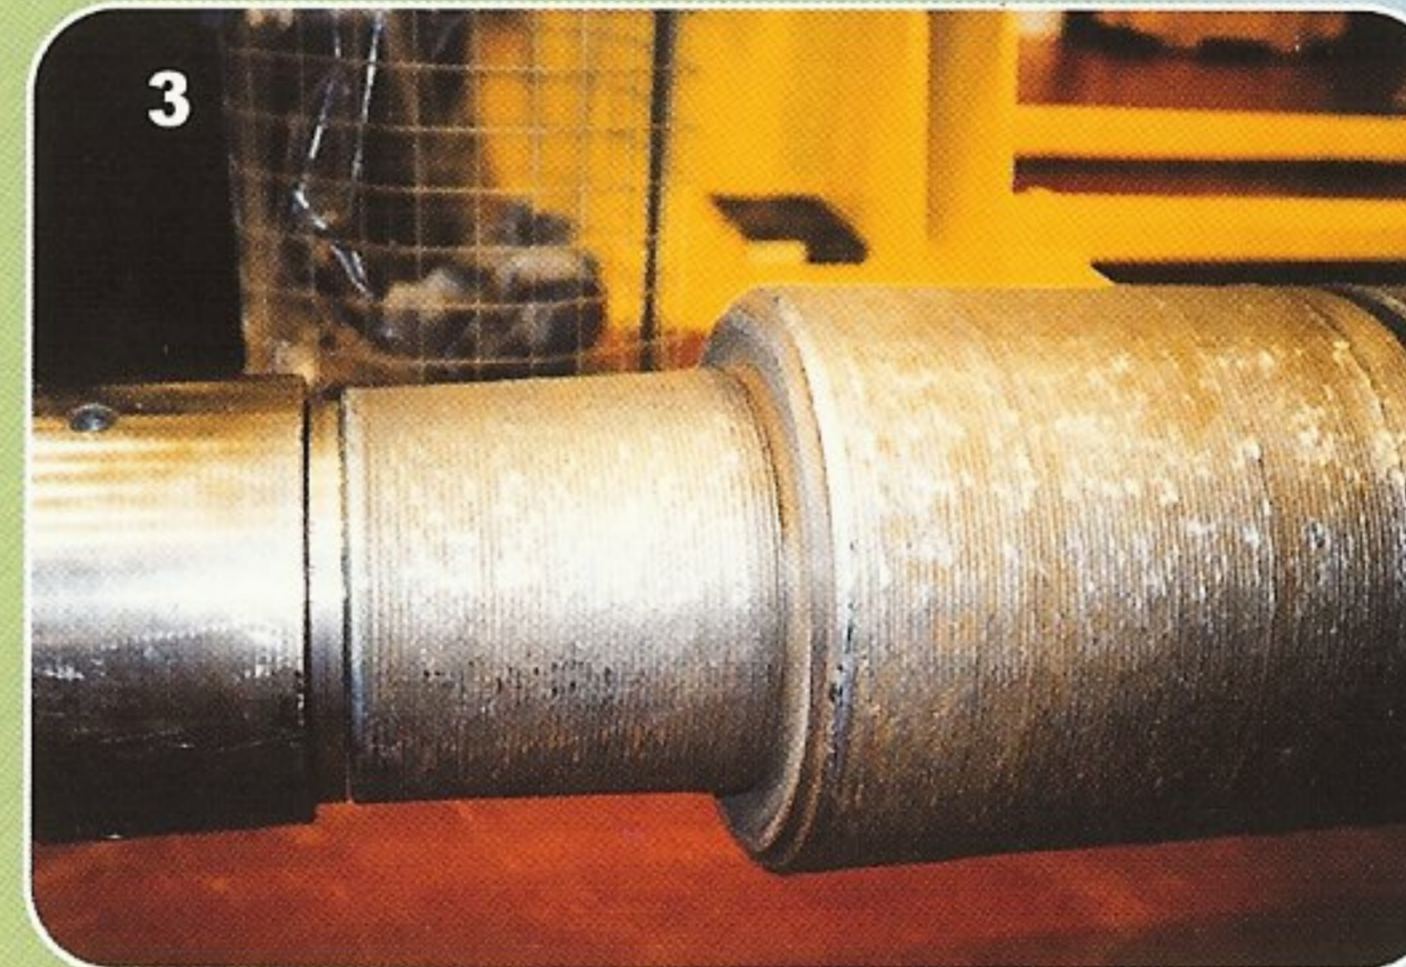
3. Major rotor shaft recovery

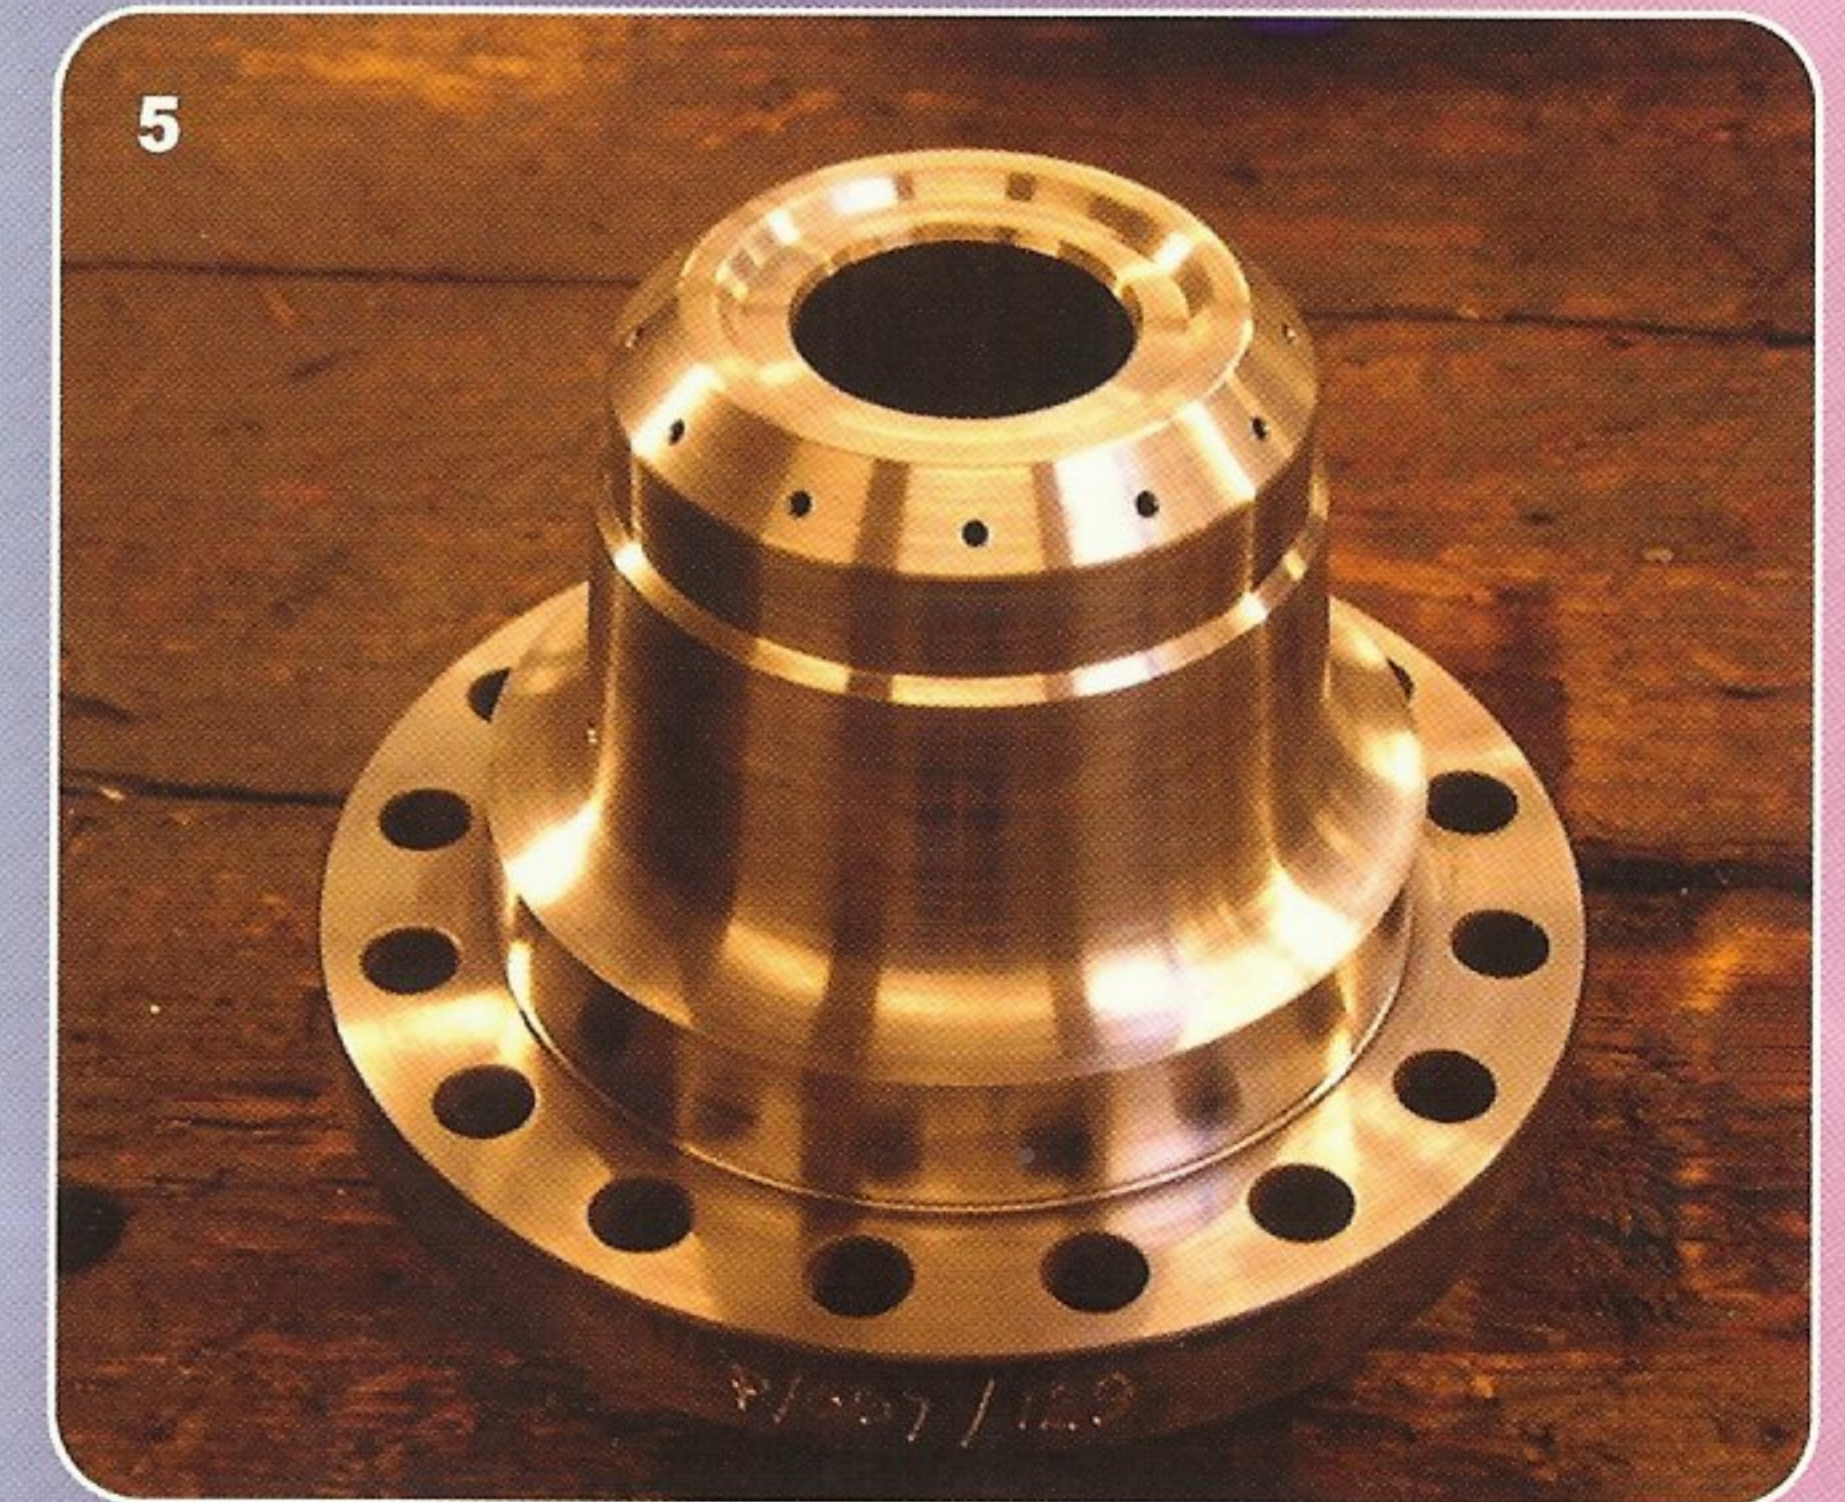
4-5 Worn control valve spray nozzle eroded by high pressure/high temperature water. Component has a cobalt alloy insert bush for increased wear resistance in the spindle guide area. Spiral Weld will either recover these nozzles by welding, or manufacture a new component, including overlaying the guide bush area with a cobalt alloy.
