Inspection Report

Property Address:
123 American Ct.
Somewhere FL 99999

Maverick Inspection Services, LLC

Sample Report

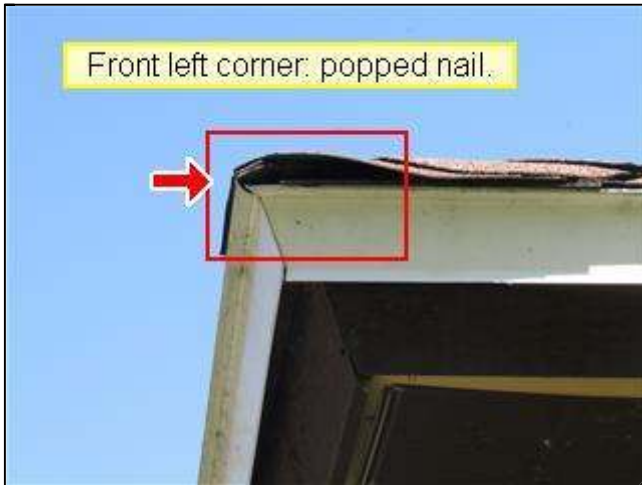
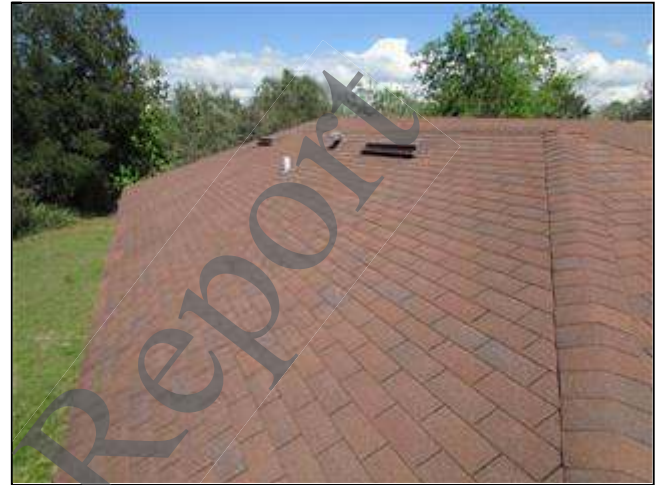
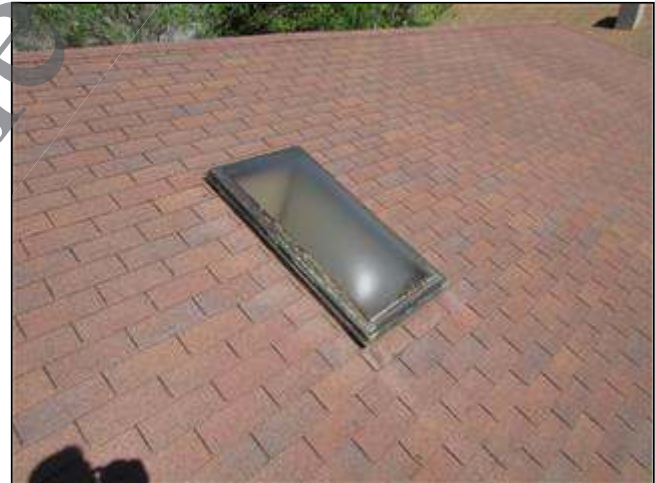
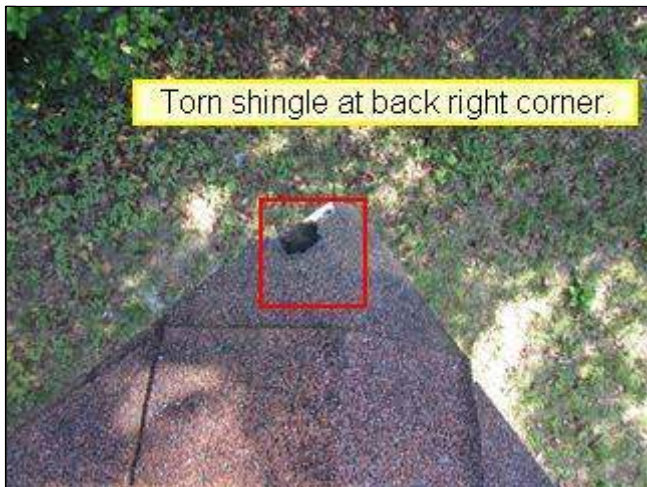
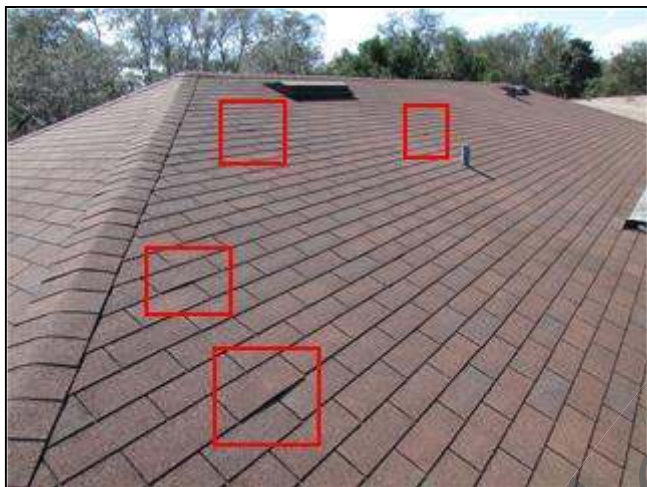
- **(Deficiency): (Popped Nails)** Popped nails were found on the roof. These nails can over time allow moisture intrusion around the nail head and cause wood rot to the roof decking beneath. Make sure all popped nails are hammered back in and cover all exposed nails with a roofing tar to prevent moisture issues from developing.
- **(Deficiency): (Decking Wood Rot)** Upon inspecting the roof covering by walking the roof, an area of decking to the left of the front door was found to have issues. This area was identified by visibly identifying areas of sagging roof deck as well as walking over areas that cracked or bent as they were met with pressure. The main roof area affected was found on the front elevation by the front door. See the attached video.

(1)
 - **(Deficiency): (Popped Nails)** Popped nails were found on the roof. These nails can over time allow moisture intrusion around the nail head and cause wood rot to the roof decking beneath. Make sure all popped nails are hammered back in and cover all exposed nails with a roofing tar to prevent moisture issues from developing.
 - **(Deficiency): (Decking Wood Rot)** Upon inspecting the roof covering by walking the roof, an area of decking to the left of the front door was found to have issues. This area was identified by visibly identifying areas of sagging roof deck as well as walking over areas that cracked or bent as they were met with pressure. The main roof area affected was found on the front elevation by the front door. See the attached video.
-

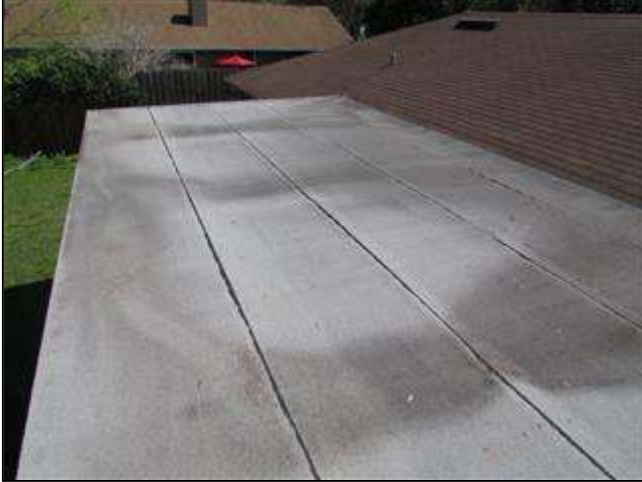
1.0 Picture 10

- **(Deficiency): (Decking Wood Rot)** Upon inspecting the roof covering by walking the roof, a few areas were found to have wood rot. These areas were identified by visibly identifying areas of sagging roof deck as well as walking over areas that cracked or bent as they were met with pressure. The main roof area affected was found on the rear elevation flat roof. See attached video. (Picture 10)
- **(Deficiency): (Flat Roof - Ponding)** Upon inspecting the flat area roof covering, a few areas were found to show ponding of water after rains. These areas are susceptible to moisture intrusion and should be repaired immediately. This area also had recent repairs. We recommend budgeting for a new flat roof in the near future.

- **(Deficiency): (Decking Wood Rot)** Upon inspecting the roof covering by walking the roof, a few areas were found to have wood rot. These areas were identified by visibly identifying areas of sagging roof deck as well as walking over areas that cracked or bent as they were met with pressure. The main roof area affected was found on the rear elevation flat roof. See attached video. (Picture 10)
- **(Deficiency): (Flat Roof - Ponding)** Upon inspecting the flat area roof covering, a few areas were found to show ponding of water after rains. These areas are susceptible to moisture intrusion and should be repaired immediately. This area also had recent repairs. We recommend budgeting for a new flat roof in the near future.

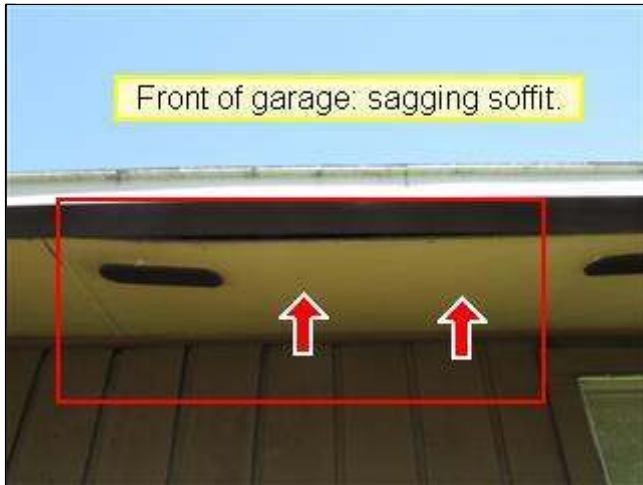
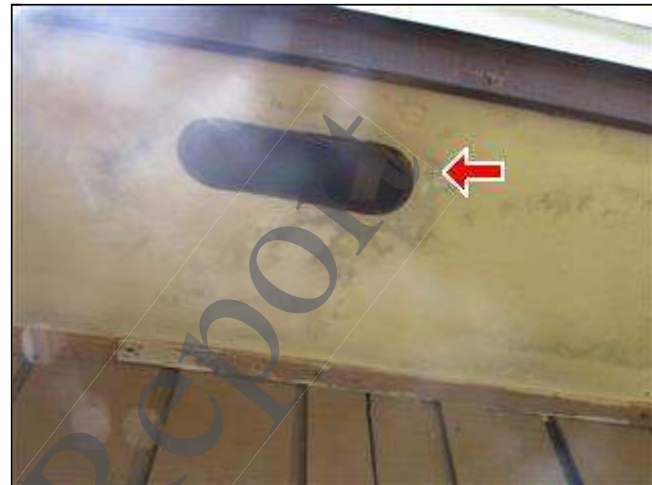
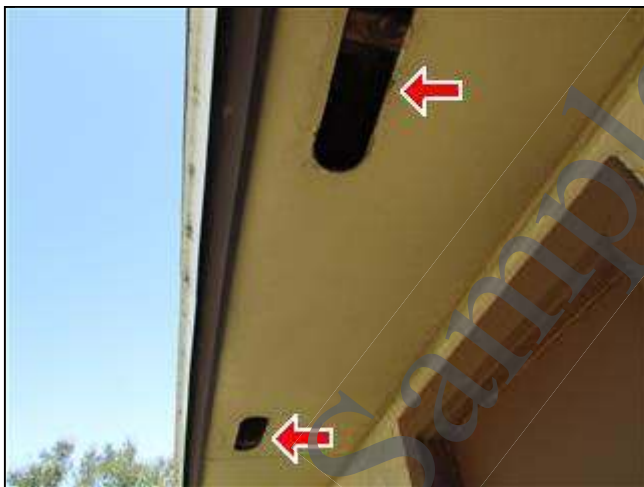
- **(Deficiency):** Upon inspecting the roof, evidence of past leaks along the drip edge were present around the fascia board. Some areas of the fascia and soffit also showed evidence of sagging. Budget for repairing these deficiencies.
- **(Deficiency):** Upon inspecting the soffits around the home, several areas were found to be damaged around the vent openings. These should be screened to protect the home from pests. This damage is most often due to rodents or bats. We recommend repairing these to keep insects and pests at bay.

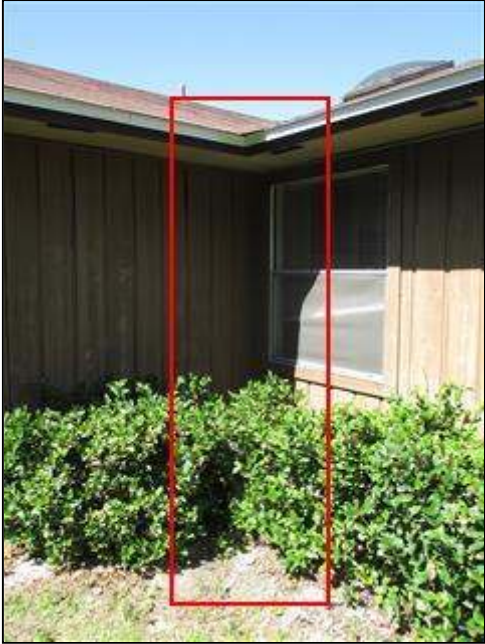
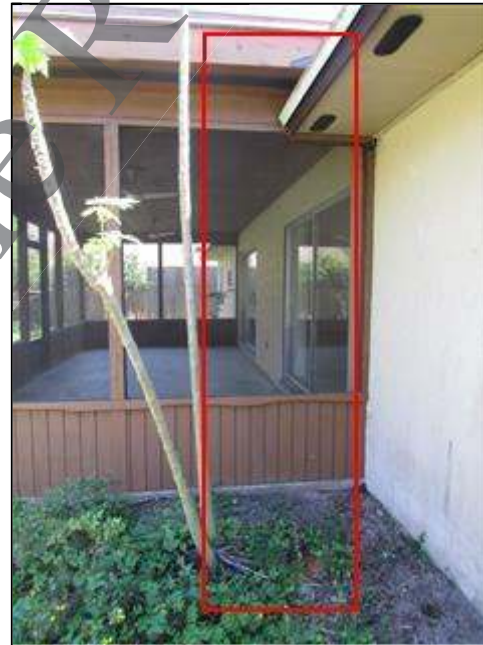
- **(Deficiency):** Gutters and drain lines are recommended to prevent soil erosion or water intrusion from occurring. Install these as needed. Consult with a qualified professional.

• **(Deficiency):** Gutters and drain lines are recommended to prevent soil erosion or water intrusion from occurring. Install these as needed. Consult with a qualified professional.

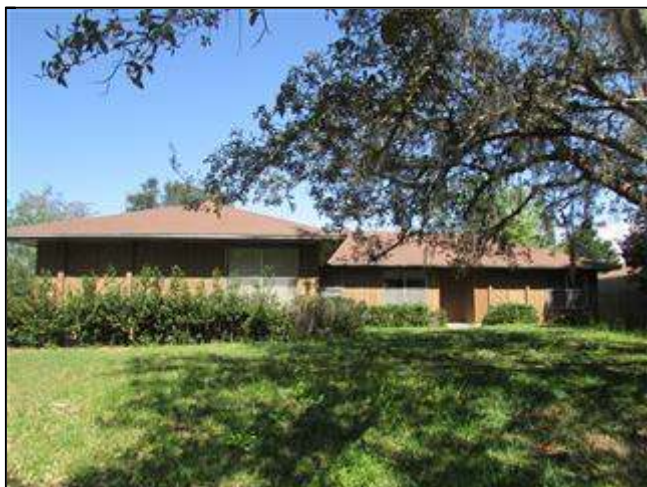
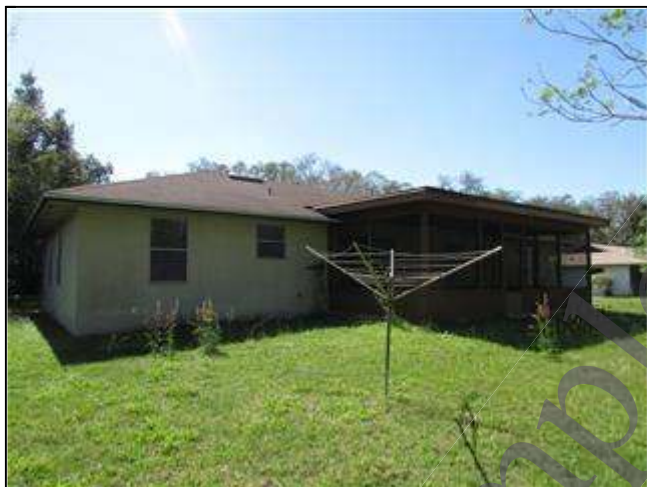
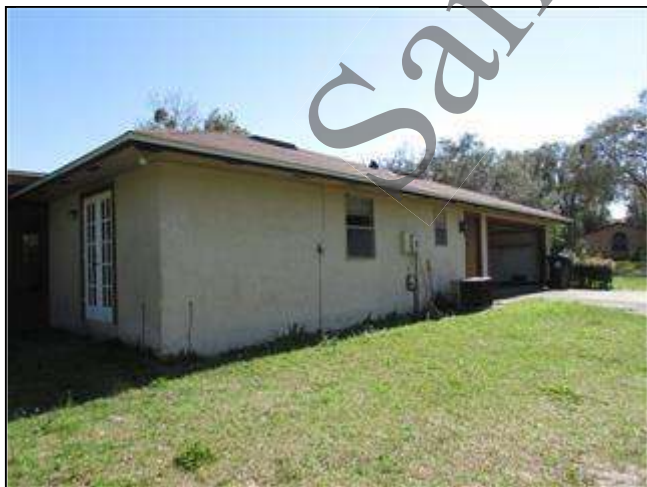
- **(Observation):** View of the exterior elevations at the time of inspection.

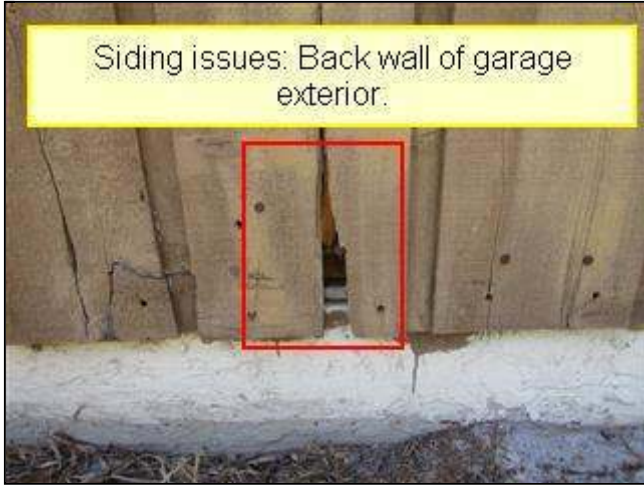
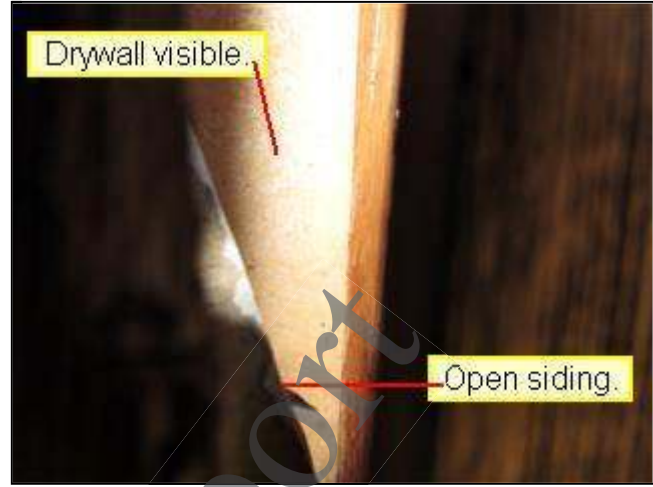
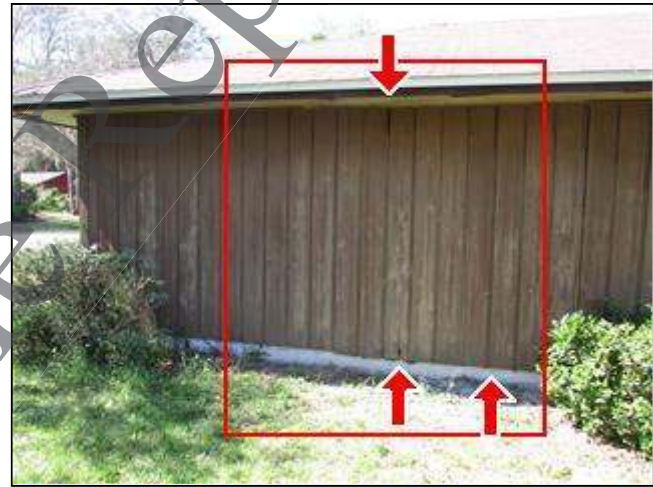
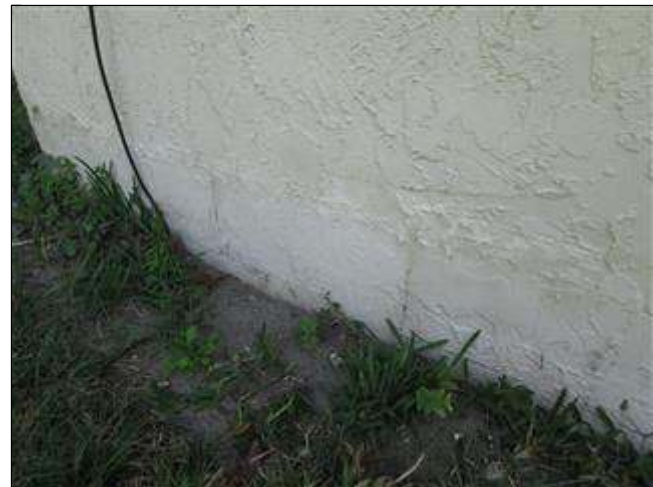
- **(Deficiency):** Upon inspecting the home, several panels of siding around the garage were found to be damaged and exposing garage interior walls and framing. Consult a licensed contractor to budget for these repairs.

(1)
 - **(Deficiency):** Upon inspecting the home, several panels of siding around the garage were found to be damaged and exposing garage interior walls and framing. Consult a licensed contractor to budget for these repairs.
-

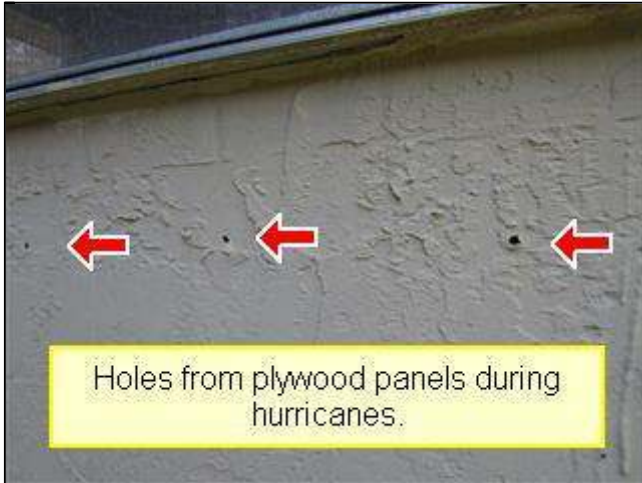
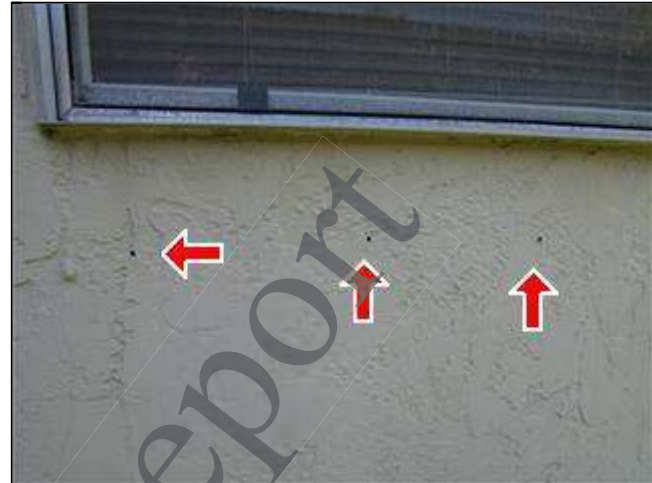
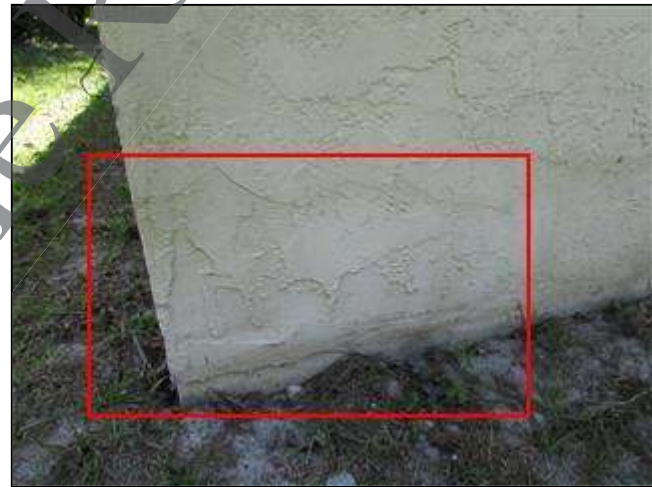
- **(Deficiency): (Step / Stucco Cracks)** Upon inspecting the home, several exterior step cracks were noticed. This cracking is due to settlement over the first few years of a home's construction as well as inadequate or insufficient stucco material being used on the buildings exterior masonry walls. To repair, seal all exterior cracks with an elastimeric silicone to prevent the possibility of moisture intrusion in the future. Holes were also found due to plywood panels from hurricanes. Repaint the exterior walls as needed with an elastimeric paint. Consult a licensed contractor to budget for these repairs.

(2)
 - **(Deficiency): (Step / Stucco Cracks)** Upon inspecting the home, several exterior step cracks were noticed. This cracking is due to settlement over the first few years of a home's construction as well as inadequate or insufficient stucco material being used on the buildings exterior masonry walls. To repair, seal all exterior cracks with an elastimeric silicone to prevent the possibility of moisture intrusion in the future. Holes were also found due to plywood panels from hurricanes. Repaint the exterior walls as needed with an elastimeric paint. Consult a licensed contractor to budget for these repairs.

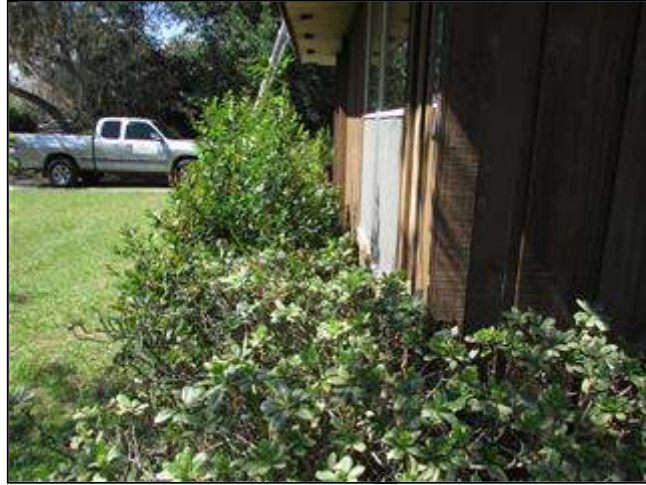
2.5 Picture 1

- **(Deficiency):
(Vegetation
Overgrown)**
Vegetation was found coming into contact with the building. This could either allow for pest issues to develop, moisture issues to develop or damage to the building. We recommend cutting back all vegetation to prevent any of these types of issues.

• **(Deficiency): (Vegetation Overgrown)** Vegetation was found coming into contact with the building. This could either allow for pest issues to develop, moisture issues to develop or damage to the building. We recommend cutting back all vegetation to prevent any of these types of issues.

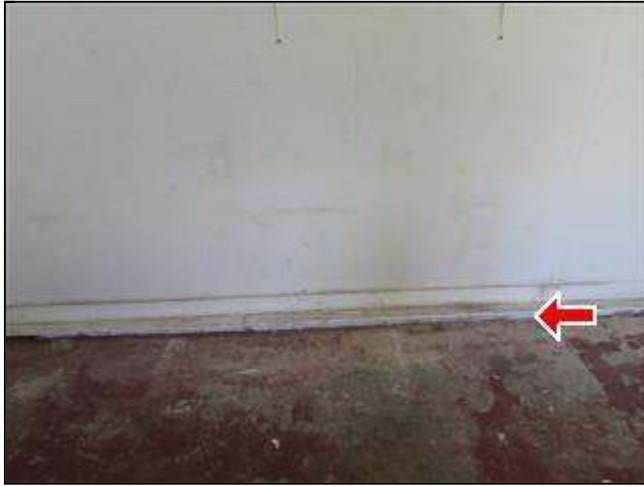
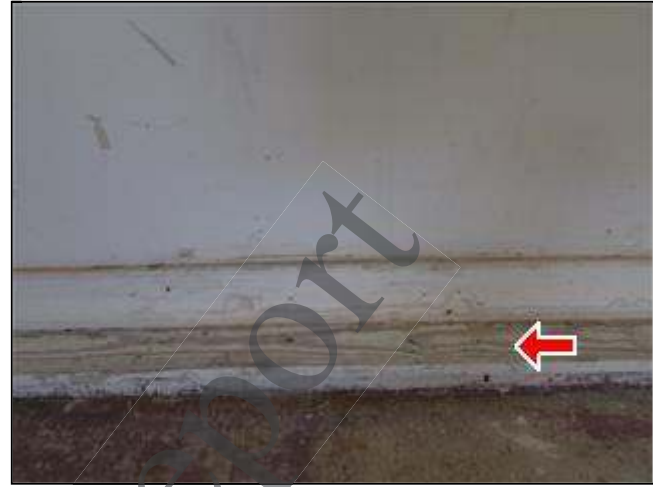
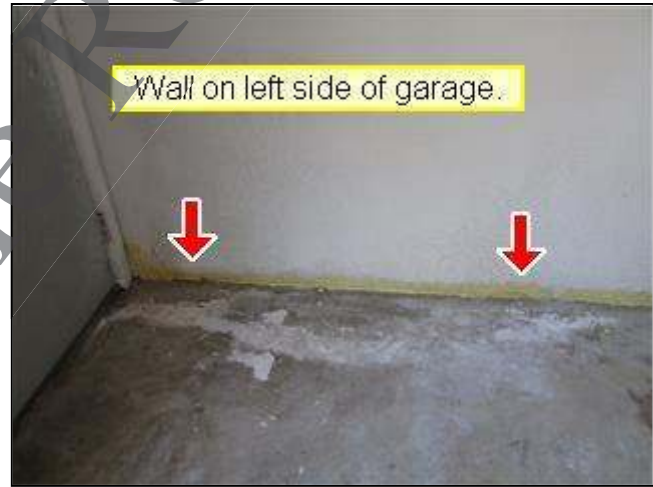
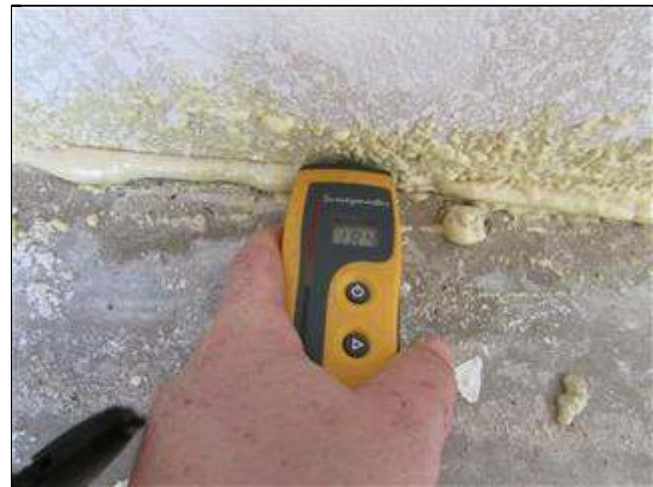
- **(Observation):** The back walls in the garage of the home showed signs of past moisture issues due to missing siding or exposed openings in the siding. Repair as needed.
- **(Deficiency): (Active water issues):** Active waste water intrusion was found to the garage left wall coming from the master bathroom toilet. Further evaluation by a licensed mold assessor is required. Budget on these repairs.

• **(Observation):** The back walls in the garage of the home showed signs of past moisture issues due to missing siding or exposed openings in the siding. Repair as needed.
- **(Deficiency): (Active water issues):** Active waste water intrusion was found to the garage left wall coming from the master bathroom toilet. Further evaluation by a licensed mold assessor is required. Budget on these repairs.

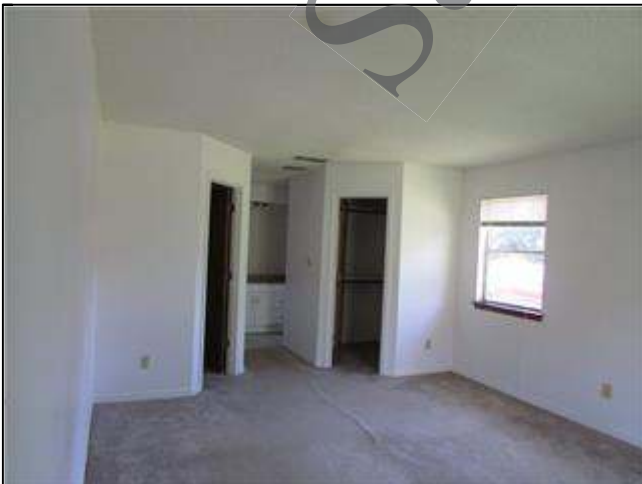
4.0 Picture 1

- **(Observation):** A view of the interior rooms of the home at the time of inspection.

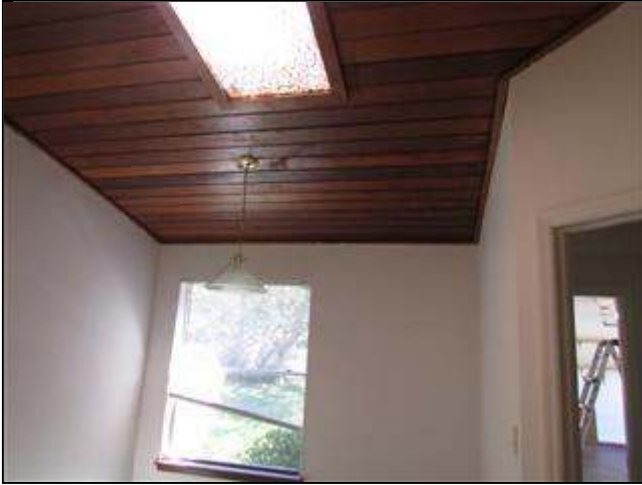
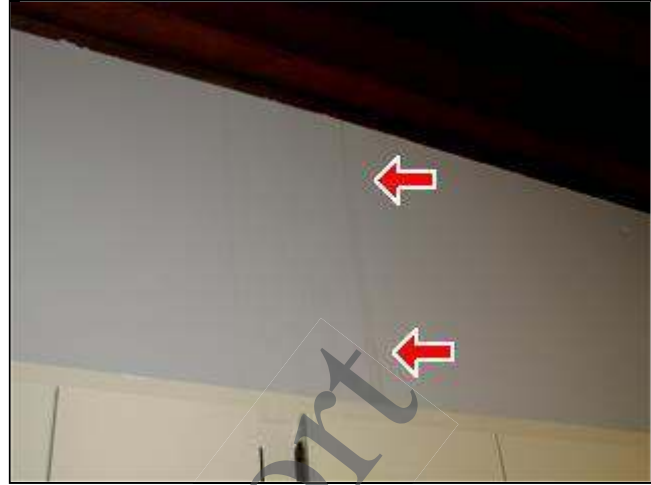
- **(Observation):** Evidence of a past leak was found on the first floor ceiling under a bathroom. No moisture was found in this area at the time of inspection.

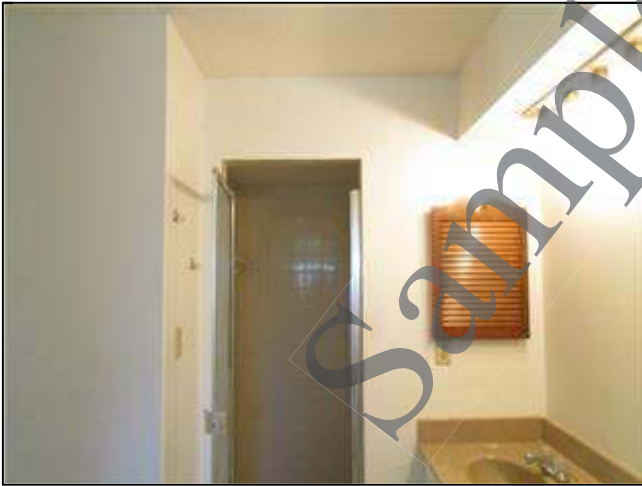
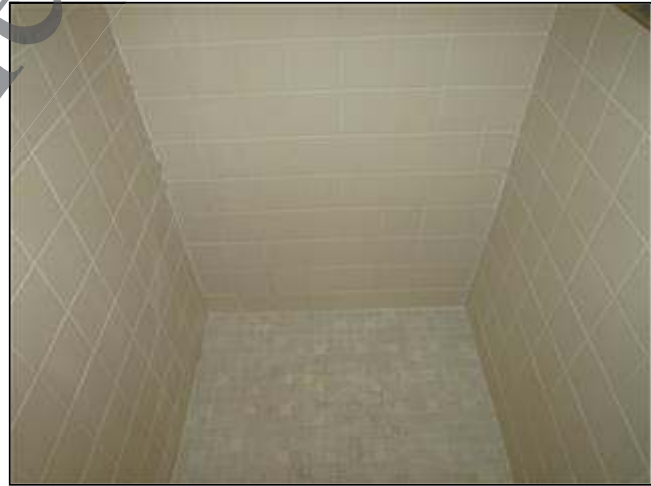
- **(Deficiency):** Upon inspecting the shower stalls and bath tub walls it was noticed that the grout has cracks or has deteriorated in areas. Since these walls are met with moisture and condensation issues often, we recommend sealing these cracks by re-grouting the tile walls as needed. This task is usually considered as regular maintenance and is relatively simple. Make sure the tile does not bow or flex when met with pressure at the time of re-grouting to ensure no water intrusion or damage has developed behind the tile. Consult a qualified contractor.

- **(Deficiency):** Upon inspecting the shower stalls and bath tub walls it was noticed that the grout has cracks or has deteriorated in areas. Since these walls are met with moisture and condensation issues often, we recommend sealing these cracks by re-grouting the tile walls as needed. This task is usually considered as regular maintenance and is relatively simple. Make sure the tile does not bow or flex when met with pressure at the time of re-grouting to ensure no water intrusion or damage has developed behind the tile. Consult a qualified contractor.

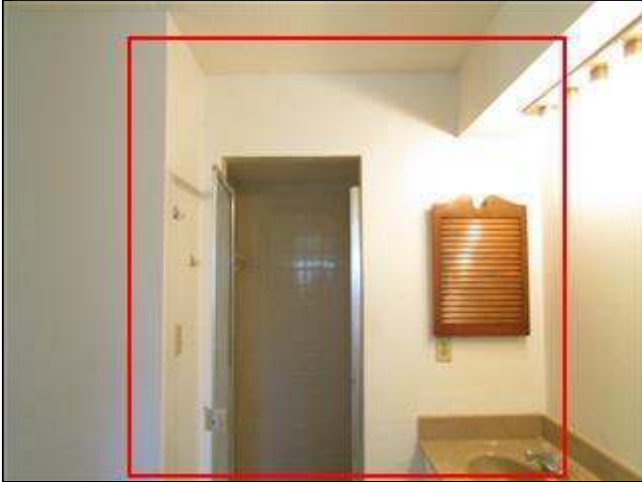
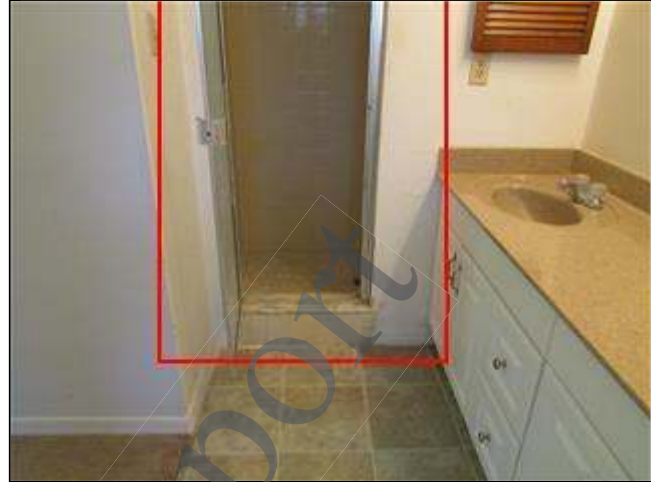
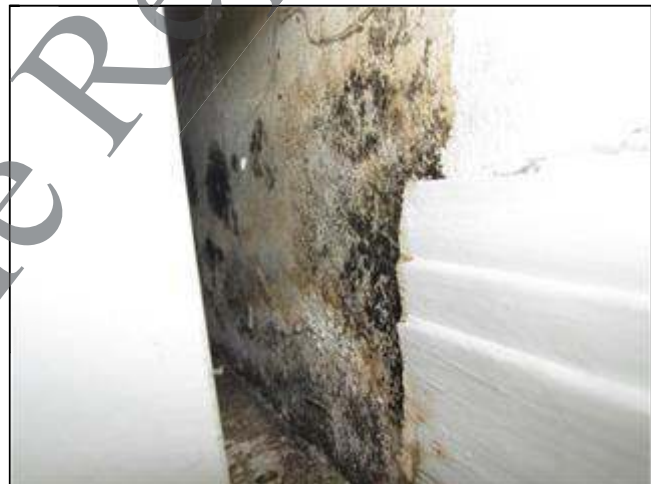
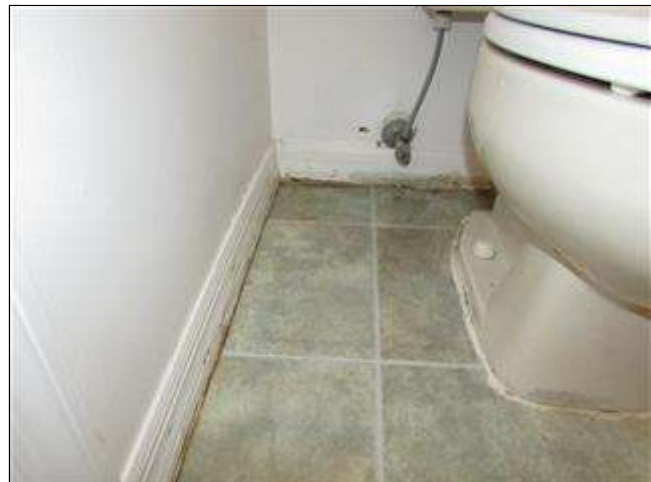
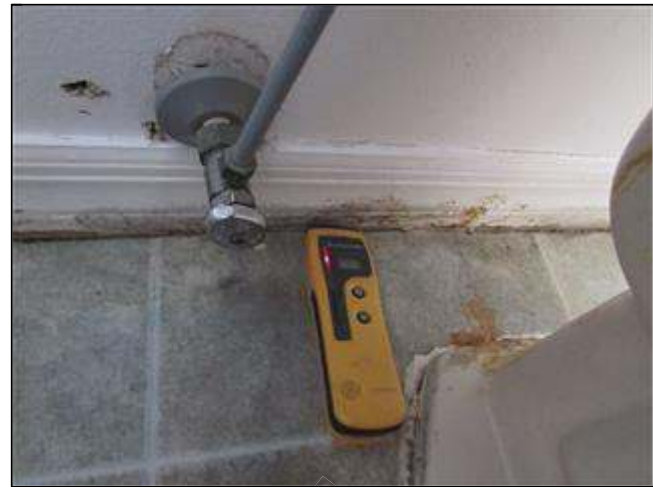
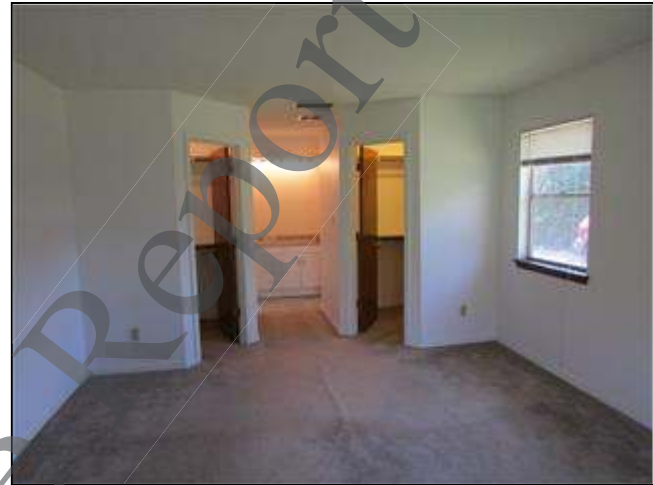
- **(Observation):** This home has had repairs made to the drywall to the master bathroom. Evidence of active moisture was found to the back wall behind the cabinet as well as the toilet room. An active leak was found to the toilet base and was found running through to the garage wall. Possible evidence of microbial growth was present. We recommend further evaluation by a state licensed mold assessor to confirm and to supply what complete repair will entail. (See attached photos of active moisture in bathroom walls, floor and garage walls.)

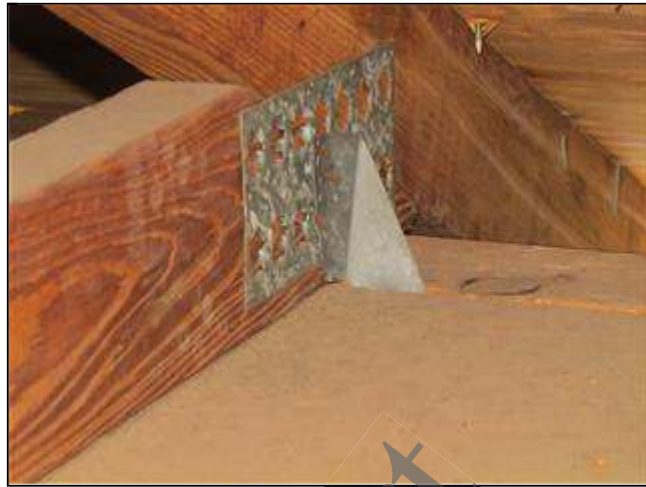
5.5 Picture 1

- **(Observation):** This home has at least one feature that qualifies it for home owners insurance discounts called wind credits. These wind credits allow for deductions in home owners insurance premiums due to their ability to harden and protect a home from high force winds or hurricane force winds. This report is called a Wind Mitigation Report, and is accepted by all insurance companies that write policies in Florida. For a report to provide to your insurance company to qualify for these savings, please contact us at 321-303-4338. or email us at inspector@maverickinspections.com. We are licensed and certified to provide you with this report.

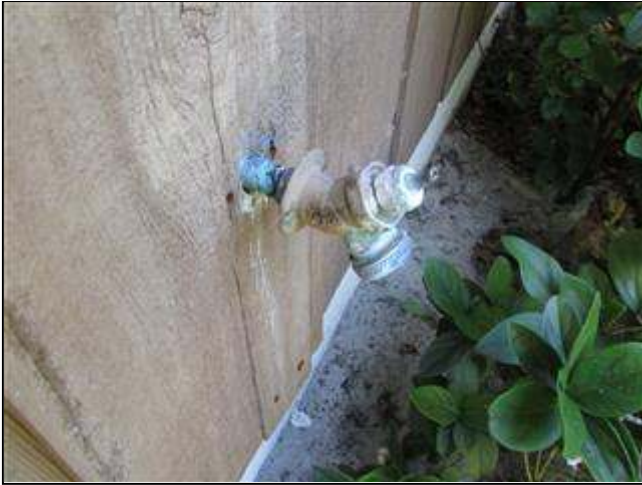
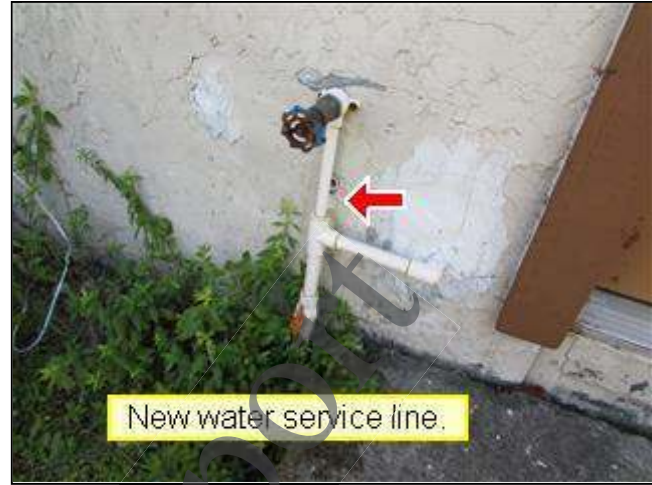
- **(Observation):** The homes plumbing system has been updated. The majority of the hose bibs outside the home appear to be original. These hose bibs were not connected to the homes active plumbing. Budget for these repairs.

- **(Observation):** The homes plumbing system has been updated. The majority of the hose bibs outside the home appear to be original. These hose bibs were not connected to the homes active plumbing. Budget for these repairs.

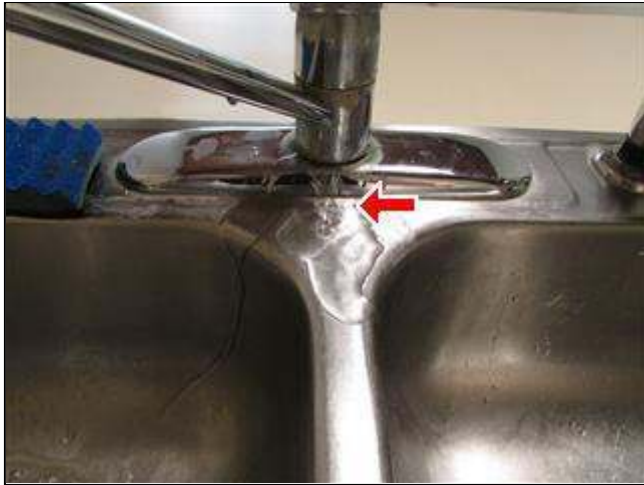
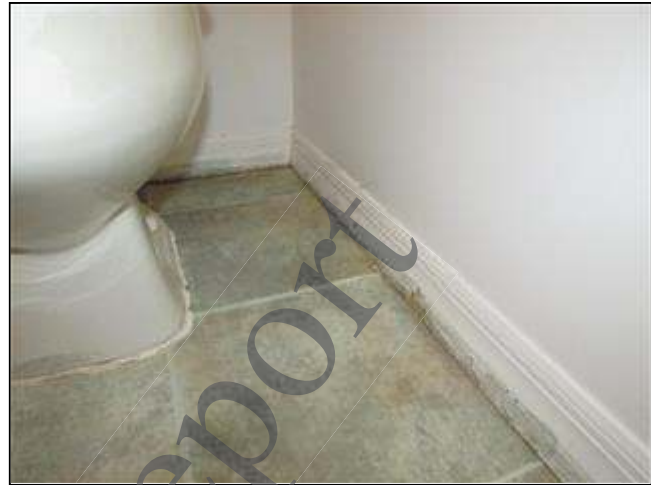
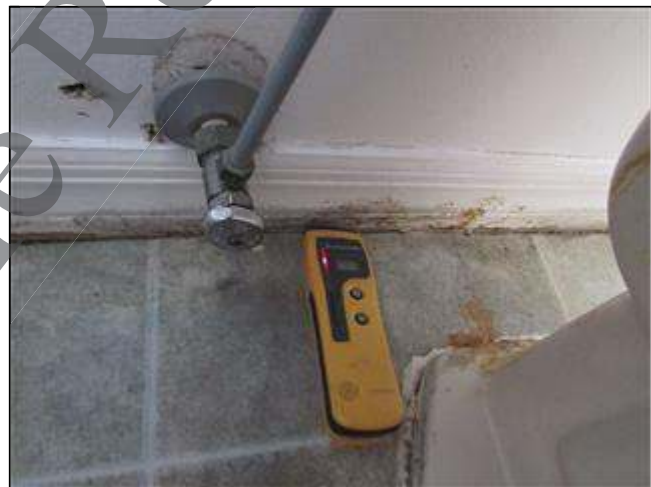
- **(Deficiency):** The kitchen sink was leaking. Repair this item at the faucet.
- **(Deficiency):** The toilet in the master bathroom was loose and not secured tightly to the floor. This has allowed water intrusion issues to develop around the flange and neighboring walls. We recommend carefully fastening the toilet down to the flange. This may require installing a new wax seal to prevent moisture issues with waste water. Consult a certified contractor for these repairs. Since the toilet has been leaking waste water, further evaluation by a licensed mold assessor is recommended.

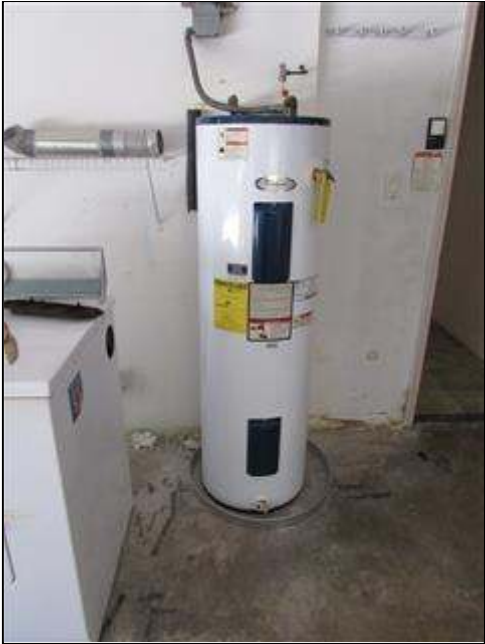
6.2 Picture 1

- **(Observation):** View of the water heater at the time of inspection.

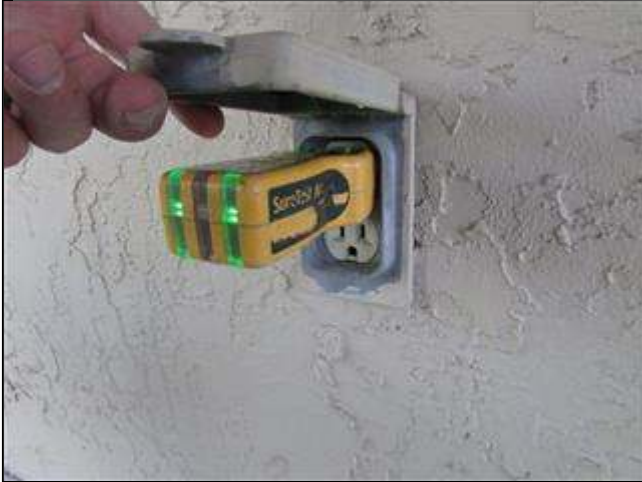
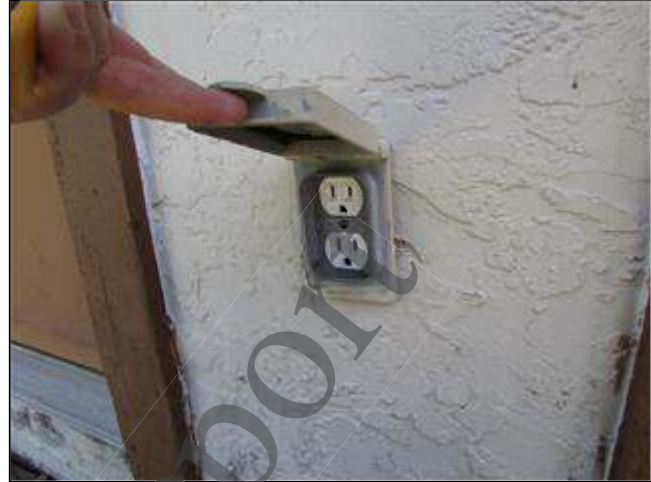
- **(Deficiency):** The home has electrical outlets that are not GFCI protected. We recommend installing GFCI protected outlets to protect against shock wherever required. GFCI protected outlets are installed on all exterior outlets, garage outlets, laundry room, kitchen and bathroom outlets.

- **(Deficiency):** The home has electrical outlets that are not GFCI protected. We recommend installing GFCI protected outlets to protect against shock wherever required. GFCI protected outlets are installed on all exterior outlets, garage outlets, laundry room, kitchen and bathroom outlets.

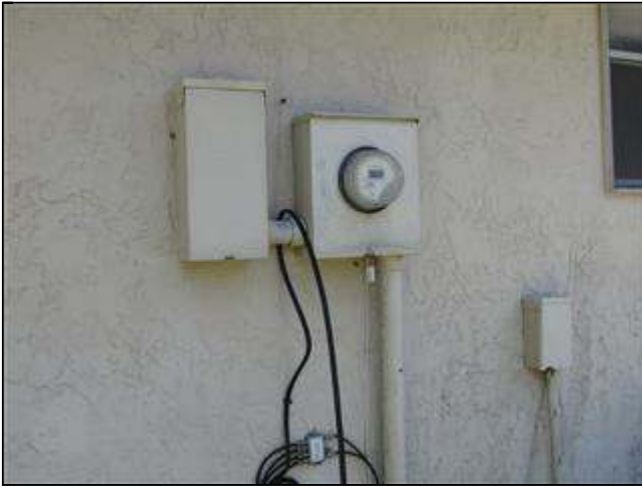
7.6 Picture 1

- **(Observation):** The main panel is located on the exterior elevation. The distribution panel is located in the garage.

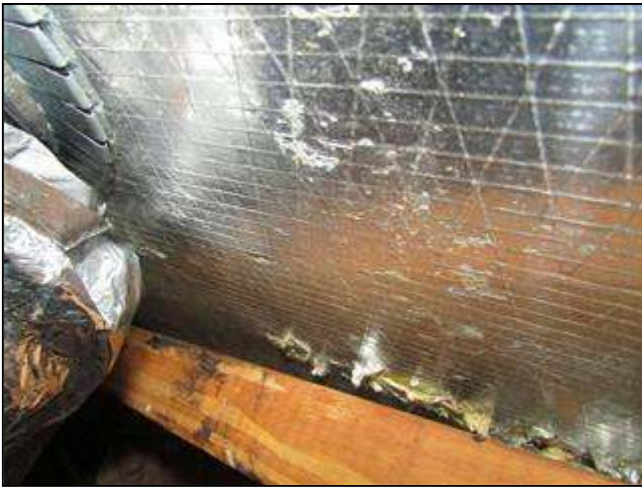
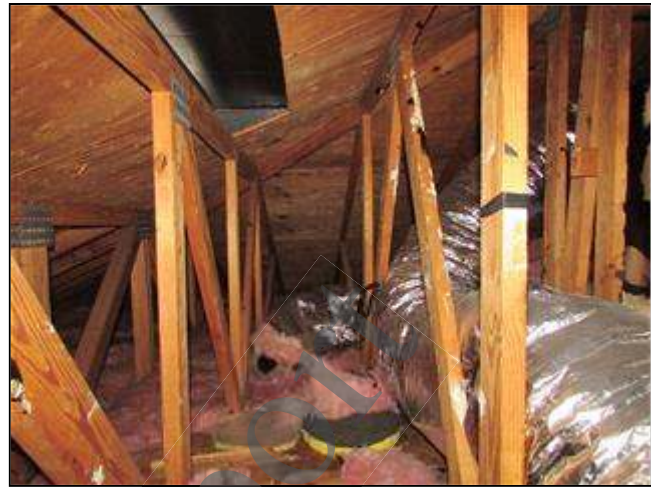
- **(Deficiency): (Duct Leak)** A conditioned air leak was detected in the duct in the attic. Repair this item to prevent air loss and increase HVAC efficiency as well as energy savings.

- **(Deficiency): (Duct Leak)** A conditioned air leak was detected in the duct in the attic. Repair this item to prevent air loss and increase HVAC efficiency as well as energy savings.

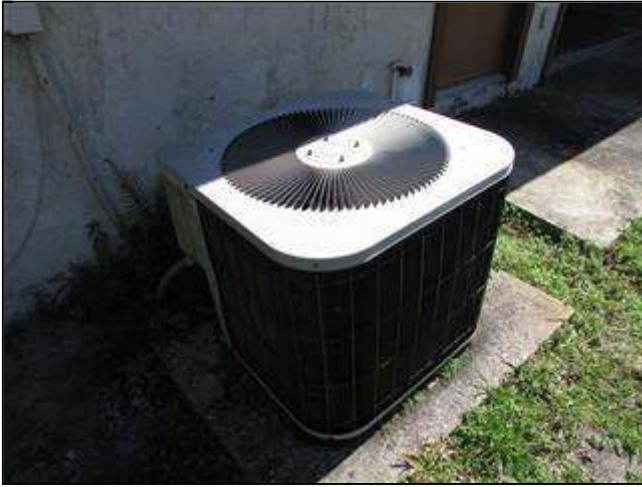
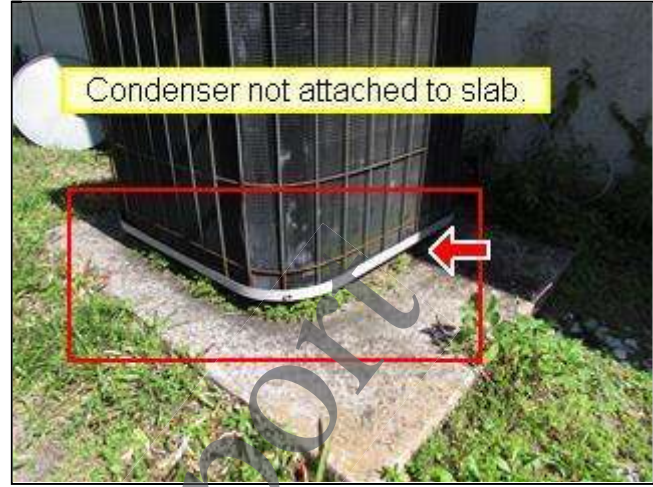
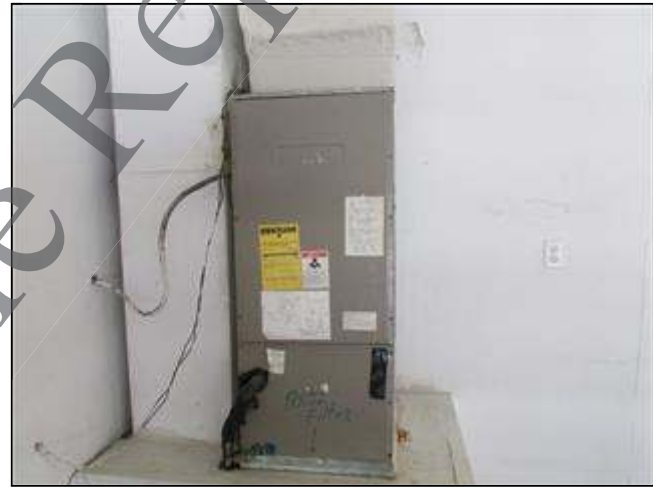
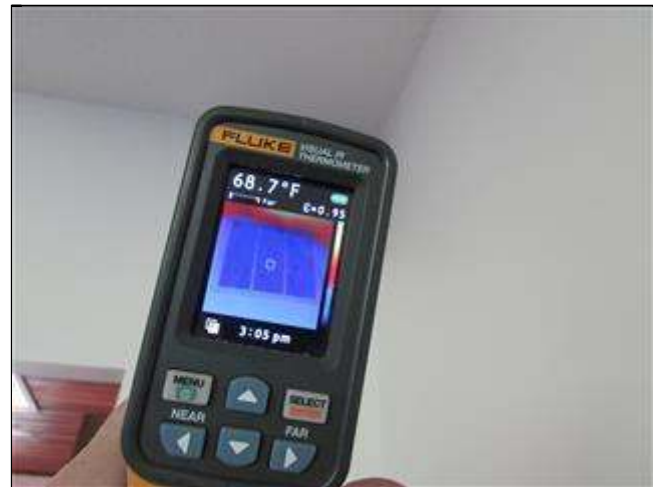
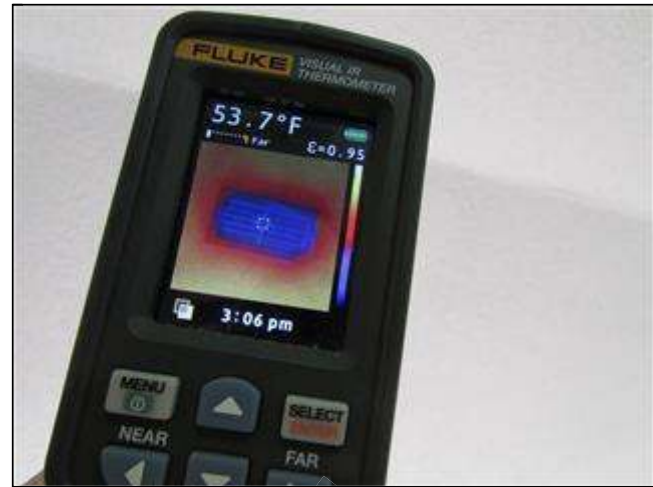
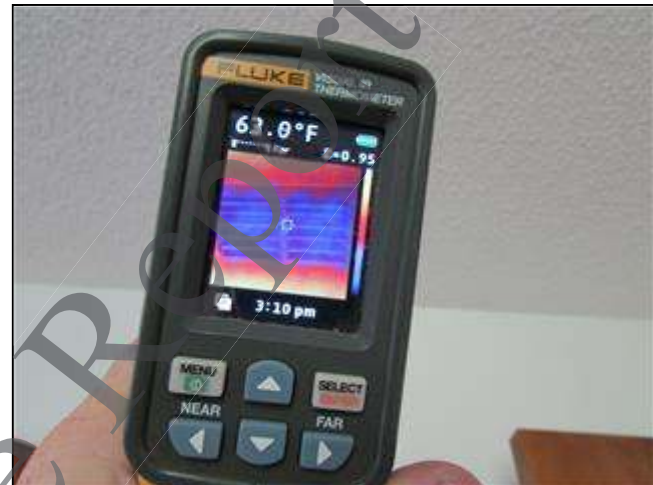
- **(Observation):** The air handler was inspected and was found functioning well at the time of inspection. The system is about 14 yrs. old. These systems typically have a life expectancy of about 15-20 yrs. when well maintained. The condenser was not attached to the slab it is placed on. The condenser was also missing insulation on the liquid lines. Repair these item. Cleaning and maintenance is recommended.

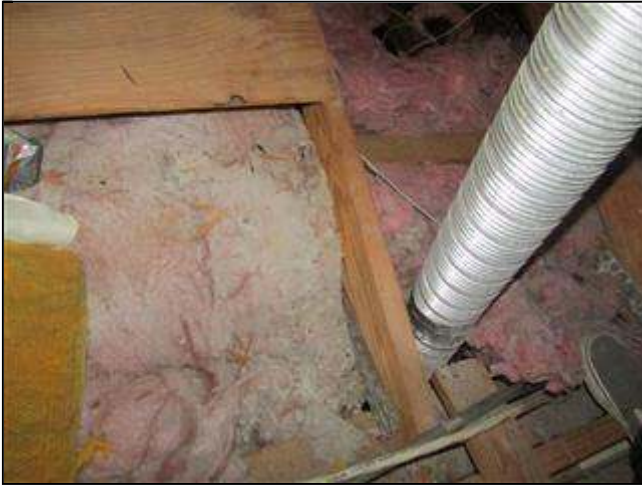
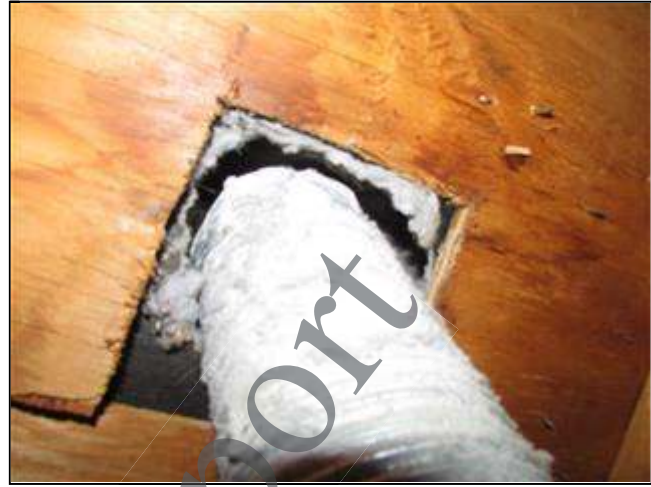
- **(Deficiency):** Upon inspecting the dryer ventilation, a build up of lint was found in the duct system. Lint was also found in the attic crawl space due to this build up. We recommend cleaning out the duct to ensure no blockage has developed in the duct and that the system is completely sealed and prevented from blowing lint further into the attic. Lint is flammable, so this is considered a fire hazard. Repair as soon as possible.

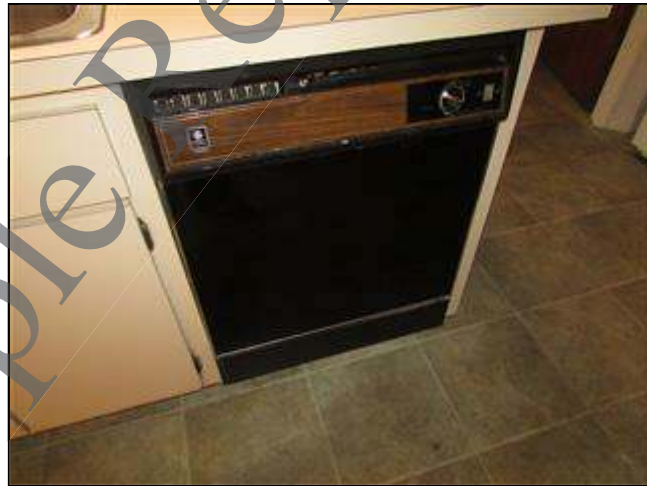
10.0 Picture 1

- This appliance was inspected and was found not working efficiently at the time of inspection. Budget on repair or replacement.

- This appliance was inspected and was found not working efficiently at the time of inspection. Budget on repair or replacement.

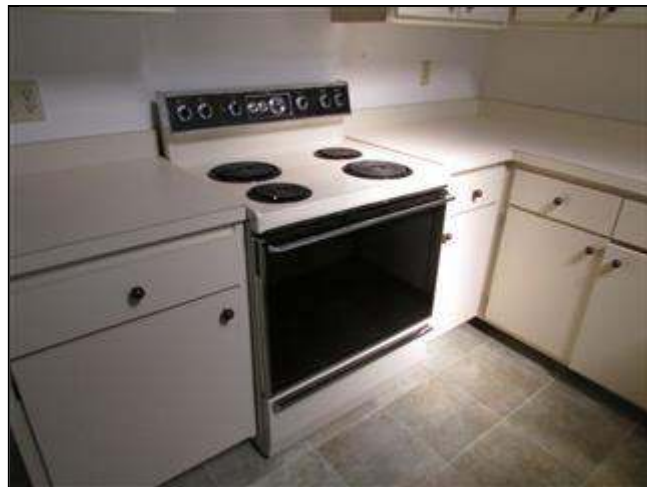
10.1 Picture 1

- This appliance was inspected and was found in good working order at the time of inspection.

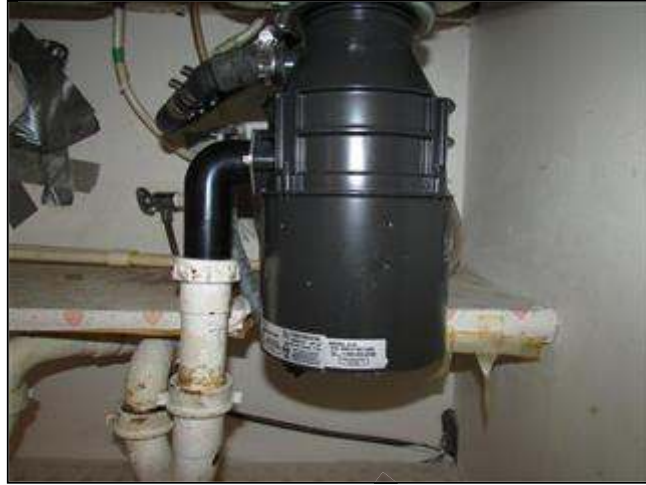
10.4 Picture 1

- This appliance was inspected and was found in good working order at the time of inspection.

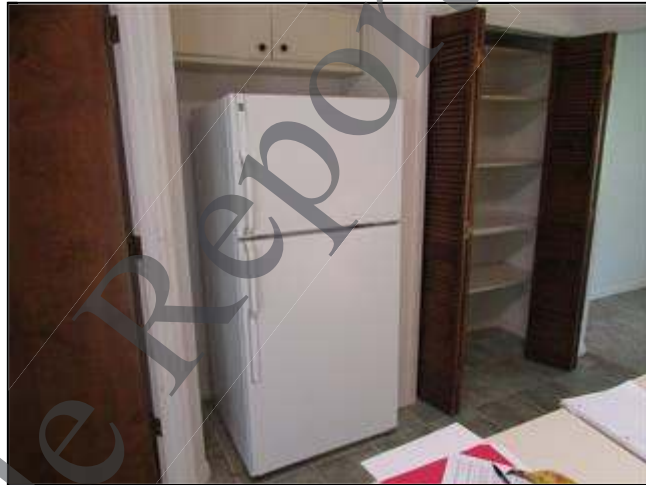
10.6 Picture 1

- This appliance was inspected and was found in good working order at the time of inspection.
