Environmental Management Services

Creosote Pole Storage - Unmade Ground Case Study

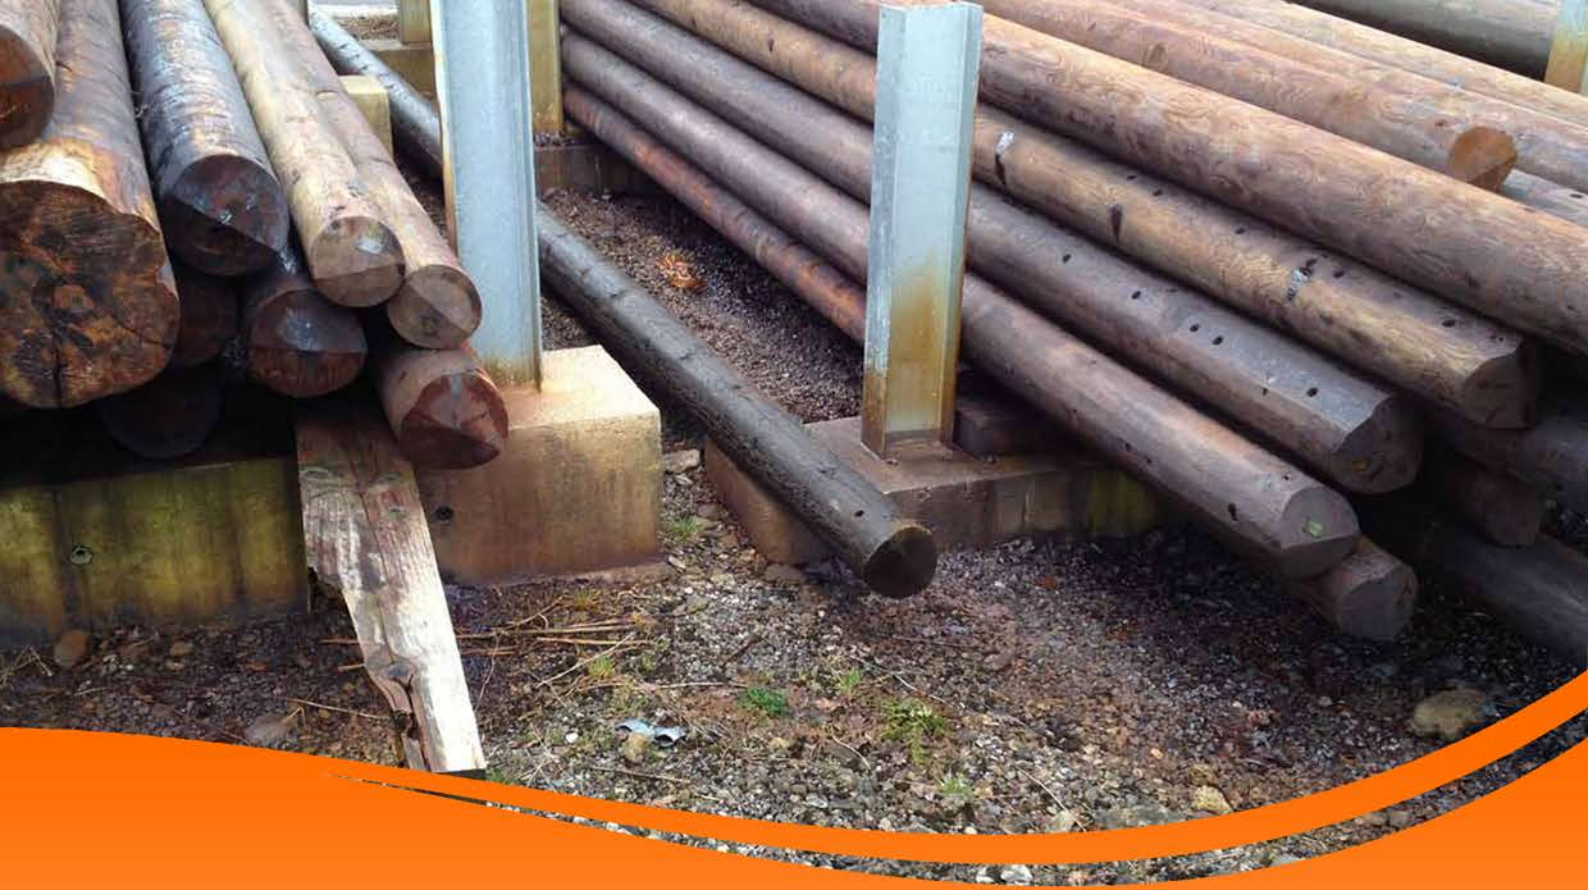
During a liquid pollution risk assessment of a major DNOs depot we found that the storage of their creosote impregnated poles had not taken into consideration the pollution hazards posed by creosote leaching out of the poles.

The poles were being stored on unmade ground allowing any creosote leachate to pollute the ground beneath the poles.

Drain alterations were conducted and a specialist lining was installed below the pole storage area to direct all run off through a specialist DNAPL interceptor. Specialist hydrophobic and non leaching absorbents were installed underneath the poles to minimise the risk of the interceptor's creosote storage capacity being reached between maintenance events.

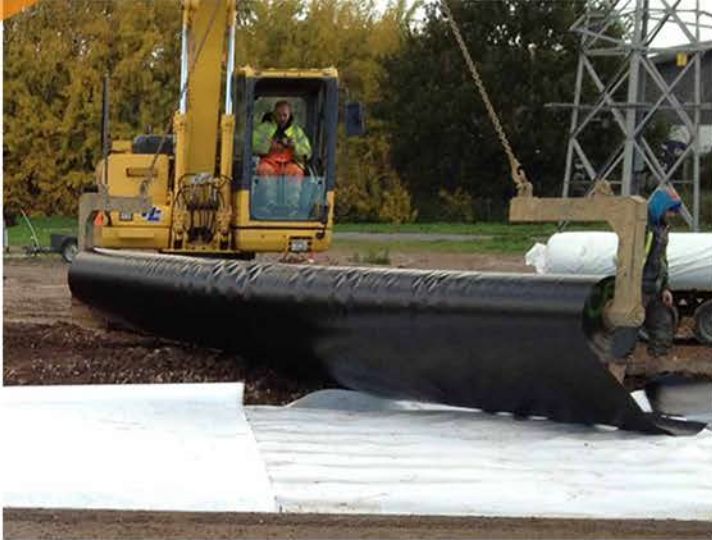
During a liquid pollution risk assessment of a major DNOs depot we found that the storage of their creosote impregnated poles had not taken into consideration the pollution hazards posed by creosote leaching out of the poles.

The client's pole storage area was located on unmade ground allowing any creosote leachate to pollute the ground beneath the poles.

Firstly we remediated the contaminated ground, removing any historical creosote pollution.

Secondly we installed new drainage and an impermeable membrane beneath the pole storage area which channelled all runoff to one of our specialist DNAPL interceptors.

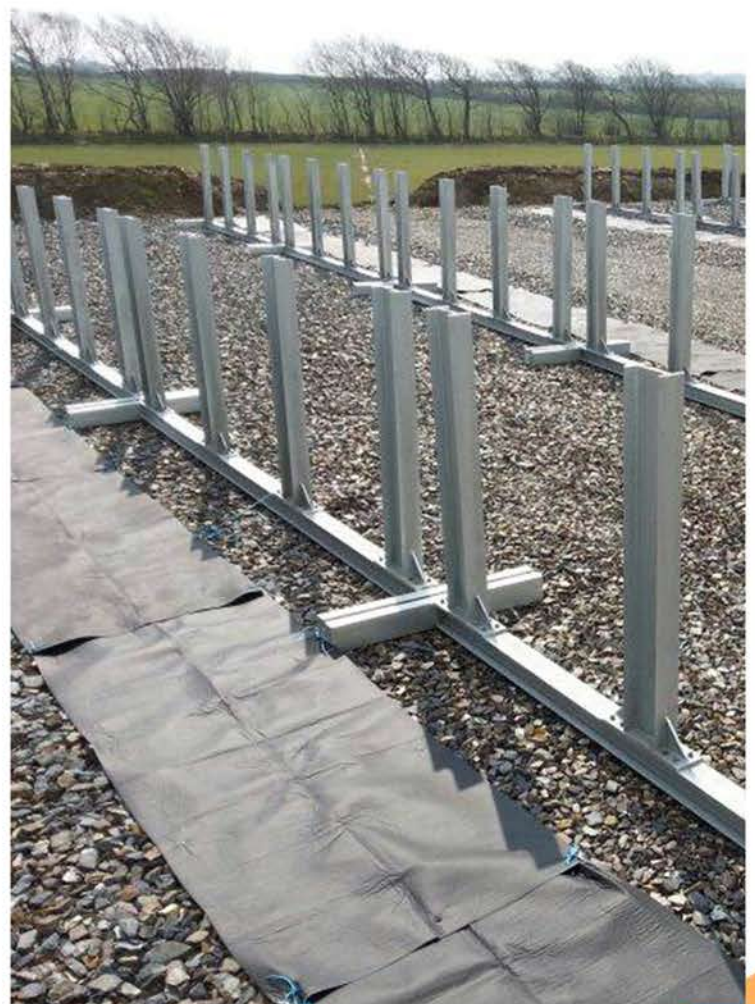
As an additional control a specialist hydrophobic and non-leaching absorbent was installed beneath the poles. This selectively absorbs creosote but not water allowing the majority of the creosote to be absorbed before it reaches the DNAPL interceptor, reducing the risk of the interceptor's capacity being reached between maintenance events.
