BELZONA REFURBISHES EIGHTY YEAR OLD TURBINE RUNNER

Hydro-electric plant, Arkansas

Severely eroded Francis turbine runner.

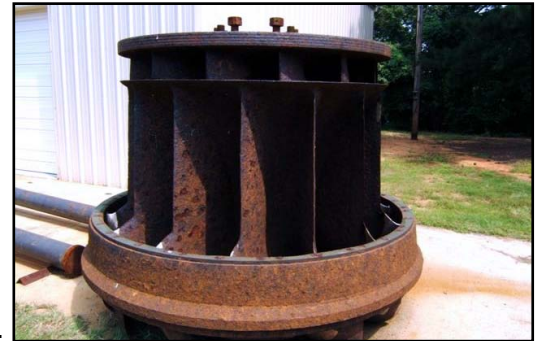
Years of use had caused severe corrosion and cavitation erosion on the turbine. Customer had received bids for new replacement but chose Belzona on economic grounds.

1. Turbine before initial blast cleaning
2. Some of the cavitation damage
3. Project after Belzona® 1121 application
4. Completed project
