Additional load resistance tests for Stonel brick surfaced external cladding panel system according to ETAG 034

Requested by: Stonel Oy

Assignment **Additional load resistance tests for Stonel brick surfaced external cladding panel system according to ETAG 034**

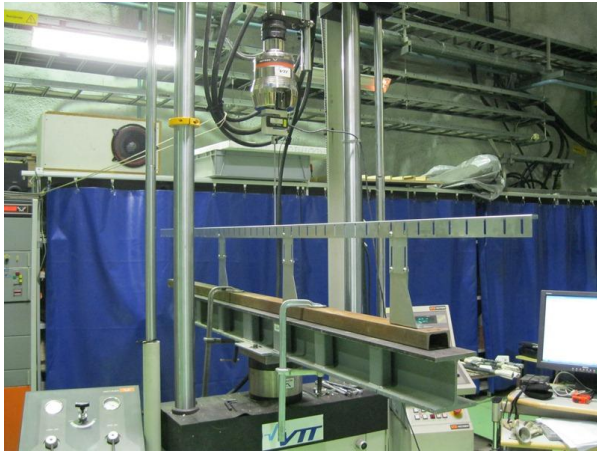
Photos 1 and 2. Test arrangements, loading point 70...130 mm from the fixing screw.

Test arrangements Horizontal load tests of vertical rail
Six tests were carried out by loading the vertical rail from the fixing point used for screw fixing of the horizontal rails. The location of the loading point was 70 – 130 mm from the screws used to fix the vertical rail to substrate. Six tests were also carried out with loosen screws. The load was increased slowly directly

to the failure, and during the loading the failure behaviour of the rail was visually surveyed. The deflection was recorded, as well.

The test arrangements are shown in photos in Appendix 1.

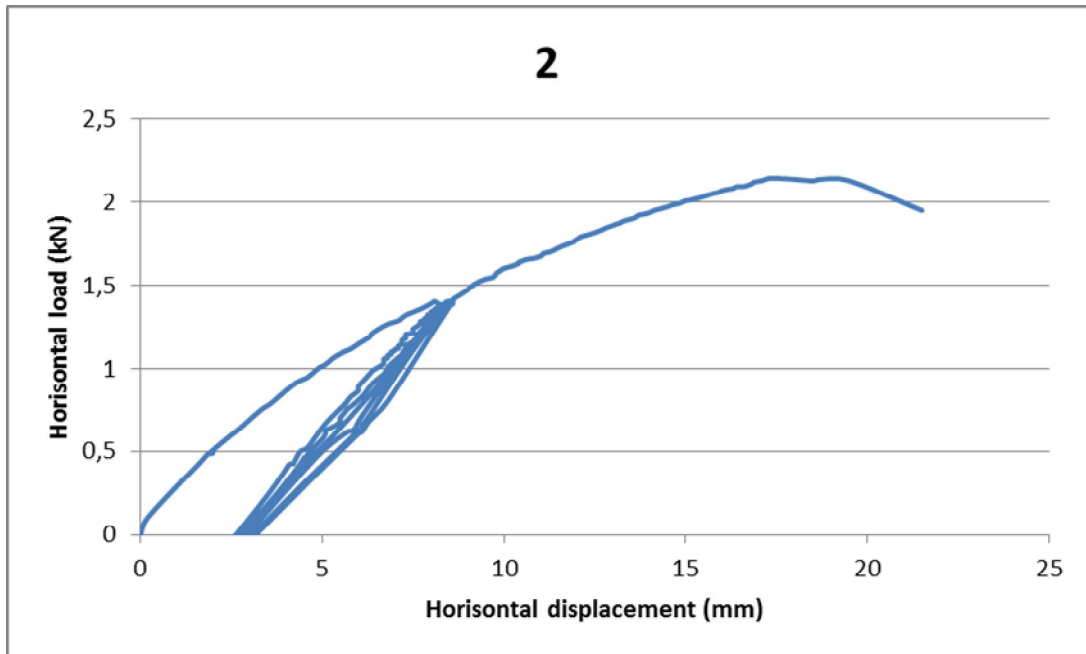
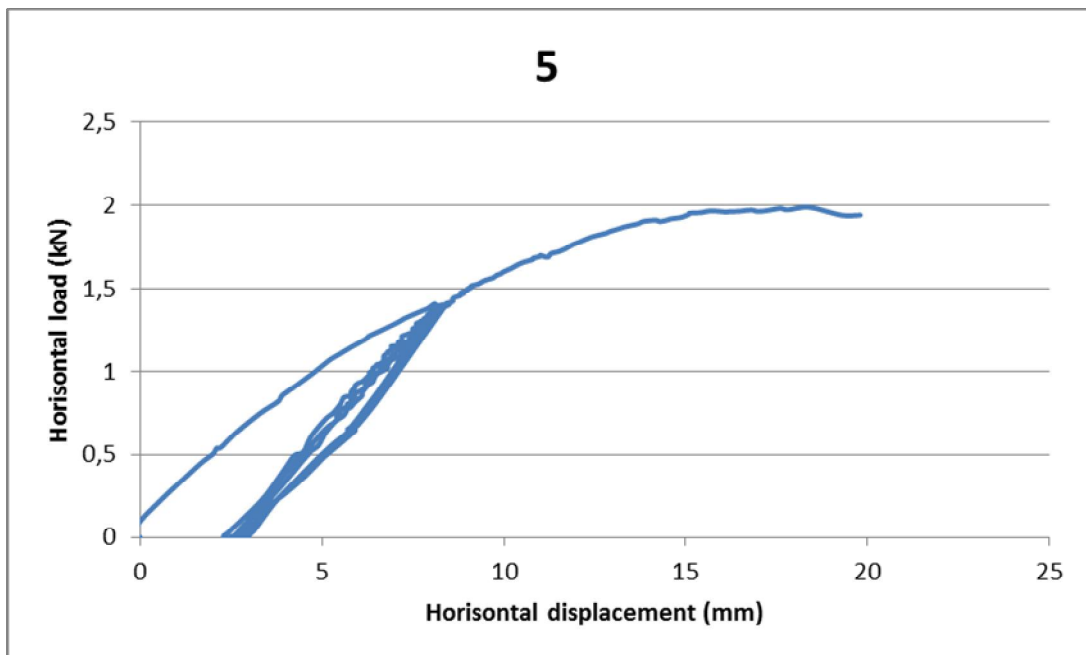
Results of horizontal load tests of horizontal rails / typical load-displacement curves

Final failure load varied from 1.85 to 2.15 kN. The average of the failure load was 1.97 kN and standard deviation was 0.10 kN. Using material safety factor 0.9 for steel rail the design horizontal load capacity is $0.9 \cdot (1.97 - 2.18 \cdot 0.10) = 1.58$ kN / two fixing point. Which makes $1.58/2/0.36 = 2.2$ kN/m² (fixing points in 0.6 m x 0.6 m mesh). Failure mode was the deflection of the horizontal rail and finally the tongue fixing of the panel was loosening from horizontal rail. The permanent horizontal deflection after three times up to 1.4 kN was about 2.5 mm

The individual test results, some typical load-deflection curves and some photos of the failures are presented in Appendix 2.

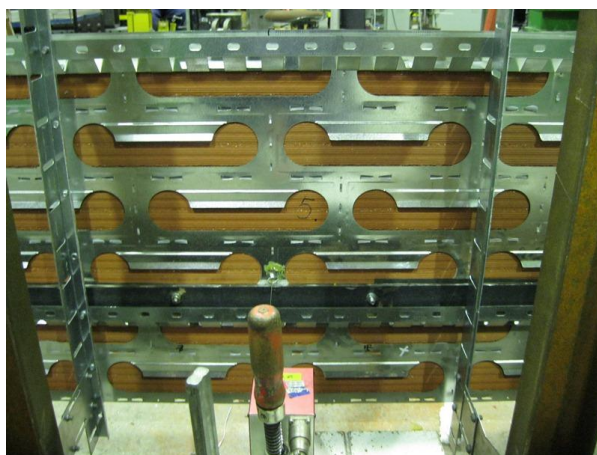
Photo 5. Test arrangements from backside of the specimen.

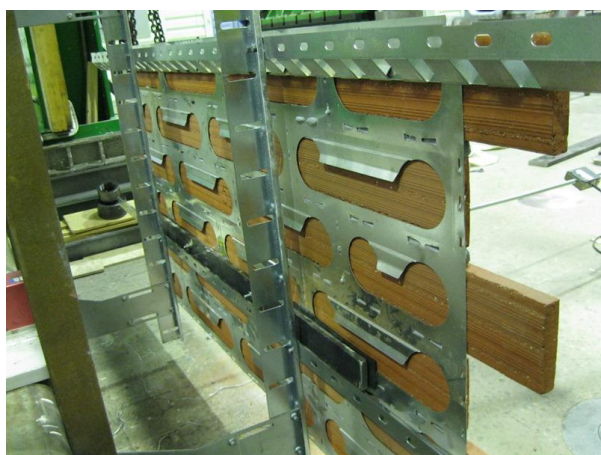
Photos 6 and 7. Load was concentrated on backside with the help of rubber strips (300 mm long) to fixing areas of horizontal rails.

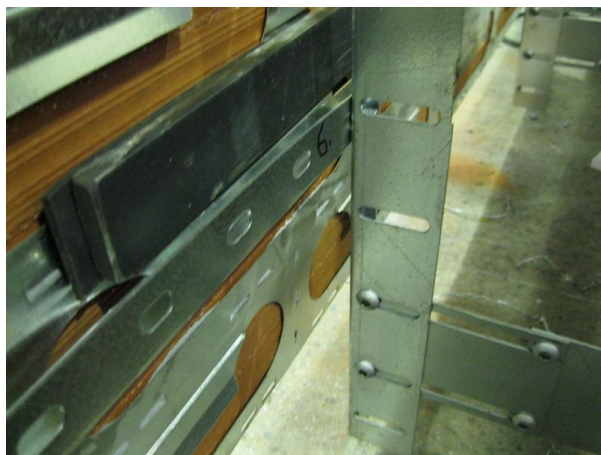
Photo 8. Start of failure.

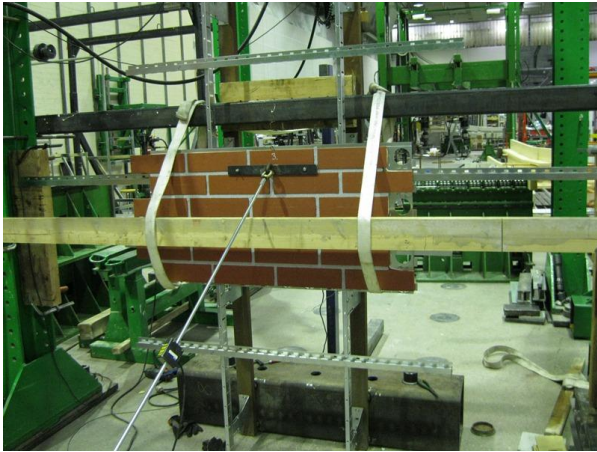
Photo 10. Test arrangements.

The load tests for combined load were carried out on specimens, which were in principle similar to those used for horizontal loading of horizontal rails. Only three tests were done using loading angle 30°, since the loading case was not critical.

The load was first increased once slowly to estimated service load of about 1.4 kN and after that directly to the failure. During the loading the failure behaviour of the rail was visually surveyed. The downward and horizontal deflection/displacements were recorded during the test.

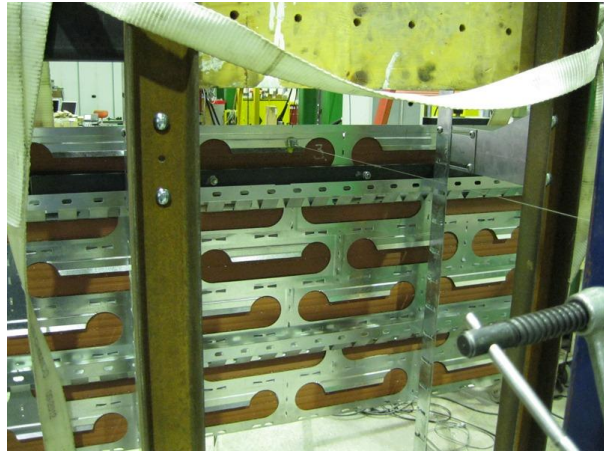
Photo 11. Test arrangements from back side.

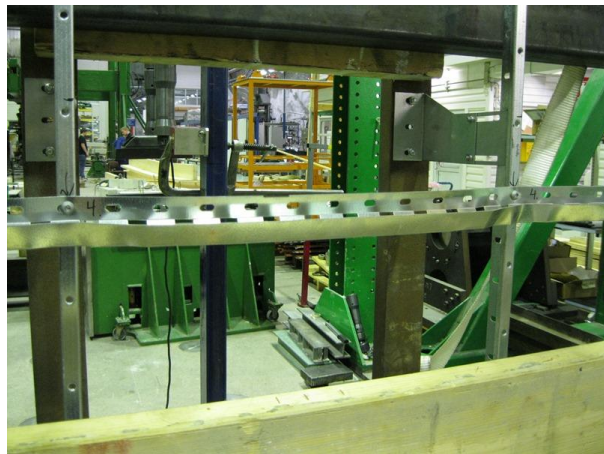
Photo 13. Horizontal rail after failure.

Final failure loads were 2.36 kN, 2.74 kN and 2.79 kN. The average of the failure load was 2.63 kN. Failure mode was the deflection of the horizontal rail and finally the tongue fixing of the panel was loosening from horizontal rail.

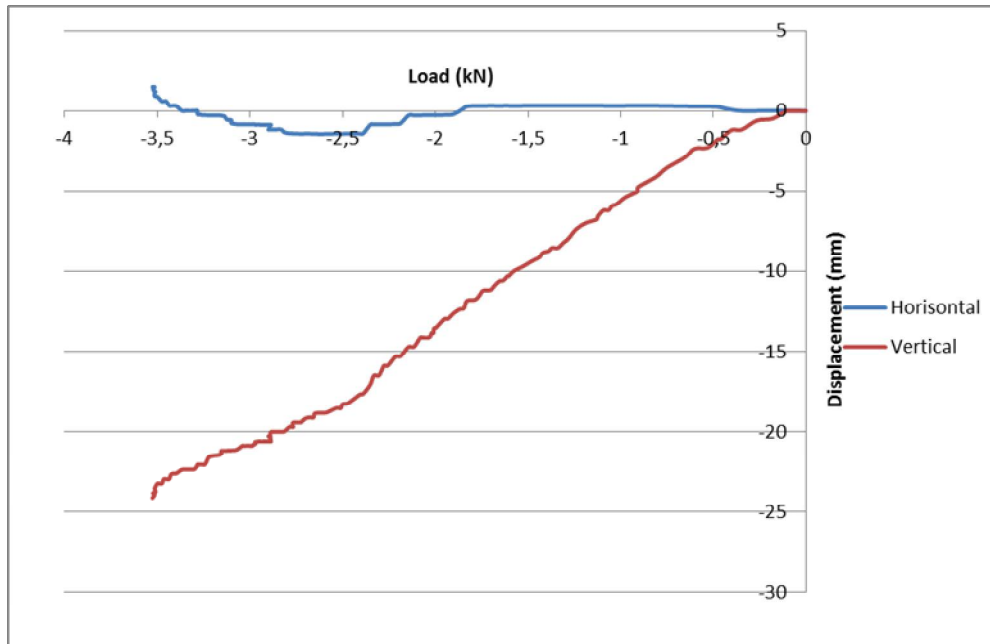
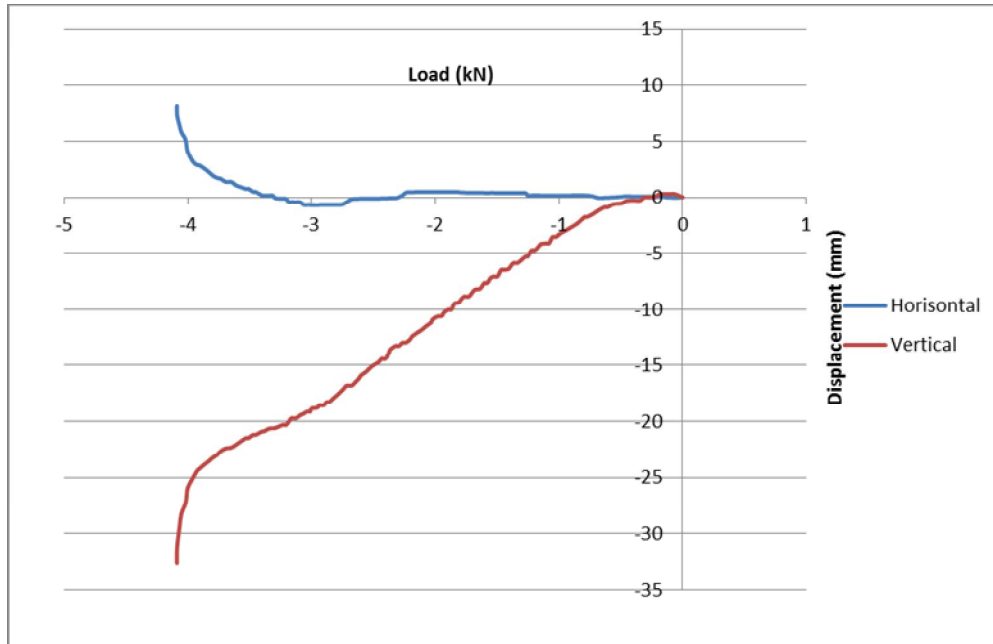
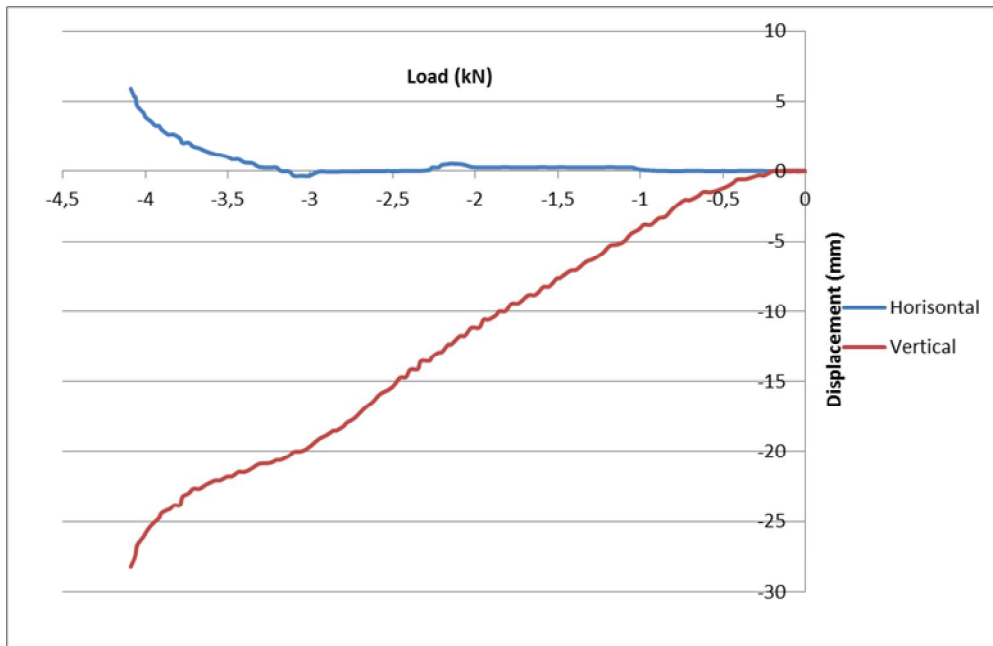
Vertical load tests Load-displacement curves

In the load test the horizontal rails behaved very elastically in the vertical direction and the vertical displacement increased linearly up to over 20 mm before failure. The final failure occurred in the horizontal rails, and near failure load the rails were buckling and the horizontal displacement increased rapidly as may be seen in the load-displacement curves in Appendix 4. The final failure loads as estimated from the curves were 3.5, 4.2, 4.0, 3.7, 4.0 and 4.0 kN:s. The average of the failure load was 3.90 kN and standard deviation was 0.25 kN. Using material safety factor 0.9 for the horizontal steel rail the design vertical load capacity can be approximated to be $0.9 \cdot (3.9 - 2.18 \cdot 0.25) = 3.0$ kN /two fixing point. This makes about 4.2 kN/m² (fixing points in 0.6 m x 0.6 m mesh). In practice, the vertical

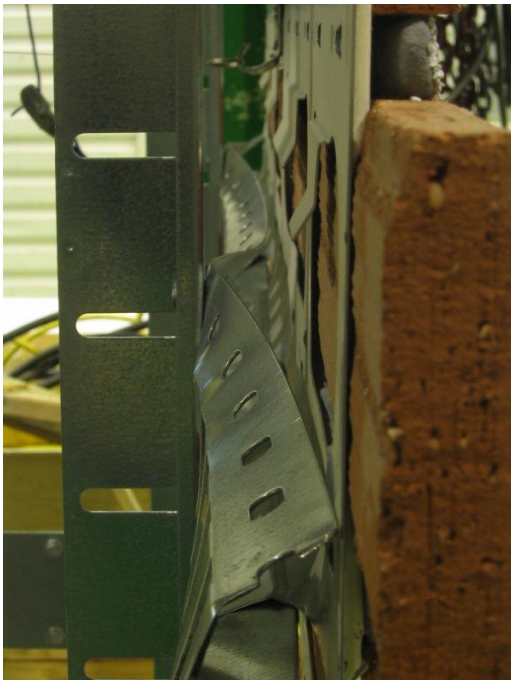
Photo 16. Failure mechanism.

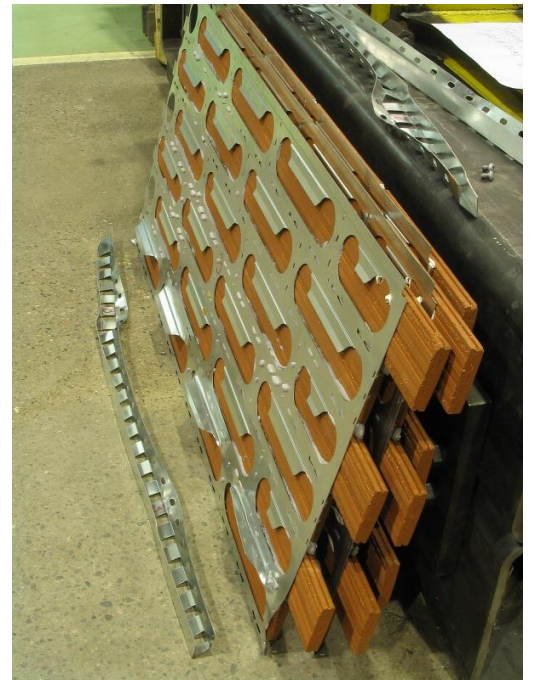
Photo 17. Panel and rail after test.

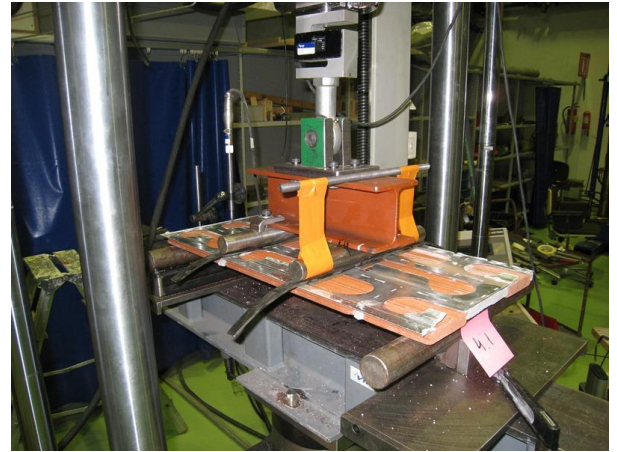
Photos 18 and 19. Test arrangements.

Six bending tests were carried out in both main directions of the panel using specimens of size 300 mm x 600 mm. The specimens were loaded with so called four point loading (linear loads in third points of the span of 540 mm).

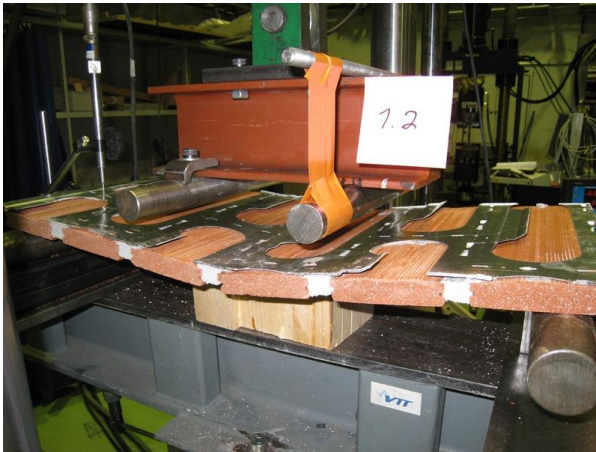
Photo 20. Failure at mortar joint.

In vertical direction/ failure of horizontal joints

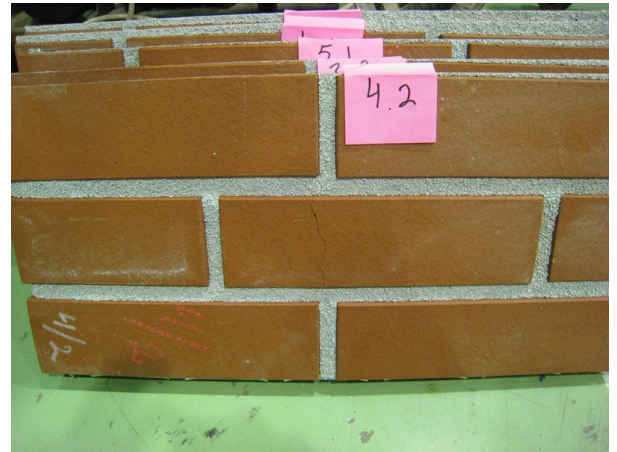
Photo 21. Failure crack.

In horizontal direction/ failure through bricks and vertical joints

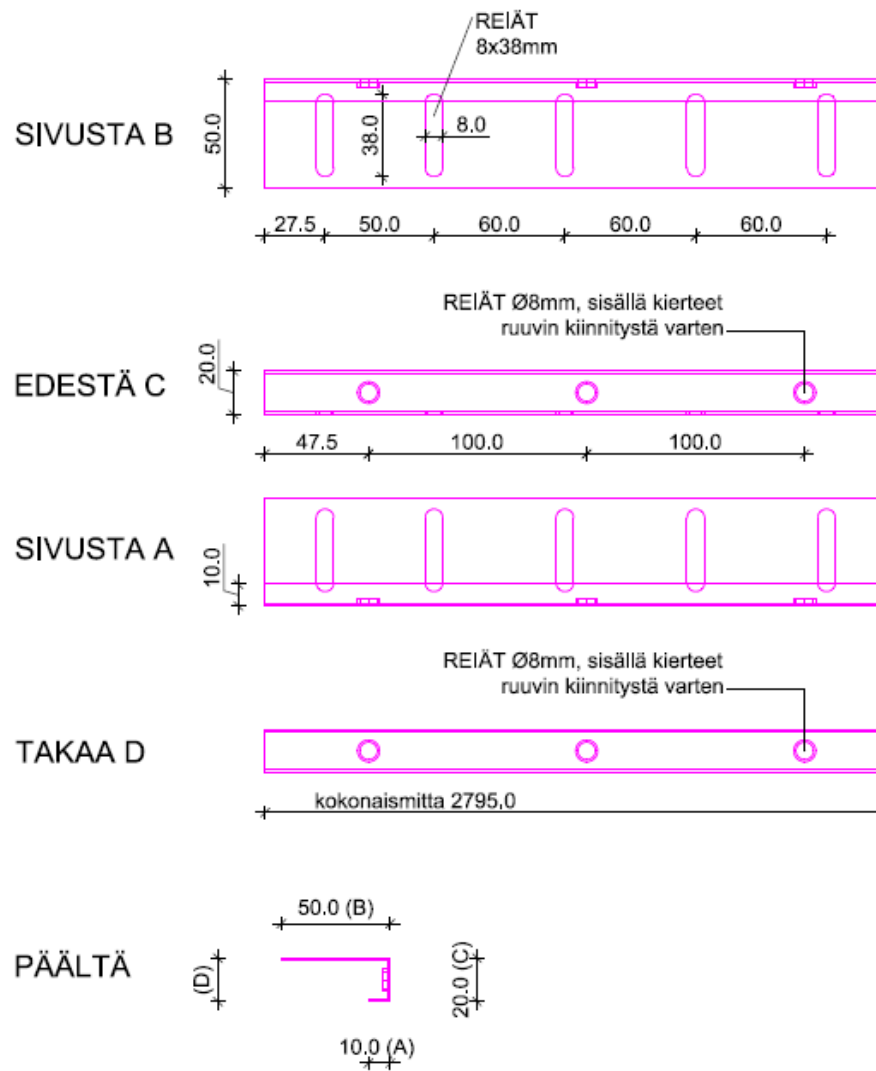
VERTICAL RAIL

ERISTYSKISKO "J" (100mm reikäväli)
symmetrinen päistään

- Seinäkiinnikkeet
 - o vahvuus 2mm
 - o Teräslaatu DX51D+Z275-M-A EN 10346:2009
- Kiskot; eristyskisko ja asennuskisko
 - o vahvuus 1,25mm
 - o Teräslaatu DX51D+Z350-M-A EN 10346:2009
- Kiinnitysruuvi
 - o 6-kolo M8x12 8.8 ISO 7380
