## Belzona 2200 Series In Action

**Item: Flap valve**

**Industry: Water Authority**

**Medium: Waste Water**

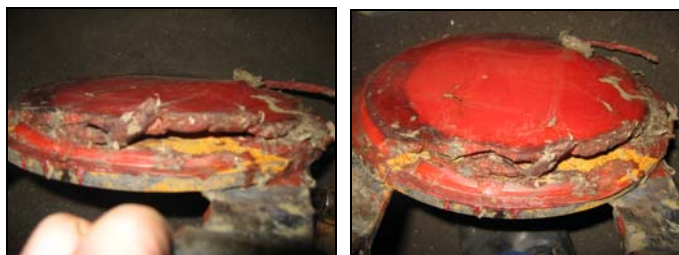
**PSRG** has recently undertaken the repair of 6 valve paddles on behalf of a water treatment works. Previous coatings had failed as can be seen in the below image

**Existing worn coating**

To achieve the correct dimensions of the seal a forming mould was manufacture.

The paddles were grit blasted to SA 2 ½ @ 75 microns so correct surface cleanliness and profile requirement were attained. The forming mould was then clamped into position. Belzona 2221 MP hi build elastomer was then applied and left to cure then removed leaving the paddle repaired

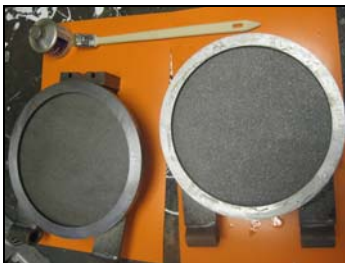
**Paddle prior to coating with mould**

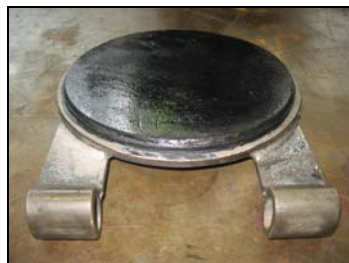
**Paddle during application**

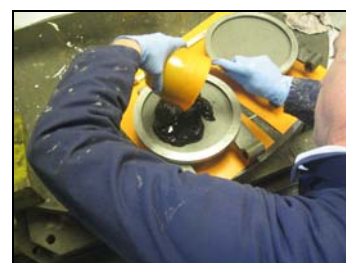
**After application of Belzona 2221**

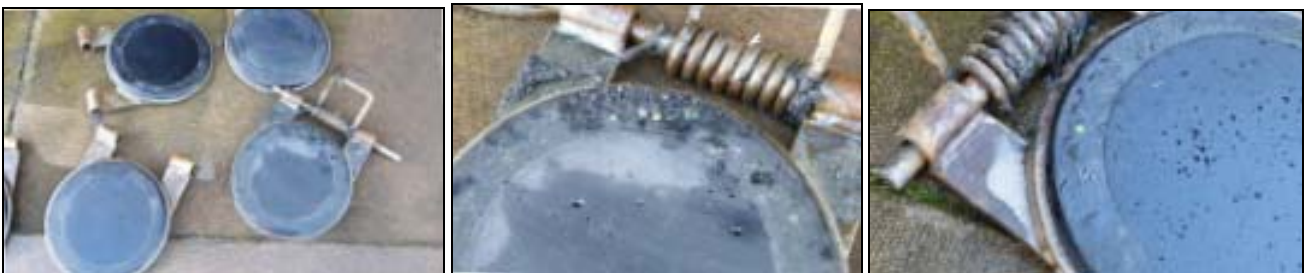
After 70 days of operation there are still no signs of drop off in pump performance. On the 22nd October 2008 after 100 days (1,750 hours) the engineer removed the valves from the pump so we could inspect the material. As you can see from the pictures the valves show little sign of wear and he was happy to put the valves back into service.

**Condition of coating after 70 days (Lasted three times longer)**
