Case Study

Emergency Temporary Repair to Scott UQ Platform C8 & C9 Caissons

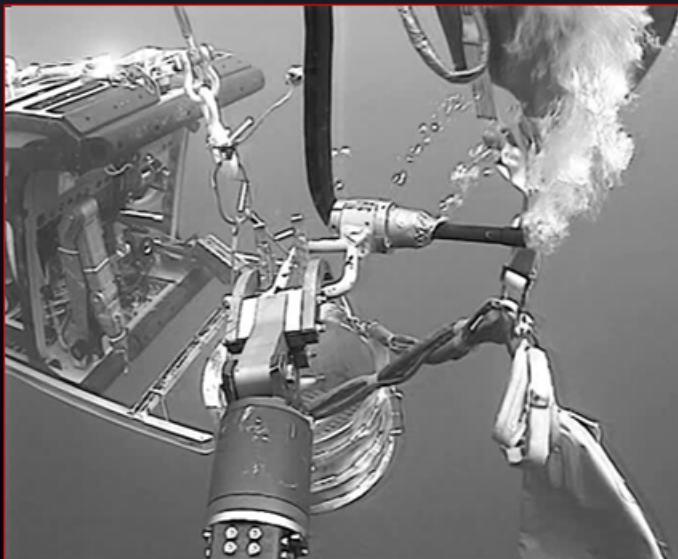
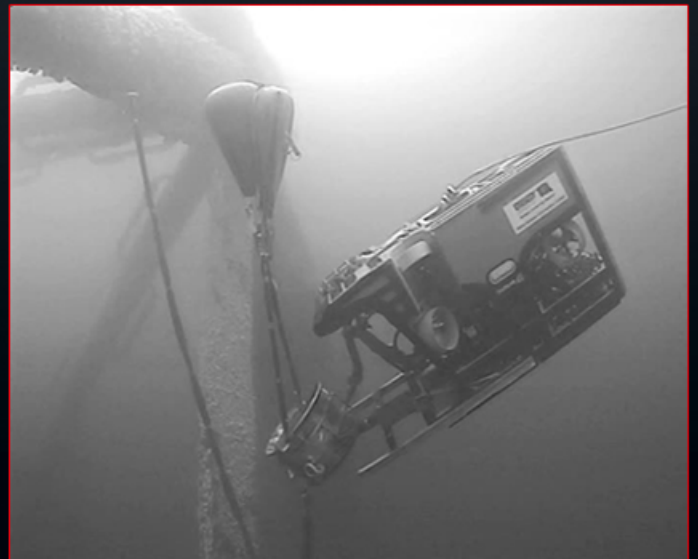
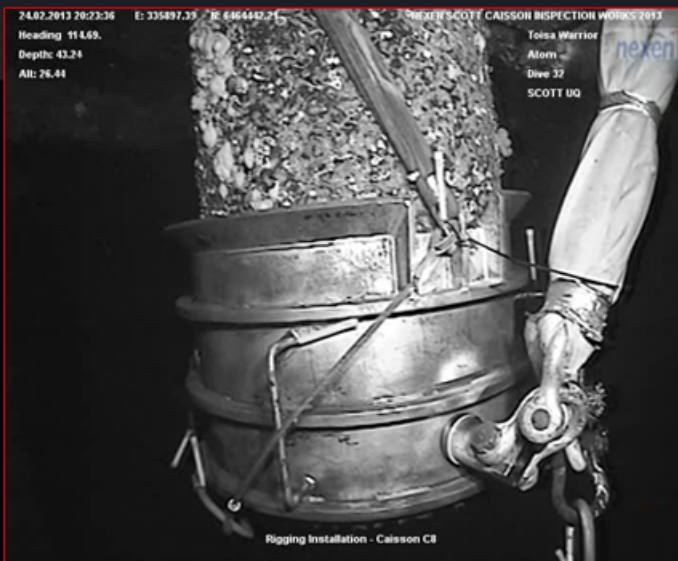
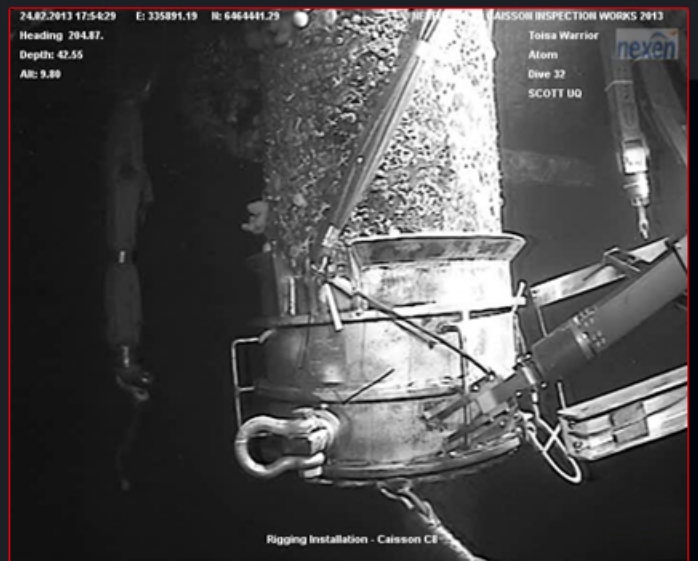
ROV Installation Imagery

The caisson C6 & C8 were identified to have large perforations at various LAT levels. The WROV installed rigging around the caisson support guide /horizontal member and insert a dowel pin through the flow slots at -43m (C6), and for Caissons C8 (-43m) a top hat arrangement was used as there was no flow slot within the caissons.
