SICK COLLEGE POOL GETS RX WITH SWIM COACH'S IAQ CONCEPTS AND DESIGN.

Fabric ductwork and dehumidifier delivers draftless air, abate swimmers' respiratory problems, & reverse building deterioration.

Carlisle, PA—Dickinson College Aquatics.

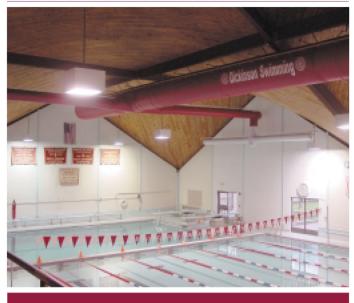
Custom lighting support.

For best air distribution and aesthetics, Richards wanted the trunk line at the center of the roof's peak, however existing lighting fixtures would have been blocked by the duct. Ellerman conceived of a fixture retrofit that would allow both the trunk and the lighting to hang at the center. He lowered the lighting below the trunk line by extending the ceiling mounted conduit pendants into an "O" shape that surrounds the duct and connects to the fixture below the duct.
