FAIRFIELD STREET, MANCHESTER

Client: Lambert Smith Hampton **Products Used:** Triple Safe Sump Pump

Overview

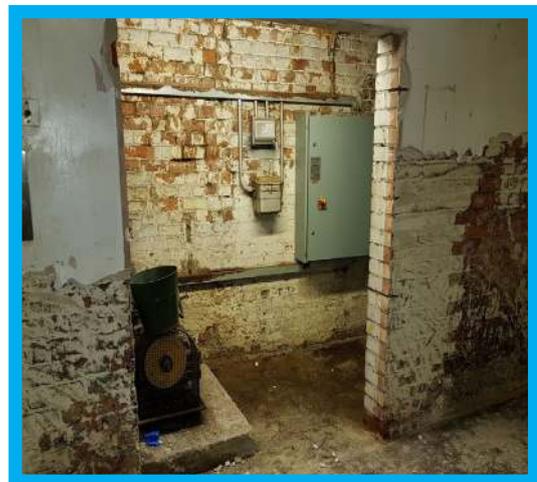
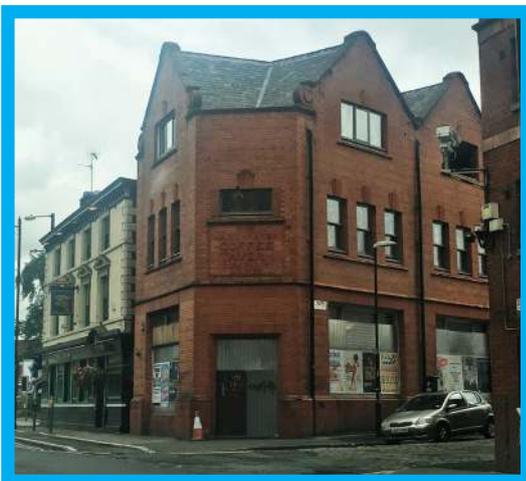
An external inspection of the property revealed damage to the roof and poor guttering which were potentially allowing water to enter the building. Timberwise carried out non-destructive inspections to all of the exposed roof and floor timbers.

However, the inspection was restricted in some areas due to the presence of kitchen units, wall tiling and radiators. Although restricted, thanks to the assistance of electronic moisture meters our damp specialist was able to record dampness at ground floor level. The dampness appeared to be due to a combination of factors such as condensation in various areas, poor roof coverings and rainwater drainage goods.

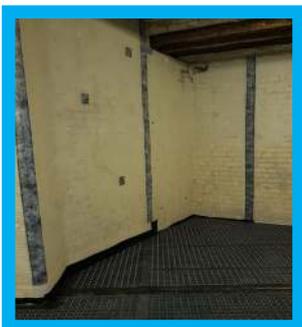
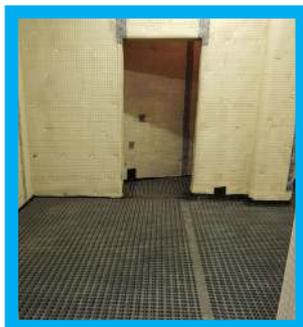
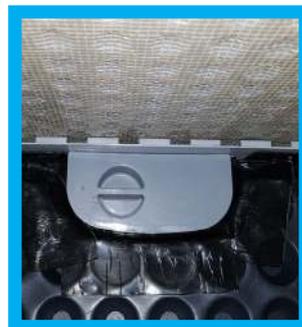
The basement was used primarily as a storage space, the walls were damaged which meant water was penetrating through the cracks.

As the customer wanted to create a dry habitable space in the basement it was agreed to install cavity drain membrane, a perimeter drainage channel and a sump and pump chamber.
