BELZONA REPAIRS ACW PUMP

Nuclear Power Station, UK

Auxiliary cooling water pump

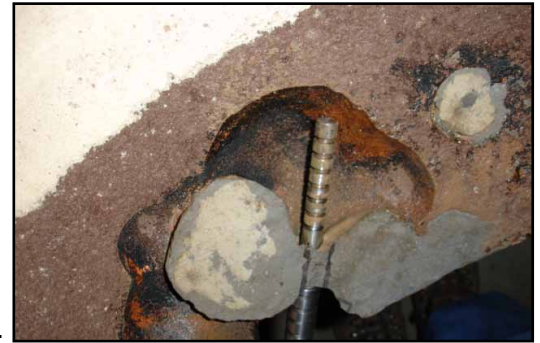
Severe abrasion damage to cutwater area of the pump meant loss of efficiency.

1. Damaged area with anchor pin in place
2. Former in position
3. Damaged area rebuilt with Belzona® 1311
4. Finished job after application of Belzona® 1321

Application was carried out in accordance with modified versions of Belzona Know-How system leaflets CEP-1 & -3. An anchor point was drilled and fixed through the casing. Belzona® 1311 was used to restore the required profile using timber formers to gain required shape. Belzona® 1321 applied to give area erosion corrosion protection.
