Sunnysands Railway Bridge and Beach Gates

(Completed May 2008)

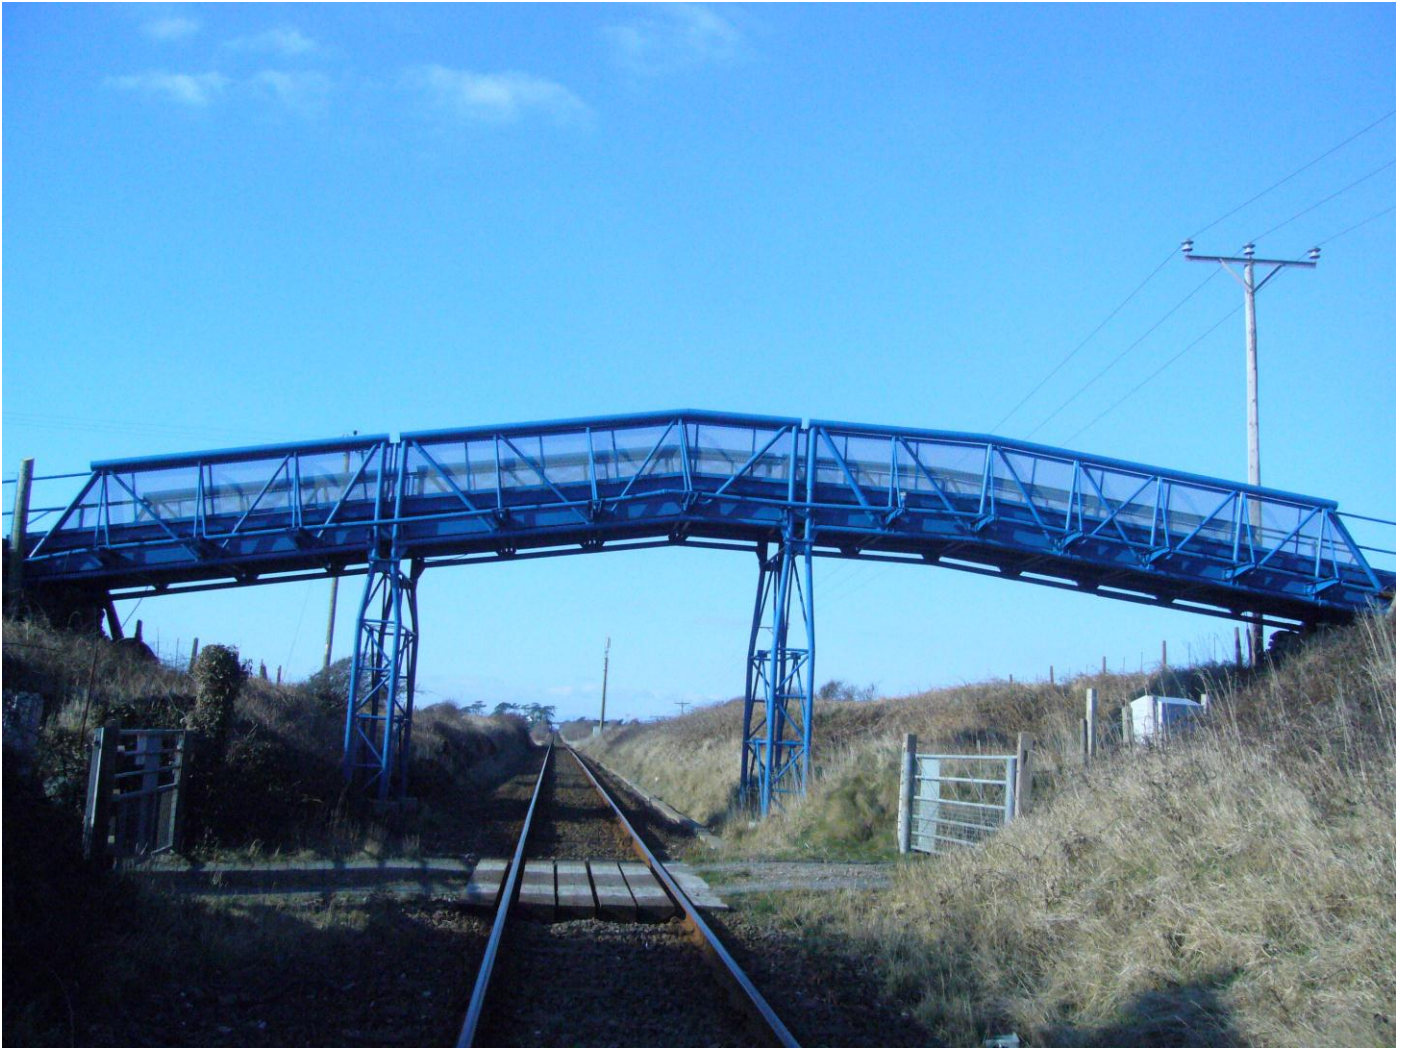
A view of the completed bridge over the railway track

This was a total refurbishment project, and the entire structure was blast-cleaned and film-galvanised with Zinga. As the bridge is on the coast, the system used was: **Zinga**: 80µm DFT + **Alufer N**: 160µm DFT + **2K PU**: 60µm DFT **Zinga** (galvanising layer) + **Alufer N** (one component MIO PU sealer) + **2K polyurethane** (UV resistant finishing coat)

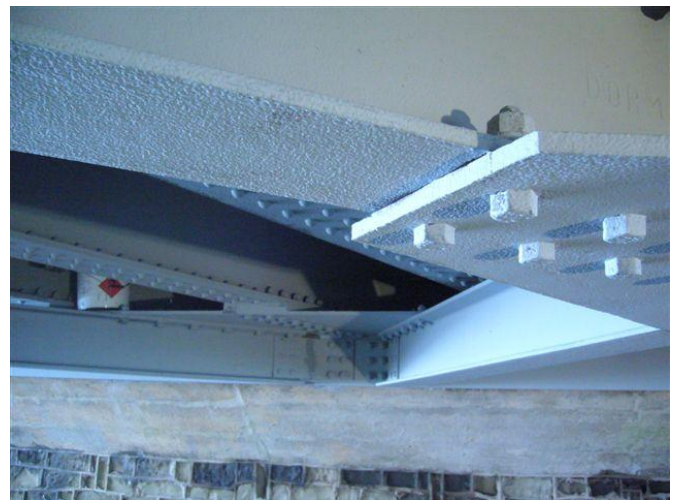
A view of some zingatised beams and fasteners

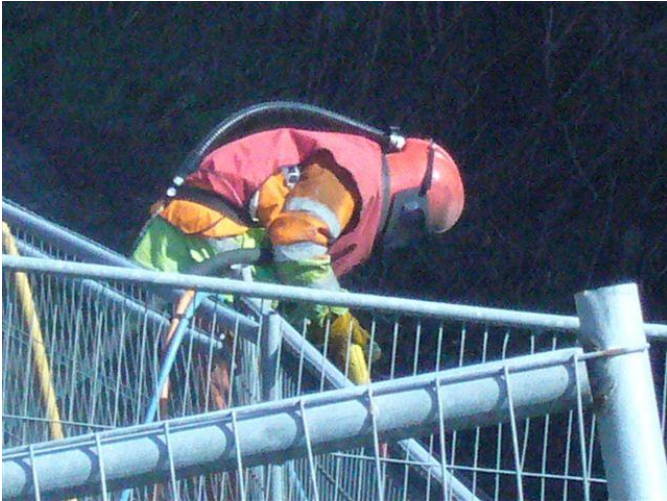
Blast-cleaning the bridge steelwork

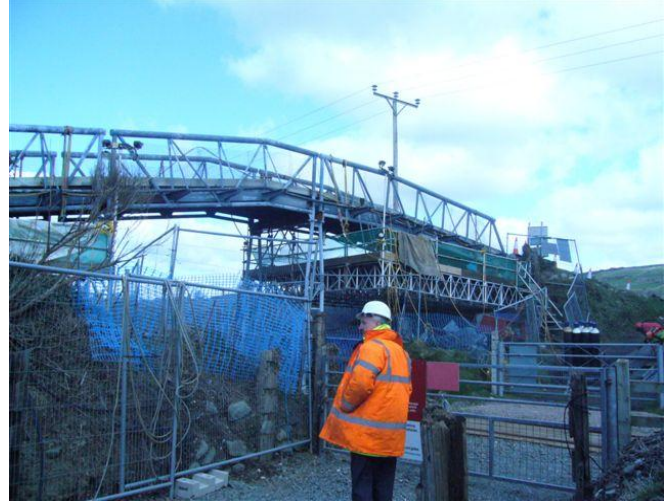
A view of the bridge during blast-cleaning operations

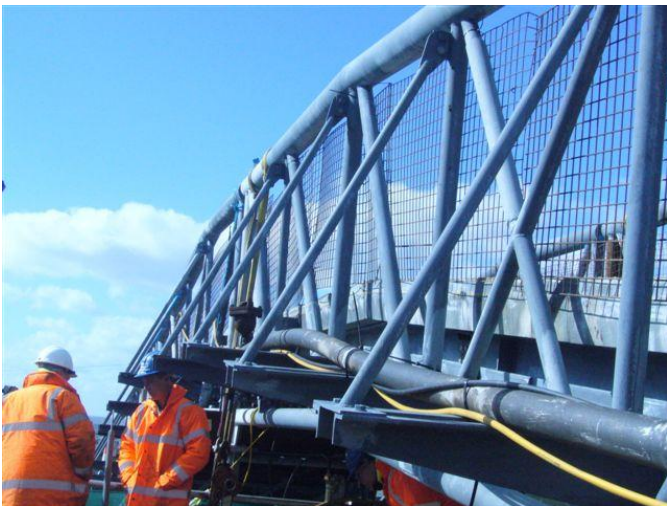
The Zinga layer has been applied on the hand-rails

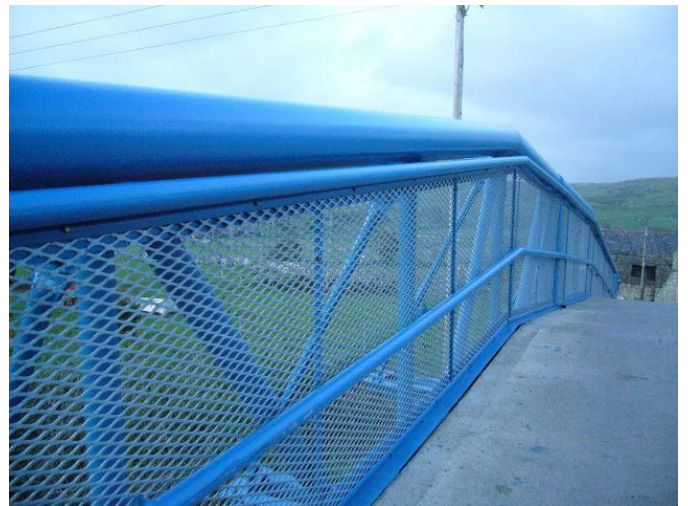
The hand-rails completed with the three-coat system

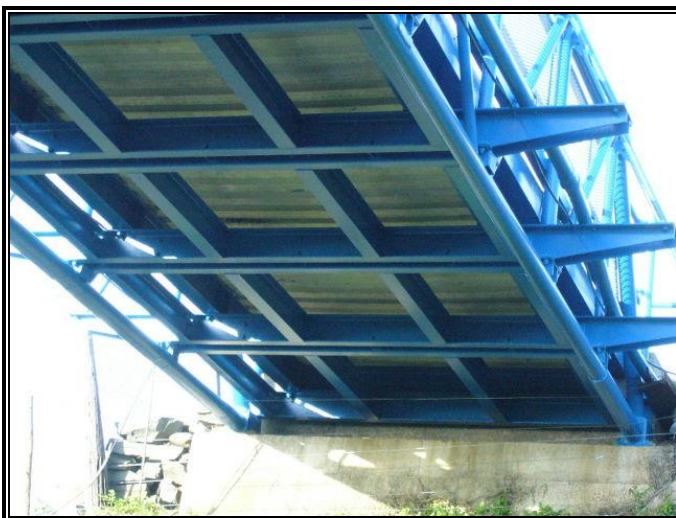
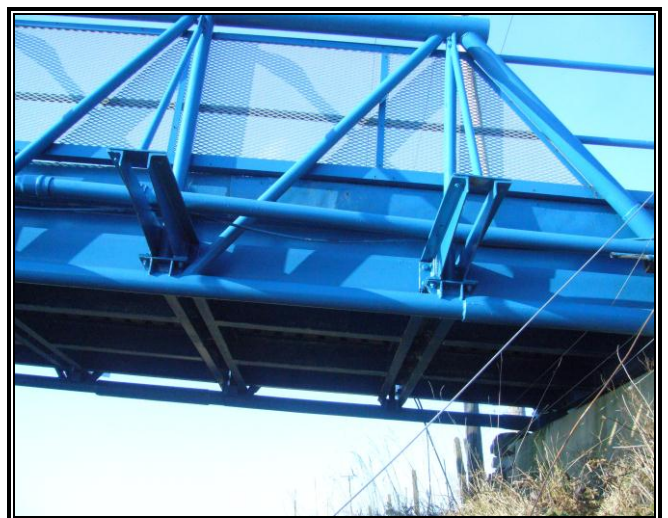
Two views of the completed bridge deck showing both the underside and the side of the deck

The above views illustrate that with the Zinga film-galvanising system the surface finish is as smooth as an automotive finish and any subsequent primers and topcoats will follow on to give a perfect, flaw-free finish every time.

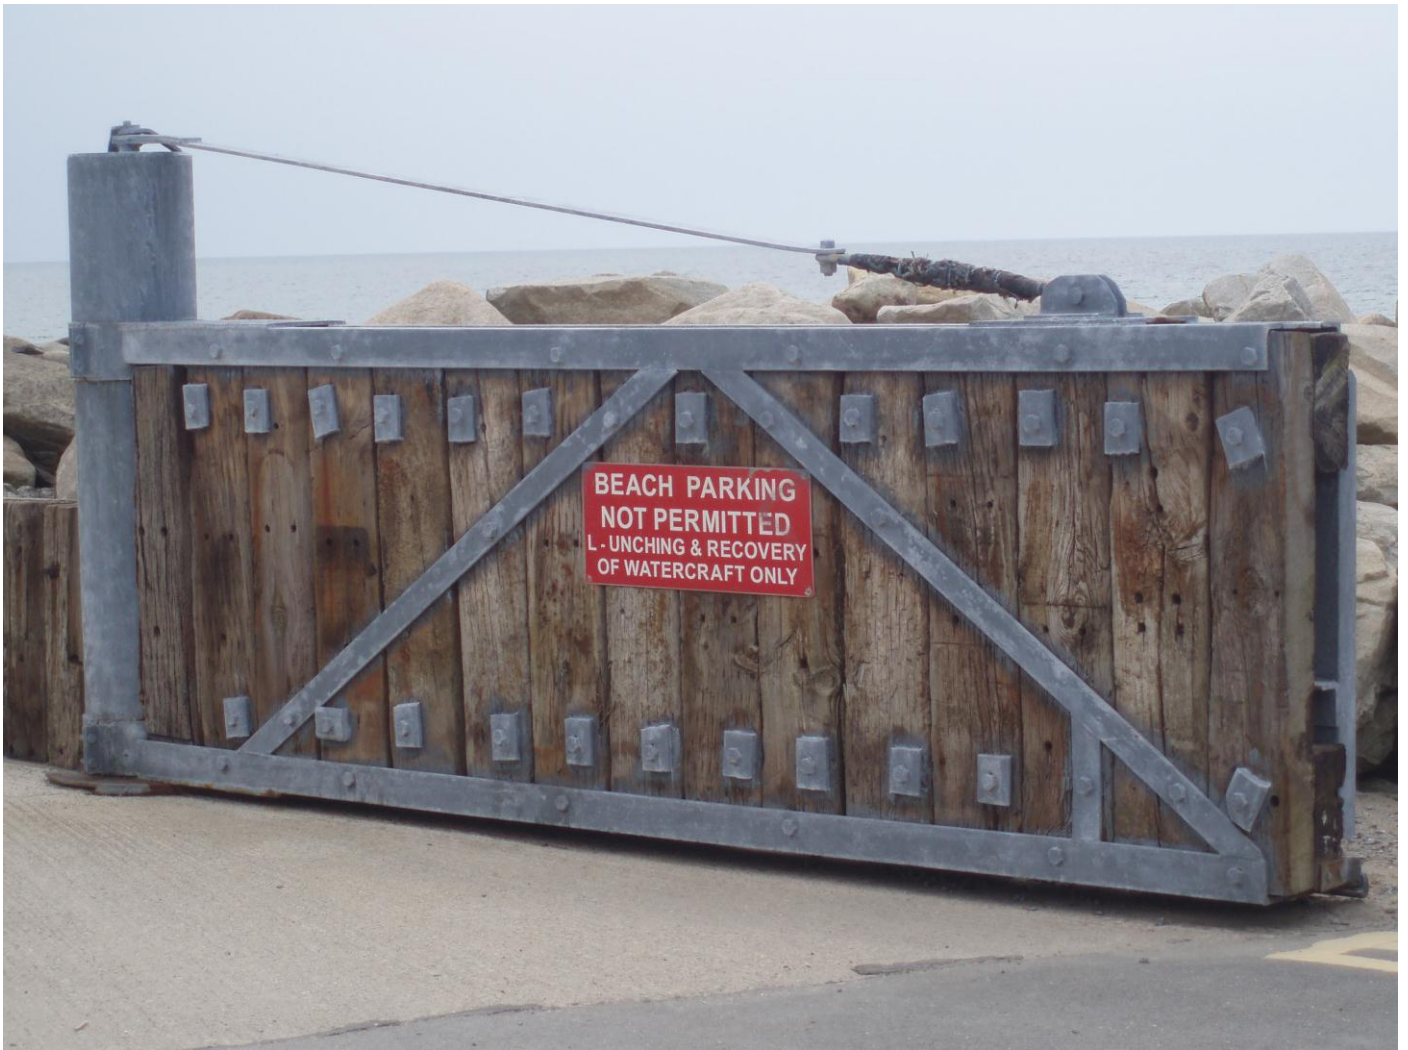
A view of the tide-gate and the heavy supporting pillar on the Sunnysands beach. An excellent reference for in-situ galvanising. The timbers were removed for blast-cleaning the steel gate-frame and application of the 150µm DFT Zinga. The steel timber-fastening plates were also film-galvanised with Zinga.

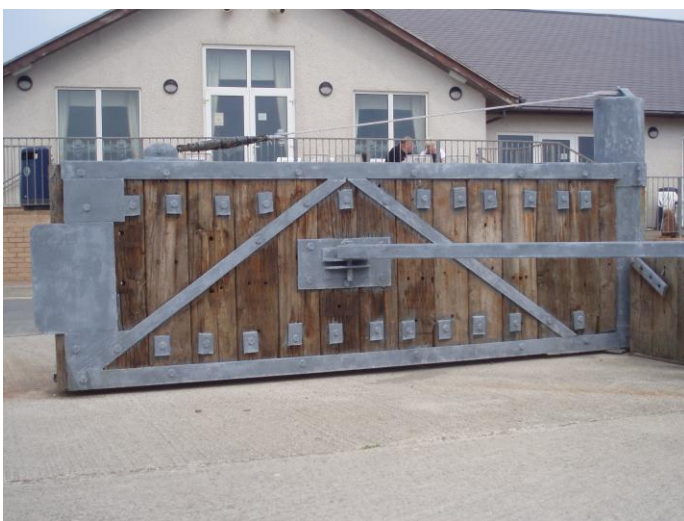
Another view of the tide-gate, showing the locking bar

This unique tide-gate prevents high tides from coming over the sand and spilling onto the public road. The locking bar is to provide additional support due to the hydraulic pressure generated at high tides from the waves.

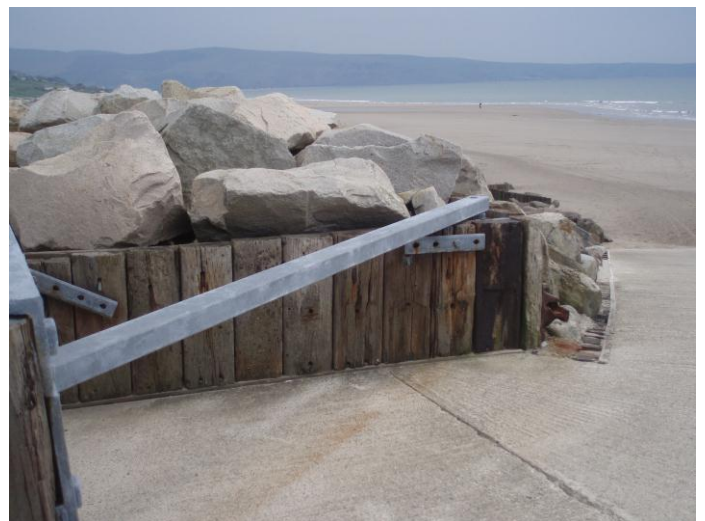
A view of the film-galvanised locking-bar
