## claxton

## CONTENTS

Our Services	02
Guiding Principles	04
Replacement Jacket Guide Assembly	06
Retrofit Centralizer Solution	80
Slot Recovery on the Beryl B Platform	09

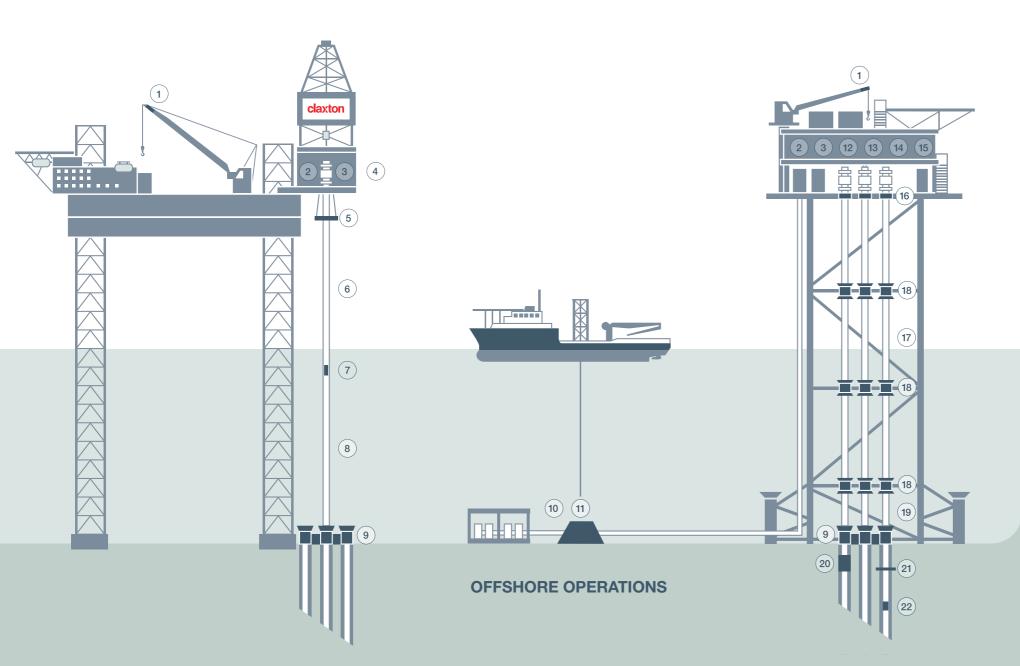
- 1 Crane camera systems
- 2 Wellhead design/supply
- 3 Cold cutting
- 4 Equipment rental
- (5) Tension rings & tension systems
- 6 Drilling riser system supply
- 7 Subsea/downhole cameras
- 8 Tieback engineering
- 9 Drilling templates
- (10) Subsea well abandonment
- 11) Protective structures

- (12) Wellhead maintenance
- 13 Hot tapping
- (14) Equipment repair and refurb
- 15 Wellhead refurb/replacement
- 16 Cellar deck centralizers
- 17 Decommissioning & abandonment
- (18) Conductor guide centralizers
- 19 Slot/conductor recovery
- (20) Cement top up
- (21) Abrasive cutting
- 22 Internal centralizers

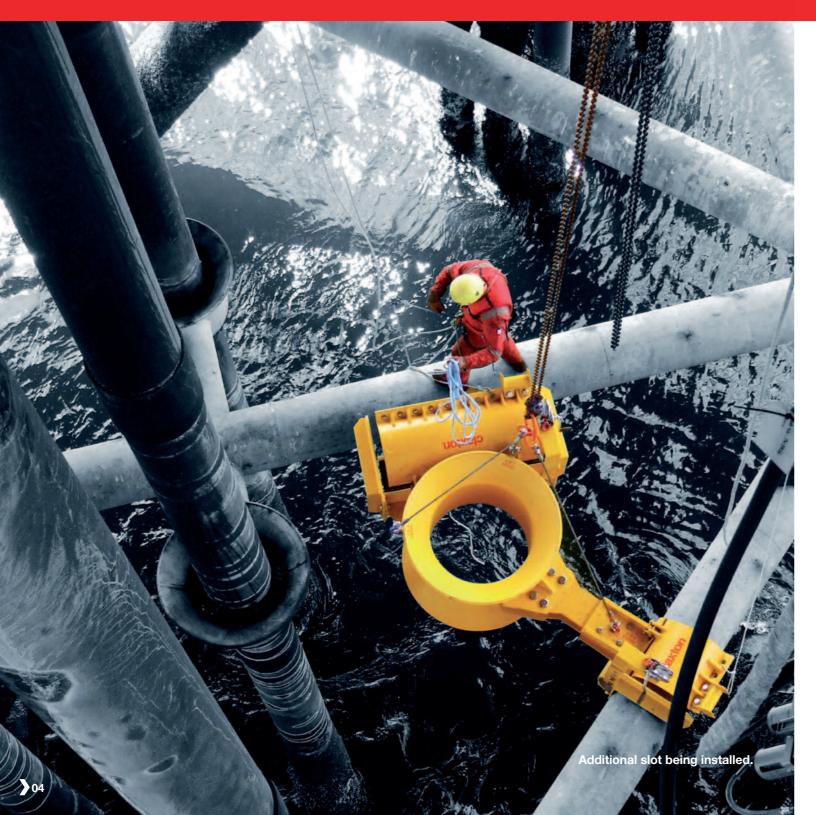
Claxton was initially sub-contracted to design, fabricate and install a new conductor guide and centralizer in the platform's splash zone. Fitting the new guide, a great team effort with main contractor PSN's construction team, was a complete success; the guide was lifted over the side of the platform, slung into place within the jacket structure and firmly secured within a few hours by a crew of four abseilers. The picture opposite shows perfectly what was involved.

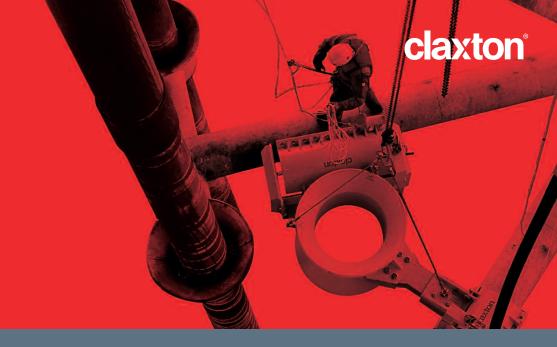
A recent Claxton fabrication contract for a replacement jacket guide assembly project called for a radical technical solution. The company's involvement started in May 2011 with a survey of the existing guide assembly, which was reaching the end of its working life, at a North Sea platform. Detailed design work for a replacement then followed. With the field operator keen to make progress, Claxton's rapid response saw design engineers going offshore in a matter of days to assess the condition of the existing structure.

The splash zones on offshore platforms are subjected to seawater exposure and high levels of lateral loading from the risers, and, in this case, it was clear that the entire splash-zone structure needed replacing. The solution Claxton proposed involved building the new assembly on top of the old guide using existing structural members for support before removing the old structure from underneath. This multistage process called for high-precision installation of uprights, beams and four rows of guides assembled with eight new guide sections. When complete, this would replace the splash deck of the platform. provide 12 new conductor guides and enable the field operator to extend the working life of the platform by up to

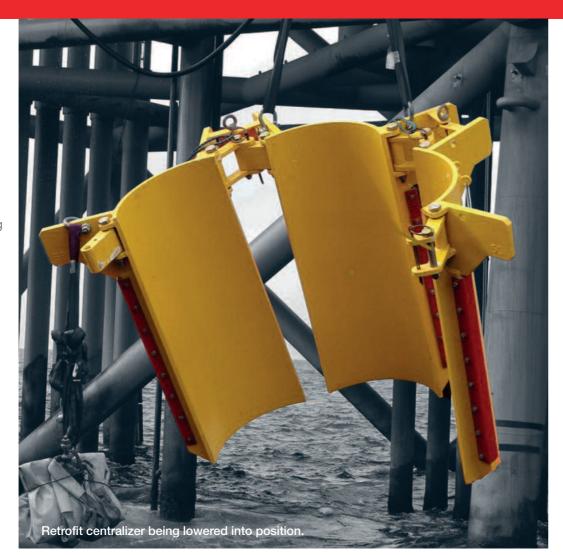
Engineers from Claxton and Subsea 7 jointly examined the specific practical challenges of the project. This led to Claxton modifying an existing centralizer design to produce a slim, lightweight, three-piece centralizer capable of being wrapped around the conductor and slipped down into the guide. The two parties continued to work closely to test the new design thoroughly onshore, develop installation procedures and plan the necessary diving operations.
