USS FREEDOM LCS-1

YYK Enterprises, Inc.

2013- Successful Preservation of Freeboard & Superstructure.

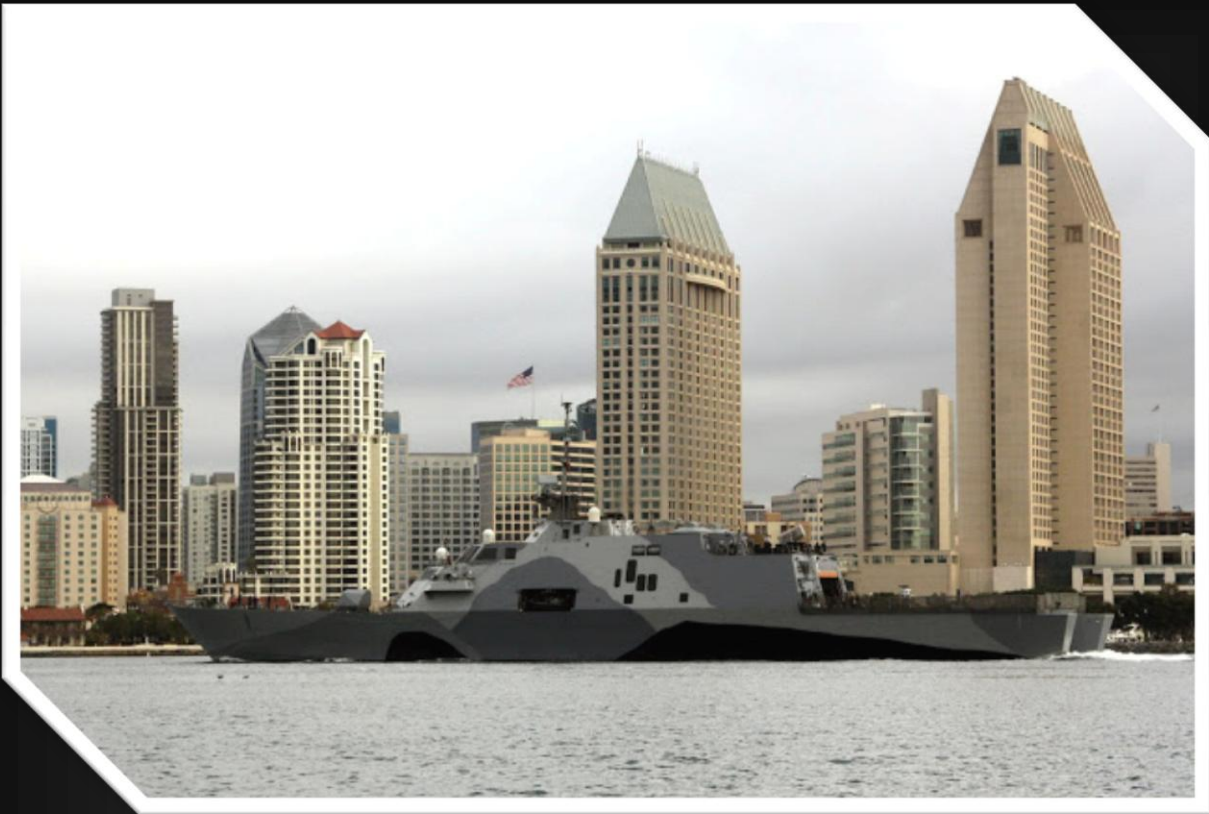
Leaving San Diego Bay with new camouflage paint scheme.

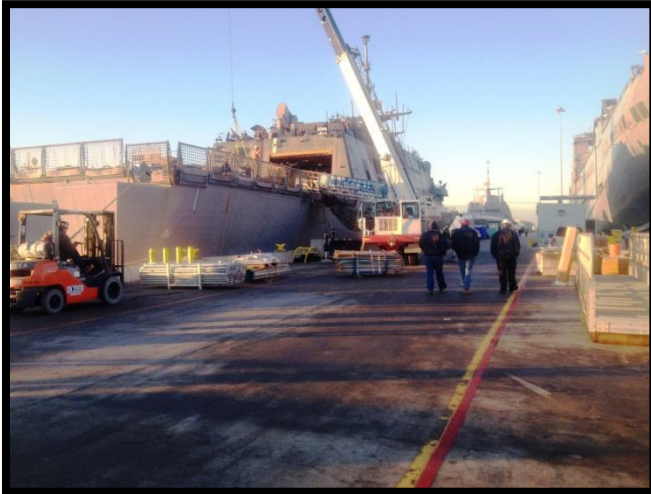
Start of superstructure scaffolding.

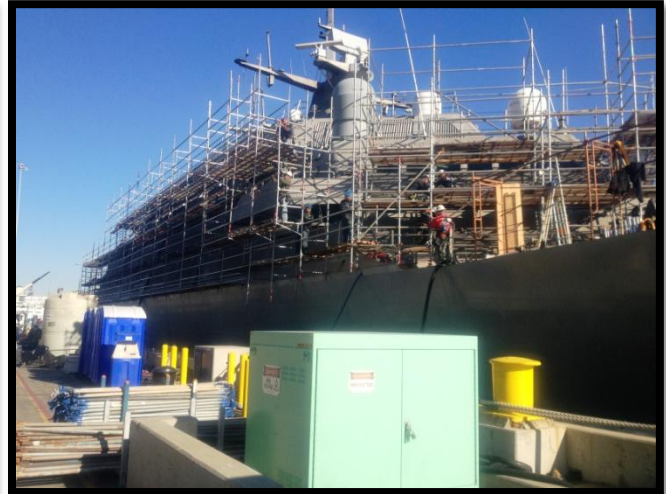
Superstructure scaffolding nearly completed pier side.

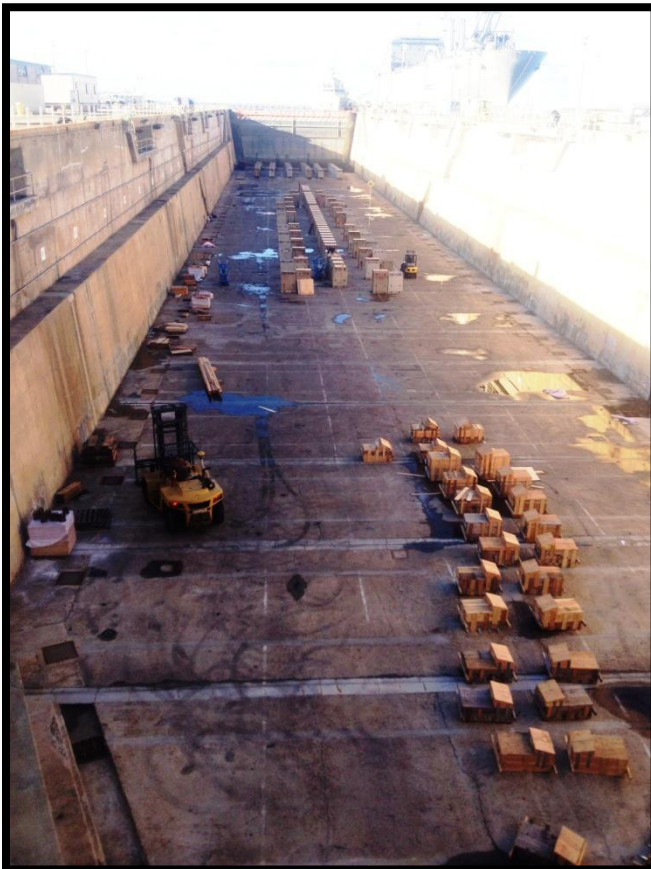
Preparing graving dock and keel blocks.

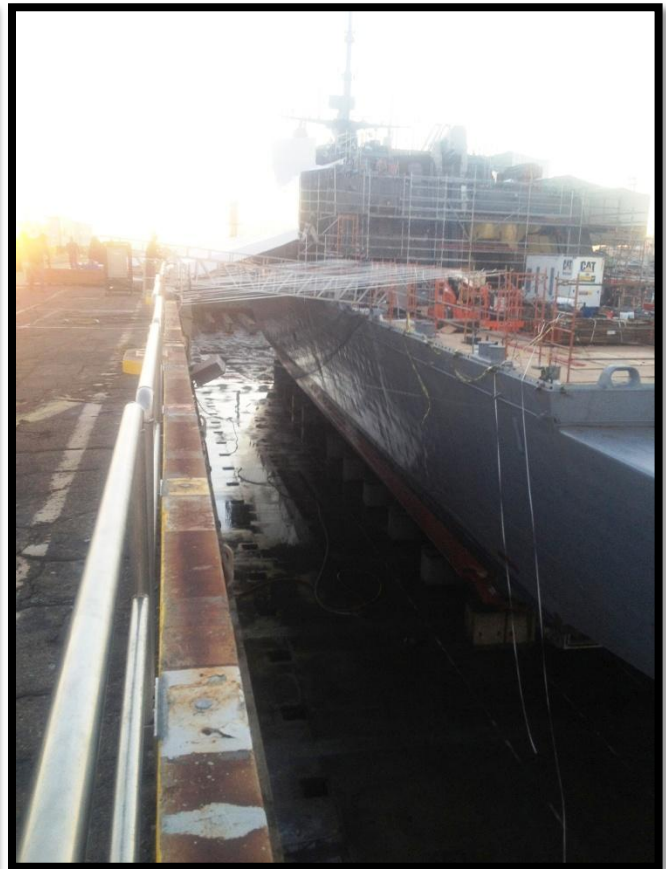
Dry docked and proceeding with encapsulation.

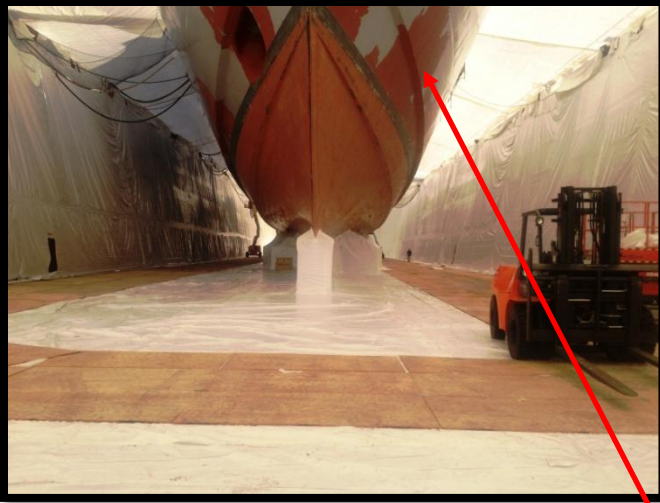
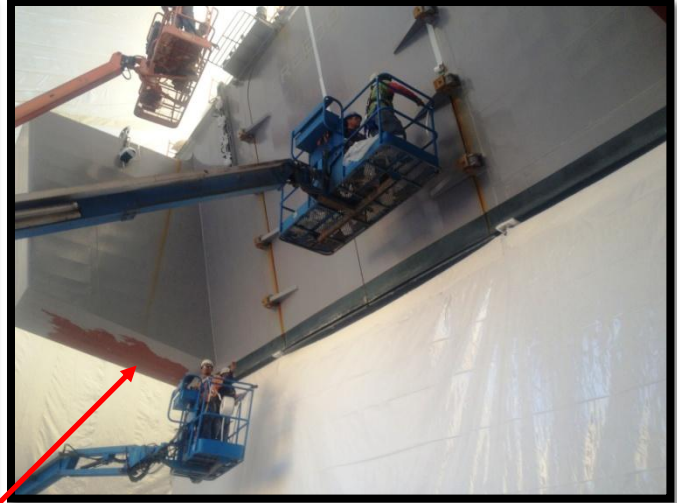
Encapsulation continues. Note existing coating failure areas.

Due to a premature freeboard coating failure, YYK was awarded the opportunity to repair the failed freeboard coating system and apply a camouflage paint scheme onto the freeboard/superstructure using Polysiloxane top coats. These paints are significantly more resistant to fading, color shifting and are far easier to clean than the older, MIL-PRF-24635, Type II or III silicone alkyd coating systems. Please visit the following sites for videos:

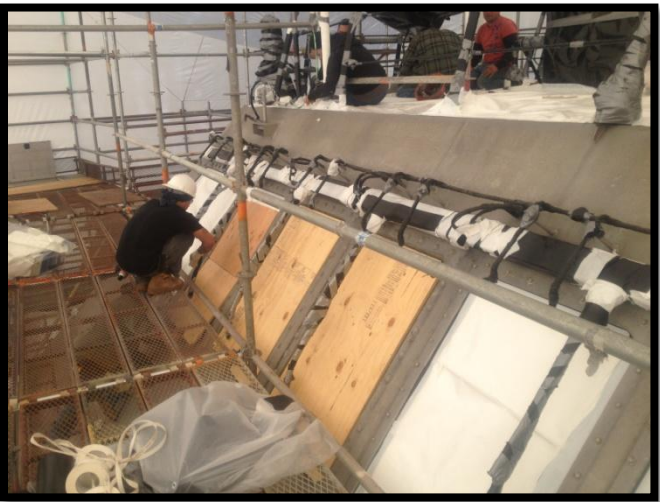
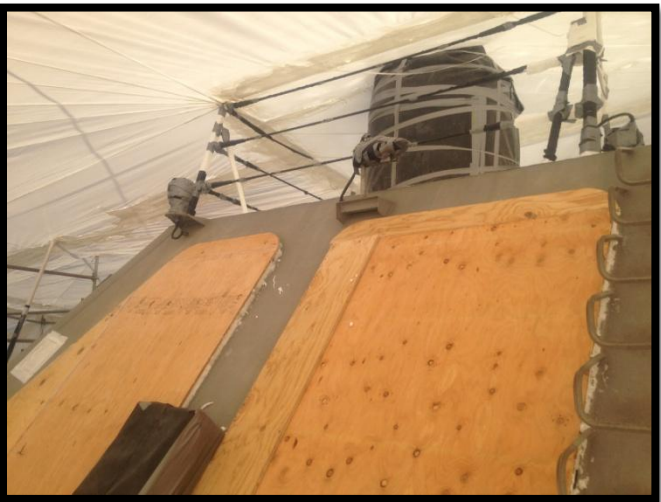
Installing protective covering on windows, vent openings, radar & appurtenances.

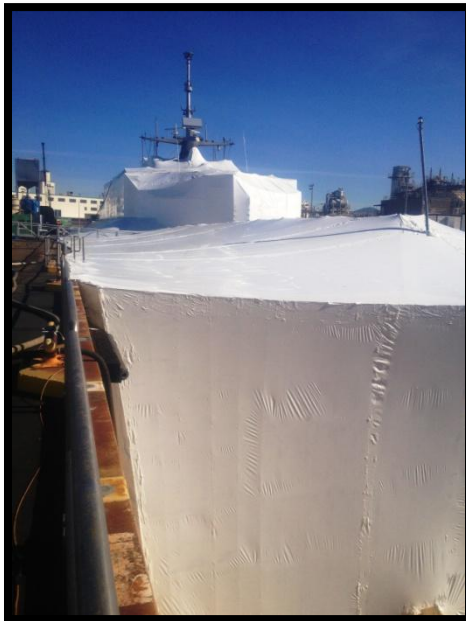
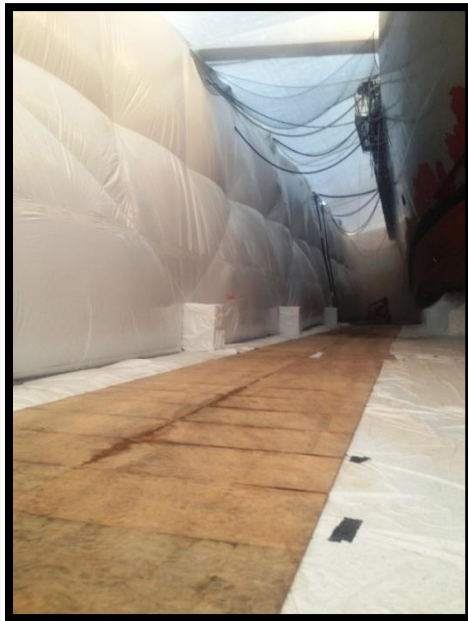
Encapsulation was completed & ready for surface preparation. The encapsulation was erected to a weather resistant degree due to the upcoming rain days which had been forecasted during the vessels availability.

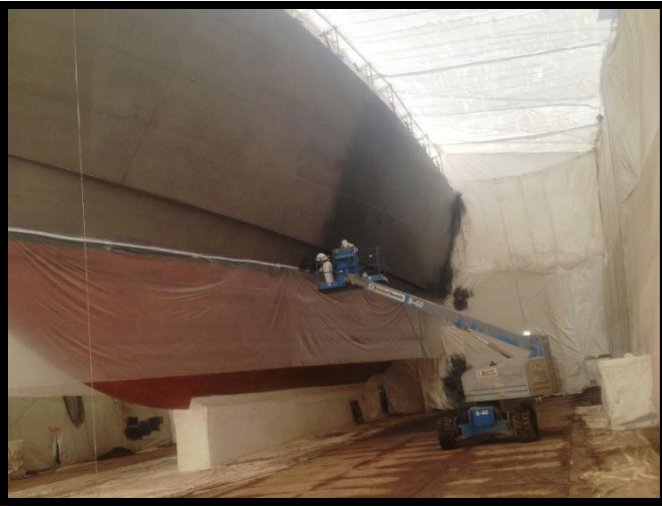
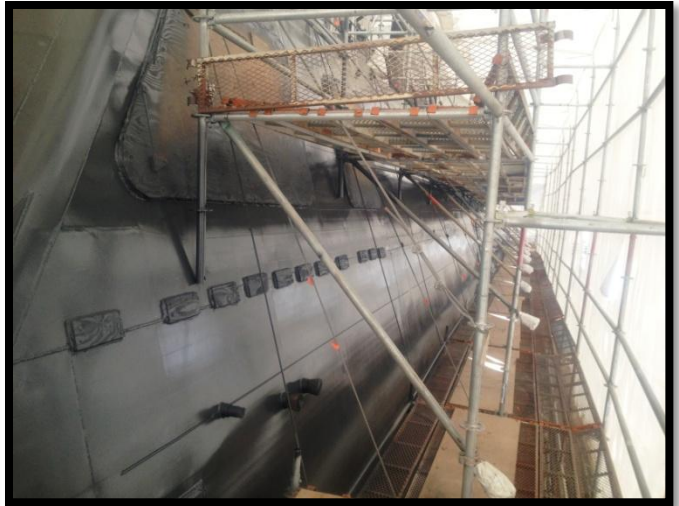
Steel & Aluminum substrates were abrasive blasted (Garnet & Copper Slag) and primed with epoxy.

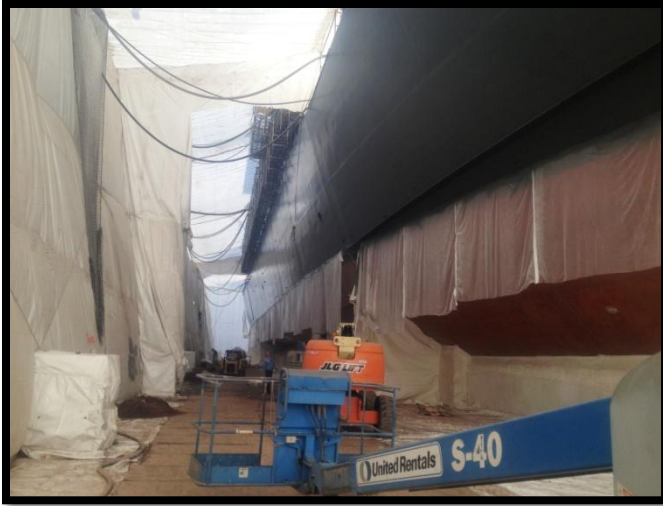
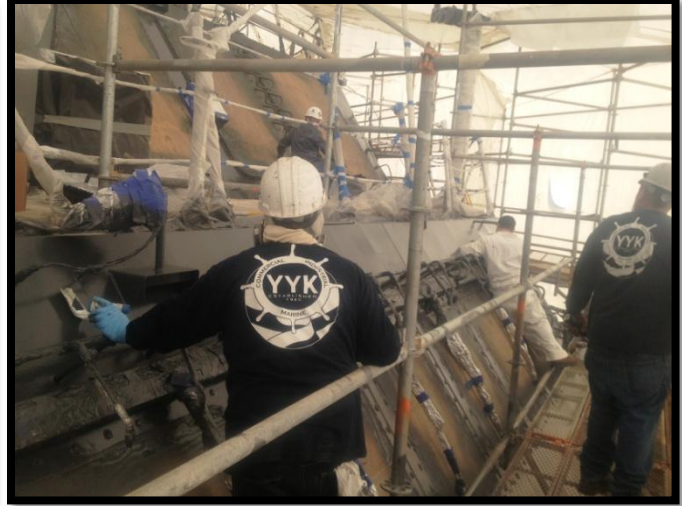
Primer application completed and YVK assures a complete sound primer coat is in place by checking for holidays prior to top coat application.

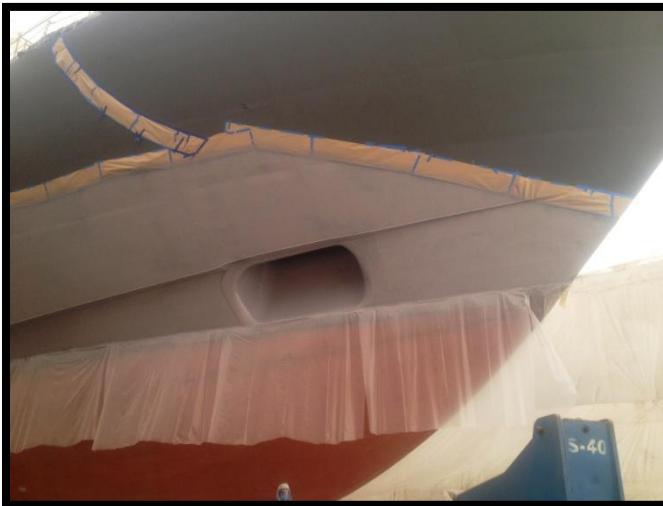
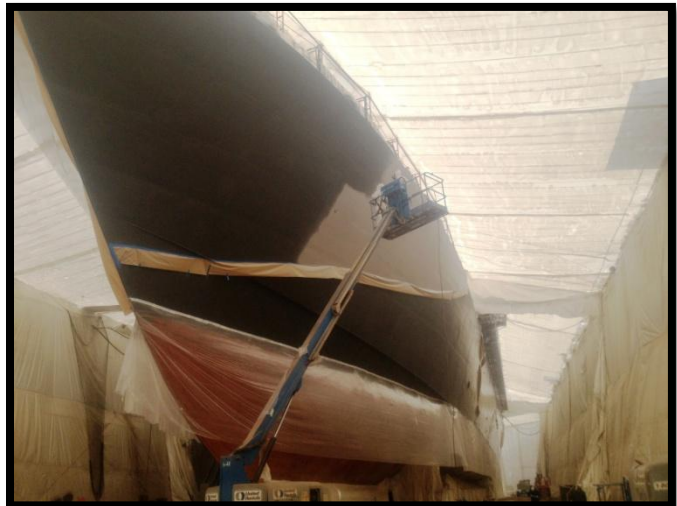
Application of Polysiloxane camouflage paint scheme begins.

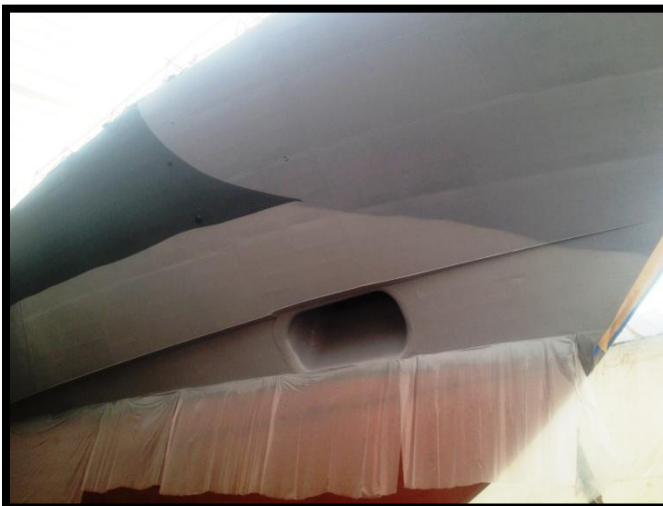
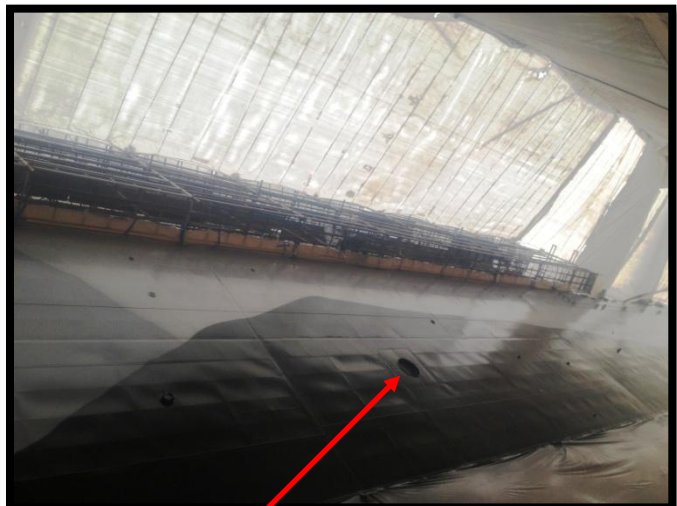
Black Polysiloxane is applied near exhaust openings so that exhaust stains don't stand out.

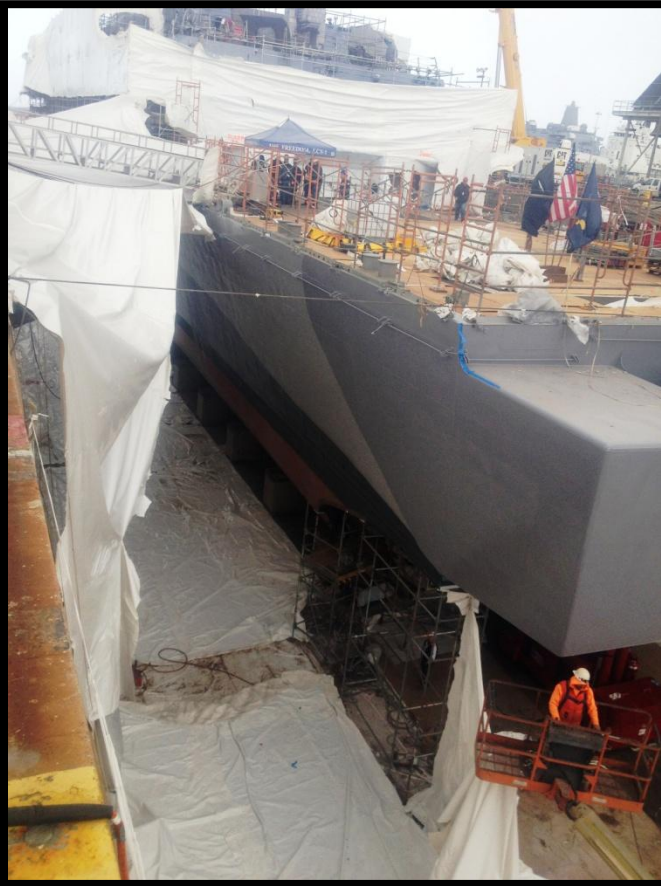
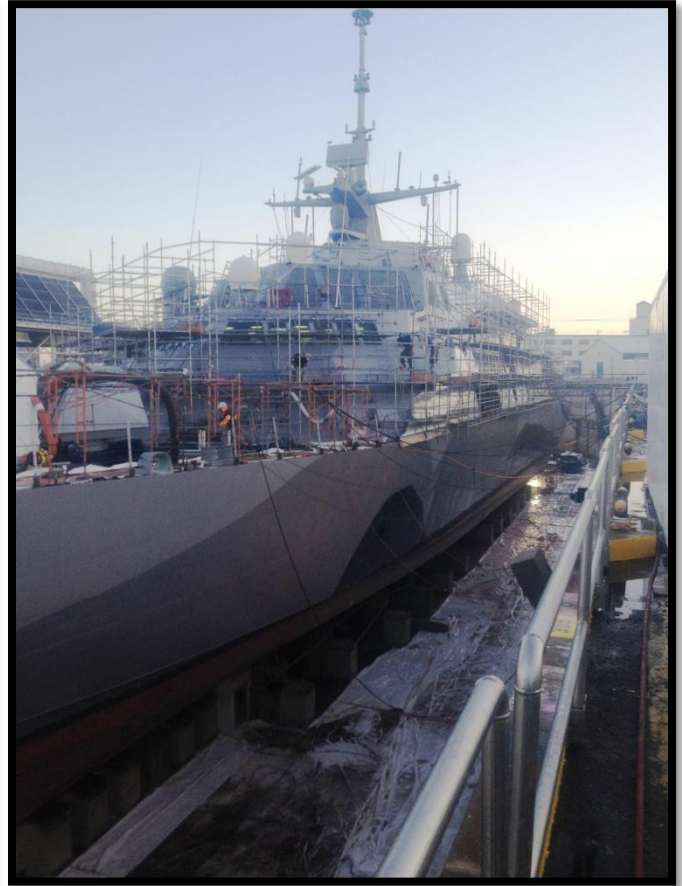
Polysiloxane camouflage paint scheme completed and tear down process begins.

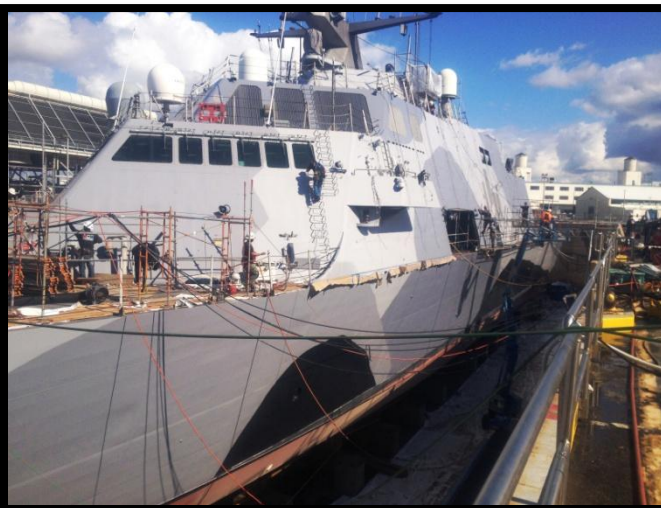
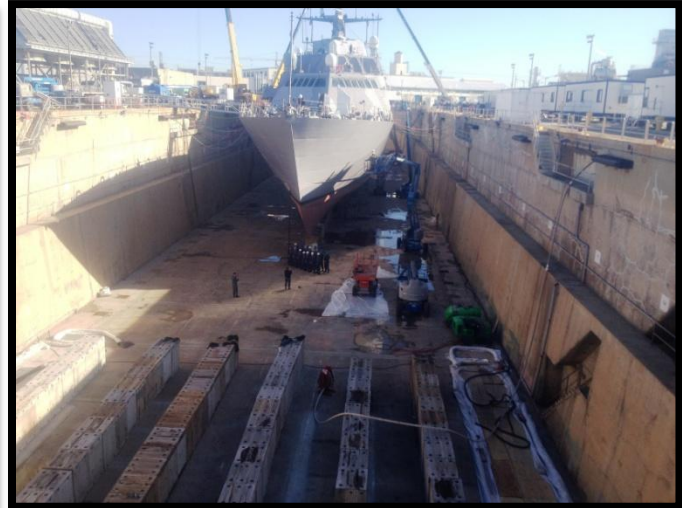
Removal of all scaffolding and cleaning of graving dock prior to undocking.

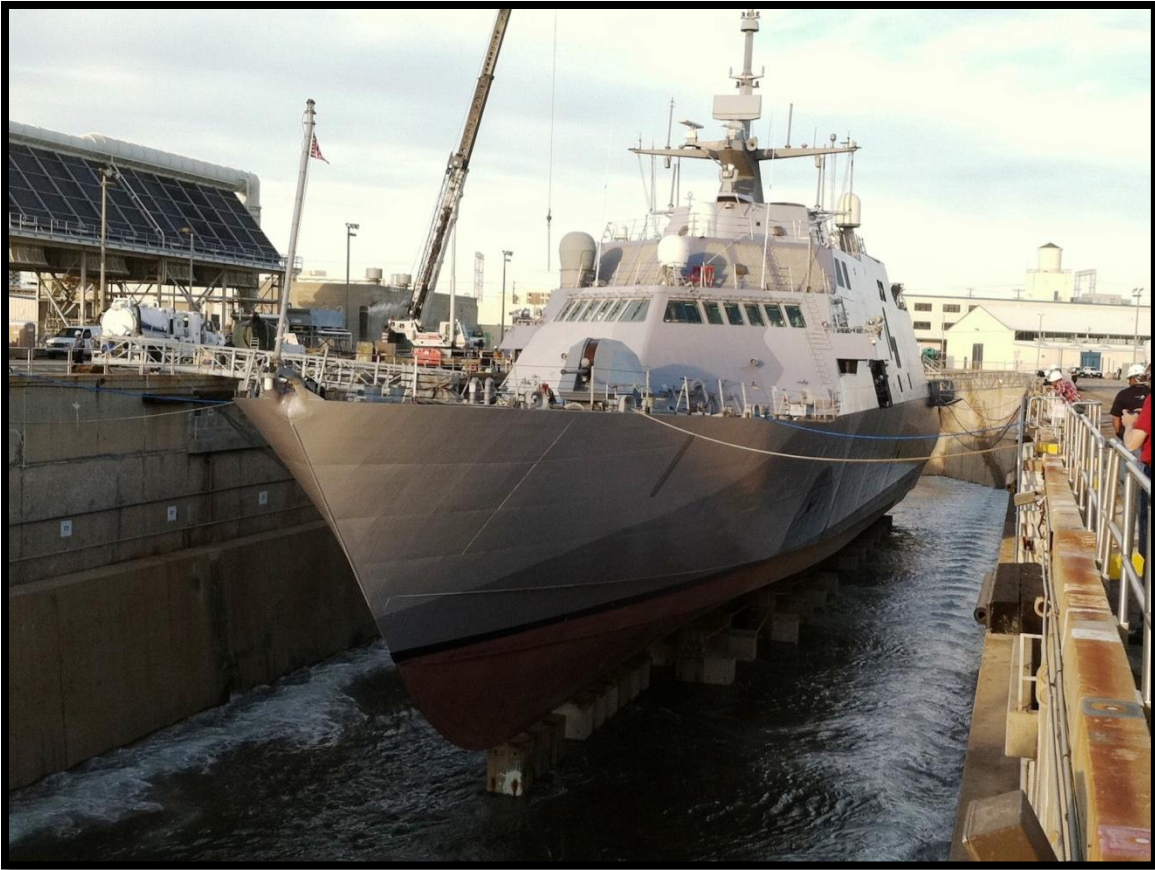
Undocking process begins.

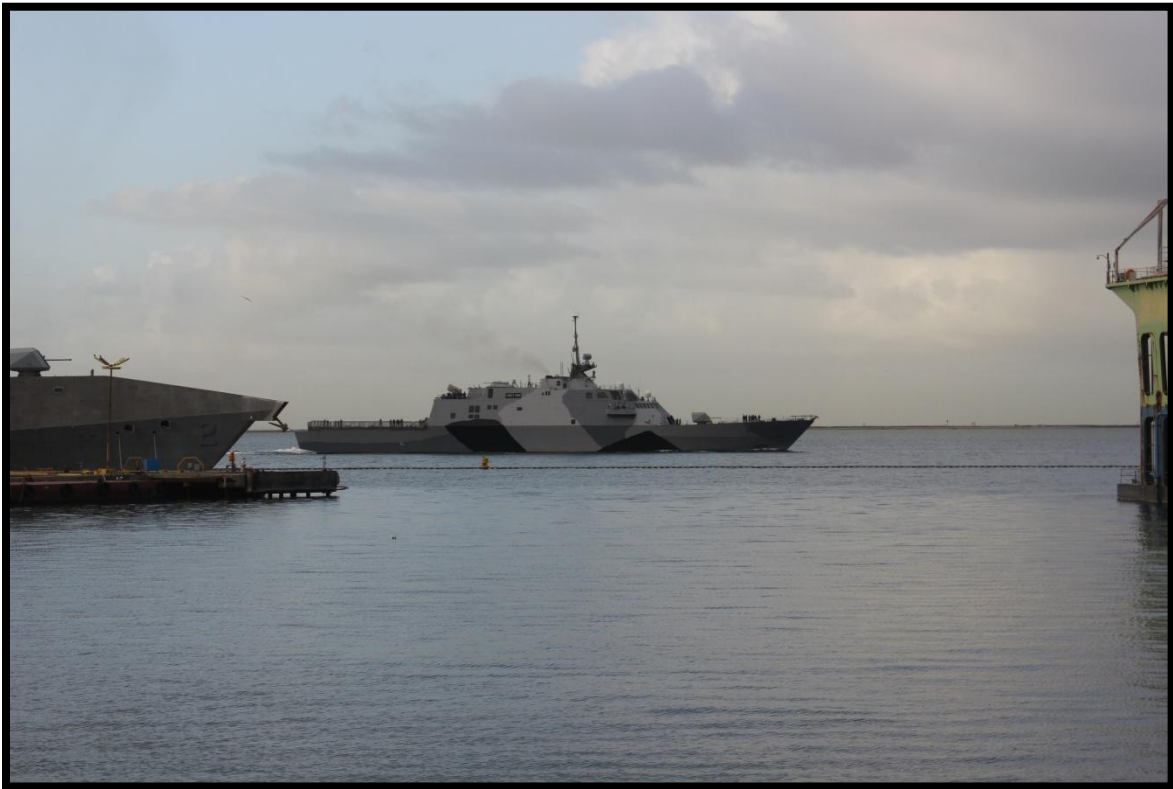
USS Freedom heads out to stretch her legs and showcase new camouflage paint scheme.

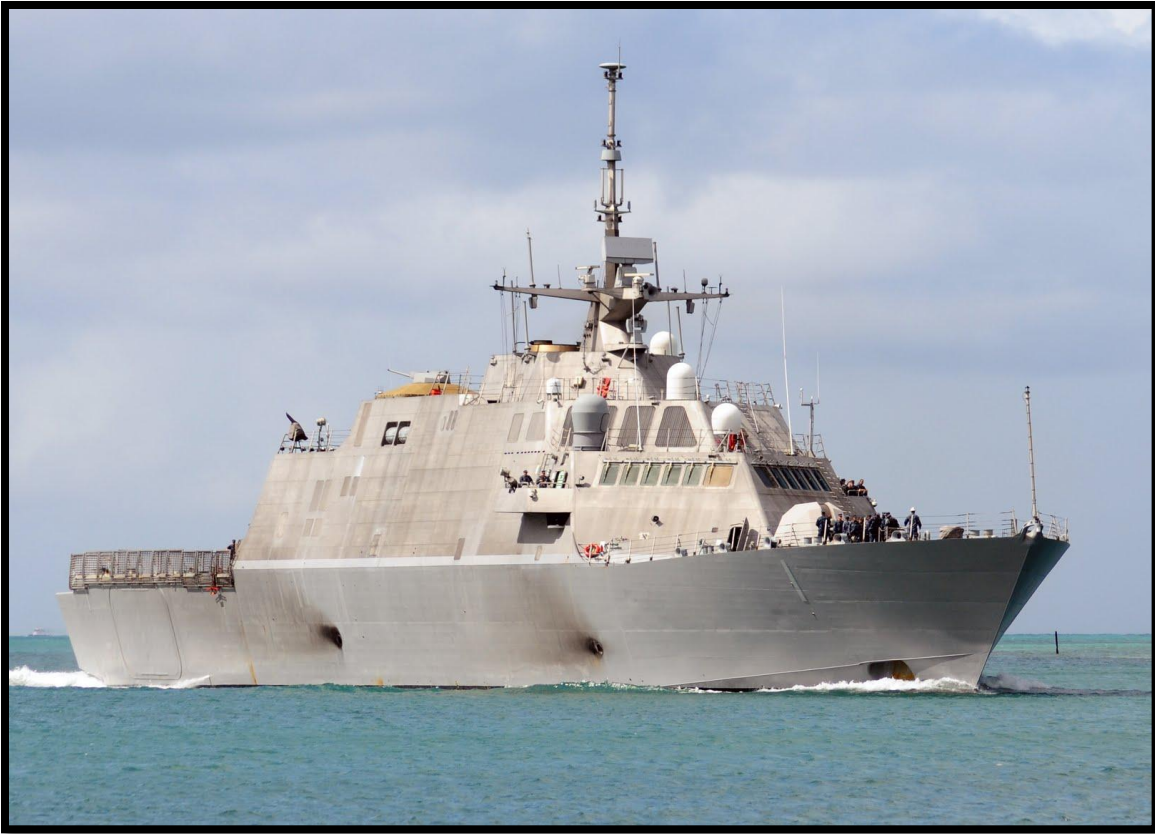
Before Preservation (Haze Gray Freeboard bare aluminum superstructure)

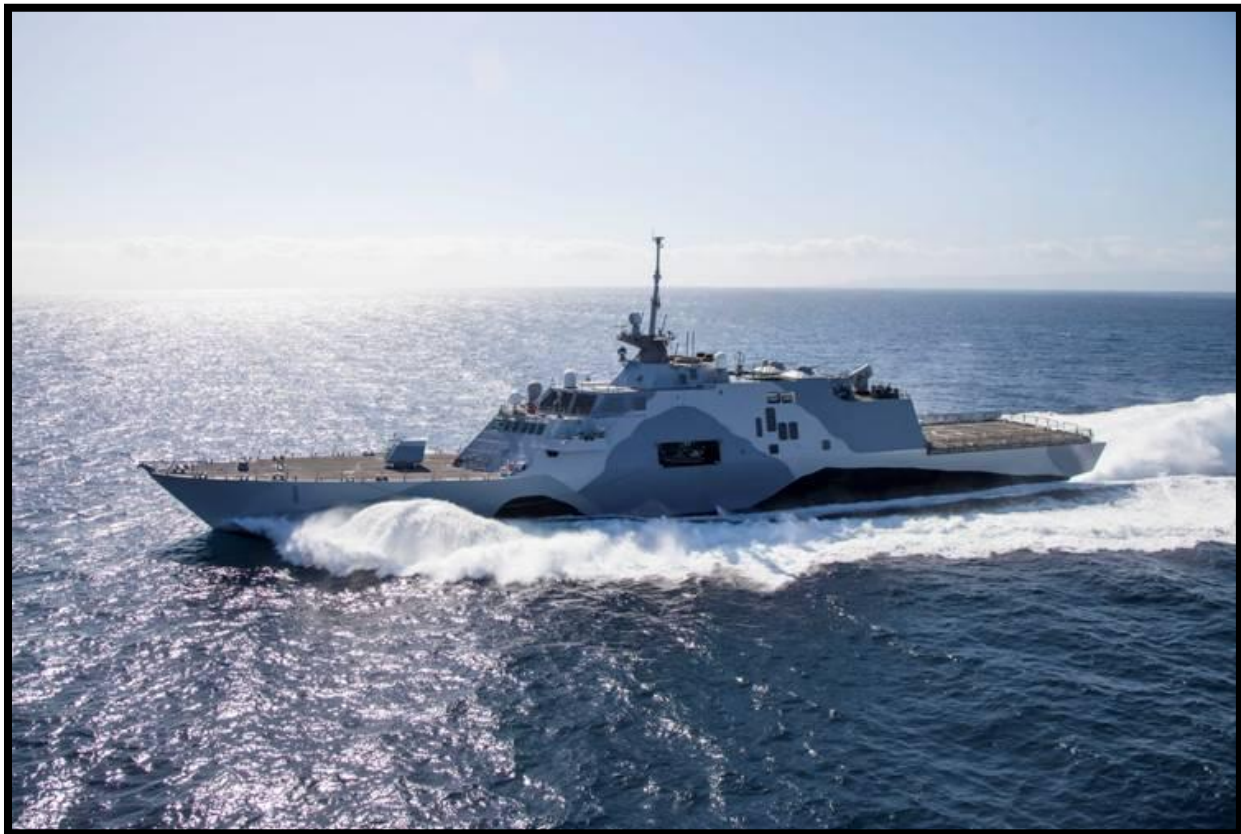
After Preservation (New Polysiloxane Camouflage Paint Scheme)
