## Turbine Lubricant Varnish Removal Case Studies using SVR

## Turbine Lubricant Varnish Removal Using SVR

As of May 2014 there are over 400 SVR installations on turbine lubricant reservoirs operating throughout the world. These systems have gained an industry leading reputation for reducing and maintaining low varnish potential including many sites where competing systems have failed.

Attached are 20 case studies that demonstrate typical results. Once an SVR is installed, the lubricant enters a "Restoration phase" that last 3-4 months on average. During this phase, previously deposited varnish dissolves back into the purified lubricant where it is removed by SVR. During this clean-up period, the MPC values fluctuate as the varnish content of the fluid varies. Once varnish deposits are removed, varnish is continually removed as it forms and the lubricant enters a "Stability phase" where MPC values are maintained at <15 (ASTM 7843). Because varnish is continually removed as it forms during the stability phase, varnish does not accumulate in the lubricant reducing the risk of varnish formation to nil. For privacy, all customer specific information has been removed.

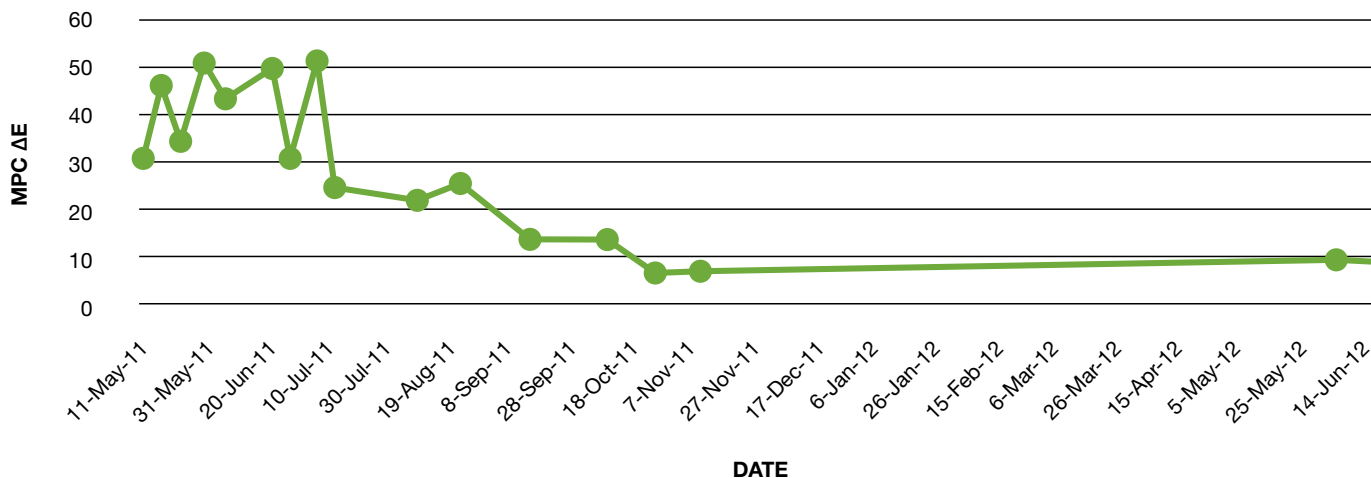
*MPC ΔE Reduction Using SVR  
Mobil DTE 732*

This site was experiencing a build-up of varnish on mechanical components. An SVR was installed and initial results described a three-month stabilization period as varnish deposits were adsorbed back into the lubricant. A significant decreasing trend began after four months of operation, which means that varnished mechanical components had been completely cleaned. SVR treatment reduced the fluid varnish potential value to below 10 over the subsequent three months. Varnish potential values are now stable and at historically low values.

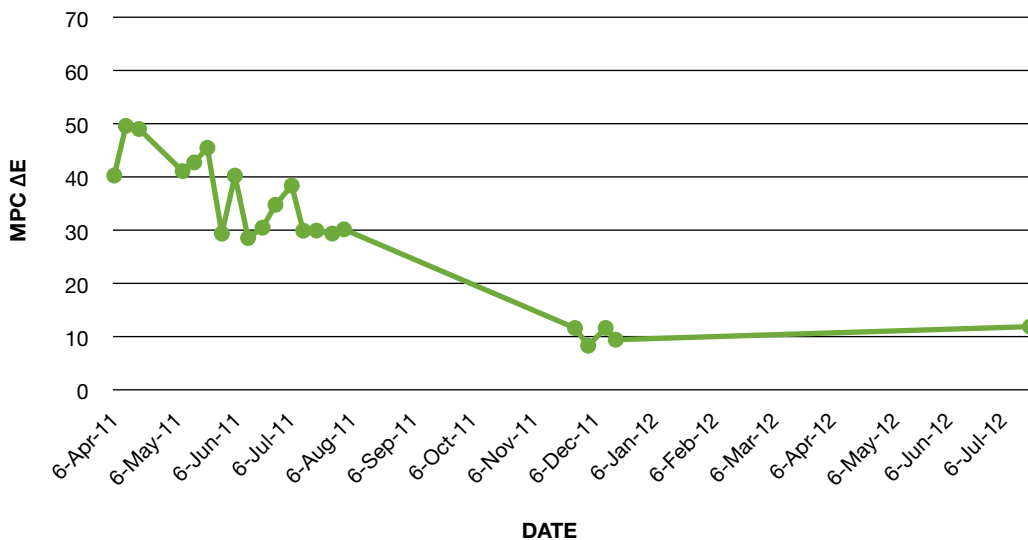
*MPC ΔE Reduction Using SVR  
Mobil DTE 732*

This site had a history of varnish problems; the customer consistently experienced build-up of varnish on mechanical components. Once SVR was installed, varnish potential numbers fluctuated over a two month period while varnish deposits were adsorbed into the lubricant. Notable reductions were achieved by month three. Consistent reductions continued over the next six months. Permanent use of SVR has been able to reduce varnish potential values by another 60% and to be maintained at 15 or below. Varnish potential values are now stable and at historical low values.

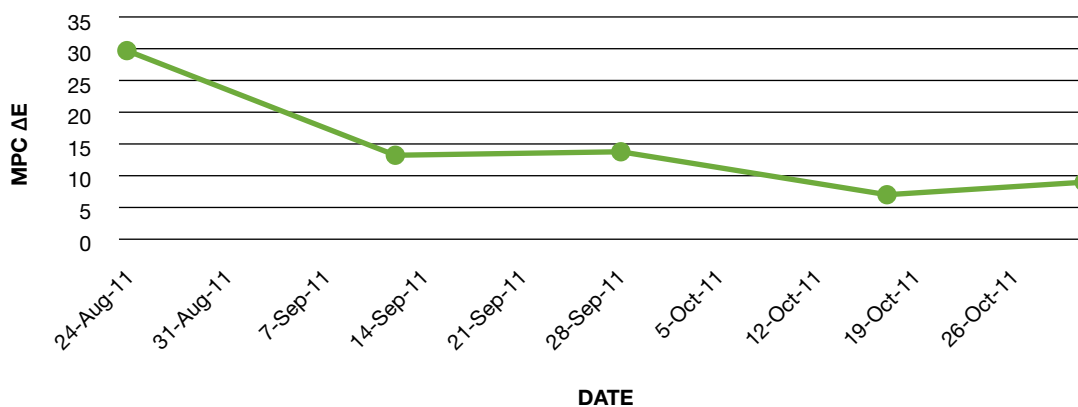
*MPC ΔE Reduction Using SVR  
Shell Turbo CC 32*

This site had a history of varnish problems with QSA® varnish potential values at 75 or higher. Previous efforts on the part of maintenance staff were unable to control varnish potential values, which was a significant concern for the turbine owner. Upon installation of SVR, varnish potential values were quickly reduced. MPC varnish potential values are now at 10 or lower.

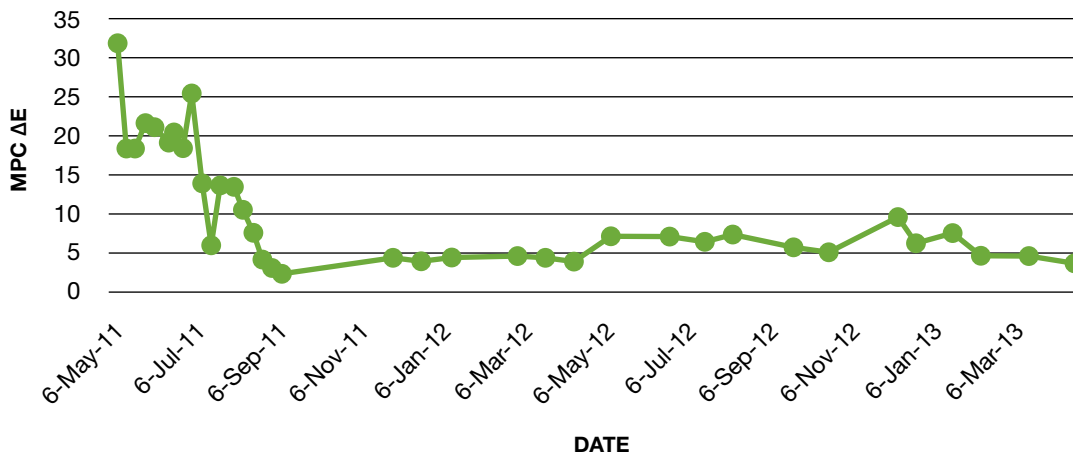
*MPC  $\Delta E$  Reduction Using SVR  
Shell Turbo TX 32*

This turbine is used as the primary generator at an oil and gas production facility. High varnish potential values were of concern due to the critical nature of the turbine and the potential loss in production associated with any turbine outage. SVR was installed and quickly reduced varnish potential values by >50%. Further decreases were observed with continued SVR use. Varnish potential values are now less than 5.0 and stable.

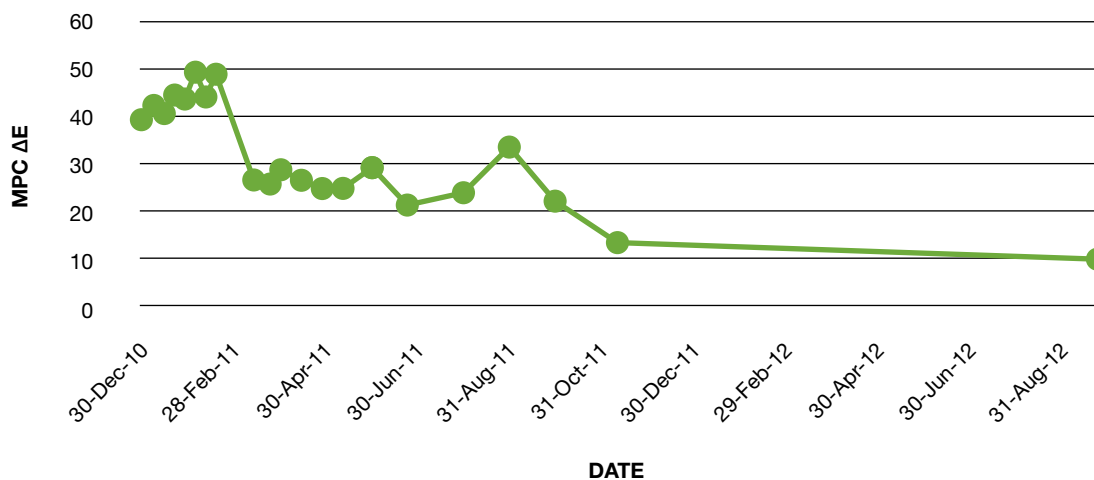
*MPC ΔE Reduction Using SVR  
Mobil DTE 832/Shell Turbo CC 32  
Mix*

This unit had a history of varnish problems with multiple unit TRIPS and fail-to-start conditions. SVR systems were installed on all turbines and quickly reduced varnish potential by over 50% with no further turbine failures occurring. Continued long term use of SVR has been able to reduce varnish potential values by another 40% with values now at <15. Varnish potential values are now stable and at historical low values.

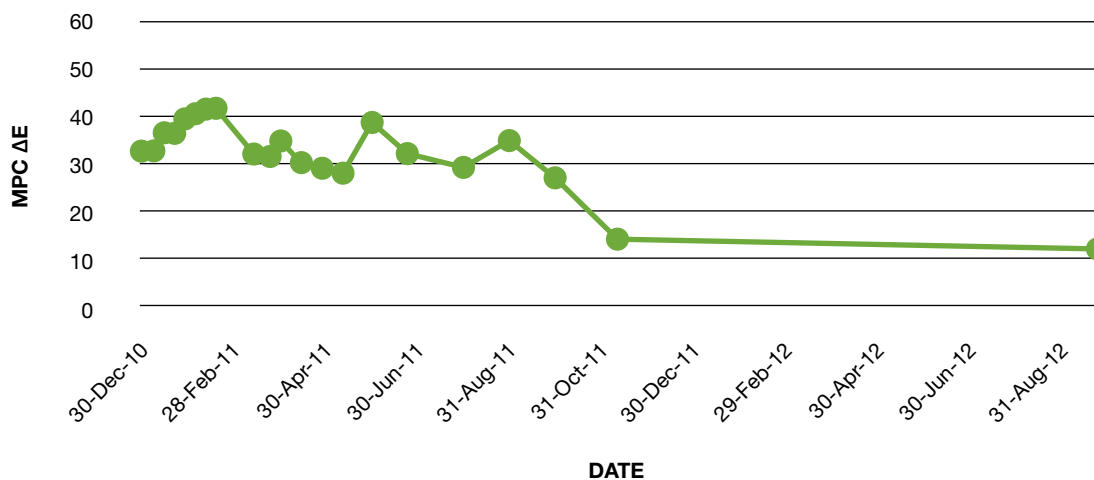
*MPC ΔE Reduction Using SVR  
Mobil DTE 832/Shell Turbo CC 32  
Mix*

Unit had a history with multiple trips and fail-to-start conditions. SVR system was installed on this unit and within six months had produced downward trending MPC results. No turbine failures occurred after the SVR system was installed. The length of time prior to decreasing MPC is based on the amount of varnish on system components. The varnish potential is now below 15 and continues to decrease.

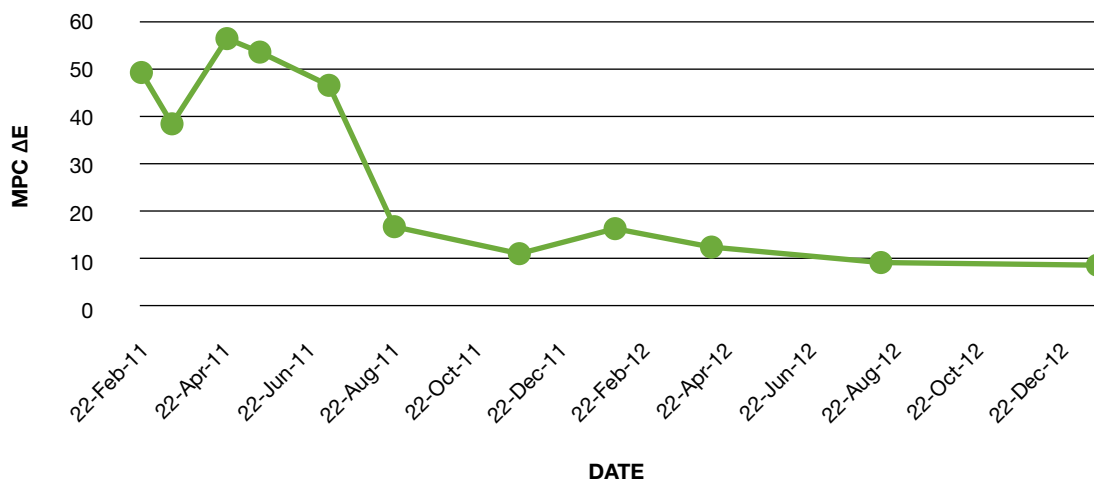
**MPC  $\Delta E$  Reduction Using SVR  
Teresso GTC 32**

An electrostatic oil cleaner was operational on this system full-time since turbine commissioning in 2009. Within 18 months of initial operation, varnish potential values had increased above 40 to critical levels. SVR was installed February 2011 and reduced varnish potential, which then increased as system deposits were adsorbed back into the lubricant. Subsequent element changes performed annually have achieved stable and historically low varnish potential values.

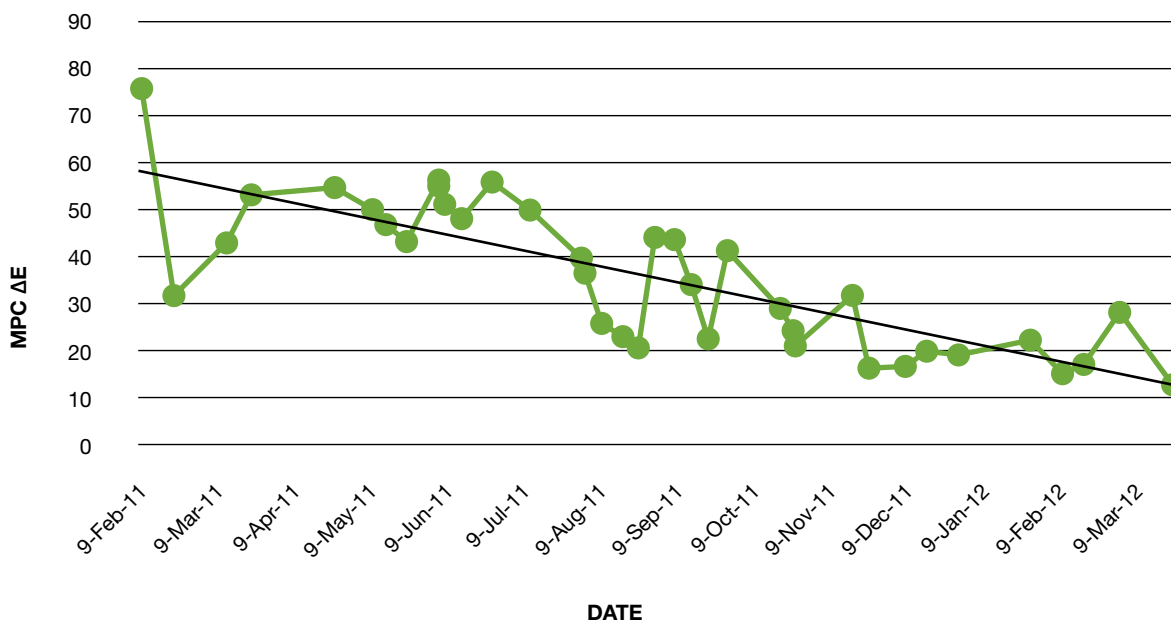
*MPC ΔE Trending Using SVR  
Shell Turbo CC 32*

When initially contacted, this site had extreme varnish potential values. SVR was installed and immediately reduced varnish potential values by >60%. Existing system deposits were then adsorbed back into the lubricant which increased varnish potential values. Based on the level of increase, the results suggest that existing system varnish deposits were above average. Secondary decreases followed by increases also suggest above average levels of varnish deposits were present. The system stabilized after eight months of SVR treatment. No additional operational problems have been experienced and varnish potential values remain at historically low levels.

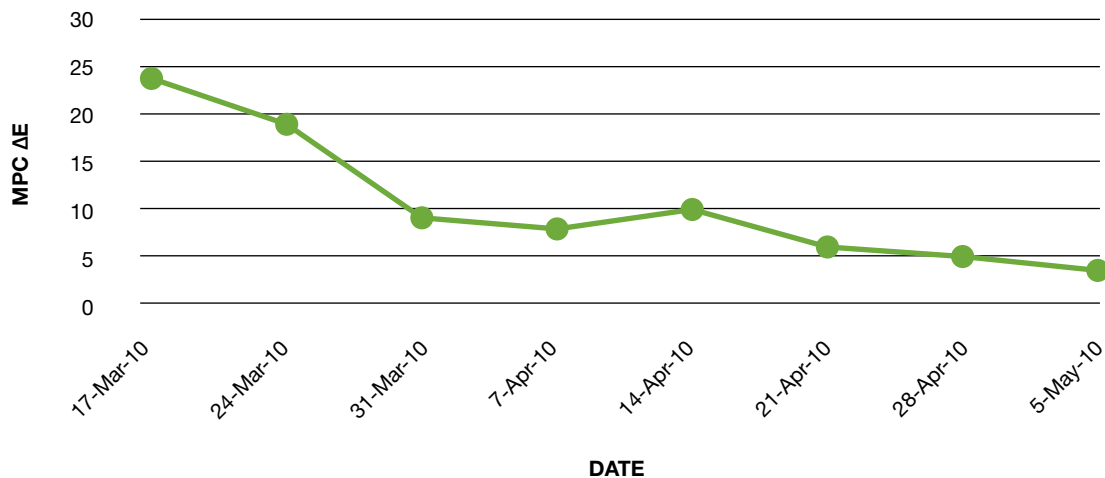
*MPC ΔE Trending Using SVR  
Mobil DTE 724*

At this facility, three GE7FA Gas turbines provide the primary power and steam for the chemical plant. Plant reliability was negatively impacted from elevated varnish potential numbers in the gas turbine. To reduce the risk of outage maintenance staff tried a number of varnish removal systems without success. SVR was installed and had an immediate impact, reducing varnish potential numbers and within three months, values had been reduced by 80% to a varnish potential value of <5. Based on these successful results, SVR has been installed on all three gas turbines at this site.

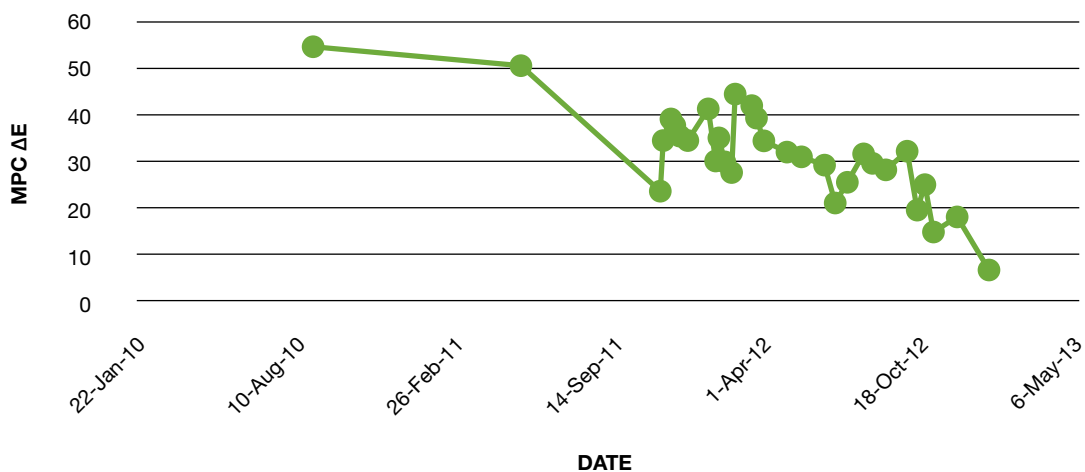
*MPC ΔE Reduction Using SVR  
Chevron GST 32*

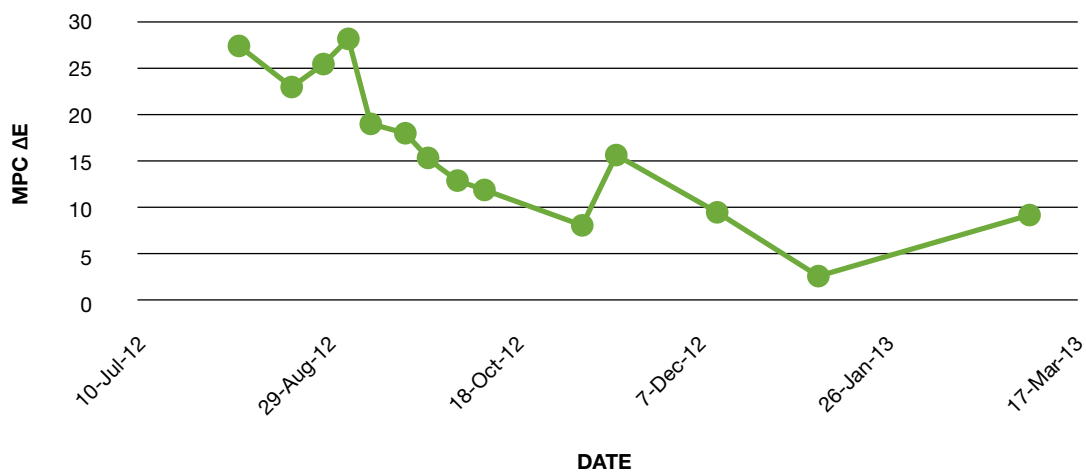
*MPC  $\Delta E$  Reduction Using SVR  
Chevron GST 32*

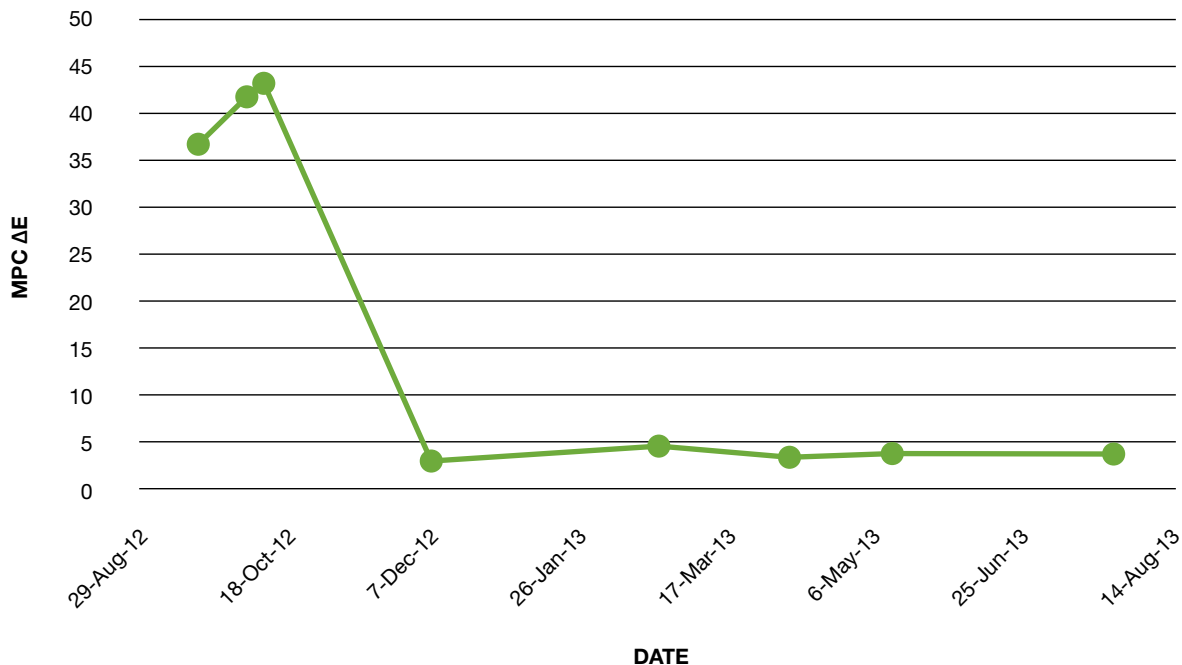
*MPC ΔE Reduction Using SVR  
Mobil DTE 832*

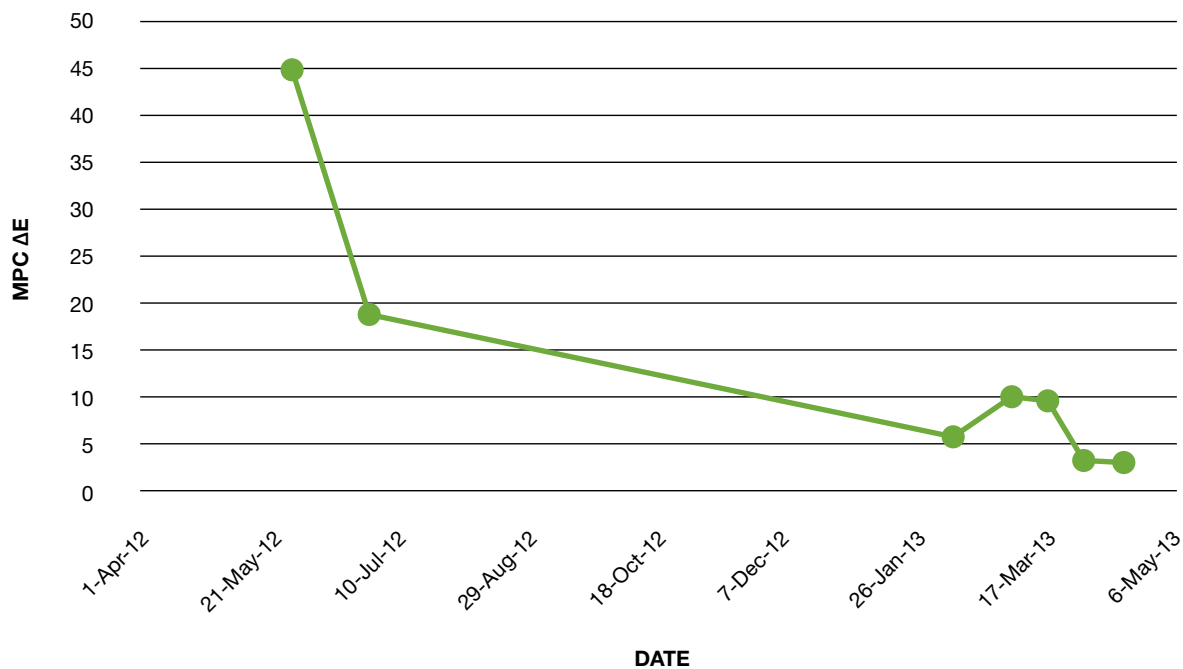
*MPC  $\Delta$ E Reduction Using SVR  
Shell Turbo CC 32*

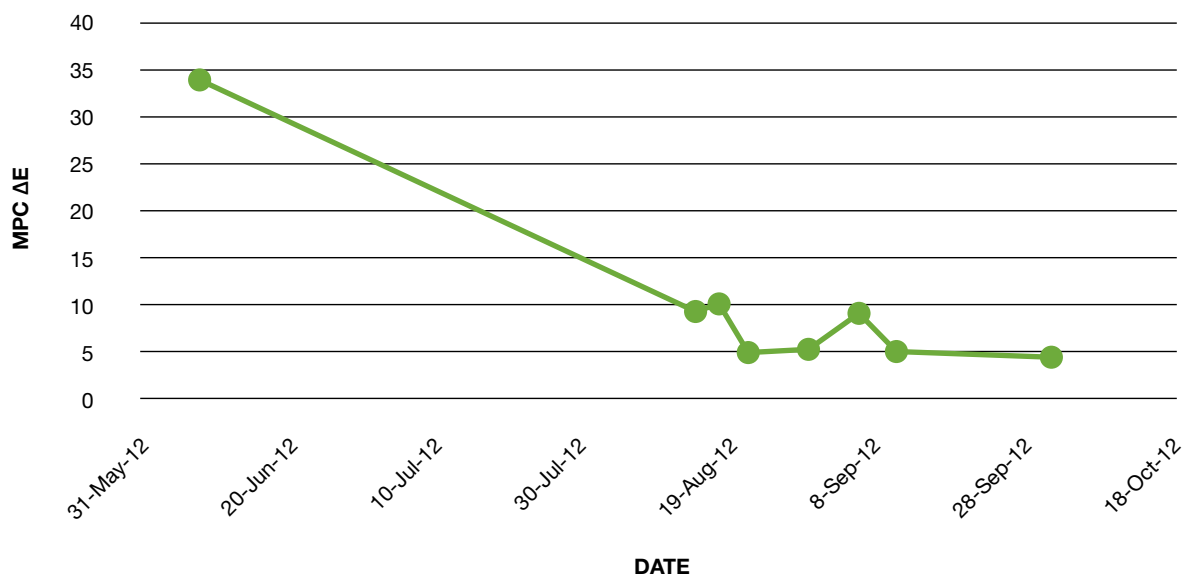
*MPC  $\Delta E$  Reduction Using SVR  
Texaco Regal R&O 32*

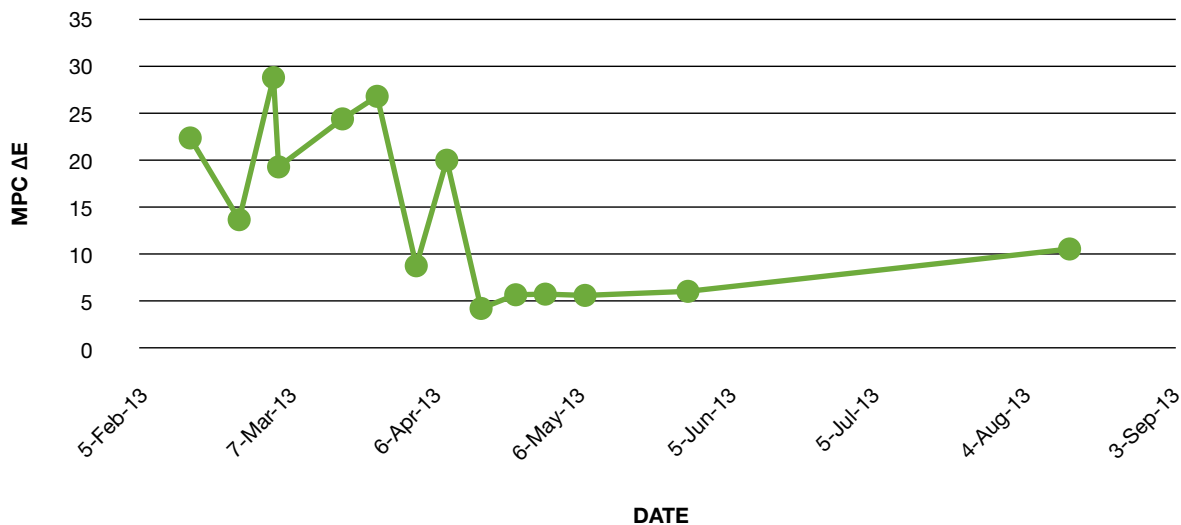
*MPC ΔE Reduction Using SVR  
Esso Teresso GTC 32*

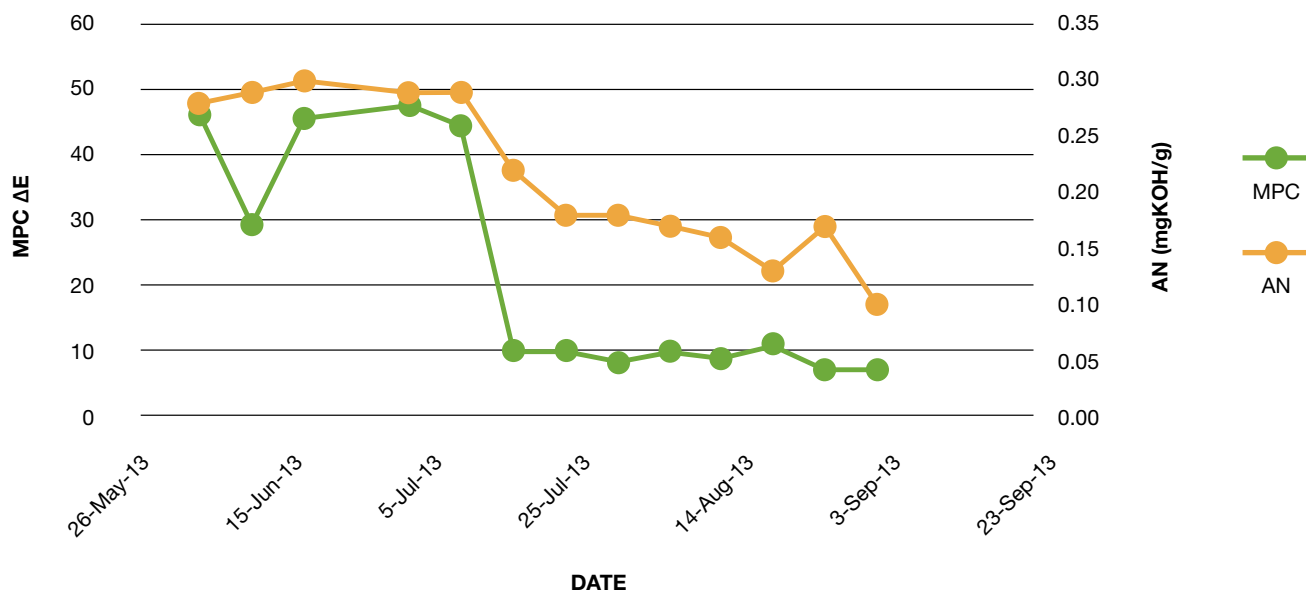
*MPC ΔE and AN Reduction Using SVR  
ConocoPhillips Hydroclear 32*

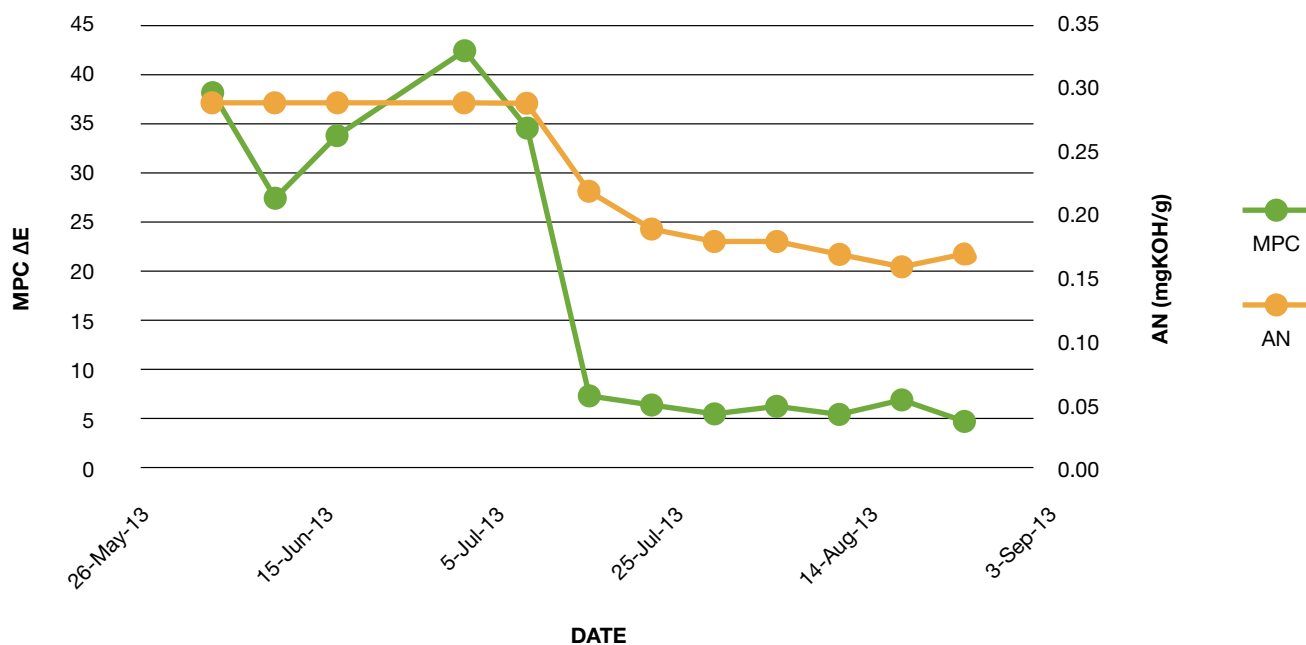
*MPC ΔE and AN Reduction Using SVR  
ConocoPhillips Hydroclear 32*

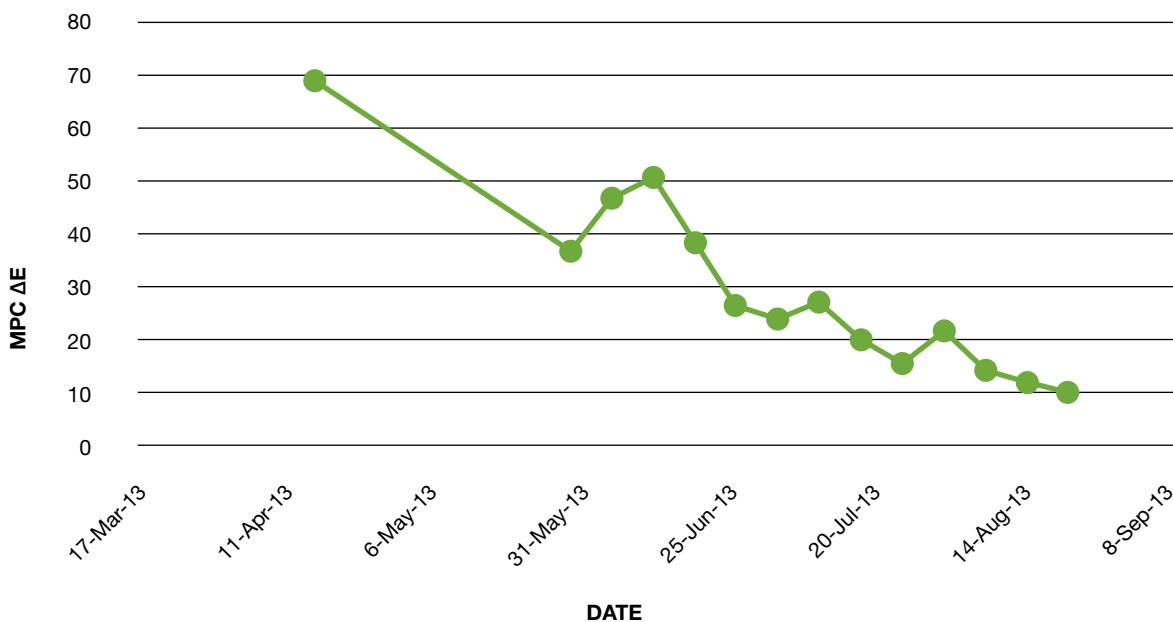
*MPC ΔE Reduction Using SVR  
Mobil DTE 832*

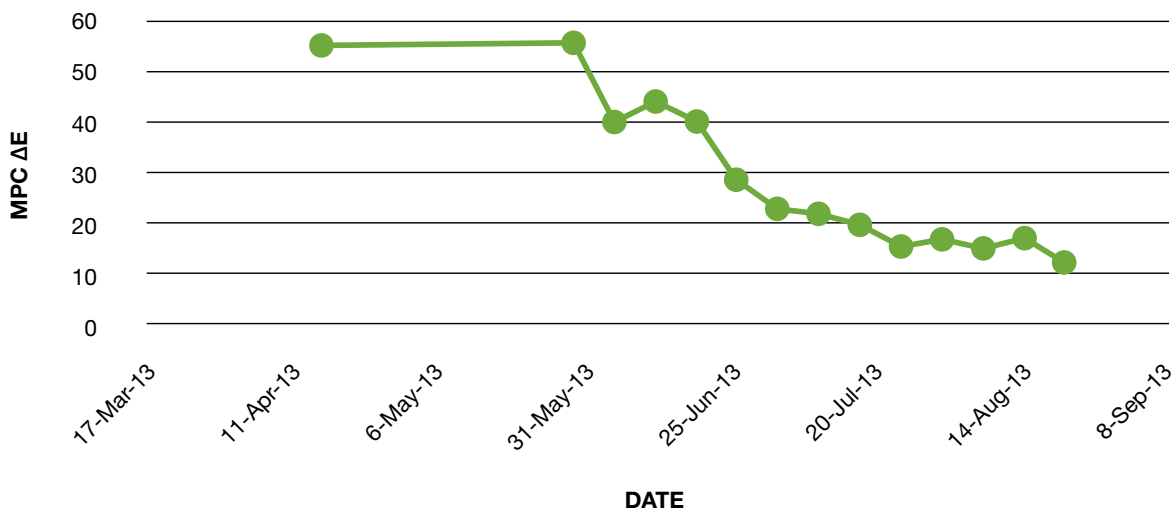
*MPC ΔE Reduction Using SVR  
Mobil DTE 832*

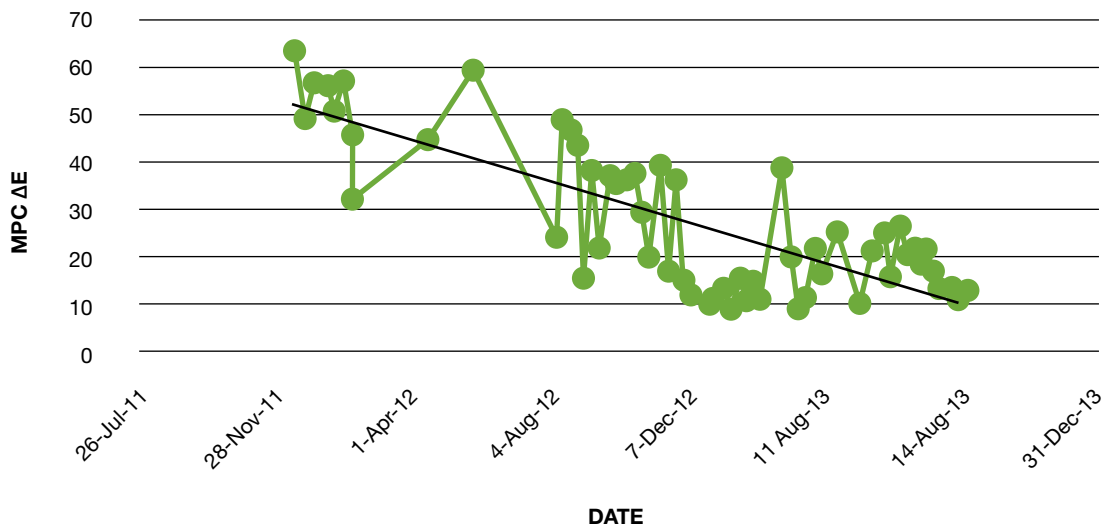
*MPC ΔE Reduction Using SVR  
Shell Turbo CC 32*
