# EFFECT OF SCARIFICATION ON ASPHALT PATCH JOINT BOND STRENGTH

Transportation Research Board  
84th Annual Meeting  
January 9-13, 2005  
Washington, D.C.

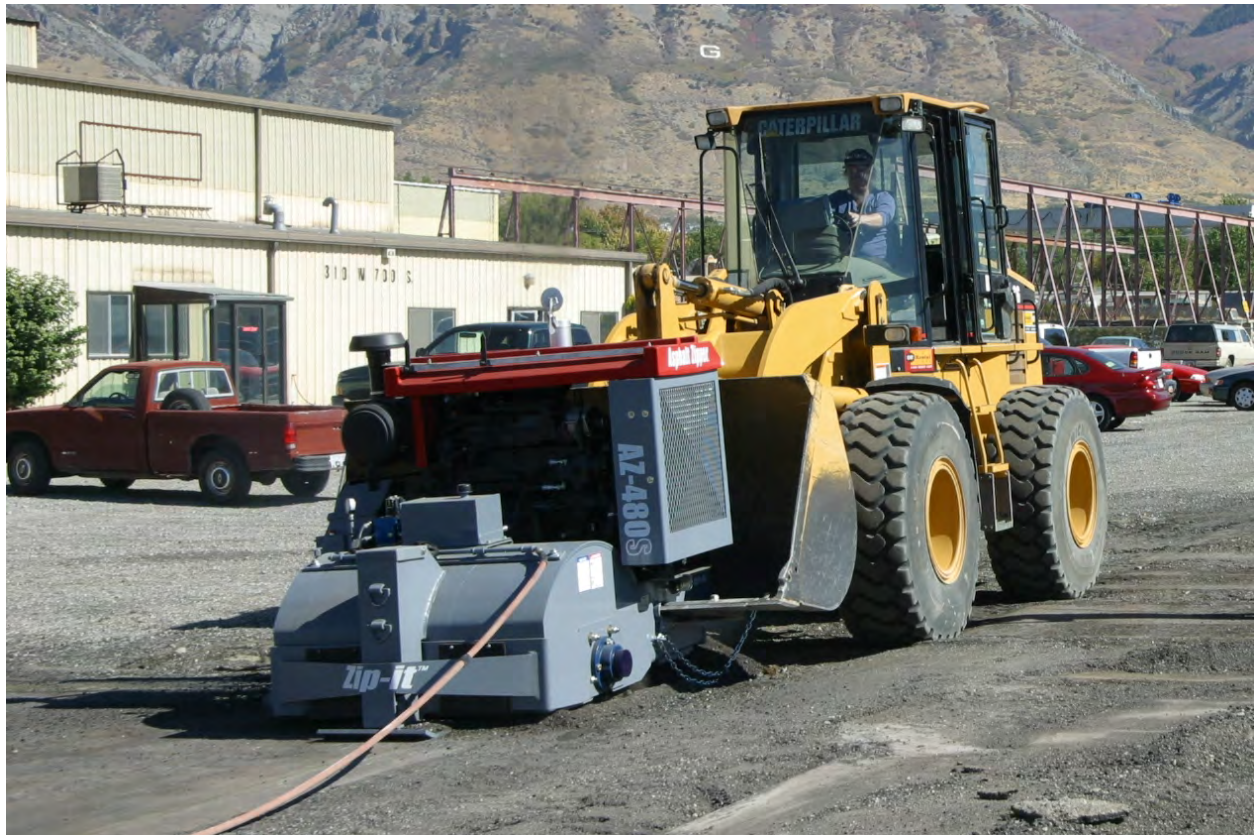
**FIGURE 1** Portable asphalt recycling machine.

In order to test the difference in shear strength between saw-cut and scarified edges, an asphalt testing yard in Pleasant Grove, Utah, was secured for the research. The portable asphalt recycling machine shown in Figure 1 was used to make a 48-in-wide experimental cut approximately 75 ft in length through a 6-in. layer of asphalt concrete. Figure 2 shows the textured vertical face resulting from the scarification process. A saw cut was then made parallel to the scarified section approximately 8 ft to one side, and all of the asphalt between the saw cut and the outer scarified edge was removed as shown in Figure 3. This configuration ensured that the adjacent asphalt concrete and the underlying base materials at both joint locations were as similar as possible. A tack coat was sprayed onto both vertical cut faces, and a hot-mix asphalt patch was placed and compacted in the trench in October 2003 by a local paving contractor as shown in Figure 4. The patch material was reportedly an AC-20 with a maximum aggregate size of 0.5 in. The asphalt cement content was 5.5 percent by weight of total mix.

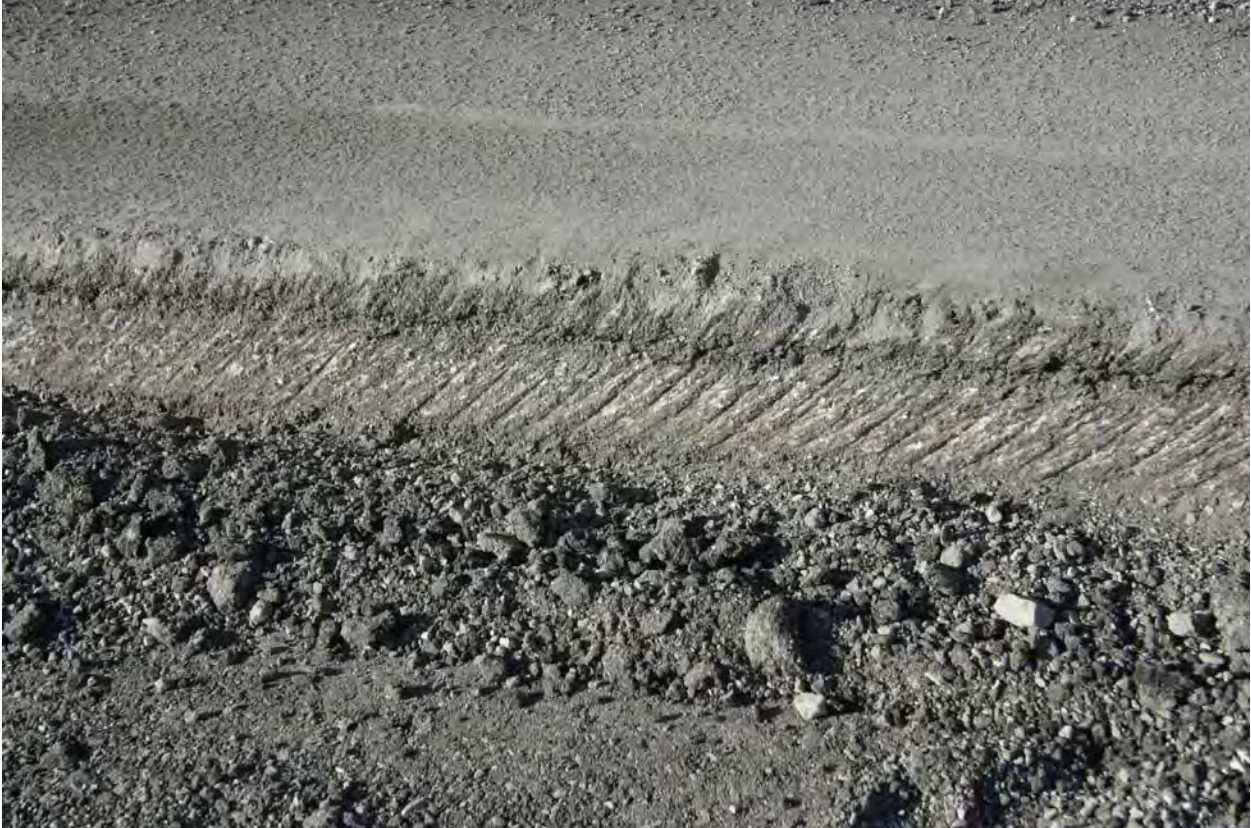
**FIGURE 2 Scarified vertical pavement face.**

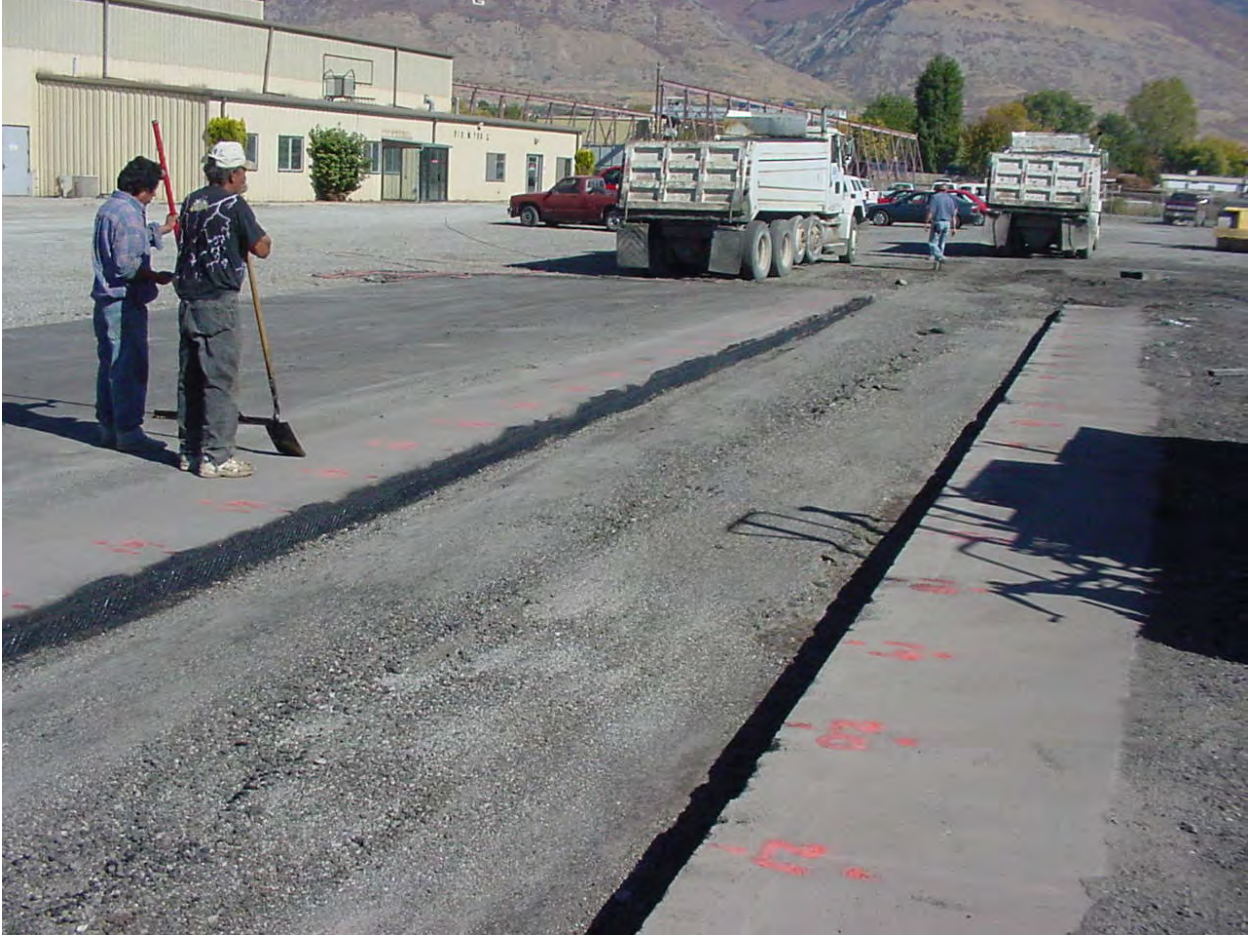
**FIGURE 3** Testing site after asphalt removal.

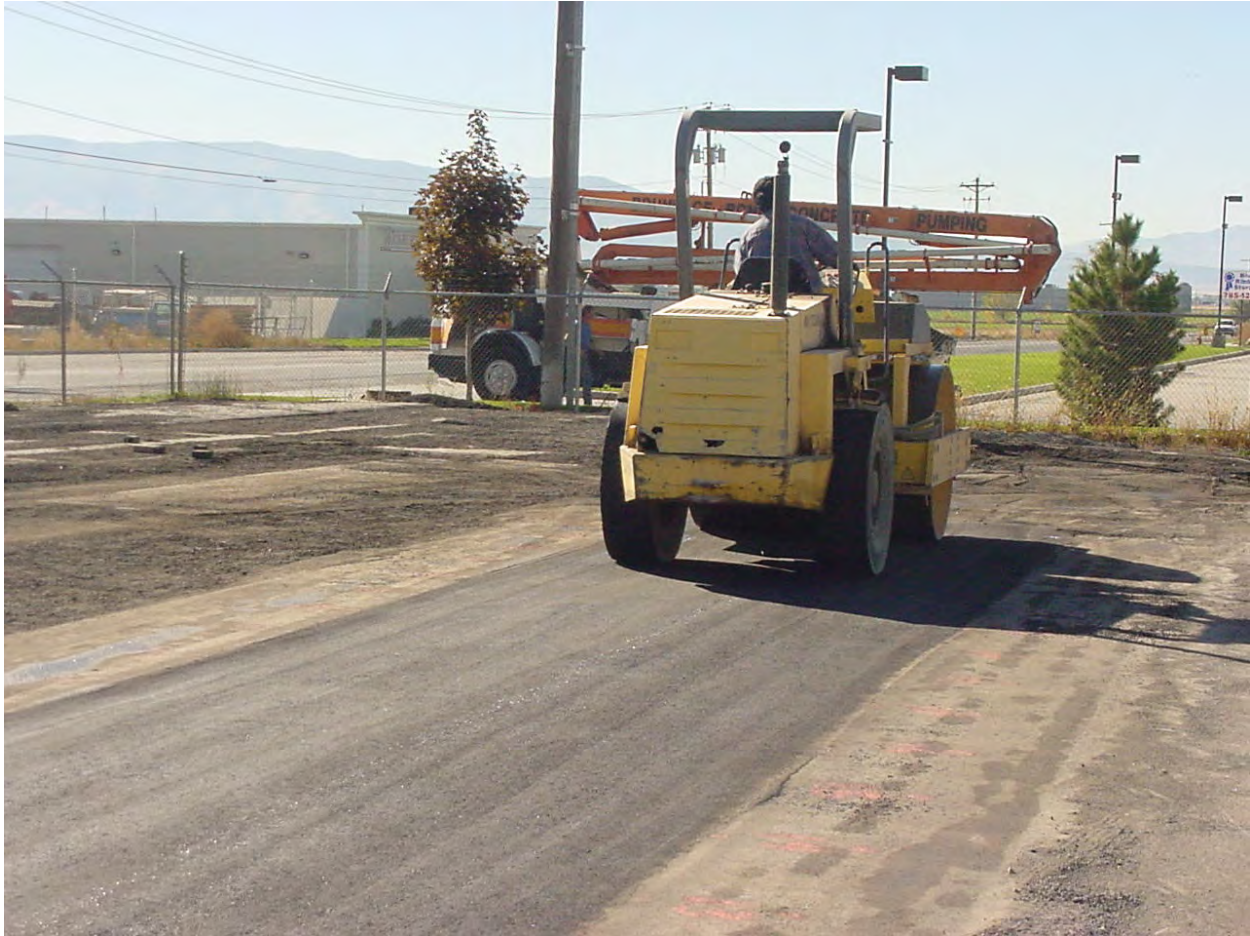
**FIGURE 4** Compaction of patch material at test site.

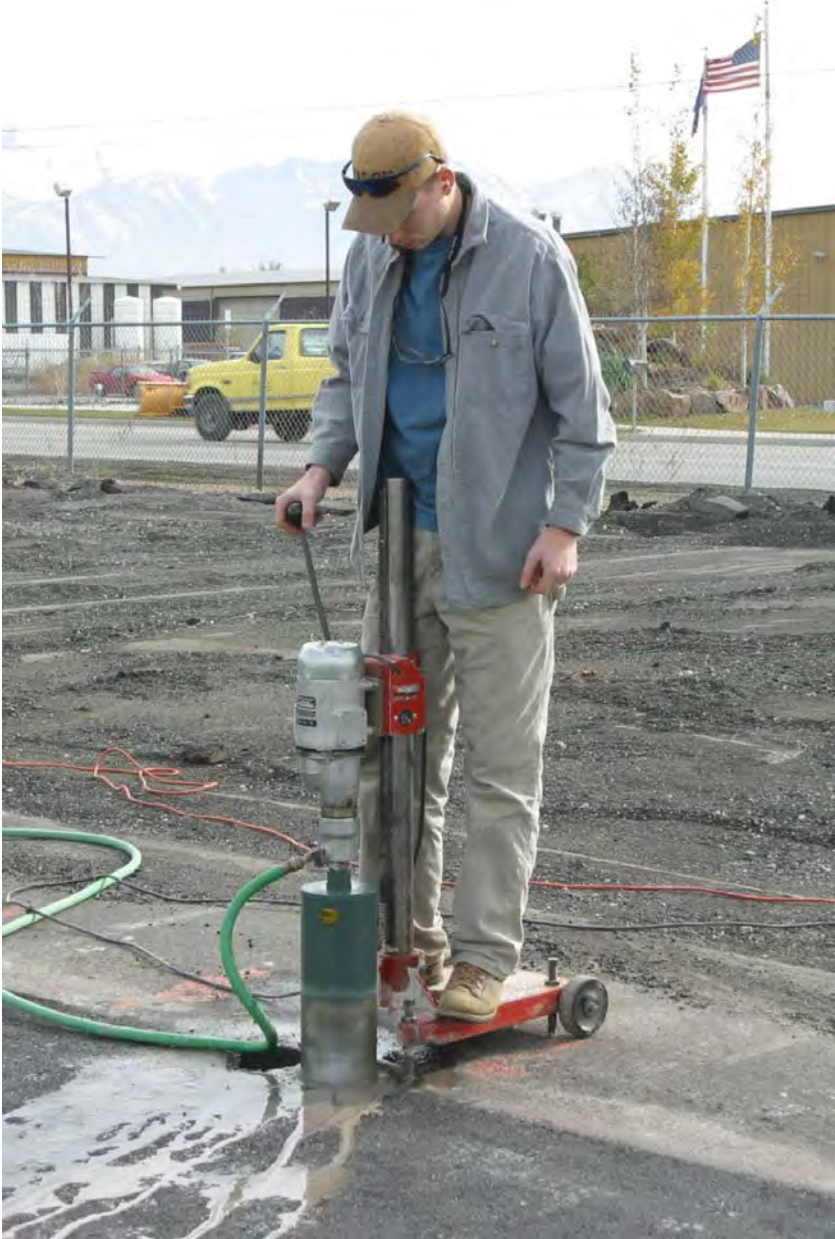
**FIGURE 5** Removal of asphalt core specimens.

To facilitate sampling before and after winter, the patch was subdivided into two sections each about 35 ft in length. Researchers removed 25 cores from each side of one of the patch sections approximately one month after patch placement and then extracted the same number of cores from the second patch section in late April 2004. The second set of cores was analyzed to evaluate the effects of in-situ freeze-thaw cycling on the overall bond strength of each joint. As depicted in Figure 5, a portable 6-in. core drill was utilized for the extractions, in which each core was centered as closely as possible on the respective joint. After removal, the cores were prepared for testing at the Brigham Young University (BYU) Highway Materials Laboratory. Each specimen was trimmed using a masonry saw to create flat, parallel end faces and then air-dried to constant weight. The heights, weights, and diameters of the cores were then measured in order to calculate the bond area and density of each specimen. Photographs of typical cores from the saw-cut and scarified joints are given in Figure 6.

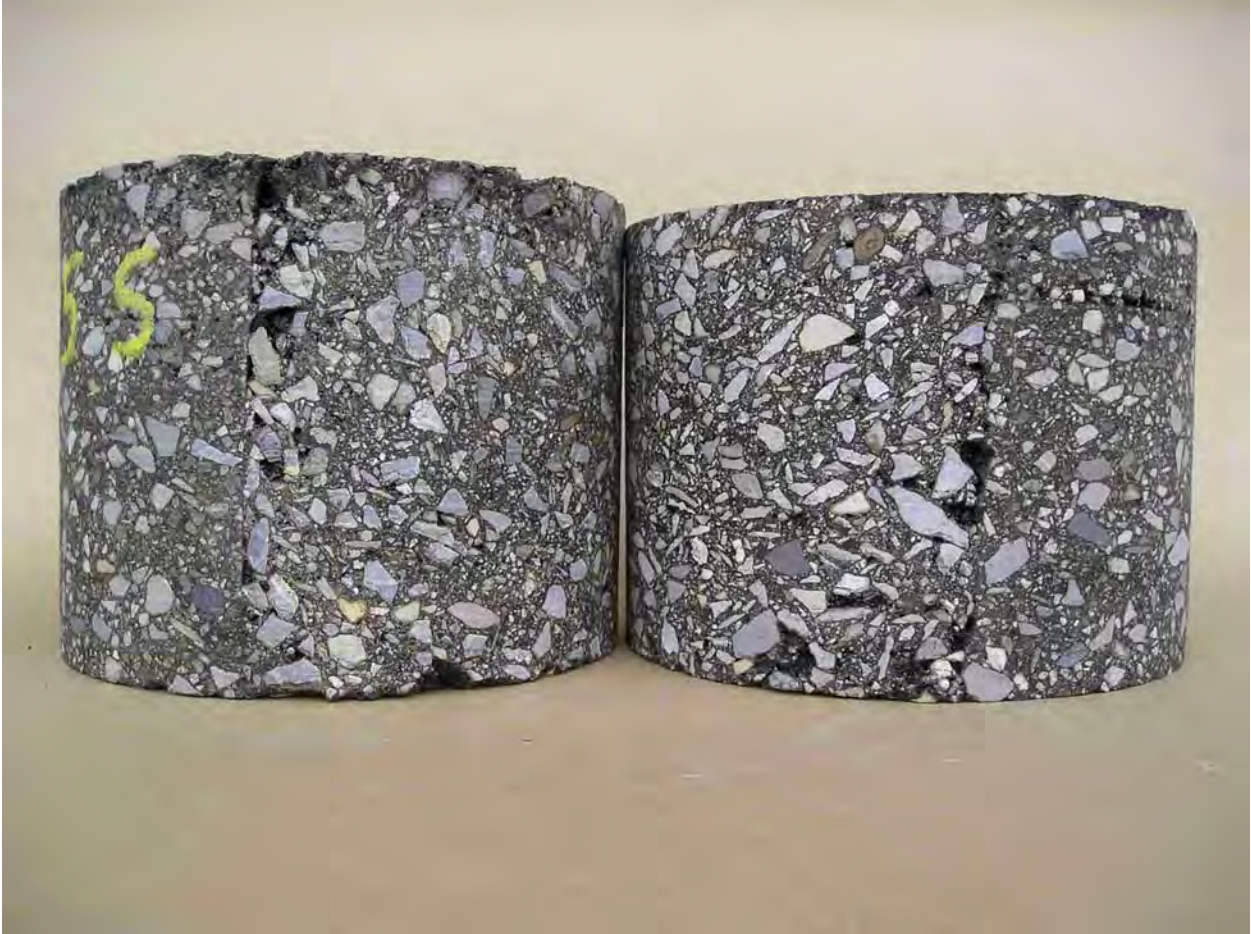
**FIGURE 6** Typical cores from saw-cut joint (left) and scarified joint (right).

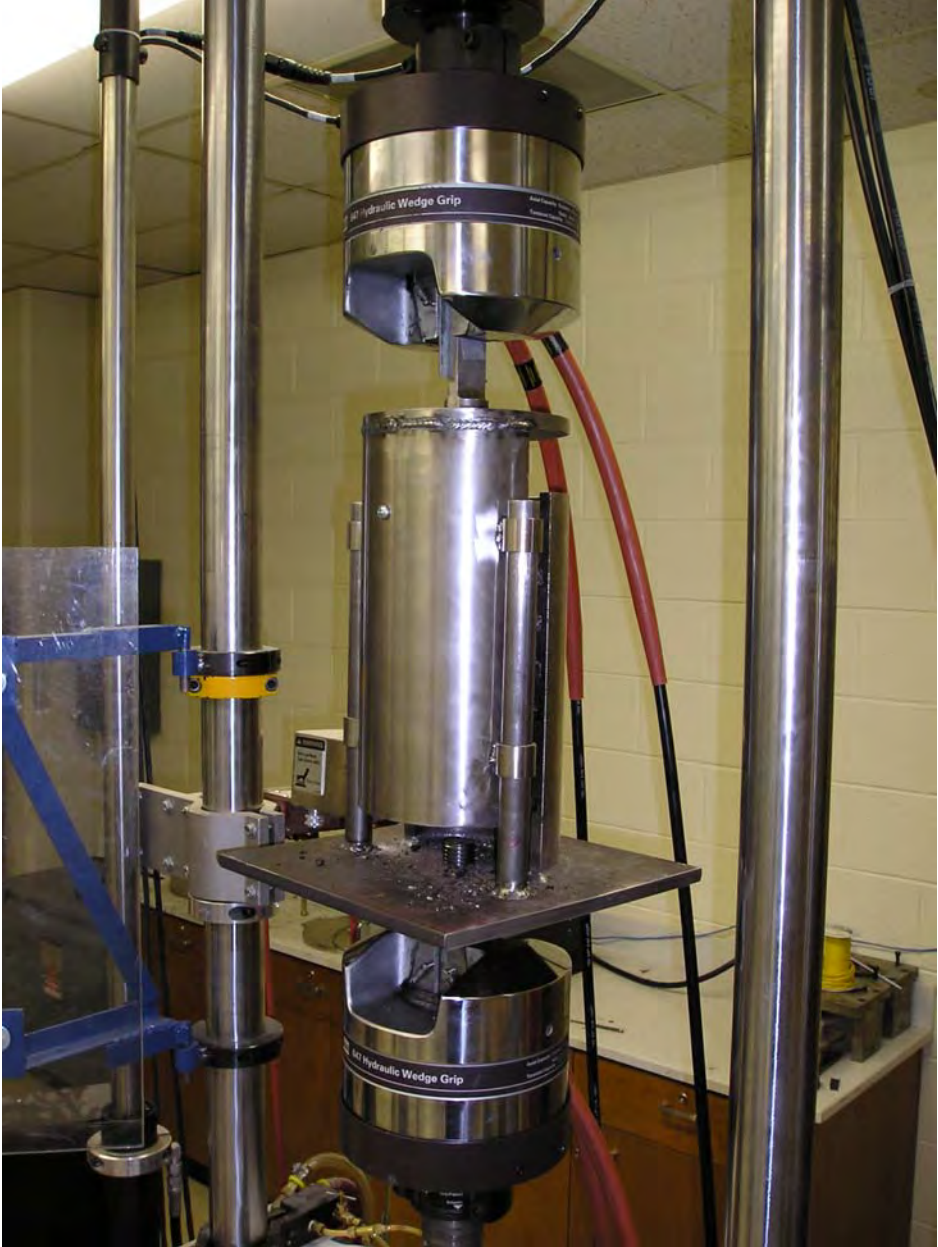
**FIGURE 7** Shear testing of core specimens.

A direct shear test was then utilized to measure the quality of the joint interface for both types of patch joints. As mentioned earlier, this testing method measures aggregate interlock more directly and simulates roadway loading conditions under trafficking more appropriately than alternative testing configurations. A specially manufactured testing apparatus was used in a servo-controlled hydraulic testing machine to shear each core at a constant strain rate of 0.05 in./min as shown in Figure 7. The load was applied across the joint in the direction parallel to the longitudinal axis of the core. The joint was carefully aligned within a 1-in. shear zone provided in the testing apparatus to accommodate variability in joint locations from one core to the next. Each core was loaded to failure at room temperature, after which the bond strength was calculated for each specimen by dividing the maximum sustained load by the bond area over which the load was applied.

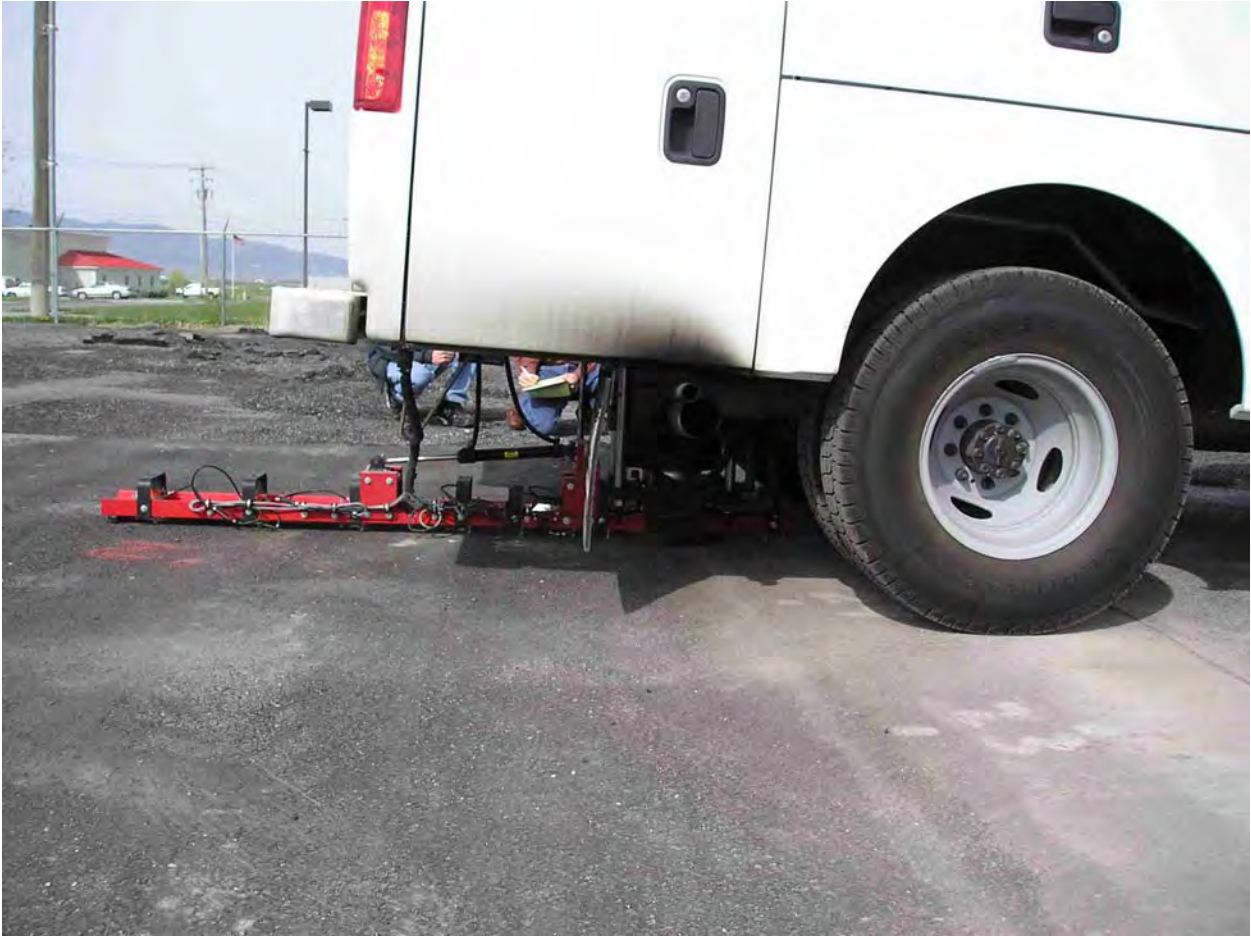
**FIGURE 8 Joint evaluation with falling-weight deflectometer.**

In addition, FWD testing was utilized to calculate the LTE for each patch joint after winter and to facilitate backcalculation of the asphalt and base layer modulus values. The FWD used in this study had sensors stationed at 0 in., 8 in., 12 in., 24 in., 36 in., 48 in., 60 in., and -12 in. from the loading plate. The patch side of each joint was loaded as illustrated in Figure 8, and the LTE was calculated from the deflections recorded at 0 in. and -12 in. The FWD operator conducted tests at approximately 8,000 lbf and 10,000 lbf at five points along each patch joint, and the recorded deflections were used to compute an equivalent deflection for a 9,000-lbf load.

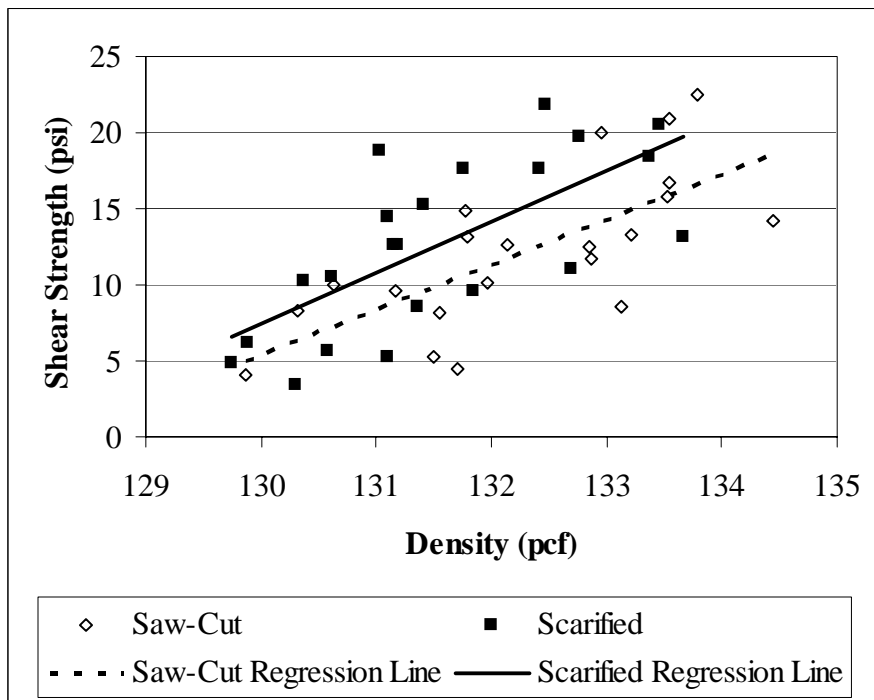
(a) Before winter.

(b) After winter.

**FIGURE 9 Relationships between shear strength and density for cores sampled (a) before winter and (b) after winter.**

Table 1 suggests that the average sample strength of the scarified cores was 19.7 percent higher than that of the saw-cut cores before winter and 3.4 percent higher than that of the saw-cut specimens after winter. However, as stated earlier, asphalt compaction density can impact joint strengths. As evidence of this assertion, Figure 9 shows a plot of density versus bond strength for each set of cores before and after winter. This plot shows that density has a marked impact on the overall bond strengths of the tested specimens. If densities are not uniform along both sides of the length of the patch, then the density variable must be accounted for in any meaningful statistical evaluation of the influence of scarification on bond strength. That is, simply averaging the measured strengths of the specimens does not accurately reflect the true relationship between bond strength and joint type.
