TEST REPORT

Report No.: HC40143A/2018

Product Description: Smart StreeCam Wi-Fi 802.11ac

1. Low Temperature Test

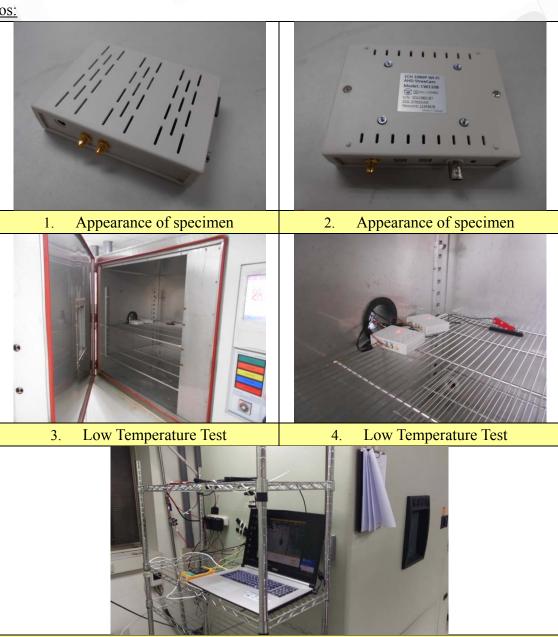
Test Photos:

Low Temperature Test

- Sample condition: Operating
- Examine the appearance of specimen(s) by visual check and perform functional check during and after this test.
- Functional check: Connect the specimen(s) with rate power and Notebook via WiFi, then examine whether the Recording, Wi-Fi connection, Live view, Remote playback from SD card, Remote file downloading, Log file downloading functions of specimen(s) could be work normally or not.
