The Royal Train Shed – Milton Keynes

(Completed May 2009)

Project: To re-furbish the Royal Train-Shed in Wolverton, Milton Keynes, and to build ten 3-bedroomed houses inside the original building. This involved blasting and re-pointing all of the existing brickwork, followed by removing and repairing all of the 80 cast-iron window-frames. The roof was then completely replaced (timber with glass skylights) and then the ten houses were built inside. The rough ground outside (the original site of the Wolverton football ground) was landscaped into a park with a small lake.

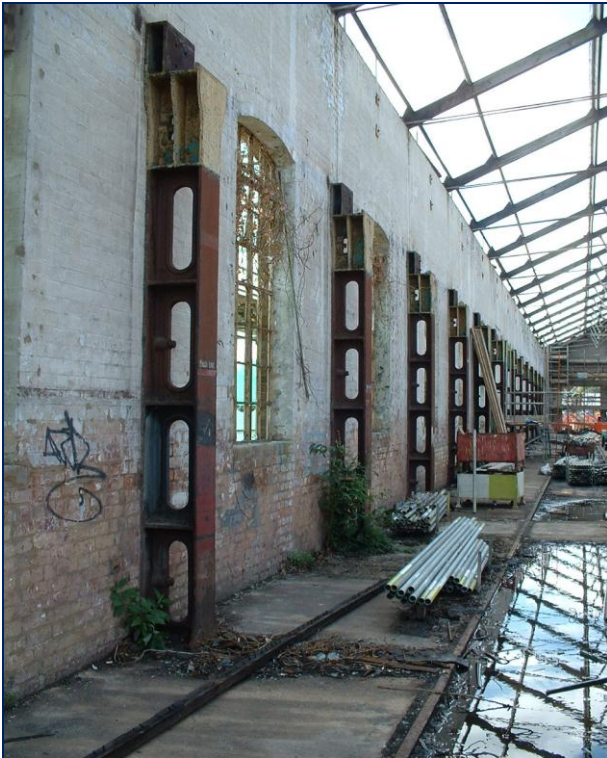
Before: The cast iron columns in 2007 before the blast-cleaning started.

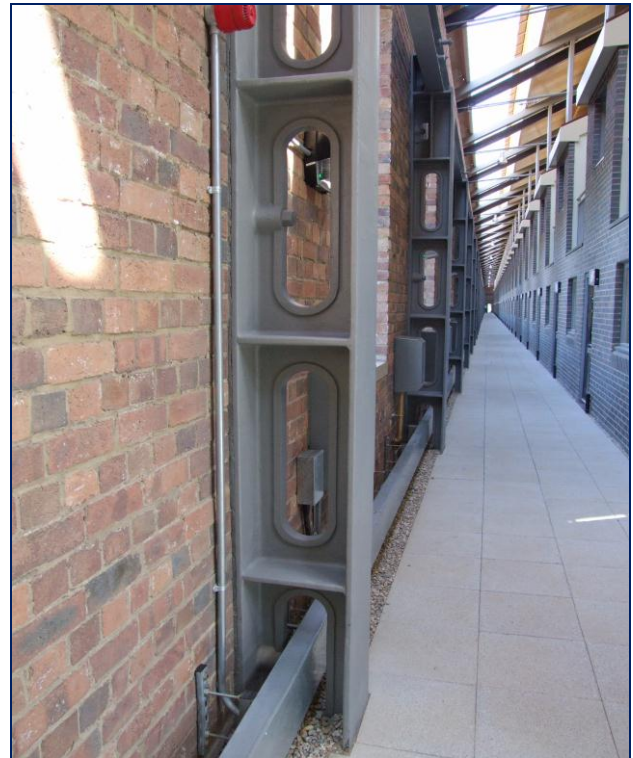
After: The columns in 2009 after being zingonised. The buildings on the right are the ten new houses inside

- Zinga: 1 x 80µm DFT
- Alufer N: 1 x 100µm DFT
- Vinyl enamel: 1 x 60µm DFT

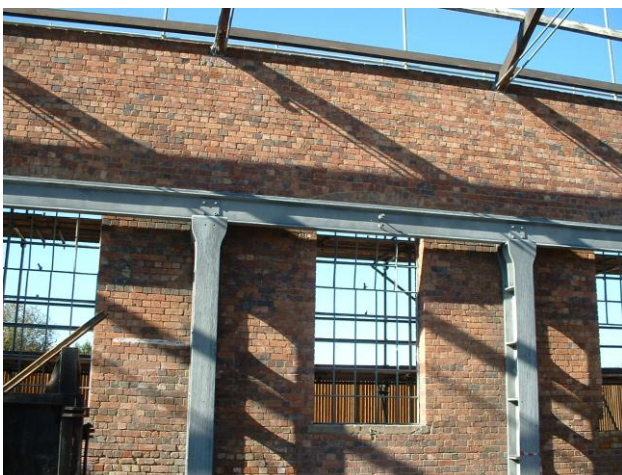
The cast-iron support columns before the roof was put on. These columns supported the original overhead crane.

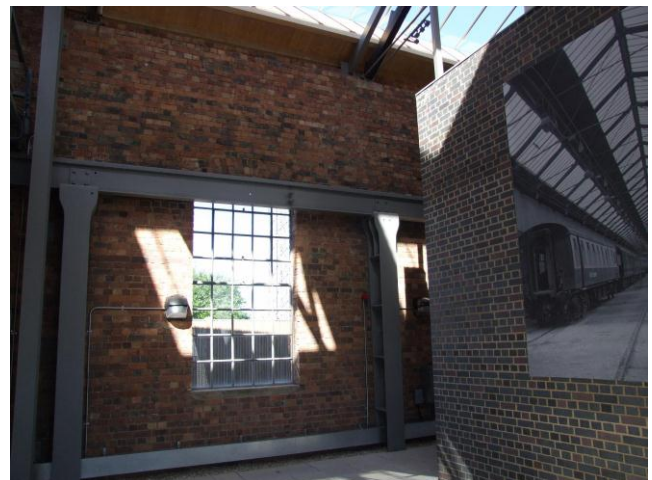
The columns after the new roof has been installed

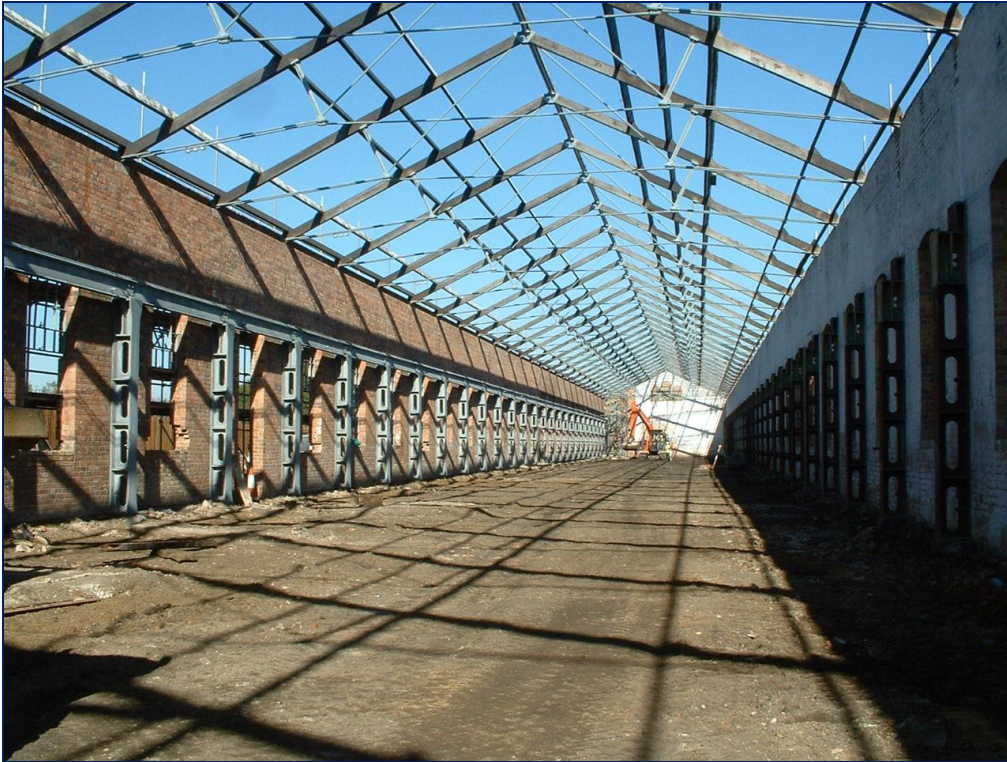
Left: A view of the main train shed in 2007 where the Royal Train of Queen Victoria was kept when not in use.

At this stage, all of the cast-iron support columns on the east side of the building and all of the wrought-iron roof-truss ties have been blast-cleaned and zingaised.

The dirt floor has been totally untouched at this point and the cast-iron windows are being removed as a few of them have cracked frames that need to be re-built before being blast-cleaned and then zingaised.

The houses were built in here.

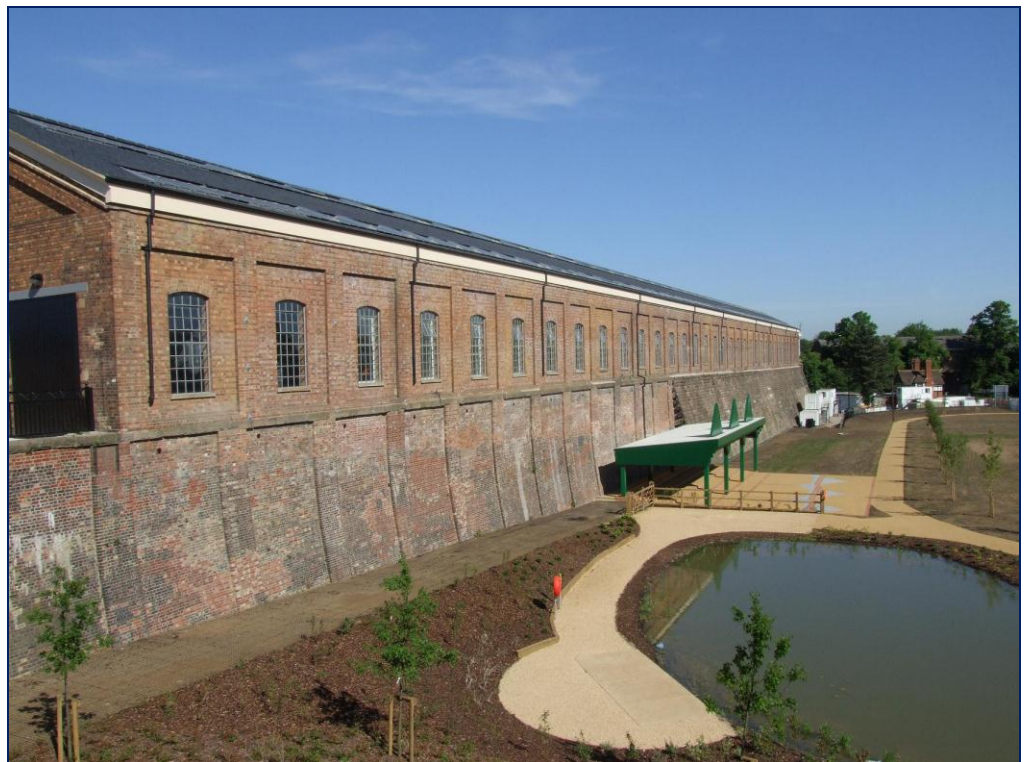
Right: A view of the exterior of the completed building in May 2009.

The 40 cast-iron windows can be clearly seen in this view. They were removed, some were partially re-built and then they were all blast-cleaned and coated with Zinga.

The zinc coating on the window frames was sealed with a one-component polyurethane MIOP coating called Alufer N prior to the final painting with vinyl enamel and then fitting and glazing of the hundreds of glass panes.

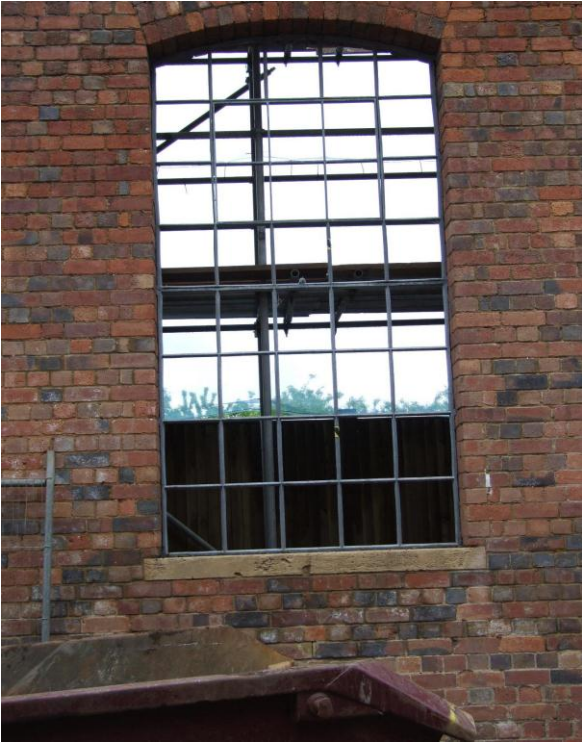
The cast-iron windows measured 5 feet x 12 feet high

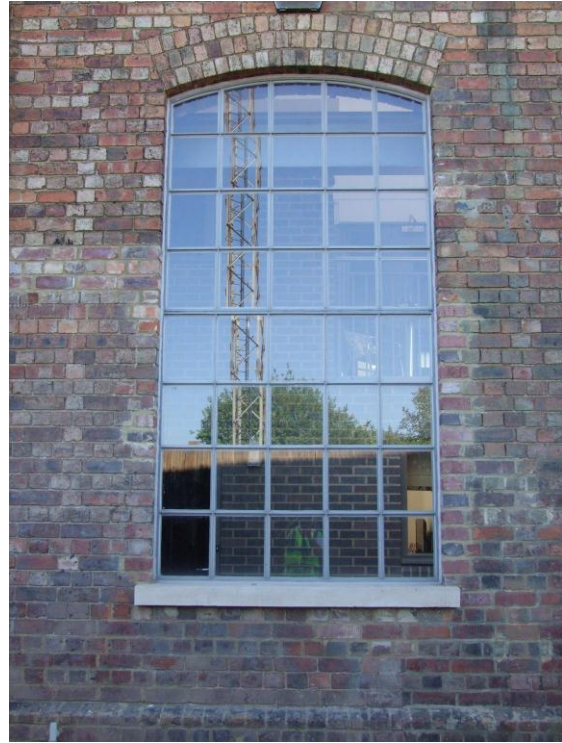
Three frames were cracked and were welded and then blast-cleaned as normal before being coated with Zinga

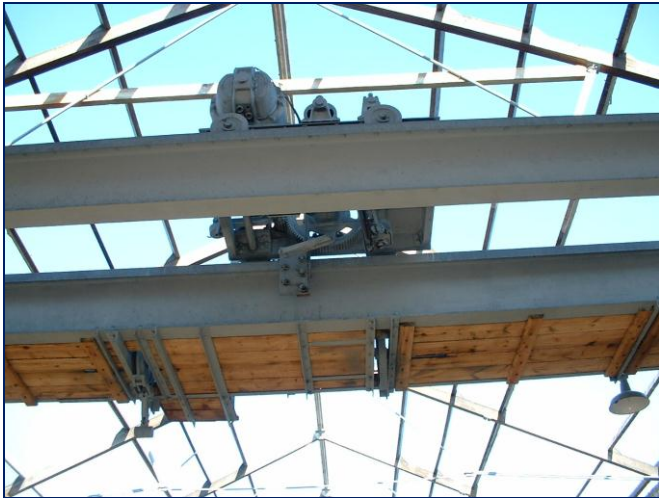
The crane was blast-cleaned and zinganned in '07 before the roof had its new timbers and glass skylights fitted.

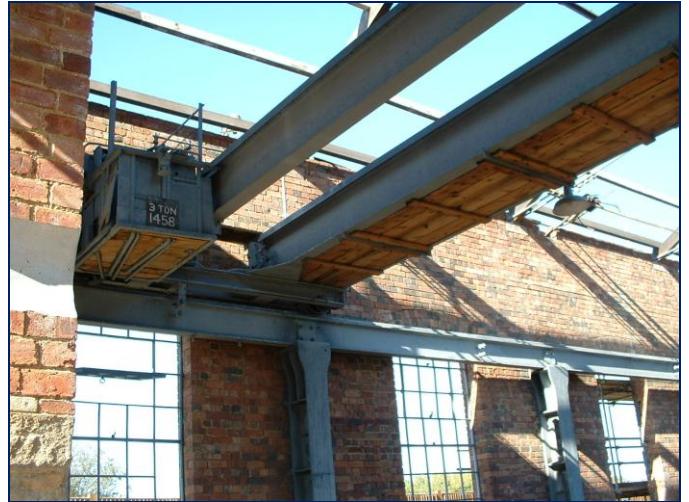
A view showing the crane resting on the H-beams supported by the vertical cast-iron columns.

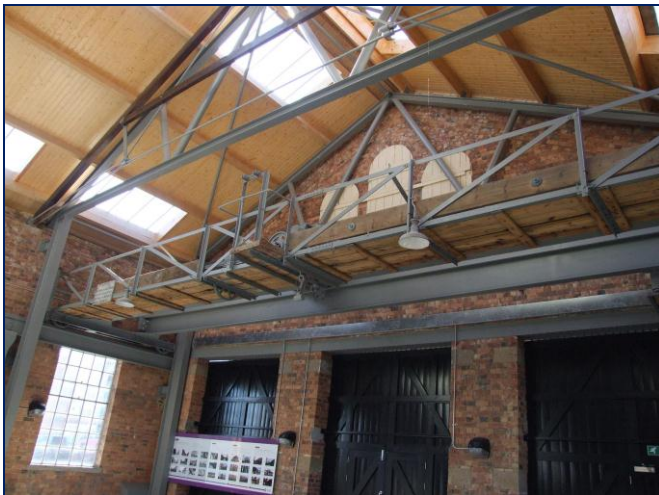
This view of the crane in May '09 shows the roof timbers and skylights now in place

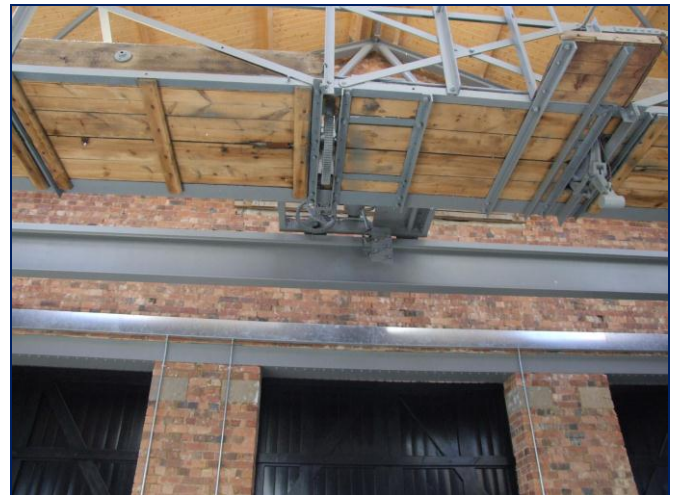
The original crawl-plank on the overhead crane were cleaned off and re-fitted onto the framework

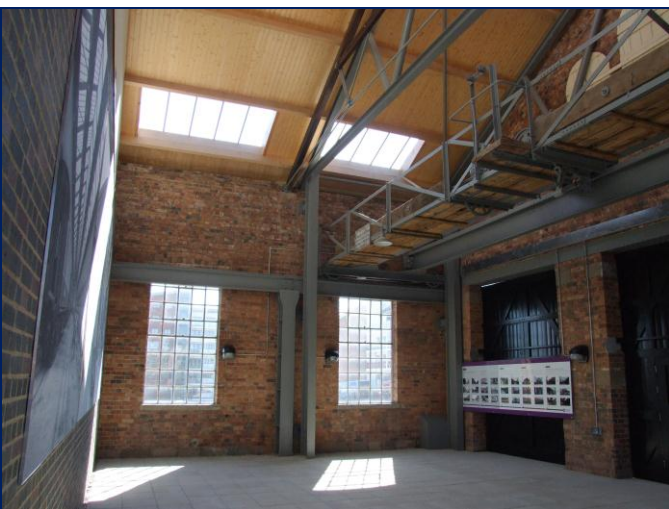
Entrance hall showing zinganned steelwork everywhere

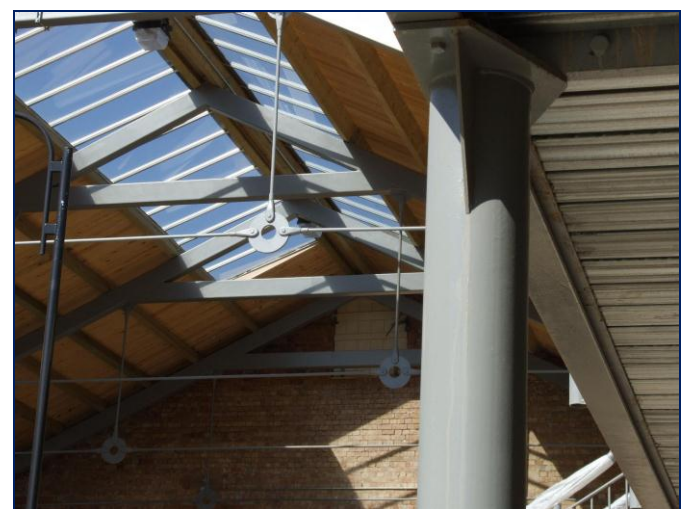
Cast-iron column, wrought iron roof-tie and mild-steel truss
