## 20 YEAR OLD BELZONA PUMP COATING

Power Plant, Yates, Texas

Cooling water pump in a coal fired power plant.

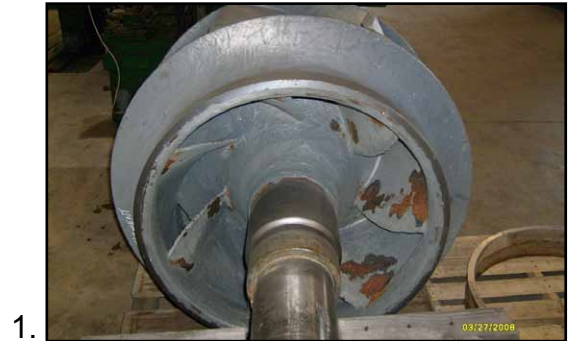
Inspection of the coated impeller showed it to still be in excellent condition with only small areas of cavitation damage. Coated pumps have proven themselves to far outlast uncoated ones, minimizing maintenance costs and downtime.

1. Cavitation Damage
2. Vanes in like-new condition
3. & 4 Closeup of localized cavitation damage. Note no corrosion creep under the coating
