# Successful Stainless Swimming Pool Design

by Catherine Houska, CSI and James Fritz, Ph.D  
(Extracted from Construction Specifier Magazine, December 2005)

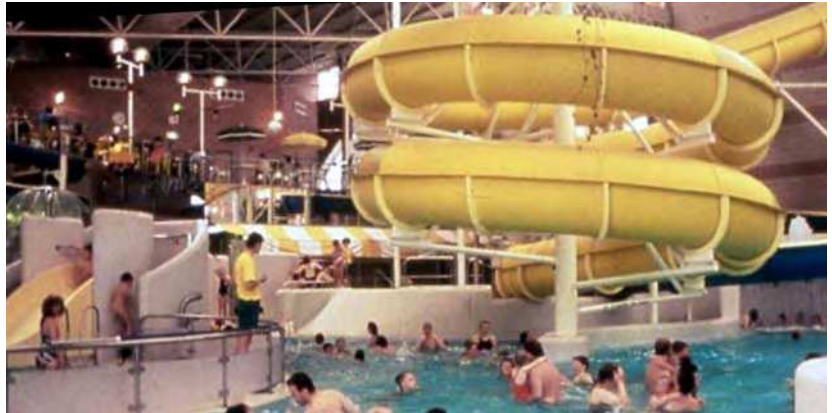
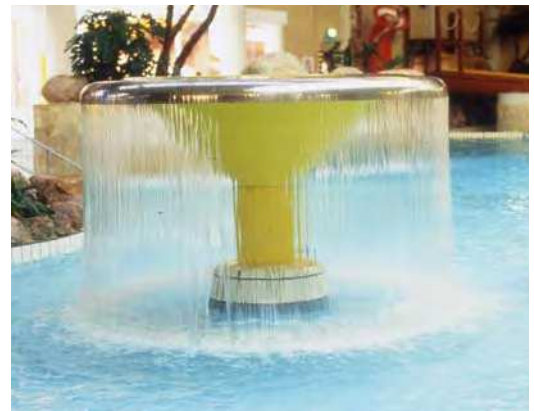
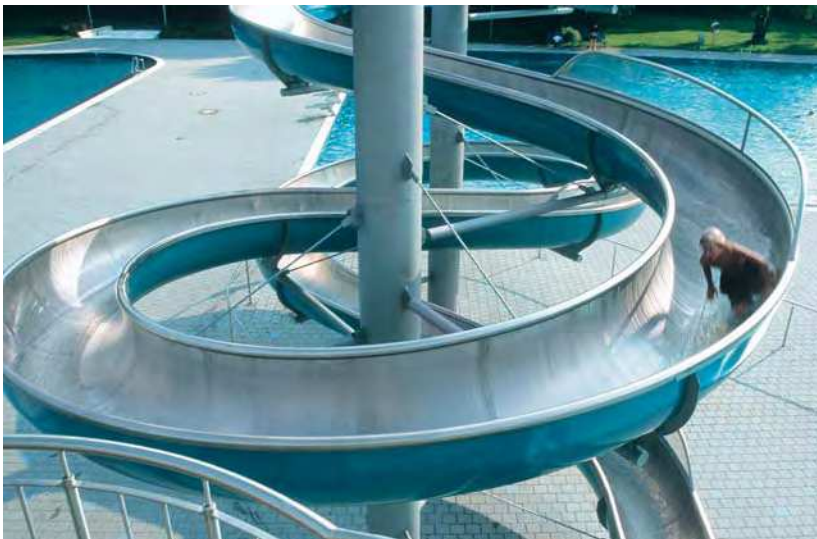
Figure 1

Figures 1, 2 and 3: Stainless steel swimming pool slide and water feature.

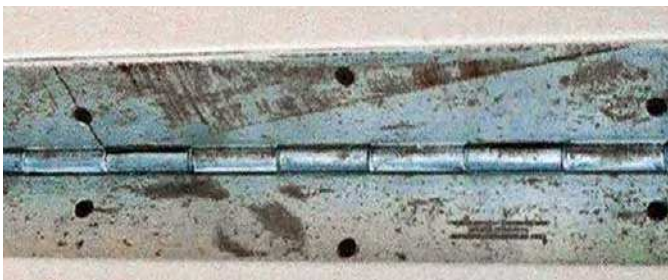
**Figure 5:** Carbon steel brushes were used by a cleaning contractor on this stainless steel door hinge that was installed beside an indoor swimming pool. The areas with carbon steel contamination are rusting. Photo courtesy of TMR Consulting

Poor maintenance and the use of inappropriate cleaning compounds can be another factor in corrosion performance. Carbon steel wool and wire brushes should never be used for cleaning or 'refinishing' stainless steel since particles can become embedded in the surface. These carbon steel particles corrode at the same rate as unprotected carbon steel and cause unsightly surface damage.

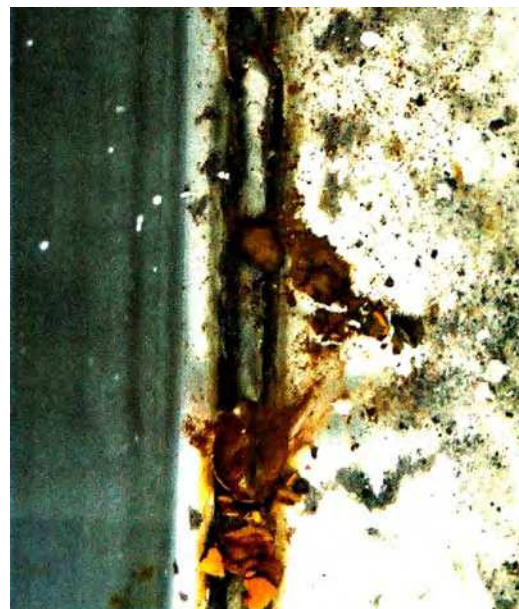
**Figure 6:** This weld within a swimming pool gutter was not cleaned properly and pitting corrosion is occurring along the weld seam. Photo courtesy of TMR Consulting

In cases where stainless steel components have welded joints, the welds should provide the same level of corrosion performance as the surrounding metal. Therefore, corrosion on and around welded stainless steel joints is unacceptable. Grinding and pickling joints is the best means of restoring a weld's corrosion resistance.

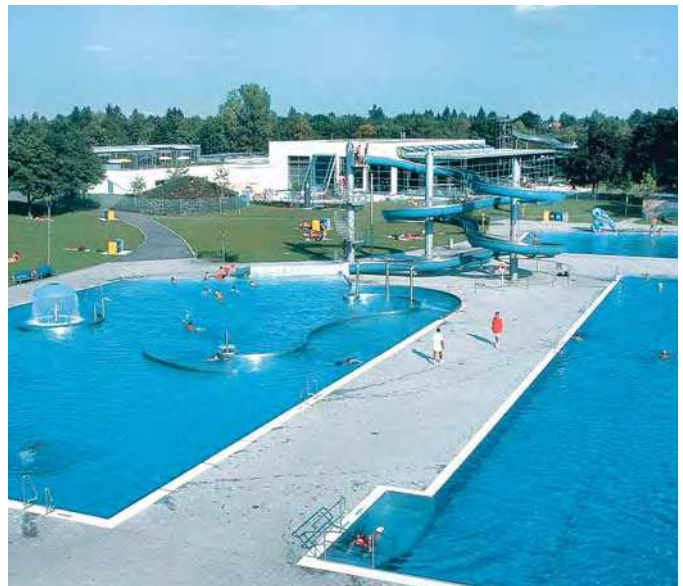
**Figure 8:** This swimming pool in Munich, Germany was relined with Type 316 stainless steel panels that were welded together. Photo courtesy of Martina Helzel

Bare Type 316 stainless steel has been used for pool linings, particularly in Europe.<sup>8</sup> In relining applications, stainless steel has replaced plastic and ceramic tiles, while in new pools, self-supporting structures composed of stainless steel sheet and structural framing are typically used for water depths up to about 2 m (6.5 ft). Deeper pools typically require a secondary support structure or heavier wall panels due to water pressure loads. The stainless steel panels are welded together, producing a watertight structure, and the seams are pickled to restore corrosion resistance. Pool lane markings can be applied in advance using electrochemical coloring, which eliminates maintenance painting.

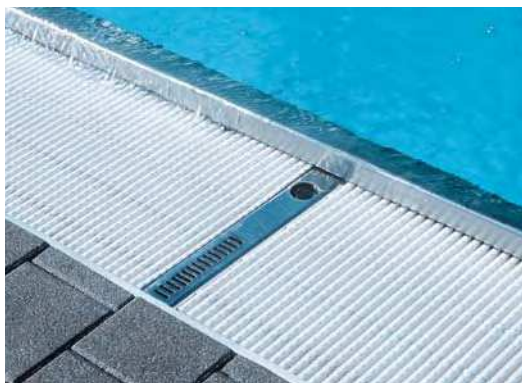
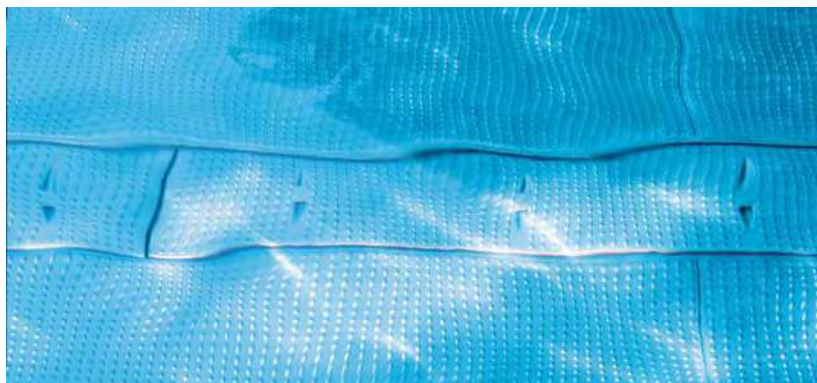
**Figure 10 and 11:** Type 316 pool gutters and water jet openings in the floor plates. Photos courtesy of Martina Helzel

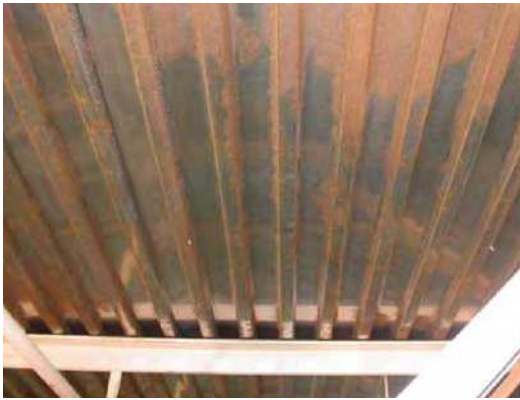
**Figure 12:** Corrosion of a Type 304 stainless steel roof deck above an indoor swimming pool.  
Photo courtesy TMR Consulting

SCC is a concern in load-bearing applications that are not splashed with pool water or cleaned, such as ceiling hangers, fasteners, brackets, supports, bolts, wires, cables, and hooks. Figures 12 and 13 depict an example of SCC attack. This North American Type 304 stainless steel natatorium roof deck was never inspected or cleaned. After a decade of exposure, there was significant brown staining on the roof panels above the diving platforms. Samples were removed from the roof deck and close examination revealed shallow pitting and extensive cracking with some fissures penetrating 80 percent of the cross-section. This cracking resulted because of the following factors:

- The stainless steel was susceptible to SCC.
- There were relatively high residual stresses from the cold working the roof panels and high roof service stress loads, particularly with winter snow loads.
- There was no cleaning to remove the accumulation of aggressive chloride compounds.
- It was a poorly controlled pool environment.
