Case Study: 17726 Sikalastic Roof Cladding Repair

LocationHeathrow airport, land side

The Task: Repair roof to cabin office construction.

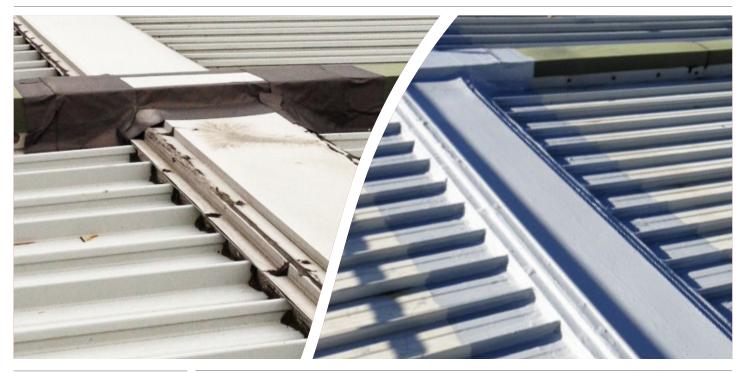
The Problem: Water ingress causing damage to internal fixtures and fittings.

The Solution: A scaffold was erected to provide access and safety rail to roof area.

The faulty roof area was then prepared by cleaning; in this case some cover trims as well. Sikalastic 618 was applied, firstly an embedment coat at 1.5L/m2. The Sika Re-mat reinforcing sheet was then dressed and allowed to cure.

Finally a top coat of Sikalastic was applied at 0.75L/m2.
