MINTEX®

Brake Pad and Brake Disc Fault Diagnosis

Technical information

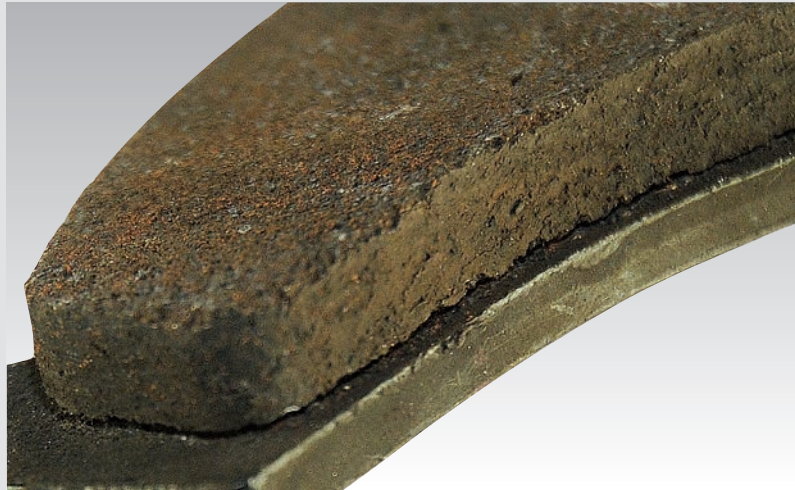
- Edge detachment due to the use of new brake pads on extremely worn brake discs
 - Inadequate spring force of the hold-down spring (off-centre travel)
 - Other mechanical overloading
 - Constant high thermal stress on the disc brake pads
-
- Friction material becomes porous (completely or in spots)
 - Friction material has become disconnected due to corrosion
 - Backing plate has obvious traces of corrosion
 - Adhesive residue
 - Underlayer and friction material visible on backing plate

► **Edge deterioration**

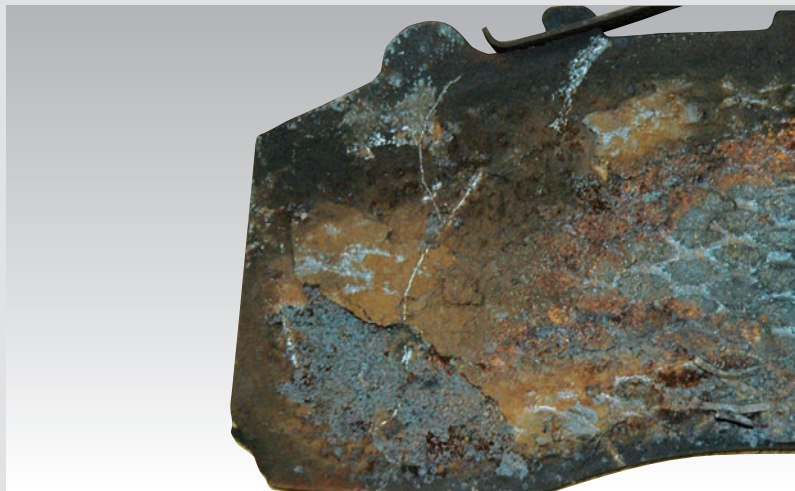
► **Heavy underlying corrosion**

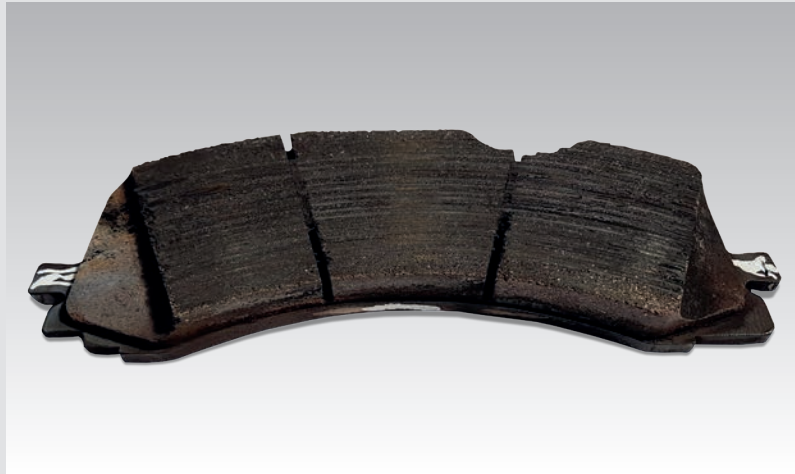
Disc brake pads have exceeded the highest permissible temperature for longer than 15–20 minutes.

During this time, constituents that contribute significantly towards stability are destroyed.

- ▶ Friction material decomposes, breaks off in some places and/or the underlayer and adhesive are damaged. Pad detaches completely; coating peels off. Partial colouring of the backing plate. Friction material has hardened, has a hard ring, reddish brown colouring of the friction material, white ash in some places.

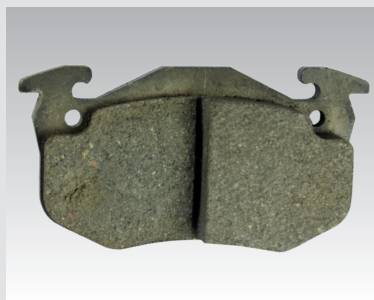
Disc brake pads have been dropped or fitted at a tilt or deformation due to extreme “wobbling” in the brake caliper.

The friction material detaches from the backing plate. Delamination occurs. Disc brake pads are new, separation above the adhesive/underlayer. Damage visible on the backing plate.

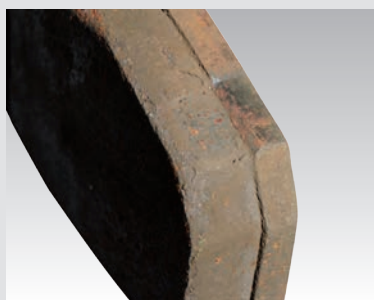
Damage as a result of bending stress visible on the backing plate.

Excessive “wobbling” of the backing plate within the brake caliper.

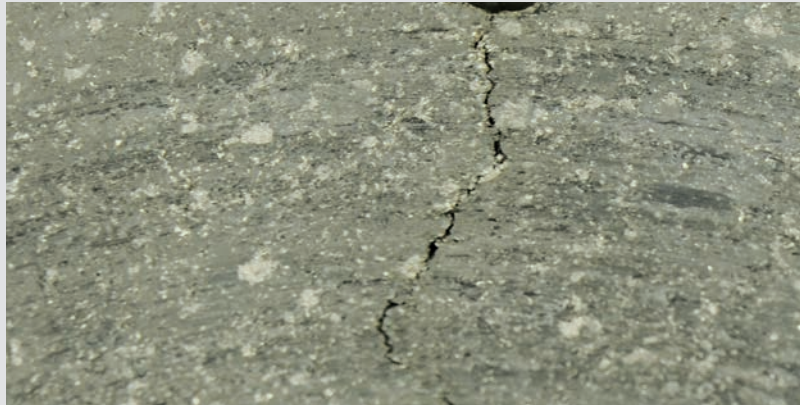
- ▶ Surface cracks can be ignored; they do not pose a safety risk. Even in the case of grooved brake pads, there is no disadvantage regarding pad stability.

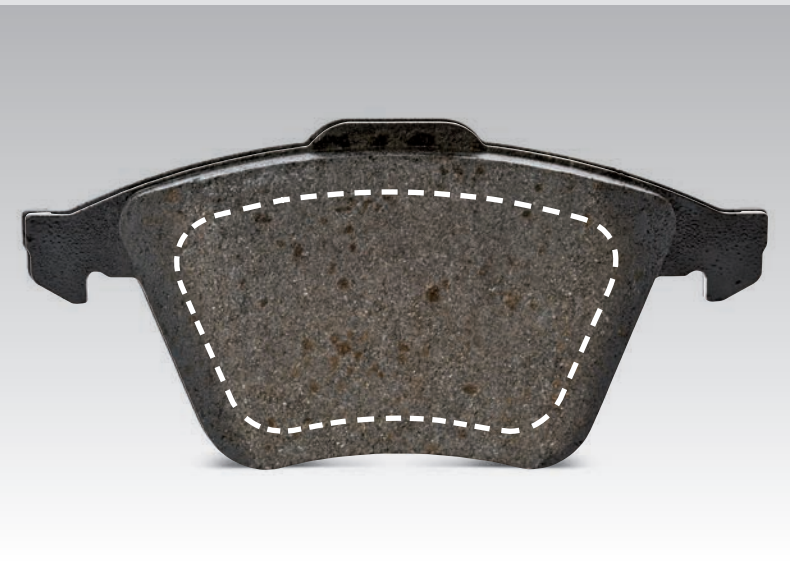
► Break-offs are permissible outside of the area marked, however, up to a maximum of 10% of the total pad surface.

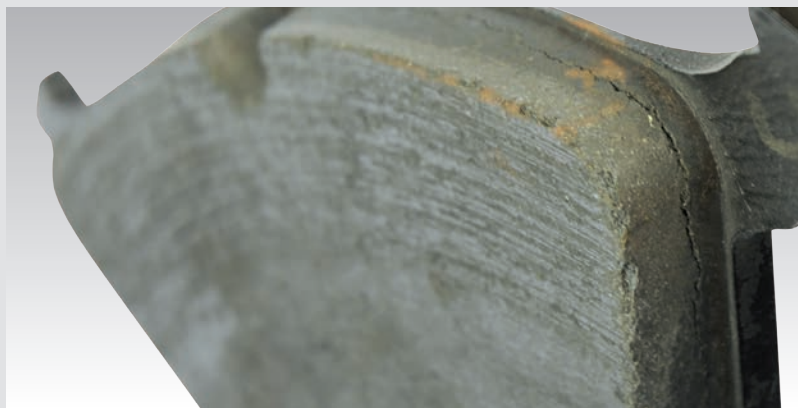
► Pad with inadmissible deterioration

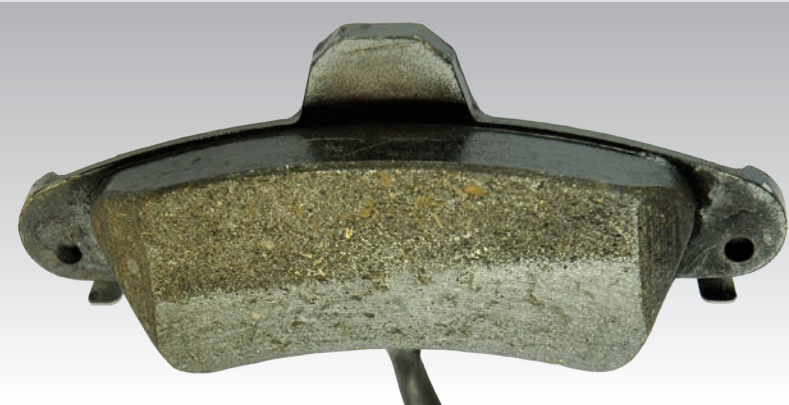
► Pad with inadequate contact pattern

- Worn or incorrect brake disc
- Brake defect/contamination
- Insufficient brake loading
- See also fitting faults/production faults

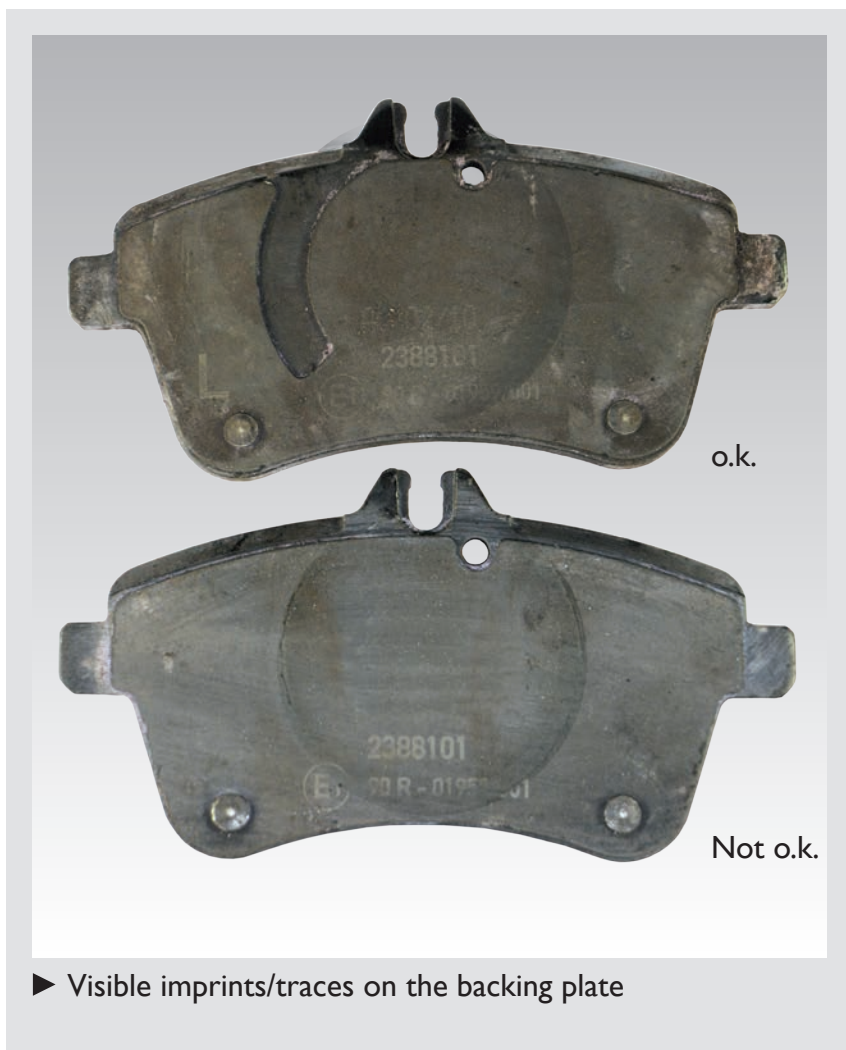
Cause:
Incorrect fitting position

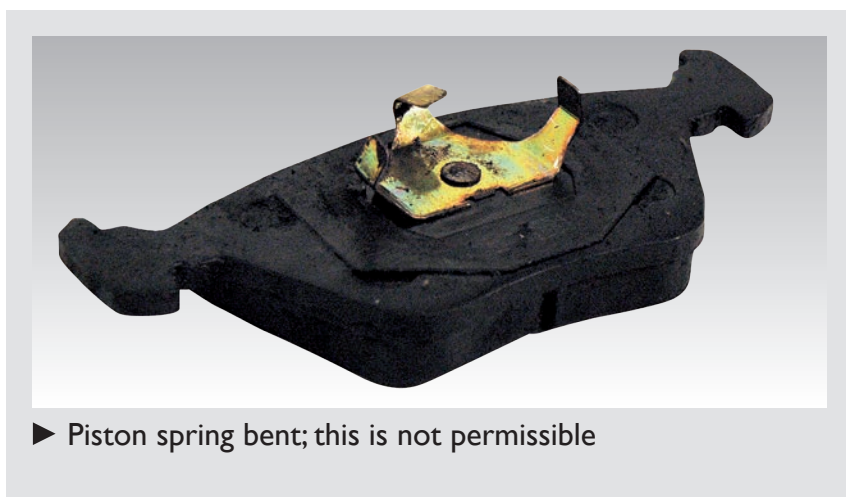
Cause:
Improper handling
prior to/during fitting

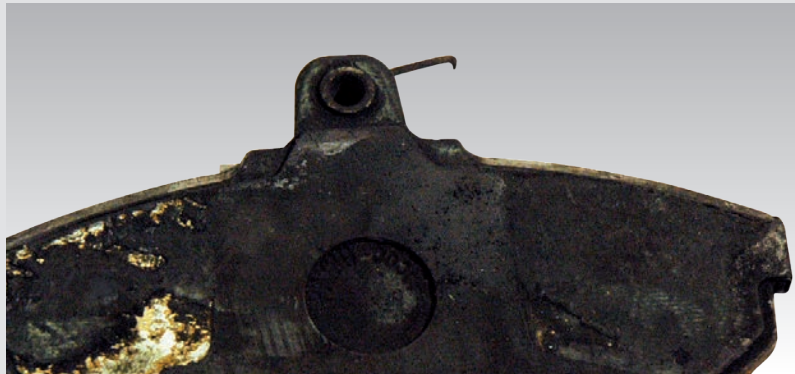
Brake pad fitted improperly

► Hold-down spring broken

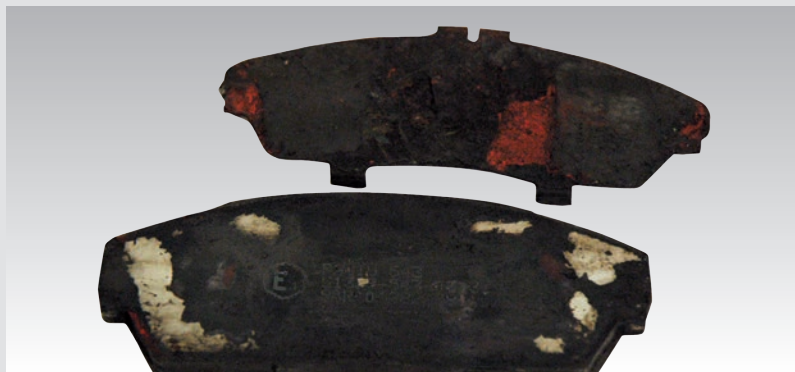
The accessory is subject to use-related wear and, depending on the model type, is included in the scope of supply.

► Clip-on plates worn

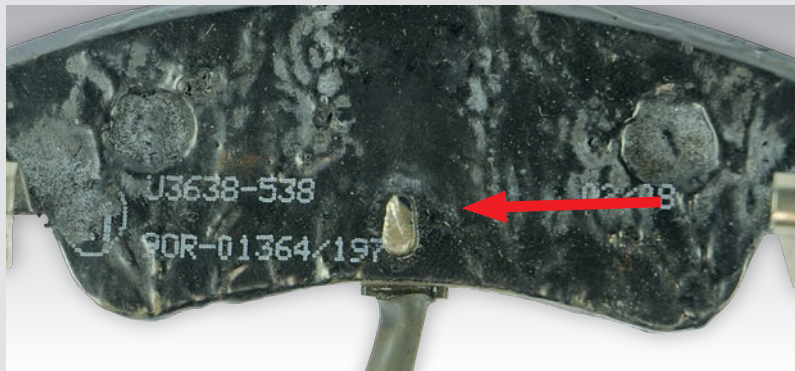
► Piston imprint on the positioning device

Pay attention to correct seating in the caliper in order to ensure perfect functioning..

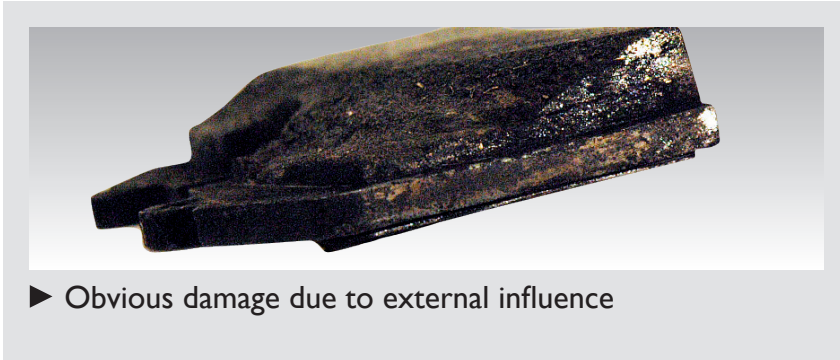
Brake caliper not freed from contamination and corrosion. Dimensional deviation of backing plate..

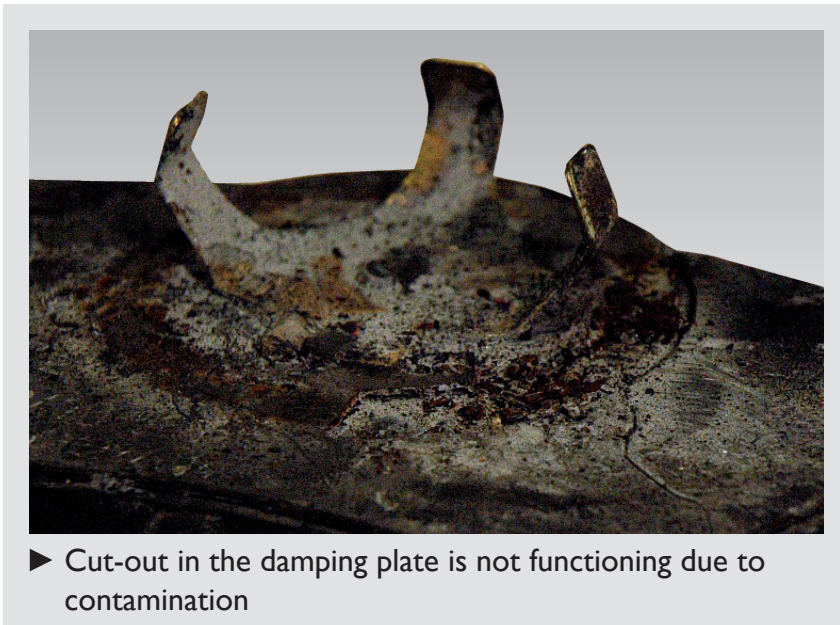
Brake caliper not freed from contamination and corrosion; excessive greasing..

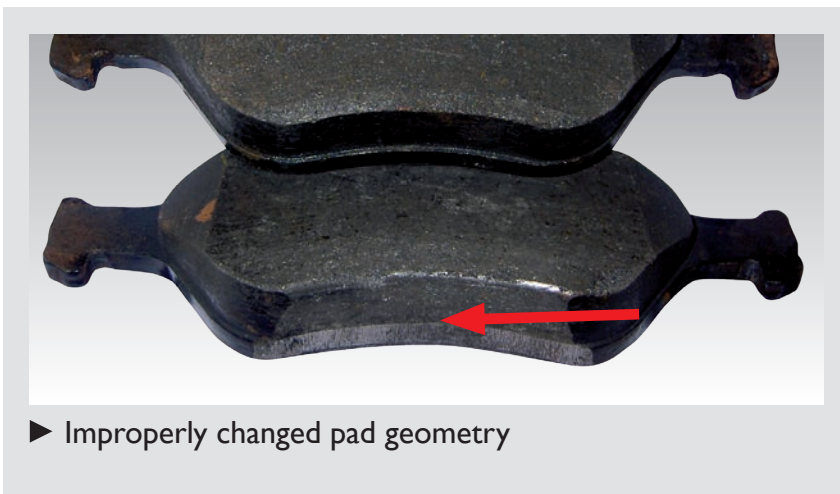
Unacceptable alteration during fitting.

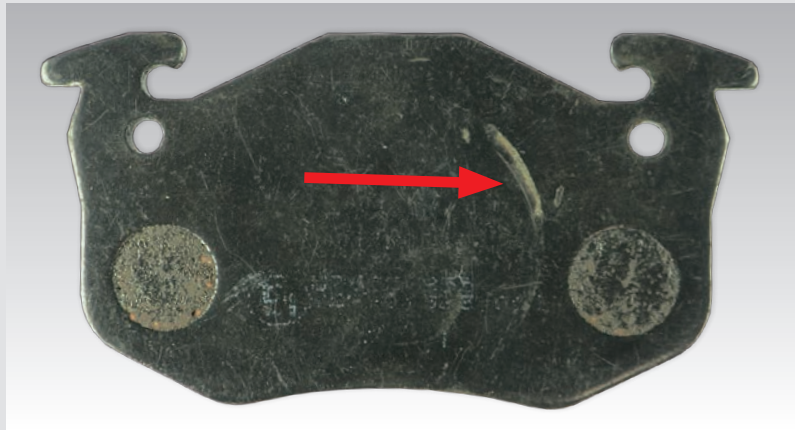
Incorrect seating of the brake pad in the caliper.

► Piston imprint not over complete surface

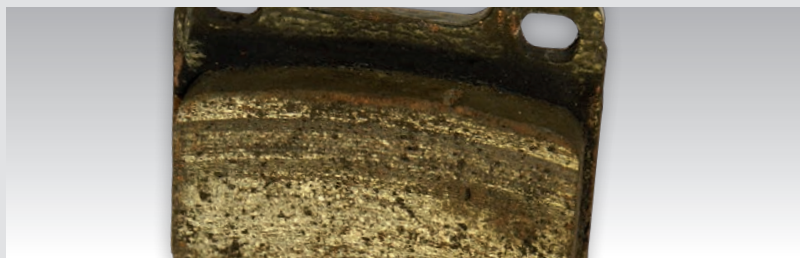
Ingress of foreign bodies such as dirt, salt or corrosion.

Inadequate distribution of friction particles in the friction material.

▶ Deep scoring in the pad surface

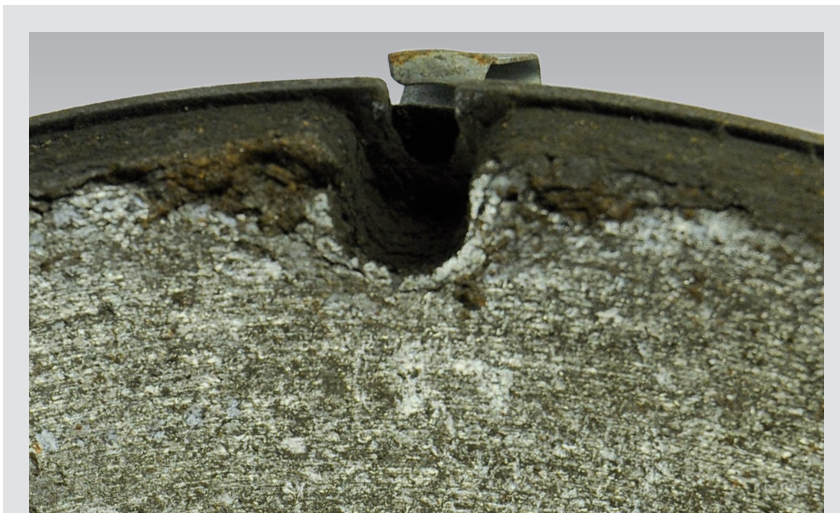
► Break-offs on the surface, no sign of high thermal stress visible

- Inadequate stability of the friction material as a result of a pressing fault, leads to porosity and break-offs on the surface..

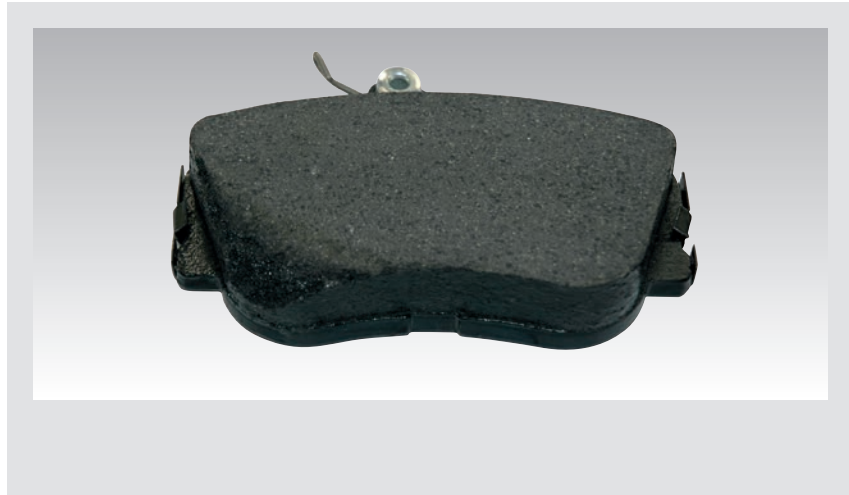
Break-offs on the edges

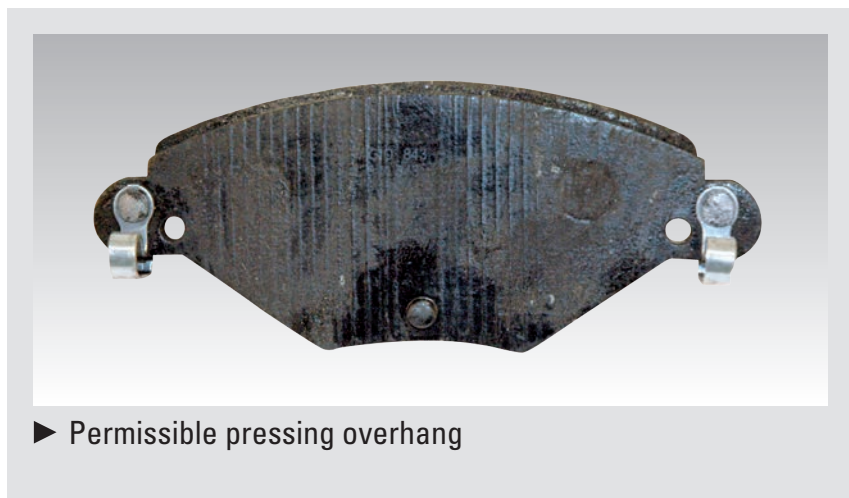
Design-related pressing overhang to completely utilise the friction ring of the brake disc.

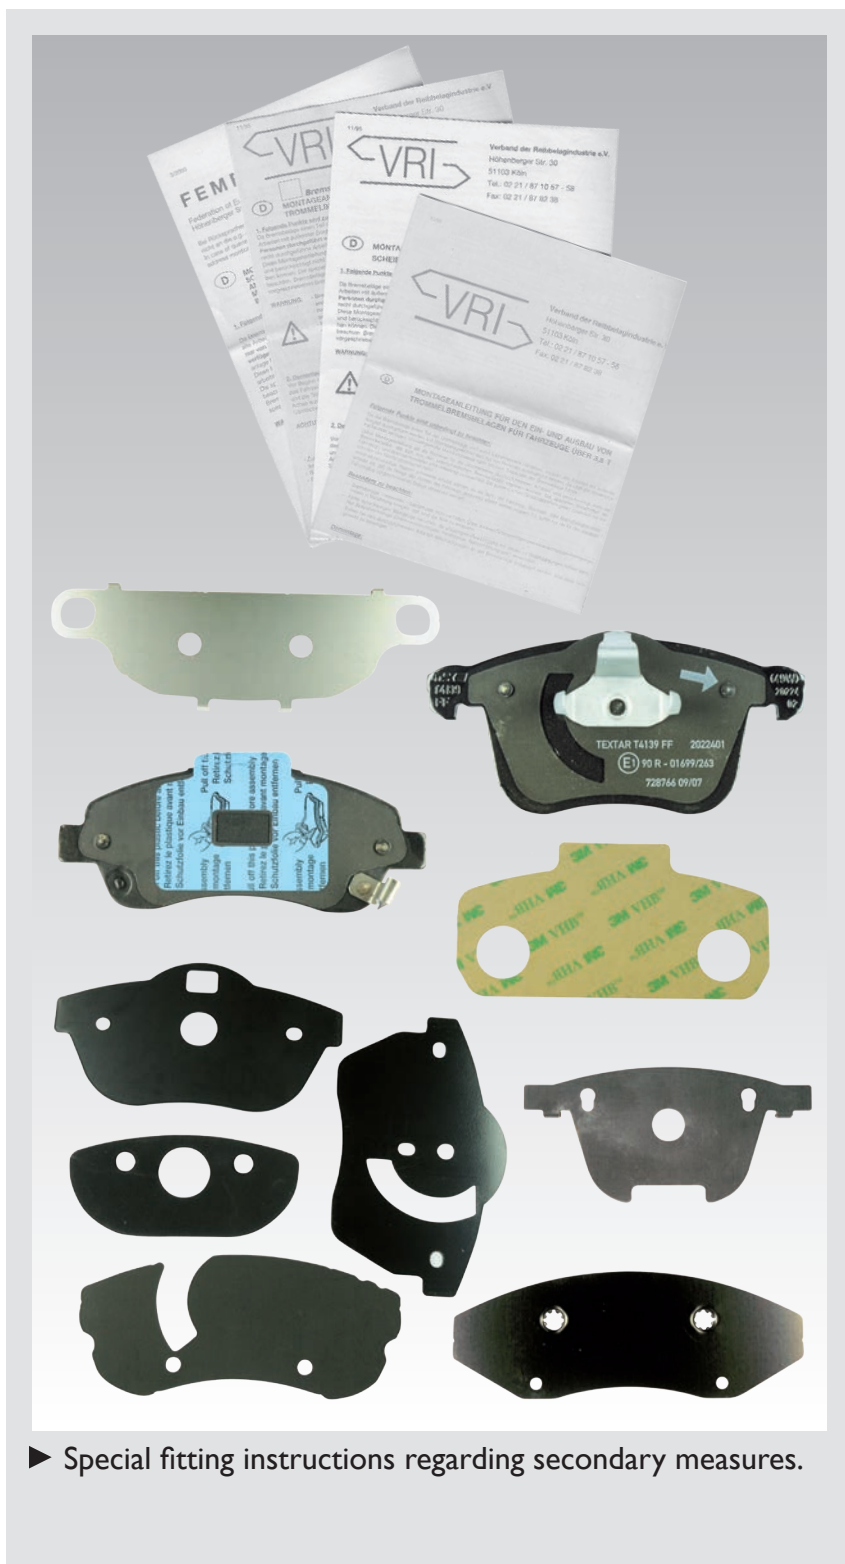
► Special fitting instructions regarding secondary measures.

Special fitting instructions regarding fitment of noise reducing components e.g. shims must be followed to prevent noise, judder, disc cracks as well as uneven wear.

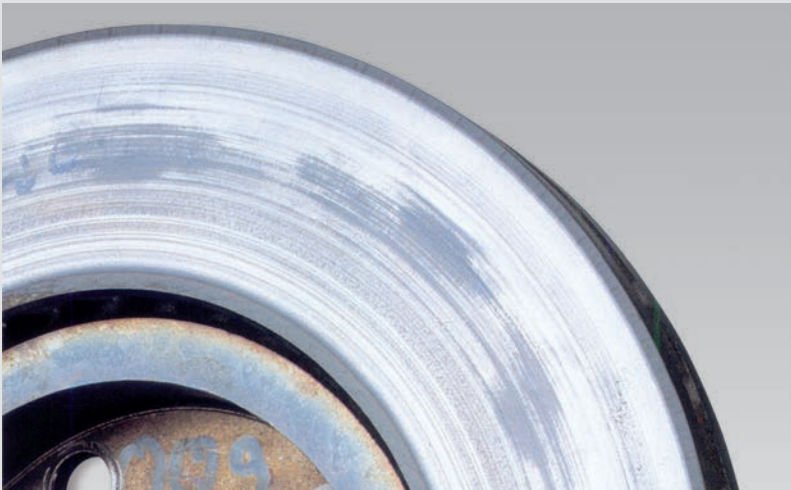
Thermal judder

► “Judder marks” through local overheating of brake disc

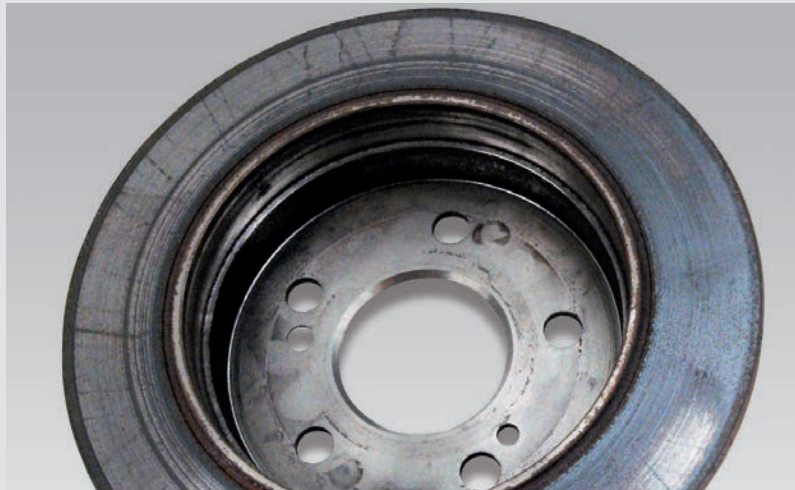
Cause:
Corrosion, caused by humidity, salt or other environmental factors.

► Brake disc with static spots

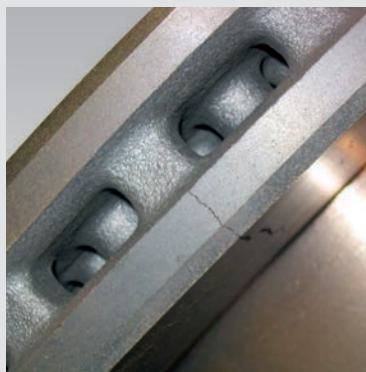
Cause:
Brake disc worn beyond permissible wear limit.

Identification:
Suddenly occurring, severe signs of judder

► Cracked brake disc

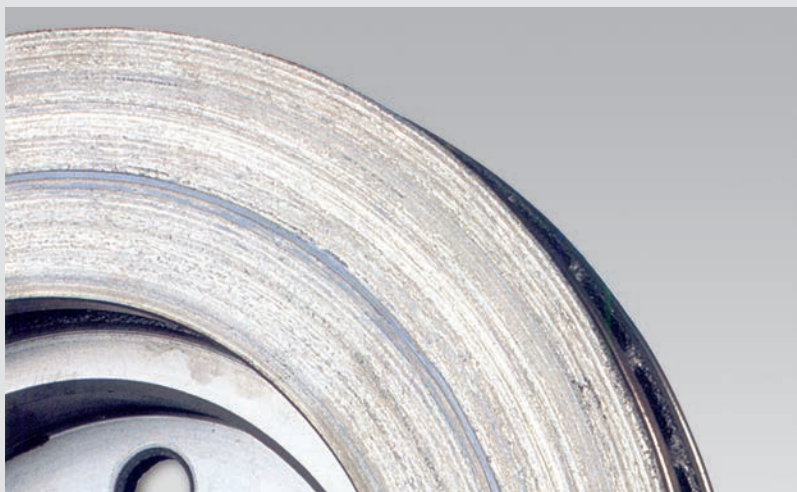
▶ Brake disc with score marks

Cause:
Soiling, overload,
unsuitable disc and/or
brake pad material.

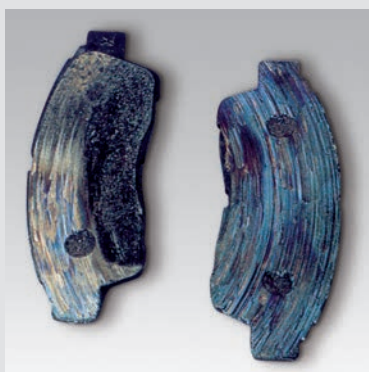
▶ Friction material worn
down to the steel back plate

Cause:
Brake pads not
replaced in time.

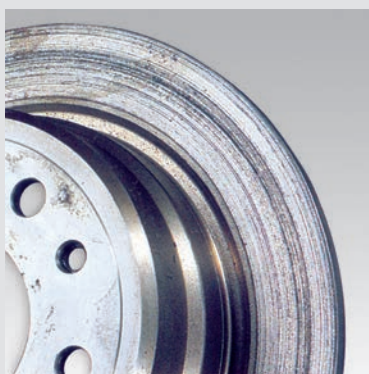
▶ Brake discs damaged by
contact with backplate
due to worn out friction
material

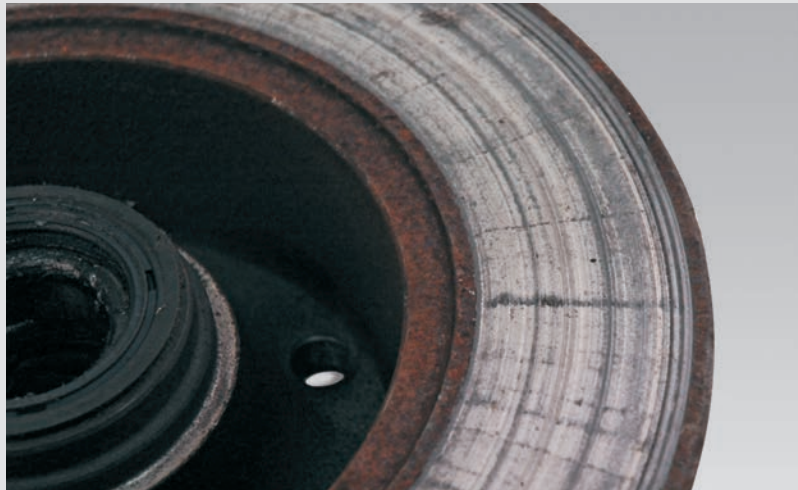
Rough brake, braking noise, signs of judder.

► Corroded brake disc

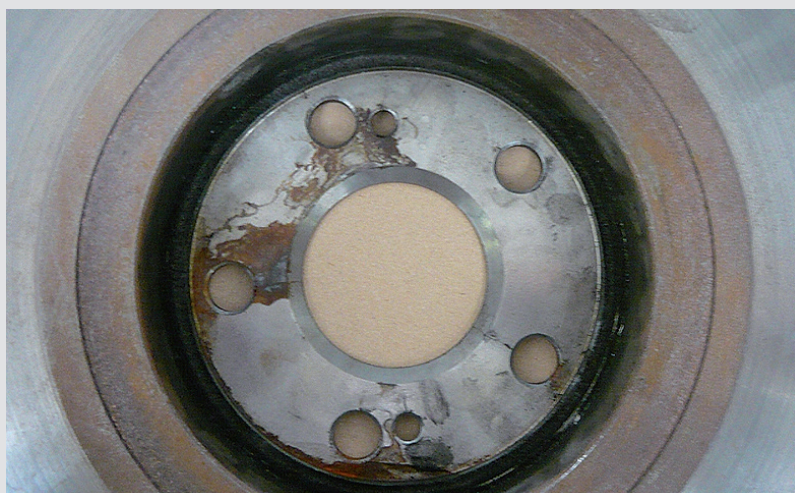
- Mounting fault (incorrect torque when mounting the brake disc).
- Incorrect seating of the brake disc as a result of non-adherence to the manufacturing tolerances.

Effect:
Reduction of stability;
brake noise

► Cracks in the area of the brake disc chamber
