Case Study – Major Component Repair

- ❖ Location: Magherafelt, Northern Ireland
- ❖ Turbine: Bonus B23 150kW
- ❖ Client: JE Wind

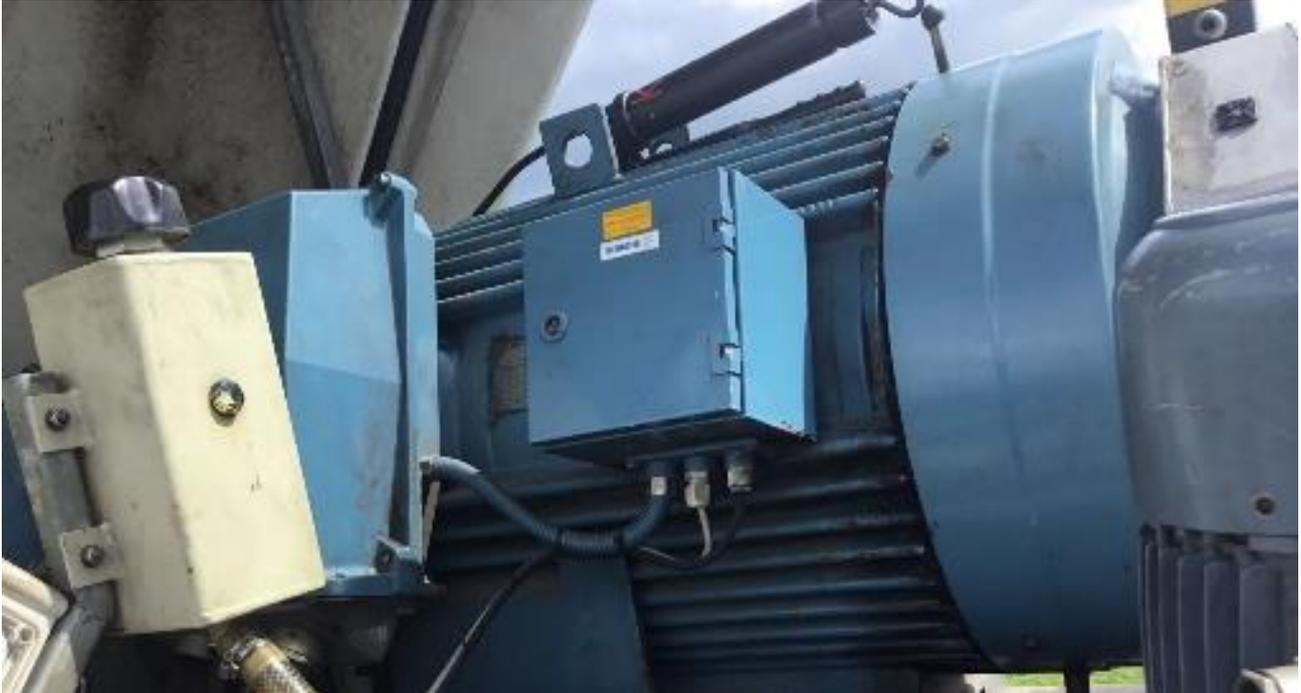
Prior to the arranged inspection taking place we were informed by the turbine owner that it had experienced a major breakdown, and, at the owner's request, a service team was dispatched to site to investigate the fault. On inspecting the generator, it was found that the insulation on the generator windings had suffered a failure and, as a result, the windings and terminals had suffered considerable heat damage rendering the generator inoperable. It was subsequently found that the cause of this failure was due to a major failure where the windings had been overloaded and had, as a result, burnt out. With storm conditions ongoing at the time of the failure and a number of grid spikes, it is likely that the cause of this failure will have been due to a storm event causing a generator overload and subsequent burnout. Our engineers provided the owner with a detailed inspection report and Realise Energy Services were asked to quote for the removal, repair and re-installation of the generator.

The Generator was removed from the turbine and delivered to an accredited generator repair facility. It was completely stripped down, rewound with new windings, new bearings, seals and terminal block. The windings were dipped in the epoxy resin primer for protection and rebuilt. On completion, the generator was fully tested, passing all tests successfully.

Following final testing at the repair facility, the generator was returned to site, reinstalled and recommissioned. The turbine was then re-energised and the necessary function tests were carried out. On completion, the turbine was fully operational, and the turbine is now maintained by Realise Energy Services under a Standard contract and has continued to run well since the major repair.
