BUILDING SURVEY REPORT

SURVEY DATE 23 Jan 2018

Etna Road, St. Albans

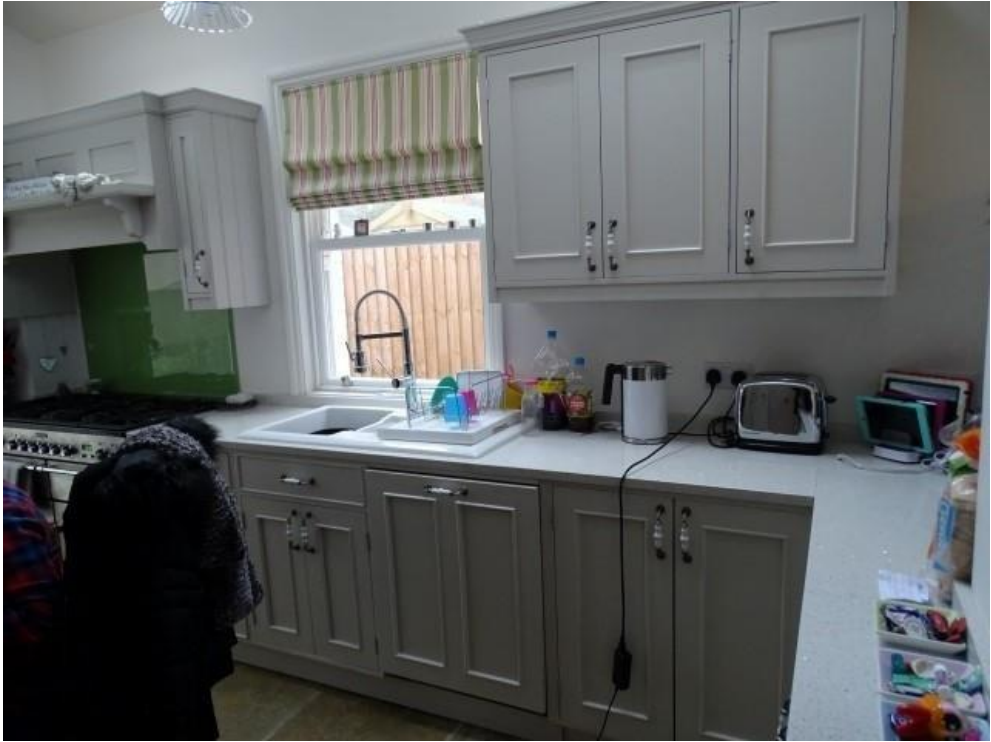
<p>DSC04150 (Small)</p> </div>

<h2 style="text-align: center;">5.6 Built-In Fittings</h2>	<p style="text-align: center;">Condition rating</p>	<p style="margin: 0;">1</p>
<p>Construction & Type</p>	<p>The kitchen fittings are modern style. The worktops are of marble, units are a mixture of wall-hung and floor standing.</p>		
<p>Nature of inspection and Limitations</p>	<p>The kitchen units and utility room were examined for general condition. A selection of cupboards and drawers were checked for normal operation. Built in appliances were not checked for operation or safety. No significant defects or damage was noted but some modernising and updating may now be required.</p> <p>Fitted wardrobes (and walk-in cupboards) were checked for general condition and door operation. Bedroom 4 wardrobe has a curtain instead of doors</p>		
<p>Condition</p>	<p>No Significant Defects are Noted.</p>		
<p>Action Required</p>	<p>Normal Maintenance is Required</p>

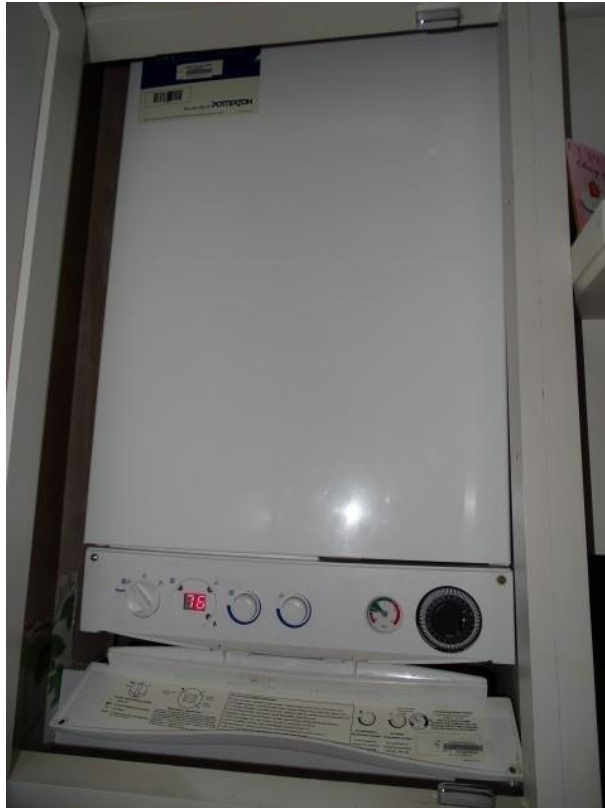
Boiler

Action Required	<p>No visible repairs were noted; normal maintenance servicing must be continually undertaken.</p> <p>Health and Safety – See also notes in 6.2 regarding the general safety and servicing of the complete Gas system.</p>
