**Project Information**Project Name  
**Brunel House**

Date:  
**04/05/2017**

# Site Report

We attended site to conduct a CCTV drain survey of all underground drains, to provide drawings outlining their locations and to provide recommendations for remedial works that may be required.

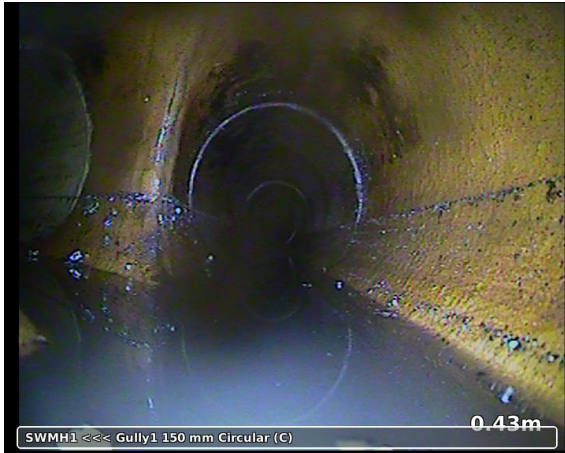
, 00:00:22, 0.43m  
Junction from/at 9 o'clock diameter: 150 mm

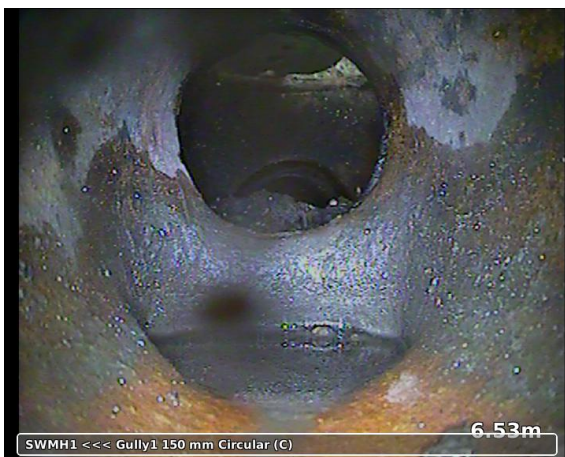
, 00:01:04, 6.53m  
Finish node type gully reference number: Gully1

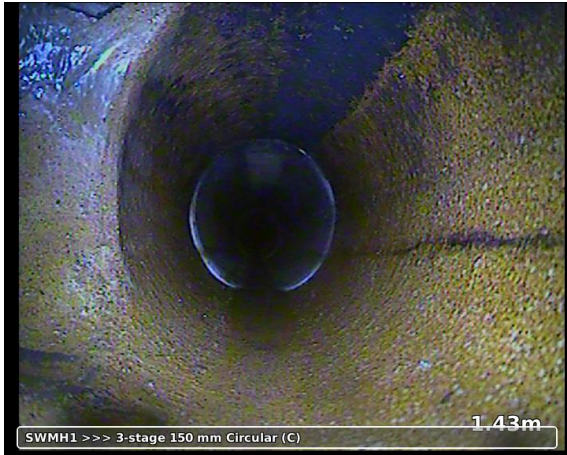
, 00:00:16, 1.43m  
Junction from/at 9 o'clock diameter: 150 mm

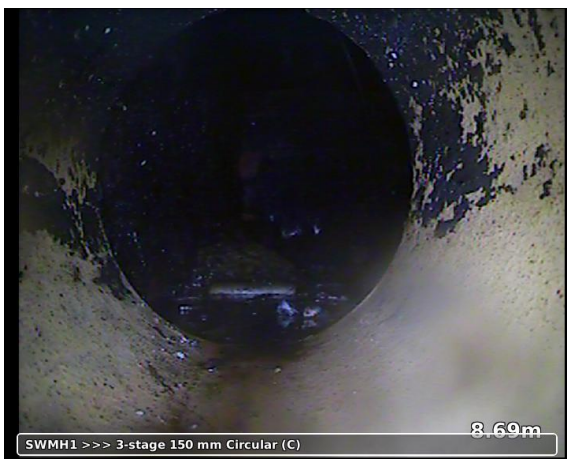
, 00:00:57, 8.69m  
Finish node type manhole reference number: 3-stage

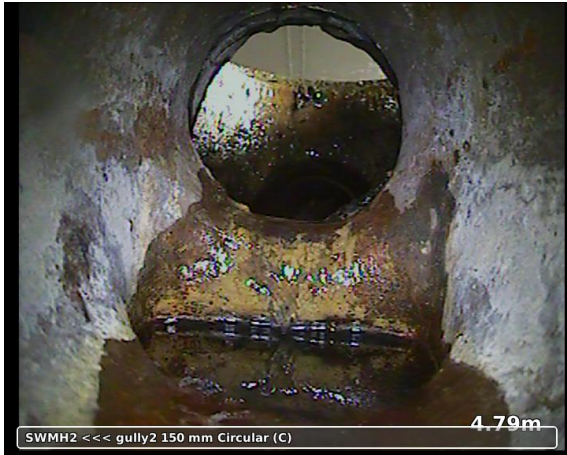
, 00:00:40, 4.79m  
Finish node type gully reference number: gully2

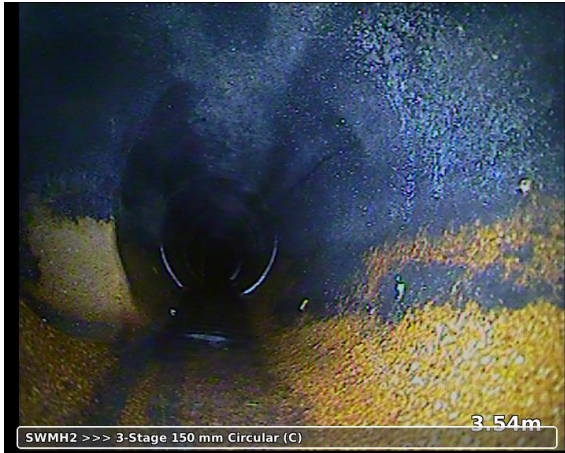
, 00:00:26, 3.54m  
Junction from/at 9 o'clock diameter: 150 mm / RWDP

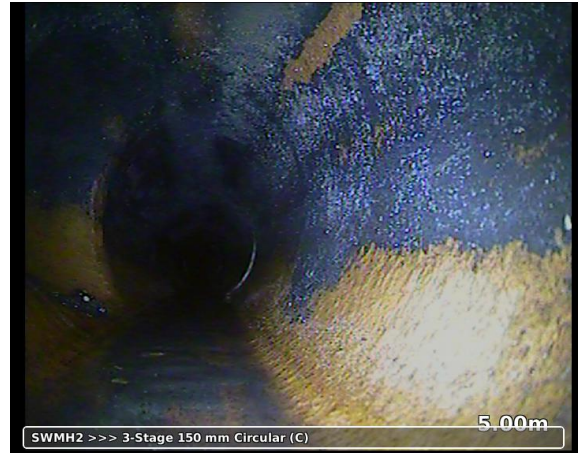
, 00:00:46, 5.00m  
Junction from/at 9 o'clock diameter: 150 mm / gully

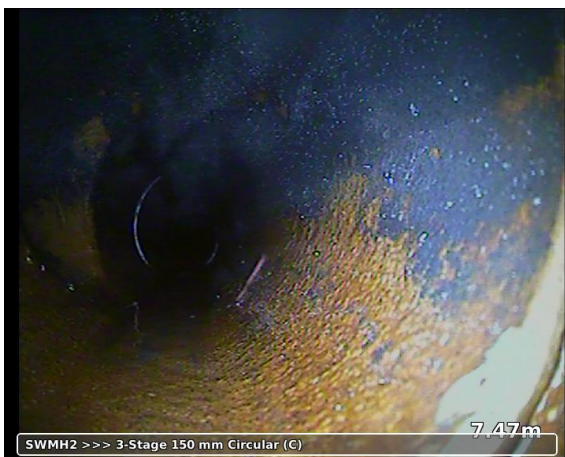
, 00:01:01, 7.47m  
Junction from/at 9 o'clock diameter: 150 mm / RWDP

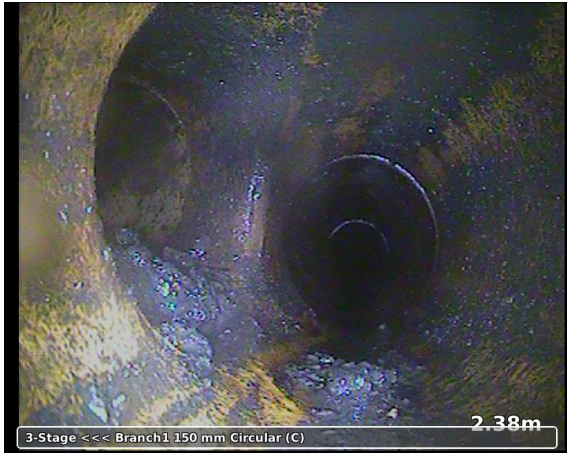
, 00:00:46, 2.38m  
Junction from/at 9 o'clock diameter: 150 mm

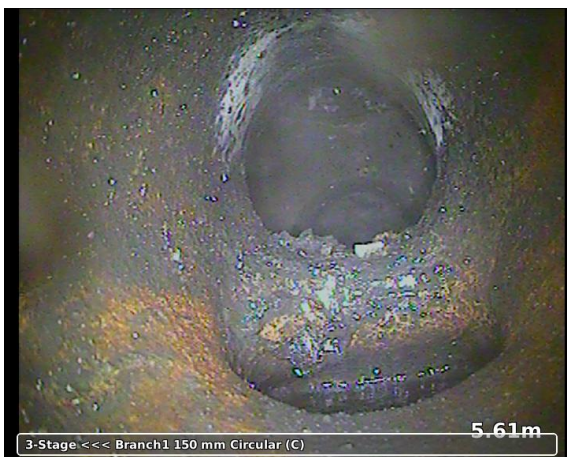
, 00:01:15, 5.61m  
Finish node type gully reference number: Branch1 / gully

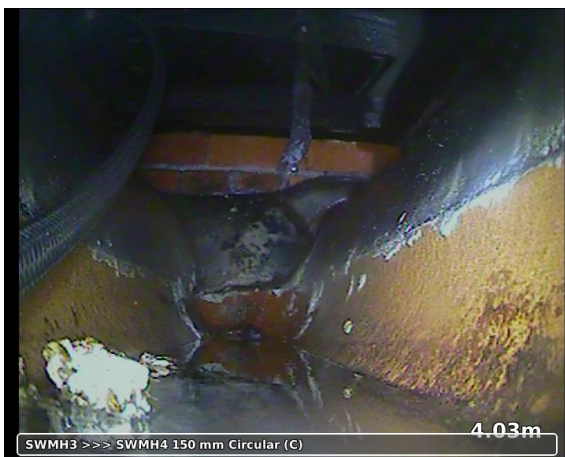
, 00:01:13, 4.03m  
Finish node type manhole reference number: SWMH4

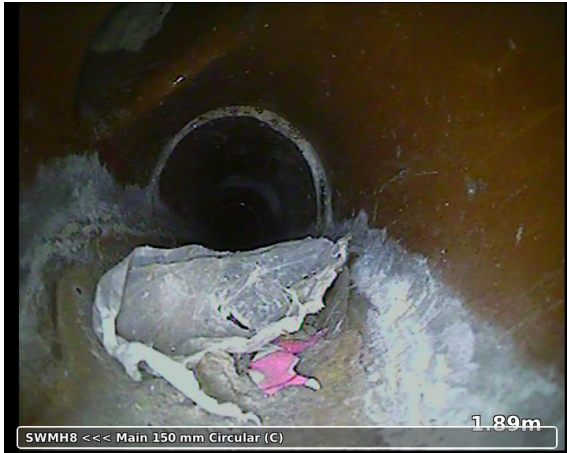
, 00:00:47, 1.89m  
Junction from/at 10 o'clock diameter: 150 mm

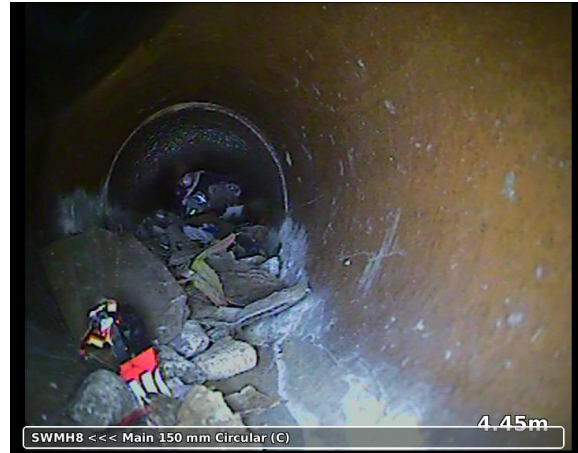
, 00:01:19, 4.45m  
Junction from/at 10 o'clock diameter: 150 mm

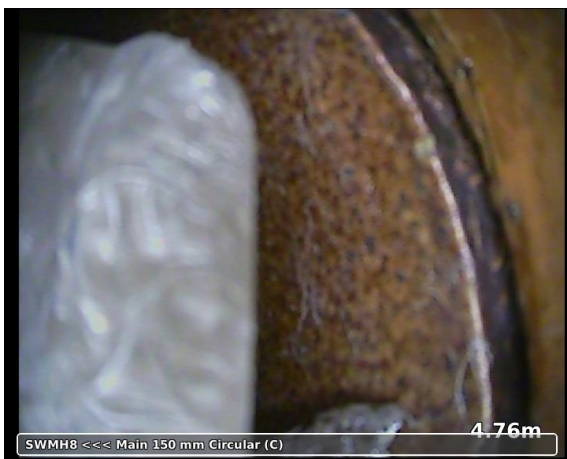
, 00:01:25, 4.76m  
Survey abandoned / Enters outlet of storm drain

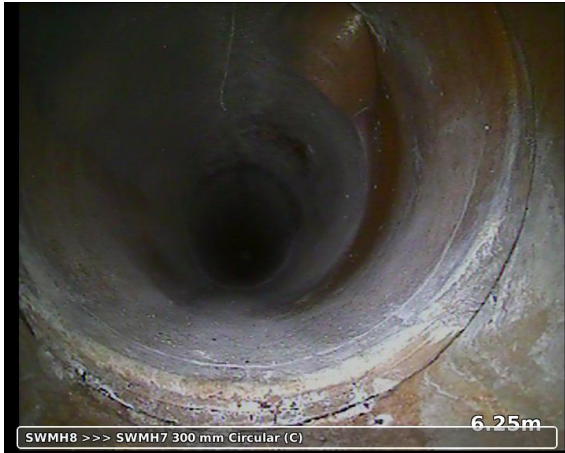
, 00:00:43, 6.25m  
Junction from/at 1 o'clock to 2 o'clock diameter: 100 mm

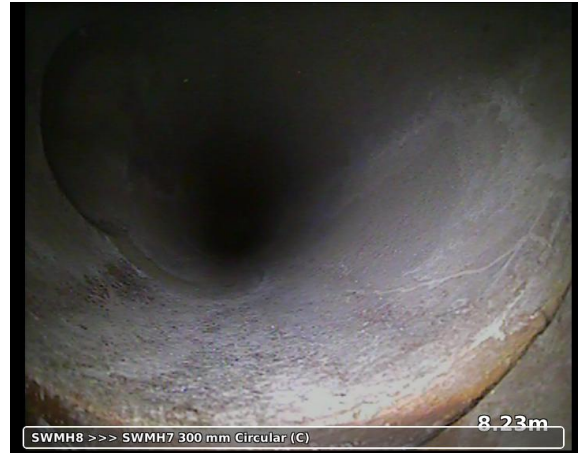
, 00:00:54, 8.24m  
Junction from/at 9 o'clock diameter: 150 mm

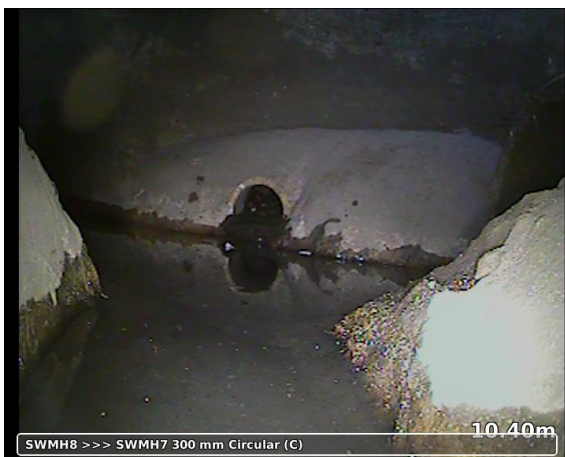
, 00:01:10, 10.40m  
Finish node type manhole reference number: SWMH7

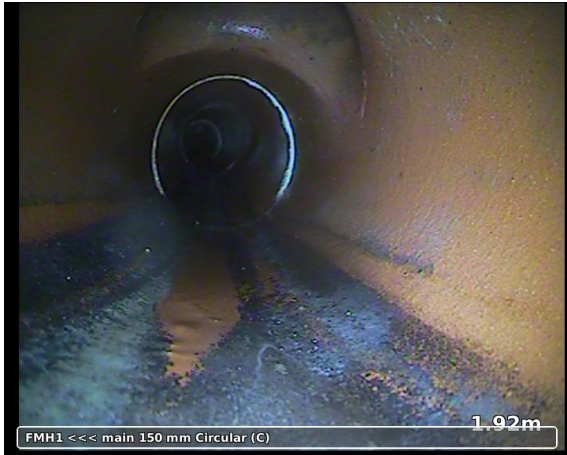
, 00:00:21, 1.92m  
Junction from/at 12 o'clock diameter: 150 mm

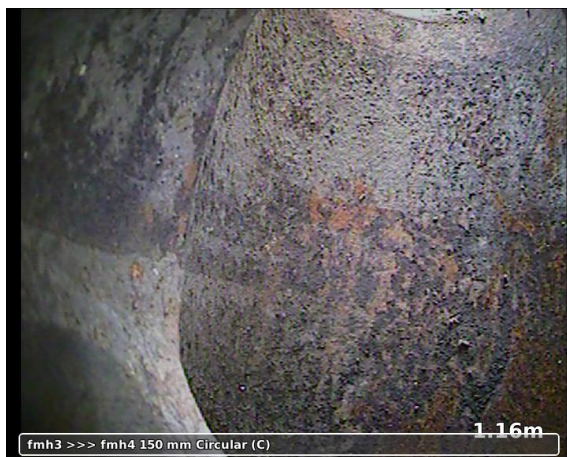
, 00:00:54, 1.16m  
 Finish node type manhole reference number: fmh4
