MANAGEMENT ASBESTOS SURVEY REPORT

SURVEY REPORT WITH MATERIAL ASSESSMENT

Survey Type: Management Survey

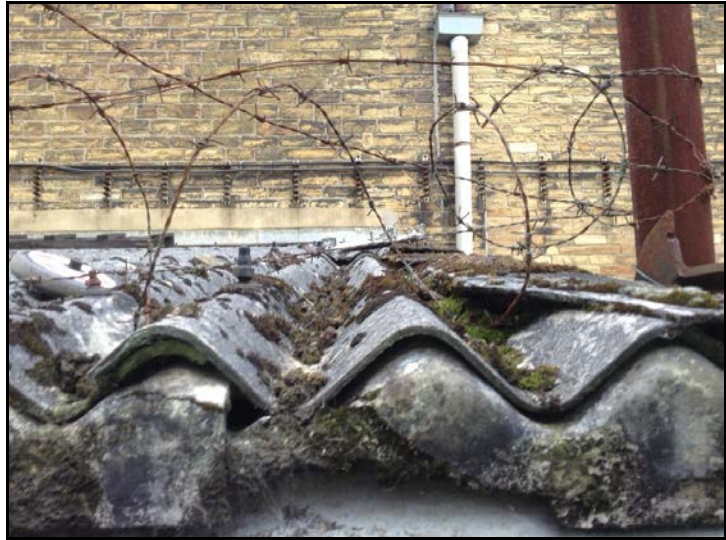
Site ID xxxxxx
Location ID 053
Building/Unit Site Name
Floor 0 (Ground)
Room / Area External Areas (Toilets)
Description Roof Sheets & Barge Boards
Surveyed Yes
Source of Information Name of Surveyor
Last Inspection Date Xx/xx/xxxx
Lab Reference
Survey Type Management
Sample Number xxxxxx/X29

MATERIAL ASSESSMENT = 4

Material	Cement Product (2)	Surface Treatment	Unsealed cement / Enclosed lagging or spray / Encapsulated board (1)
Condition	Good Condition (0)	Sample Result	Chrysotile
Location	Outdoors	Amount	50 m ²
Accessibility	Occasional Disturbance

Recommendations **The asbestos cement is in a good condition and can remain in-situ if required. A management plan needs to be put in place to monitor the cement on a regular basis for any signs of deterioration or damage. Should any damage occur, then repair or removal by suitably trained persons under controlled conditions should be considered.**

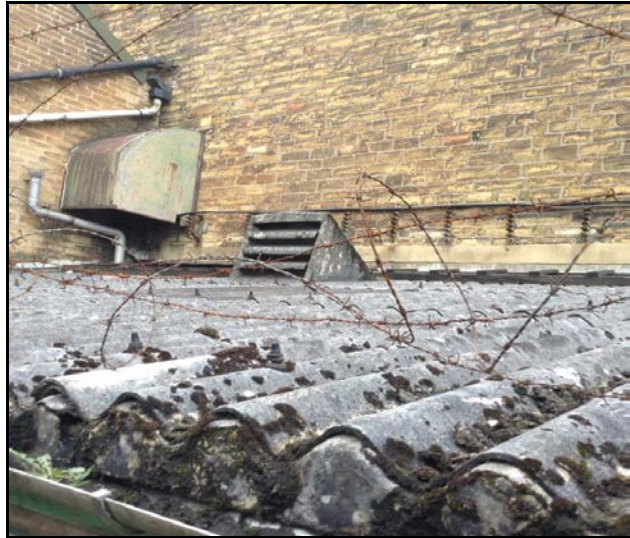
Site ID xxxxxx
Location ID 053
Building/Unit Site Name
Floor 0 (Ground)
Room / Area External Areas (Toilets)
Description Vent
Surveyed Yes
Source of Information Name of Surveyor
Last Inspection Date xx/xx/xxxx
Lab Reference
Survey Type Management
Sample Number xxxxxx/X29

MATERIAL ASSESSMENT = 4

Material	Cement Product (2)	Surface Treatment	Unsealed cement / Enclosed lagging or spray / Encapsulated board (1)
Condition	Good Condition (0)	Sample Result	Chrysotile
Location	Outdoors	Amount	
Accessibility	Occasional Disturbance

Recommendations The asbestos cement is in a good condition and can remain in-situ if required. A management plan needs to be put in place to monitor the cement on a regular basis for any signs of deterioration or damage. Should any damage occur, then repair or removal by suitably trained persons under controlled conditions should be considered.

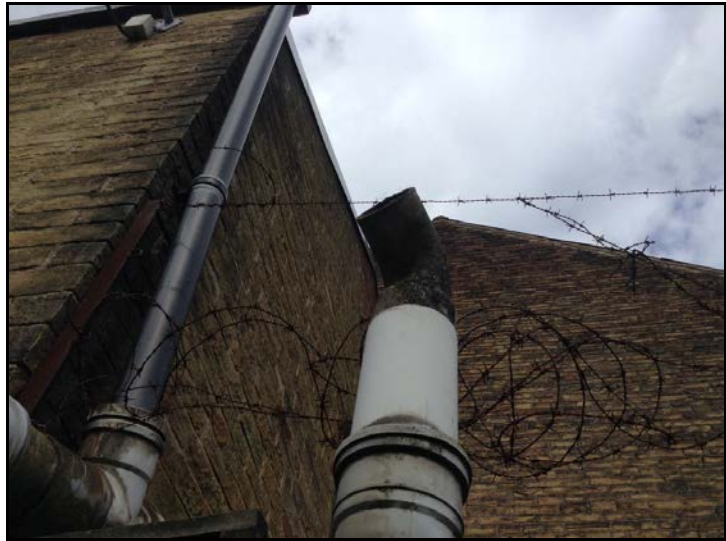
Site ID xxxxxx
Location ID 053
Building/Unit Site Name
Floor 0 (Ground)
Room / Area External Areas
Description Flue Pipe Sections
Surveyed Yes
Source of Information Name of Surveyor
Last Inspection Date Xx/xx/xxxx
Lab Reference
Survey Type Management
Sample Number xxxxxx/X18

MATERIAL ASSESSMENT = 4

Material	Cement Product (2)	Surface Treatment	Unsealed cement / Enclosed lagging or spray / Encapsulated board (1)
Condition	Good Condition (0)	Sample Result	Chrysotile
Location	Outdoors	Amount	
Accessibility	Occasional Disturbance

Recommendations The asbestos cement is in a good condition and can remain in-situ if required. A management plan needs to be put in place to monitor the cement on a regular basis for any signs of deterioration or damage. Should any damage occur, then repair or removal by suitably trained persons under controlled conditions should be considered.

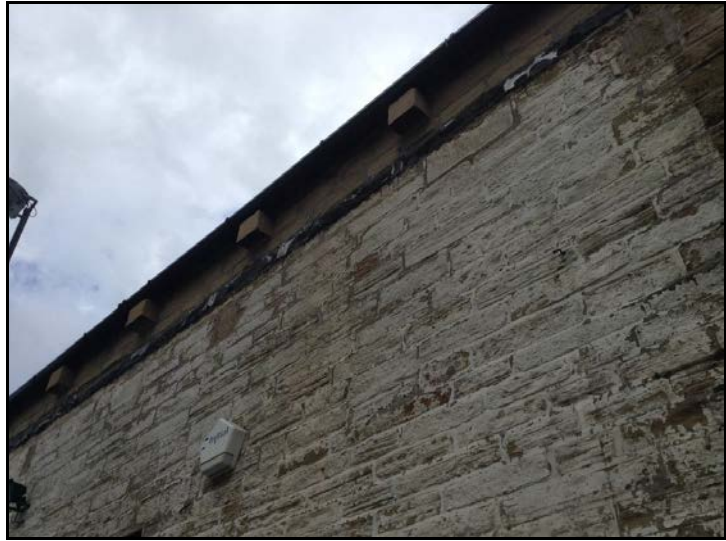
Site ID xxxxxx
Location ID 055
Building/Unit Site Name
Floor 0 (Ground)
Room / Area Warehouse (Trade Counter)
Description Felt Remnants
Surveyed Yes
Source of Information Name of Surveyor
Last Inspection Date Xx/xx/xxxx
Lab Reference Xxxxxx/xxxxxx
Survey Type Management
Sample Number xxxxxx/S35

MATERIAL ASSESSMENT = 4

Material	Bituminous Product (1)	Surface Treatment	Composite, reinforced or bonded (0)
Condition	Medium Damage (2)	Sample Result	Chrysotile
Location	Outdoors	Amount	
Accessibility	Occasional Disturbance

Recommendations **The asbestos containing felt remnants need to be removed by suitably trained persons under controlled conditions using HSE Guidelines, prior to the commencement of any works.**

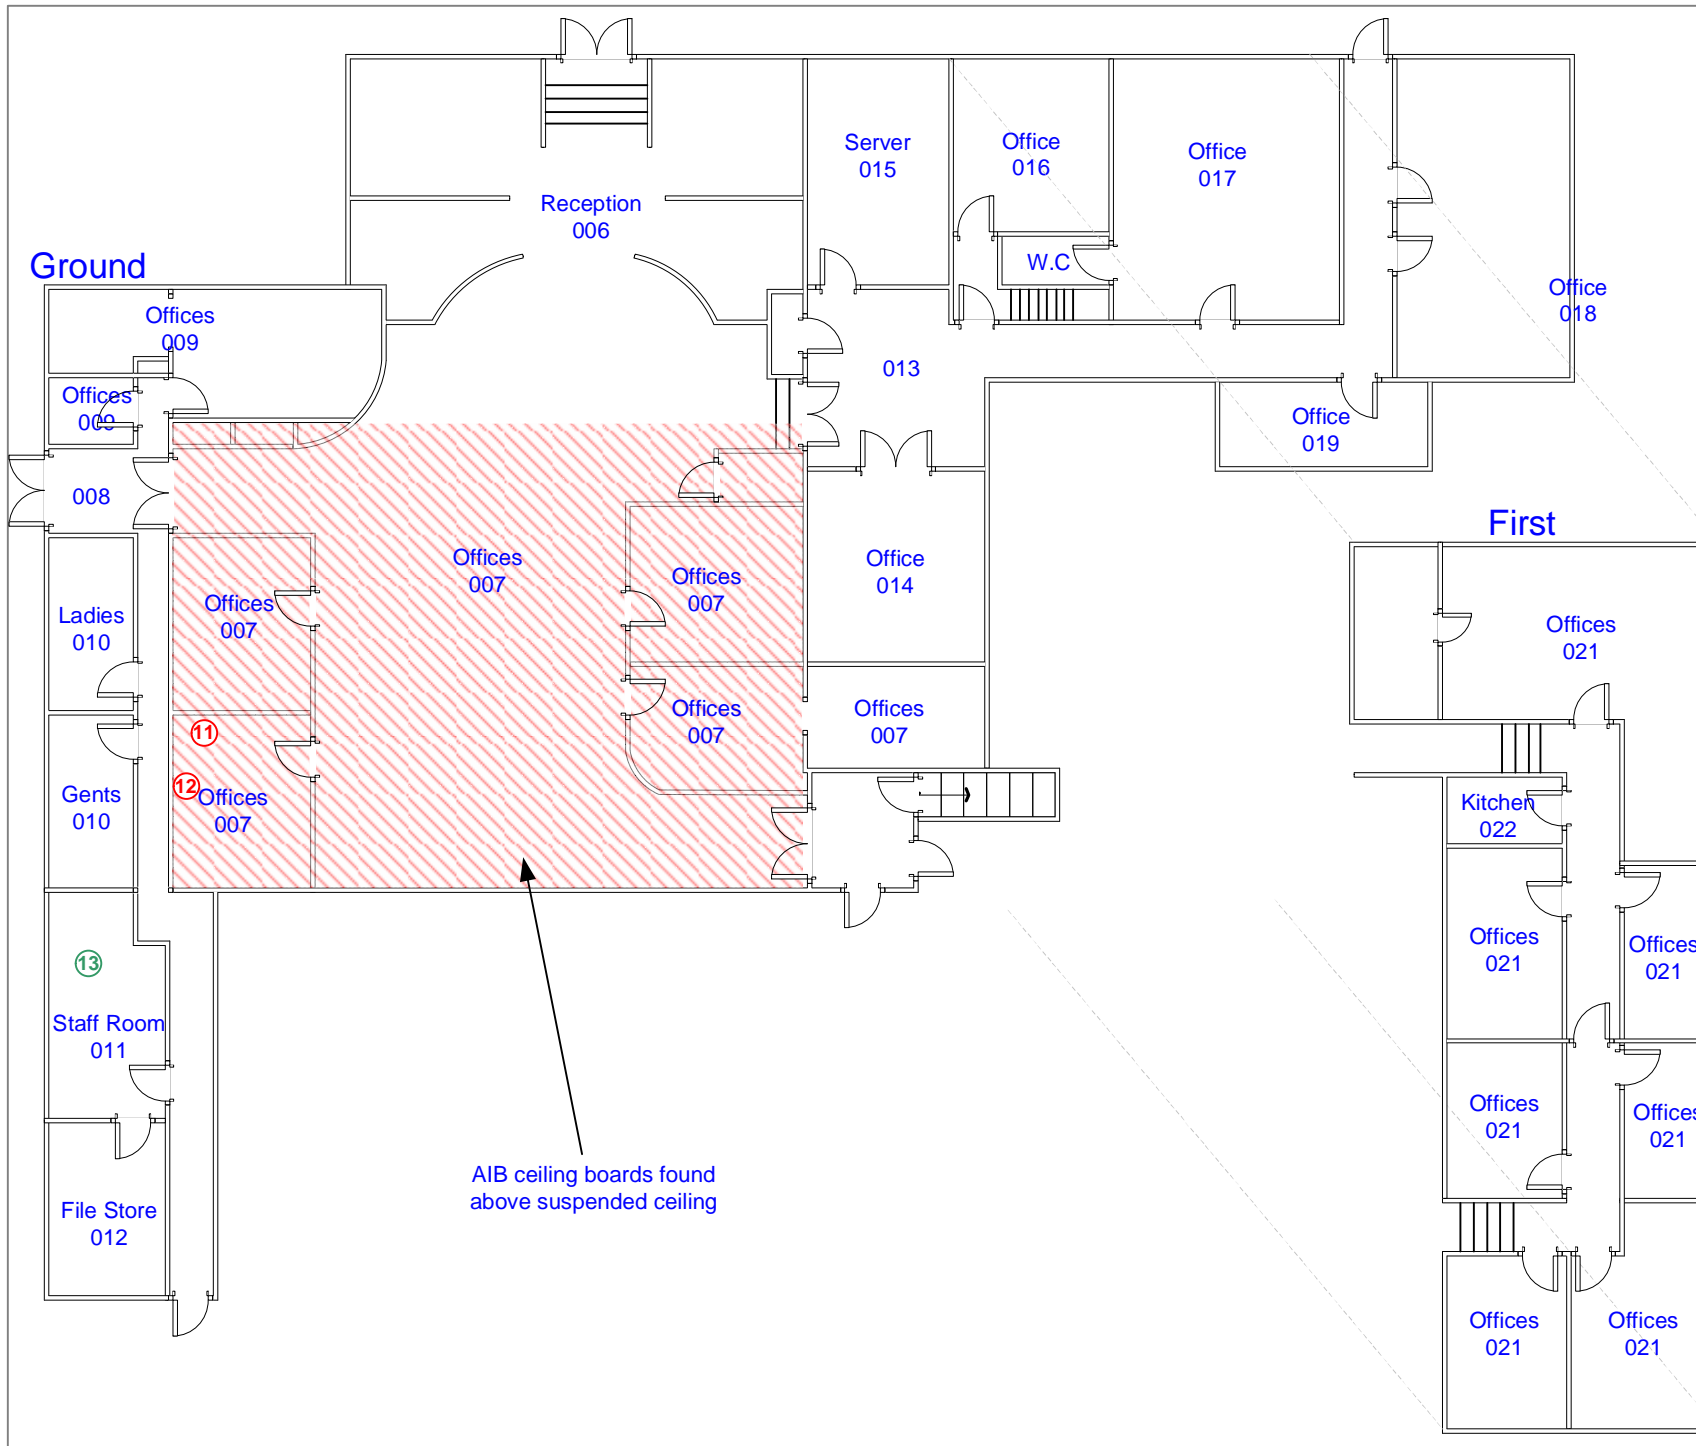
AIB ceiling boards found above suspended ceiling
