REFURBISHMENT/DEMOLITION ASBESTOS SURVEY REPORT

SURVEY REPORT WITH MATERIAL ASSESSMENT

Survey Type: Refurbishment and Demolition Survey

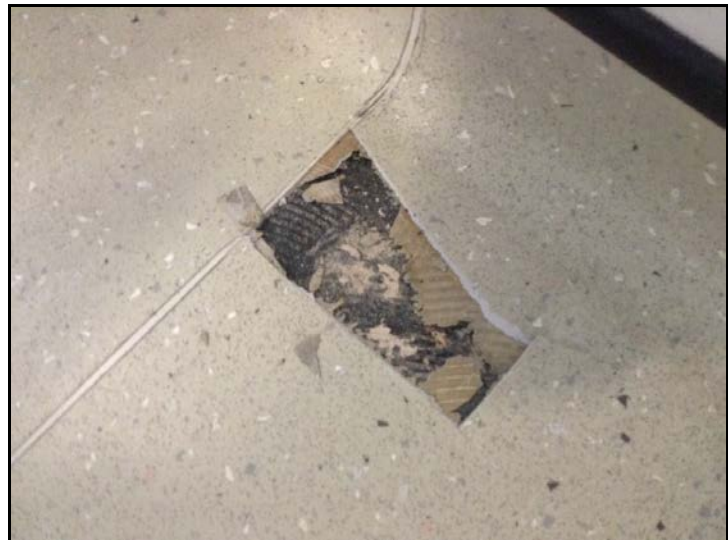
Site ID xxxxxx
Location ID 106
Building/Unit Site Name
Floor 1 (1st Floor)
Room / Area Gents W.C
Description Bitumen Adhesive
Surveyed Yes
Source of Information Name of Surveyor
Last Inspection Date Xx/xx/xxxx
Lab Reference Xxxxxx/xxxxxx
Survey Type Refurbishment
 Demolition
Sample Number xxxxxx/S16

Material	Bituminous Product (1)	Surface Treatment	Composite, reinforced or bonded (0)
Condition	Good Condition (0)	Sample Result	Chrysotile
Location	Room(s) up to 100m ²	Amount	
Accessibility	Easily Disturbed

Recommendations **The bitumen adhesive along with the linoleum needs to be removed by suitably trained persons under controlled conditions using HSE Guidelines, prior to the commencement of any works.**

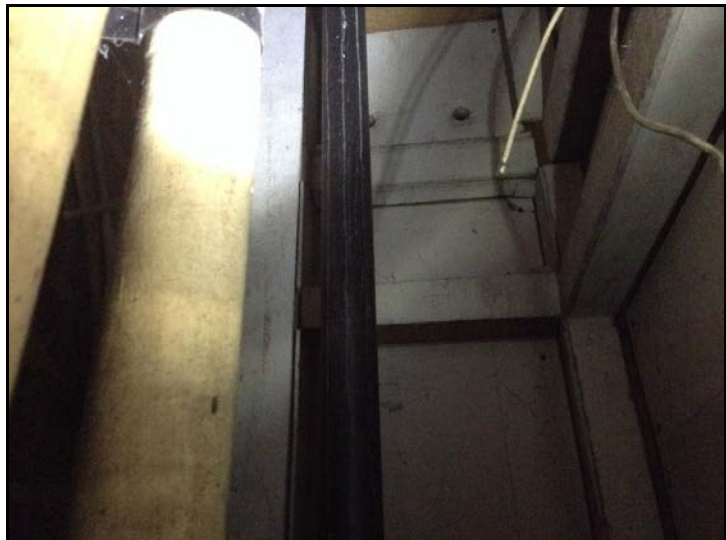
Site ID xxxxxx
Location ID 113
Building/Unit Site Name
Floor 1 (1st Floor)
Room / Area Offices
Description Lining to Riser
Surveyed Yes
Source of Information Name of Surveyor
Last Inspection Date Xx/xx/xxxx
Lab Reference
Survey Type Refurbishment
 Demolition
Sample Number xxxxxx/X37

Material	Insulating Board (2)	Surface Treatment	Unsealed board or cloth / Encapsulated lagging or spray (2)
Condition	Medium Damage (2)	Sample Result	Amosite/Chrysotile
Location	Room(s) up to 100m ²	Amount	5 m ²
Accessibility	Easily Disturbed

Recommendations **The asbestos boards need to be removed by a licensed removal company prior to the commencement of any works.**

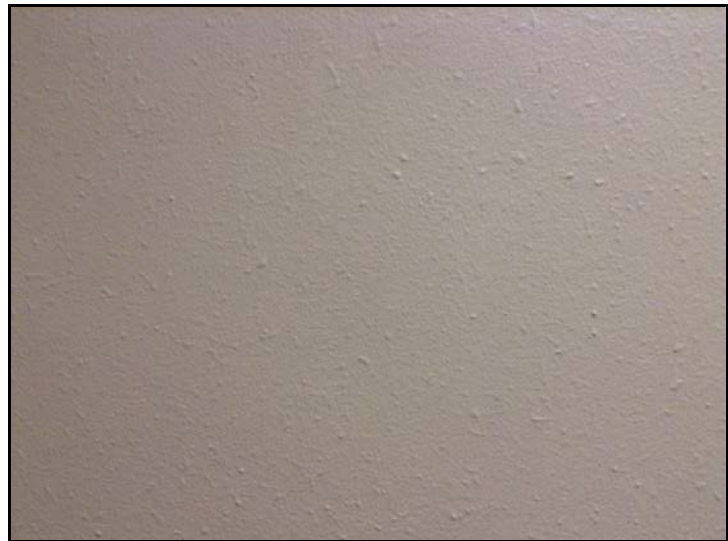
Site ID xxxxxx
Location ID 201
Building/Unit Site Name
Floor 2 (2nd Floor)
Room / Area Landing
Description Textured Coating to Walls
Surveyed Yes
Source of Information Luke Poston
Last Inspection Date Xx/xx/xxxx
Lab Reference Xxxxxx/xxxxxx
Survey Type Refurbishment
 Demolition
Sample Number xxxxxx/S01

Action	Priority	Notifiable	Licensed
Additional Comments	No asbestos was identified within the sample analysed.		
Recommendations

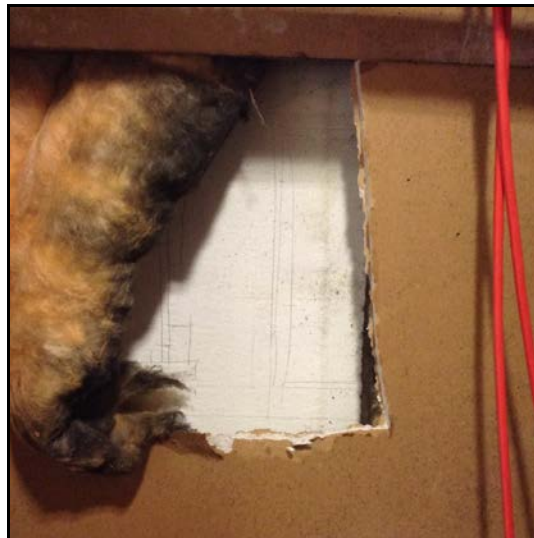
Site ID xxxxxx
Location ID 205
Building/Unit Site Name
Floor 2 (2nd Floor)
Room / Area Riser
Description Lining Boards
Surveyed Yes
Source of Information Luke Poston
Last Inspection Date Xx/xx/xxxx
Lab Reference xxxxxx/xxxxxx
Survey Type Refurbishment
 Demolition
Sample Number xxxxxx/S02

Material	Insulating Board (2)	Surface Treatment	Unsealed board or cloth / Encapsulated lagging or spray (2)
Condition	High Damage (3)	Sample Result	Amosite/Chrysotile
Location	Room(s) up to 100m ²	Amount	3 m ²
Accessibility	Easily Disturbed

Recommendations **The asbestos boards need to be removed by a licensed removal company prior to the commencement of any works.**

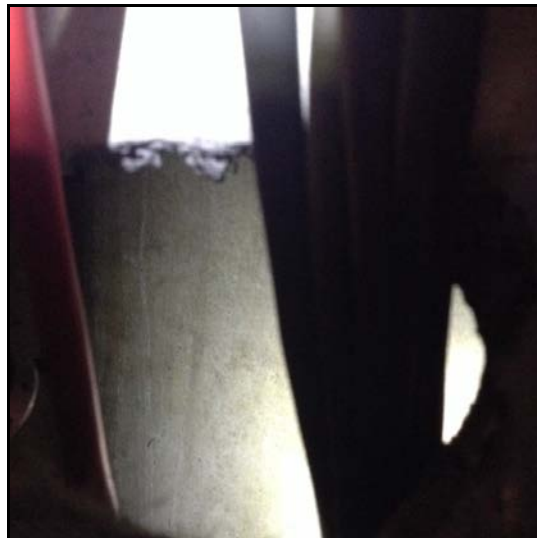
Site ID xxxxxx
Location ID 205
Building/Unit Site Name
Floor 2 (2nd Floor)
Room / Area Riser
Description Flue Pipe
Surveyed Yes
Source of Information Name of Surveyor
Last Inspection Date Xx/xx/xxxx
Lab Reference
Survey Type Refurbishment
 Demolition
Sample Number xxxxxx/X10

Material	Cement Product (2)	Surface Treatment	Unsealed cement / Enclosed lagging or spray / Encapsulated board (1)
Condition	Good Condition (0)	Sample Result	Chrysotile
Location	Room(s) up to 100m ²	Amount	3 lin
Accessibility	Easily Disturbed

Action	REMOVE (AC)	Priority	1	Notifiable	No	Licensed	No
Additional Comments	This pipe is a continuation from the basement boiler room.						
Recommendations	Although no sample was taken from this location, it is the same as sample number xxxxxx/S010, laboratory reference number xxxxxx/xxxxxx which was proven to contain asbestos within sample analysed.						
	The asbestos cement needs to be removed by suitably trained persons under controlled conditions, and disposed of at a licensed disposal facility prior to the commencement of any works.

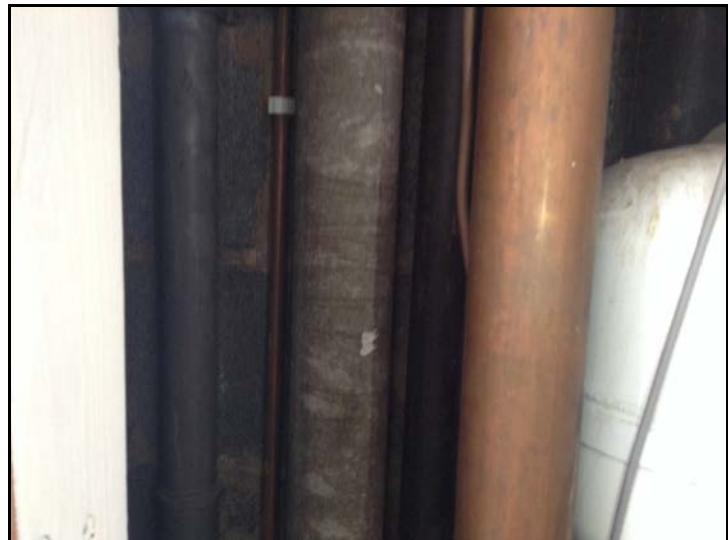
Site ID xxxxxx
Location ID 206
Building/Unit Site Name
Floor 2 (2nd Floor)
Room / Area W.C
Description Flue Pipe
Surveyed Yes
Source of Information Name of Surveyor
Last Inspection Date Xx/xx/xxxx
Lab Reference Xxxxxx/xxxxxx
Survey Type Refurbishment
 Demolition
Sample Number xxxxxx/S03

Material	Cement Product (2)	Surface Treatment	Unsealed cement / Enclosed lagging or spray / Encapsulated board (1)
Condition	Good Condition (0)	Sample Result	Chrysotile
Location	Room(s) up to 100m ²	Amount	3 lin
Accessibility	Easily Disturbed

Recommendations **The asbestos cement needs to be removed by suitably trained persons under controlled conditions, and disposed of at a licensed disposal facility prior to the commencement of any works.**

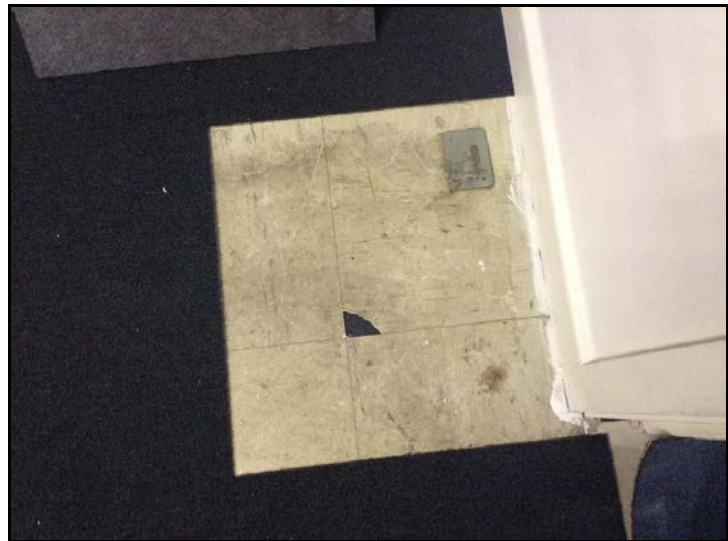
Site ID xxxxxx
Location ID 217
Building/Unit Site Name
Floor 2 (2nd Floor)
Room / Area Store
Description Floor Tiles & Adhesive
Surveyed Yes
Source of Information Name of Surveyor
Last Inspection Date Xx/xx/xxxx
Lab Reference Xxxxxx/xxxxxx
Survey Type Refurbishment
 Demolition
Sample Number xxxxxx/S04

Material	Vinyl Tiles (1)	Surface Treatment	Composite, reinforced or bonded (0)
Condition	Good Condition (0)	Sample Result	Chrysotile
Location	Room(s) up to 100m ²	Amount	10 m ²
Accessibility	Easily Disturbed

Recommendations The floor tiles and bitumen adhesive need to be removed by suitably trained persons under controlled conditions using HSE Guidelines, prior to the commencement of any works.

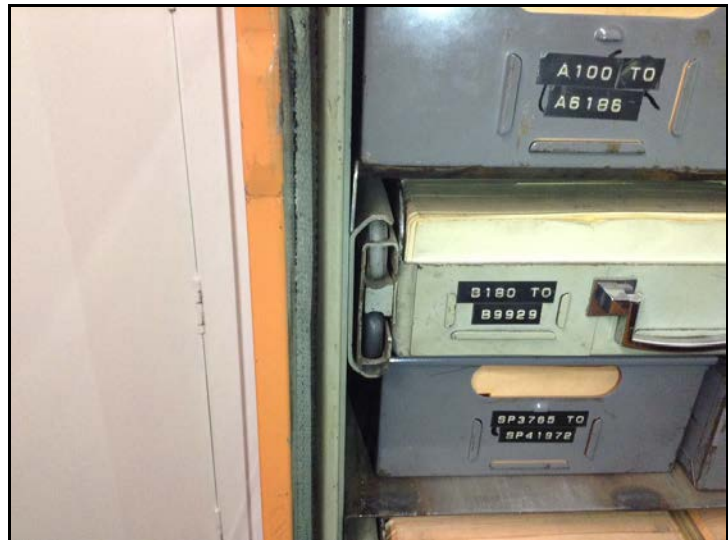
Site ID xxxxxx
Location ID 217
Building/Unit Site Name
Floor 2 (2nd Floor)
Room / Area Store
Description Seal to Safe
Surveyed Yes
Source of Information Name of Surveyor
Last Inspection Date Xx/xx/xxxx
Lab Reference Xxxxxx/xxxxxx
Survey Type Refurbishment
 Demolition
Sample Number xxxxxx/S05

Material	Gaskets (Rope/Woven) (2)	Surface Treatment	Unsealed cement / Enclosed lagging or spray / Encapsulated board (1)
Condition	Good Condition (0)	Sample Result	Chrysotile
Location	Room(s) up to 100m ²	Amount	
Accessibility	Easily Disturbed

The asbestos containing seal needs to be removed by suitably trained persons under controlled conditions, using HSE Guidelines, and be disposed of at a licensed disposal facility prior to the commencement of any works. Please note that this product needs to be notified to the HSE by way of an ASB1 form, prior to the works commencing.

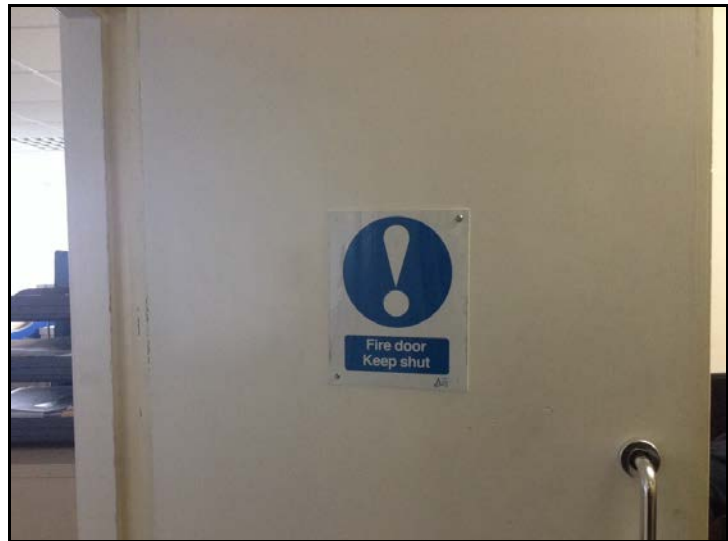
Site ID xxxxxx
Location ID 217
Building/Unit Site Name
Floor 2 (2nd Floor)
Room / Area Store
Description Internal Lining to Door
Surveyed Yes
Source of Information Luke Poston
Last Inspection Date Xx/xx/xxxx
Lab Reference Xxxxxx/xxxxxx
Survey Type Refurbishment
 Demolition
Sample Number xxxxxx/S06

Material	Insulating Board (2)	Surface Treatment	Unsealed cement / Enclosed lagging or spray / Encapsulated board (1)
Condition	Good Condition (0)	Sample Result	Amosite/Chrysotile
Location	Room(s) up to 100m ²	Amount	1 door
Accessibility	Easily Disturbed

Action	REMOVE (DOOR COMPLETE)	Priority	1	Notifiable	No	Licensed	No
Additional Comments							
Recommendations	<p>The door needs to be removed complete without any disturbance to the asbestos materials by suitably trained persons under controlled conditions using HSE Guidelines, and be disposed of at a licensed disposal facility prior to the commencement of any works.</p>

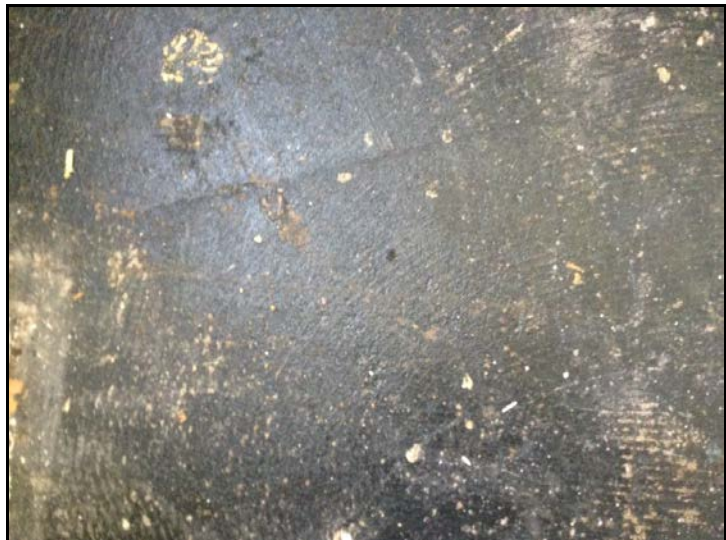
Site ID xxxxxx
Location ID 219
Building/Unit Site Name
Floor 2 (2nd Floor)
Room / Area Canteen Store
Description Bitumen Adhesive
Surveyed Yes
Source of Information Name of Surveyor
Last Inspection Date Xx/xx/xxxx
Lab Reference Xxxxxx/xxxxxx
Survey Type Refurbishment
 Demolition
Sample Number xxxxxx/S07

Material	Bituminous Product (1)	Surface Treatment	Composite, reinforced or bonded (0)
Condition	Good Condition (0)	Sample Result	Chrysotile
Location	Room(s) up to 100m ²	Amount	4 m ²
Accessibility	Easily Disturbed

Recommendations **The bitumen adhesive needs to be removed by suitably trained persons under controlled conditions using HSE Guidelines, prior to the commencement of any works.**

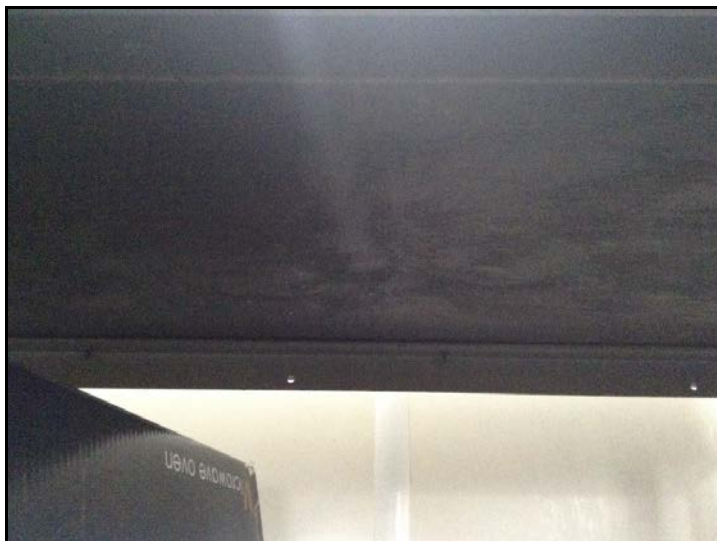
Site ID xxxxxx
Location ID 220
Building/Unit Site Name
Floor 2 (2nd Floor)
Room / Area Kitchen
Description Bitumen Coating to Work Surfaces
Surveyed Yes
Source of Information Name of Surveyor
Last Inspection Date Xx/xx/xxxx
Lab Reference Xxxxxx/xxxxxx
Survey Type Refurbishment
 Demolition
Sample Number xxxxxx/S08

Action	Priority	Notifiable	Licensed
Additional Comments	No asbestos was identified within the sample analysed.		
Recommendations

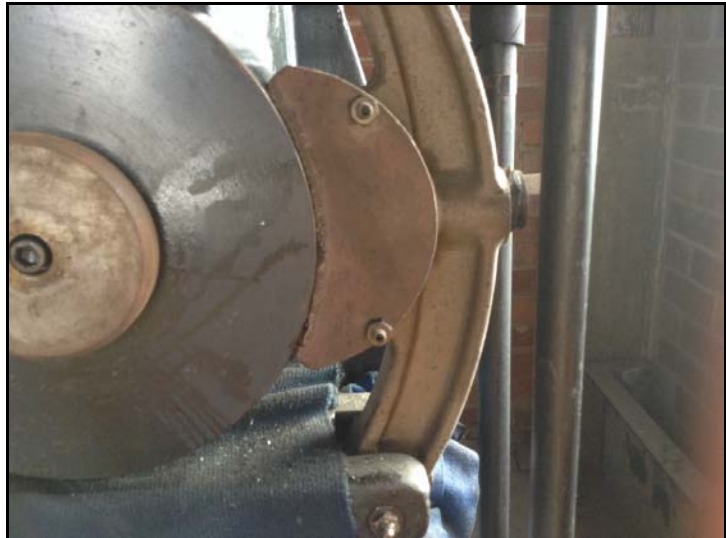
Site ID xxxxxx
Location ID 301
Building/Unit Site Name
Floor 2 (2nd Floor)
Room / Area Lift Motor Room
Description Brake Pads
Surveyed Yes
Source of Information Name of Surveyor
Last Inspection Date Xx/xx/xxxx
Lab Reference Xxxxxx/xxxxxx
Survey Type Refurbishment
 Demolition
Sample Number xxxxxx/S09

Material	Friction Material (2)	Surface Treatment	Composite, reinforced or bonded (0)
Condition	Good Condition (0)	Sample Result	Chrysotile
Location	Room(s) up to 100m ²	Amount	
Accessibility	Easily Disturbed

Recommendations **The asbestos brake pads need to be removed by suitably trained persons under controlled conditions using HSE Guidelines, prior to the commencement of any works.**

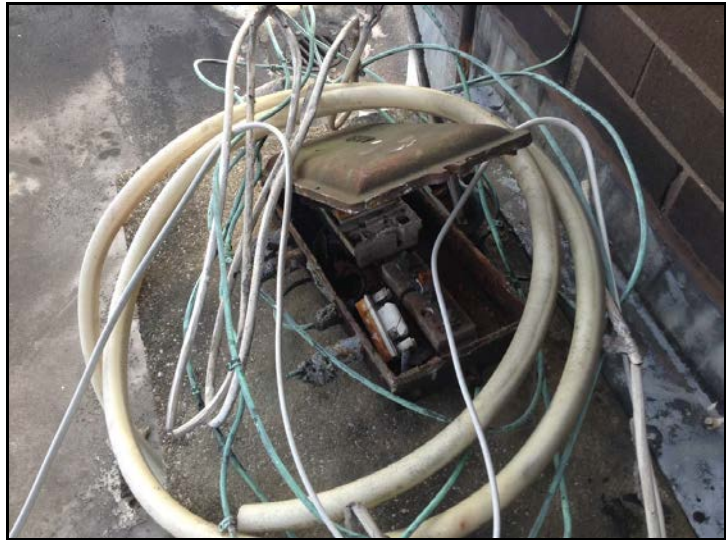
Site ID xxxxxx
 Location ID 303
 Building/Unit Site Name
 Floor 2 (2nd Floor)
 Room / Area Roof
 Description Flash Pads
 Surveyed Yes
 Source of Information Name of Surveyor
 Last Inspection Date Xx/xx/xxxx
 Lab Reference Xxxxxx/xxxxxx
 Survey Type Refurbishment
 Demolition
 Sample Number xxxxxx/S12

Material	Woven Product (2)	Surface Treatment	Unsealed cement / Enclosed lagging or spray / Encapsulated board (1)
Condition	Good Condition (0)	Sample Result	Chrysotile
Location	Outdoors	Amount	
Accessibility	Easily Disturbed

Recommendations
The fuse boxes need to be removed complete without any disturbance to the internal materials by suitably trained persons under controlled conditions using HSE Guidelines, and be disposed of at a licensed disposal facility prior to the commencement of any works.

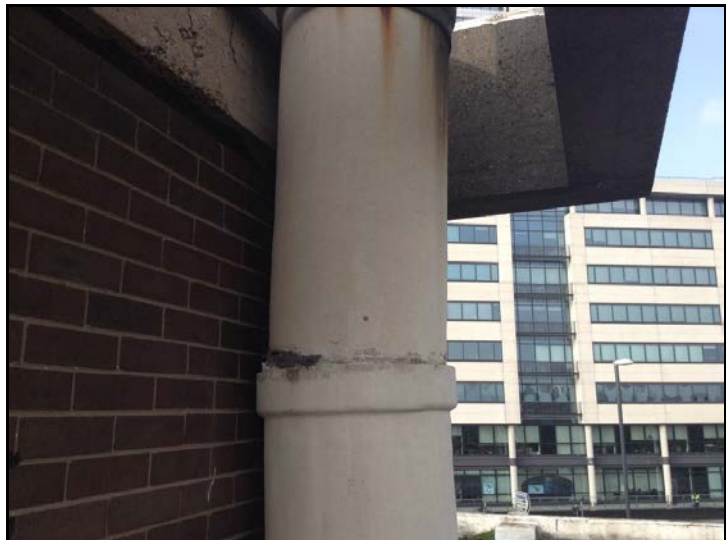
Site ID xxxxxx
Location ID 303
Building/Unit Site Name
Floor 2 (2nd Floor)
Room / Area Roof
Description Flue Pipe
Surveyed Yes
Source of Information Name of Surveyor
Last Inspection Date Xx/xx/xxxx
Lab Reference Xxxxxx/xxxxxx
Survey Type Refurbishment
 Demolition
Sample Number xxxxxx/S10

Material	Cement Product (2)	Surface Treatment	Unsealed cement / Enclosed lagging or spray / Encapsulated board (1)
Condition	Good Condition (0)	Sample Result	Chrysotile
Location	Outdoors	Amount	3 lin
Accessibility	Easily Disturbed

Recommendations **The asbestos cement needs to be removed by suitably trained persons under controlled conditions, and disposed of at a licensed disposal facility prior to the commencement of any works.**

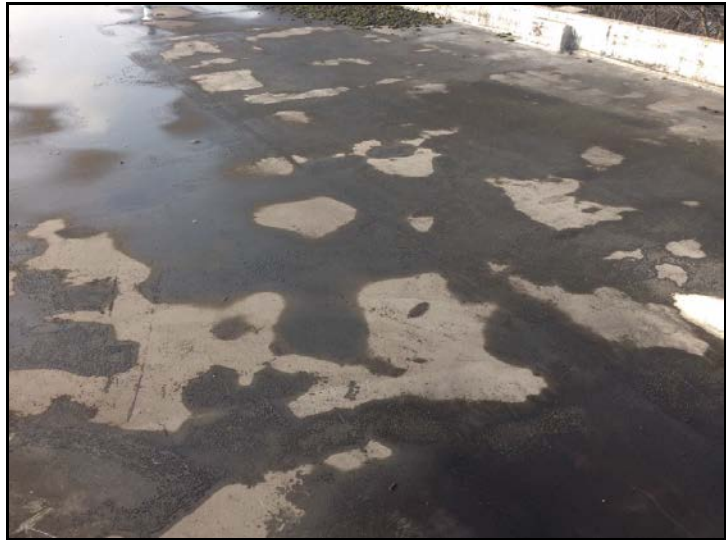
Site ID xxxxxx
 Location ID 303
 Building/Unit Site Name
 Floor 2 (2nd Floor)
 Room / Area Roof
 Description Roof Covering
 Surveyed Yes
 Source of Information Name of Surveyor
 Last Inspection Date Xx/xx/xxxx
 Lab Reference Xxxxxx/xxxxxx
 Survey Type Refurbishment
 Demolition
 Sample Number xxxxxx/S13

Action	Priority	Notifiable	Licensed
Additional Comments	No asbestos was identified within the sample analysed.		
Recommendations

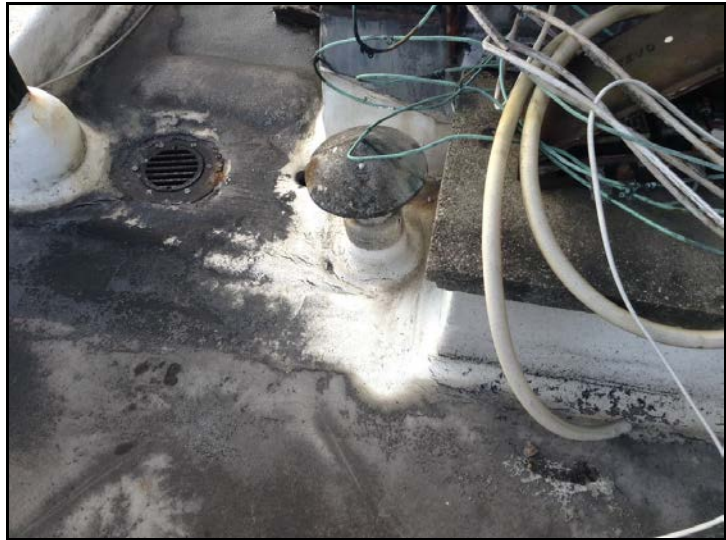
Site ID xxxxxx
 Location ID 303
 Building/Unit Site Name
 Floor 2 (2nd Floor)
 Room / Area Roof
 Description Chimney Top
 Surveyed Yes
 Source of Information Name of Surveyor
 Last Inspection Date Xx/xx/xxxx
 Lab Reference Xxxxxx/xxxxxx
 Survey Type Refurbishment
 Demolition
 Sample Number xxxxxx/S11

Material	Cement Product (2)	Surface Treatment	Unsealed cement / Enclosed lagging or spray / Encapsulated board (1)
Condition	Good Condition (0)	Sample Result	Chrysotile
Location	Outdoors	Amount	
Accessibility	Easily Disturbed

Recommendations **The asbestos cement needs to be removed by suitably trained persons under controlled conditions, and disposed of at a licensed disposal facility prior to the commencement of any works.**

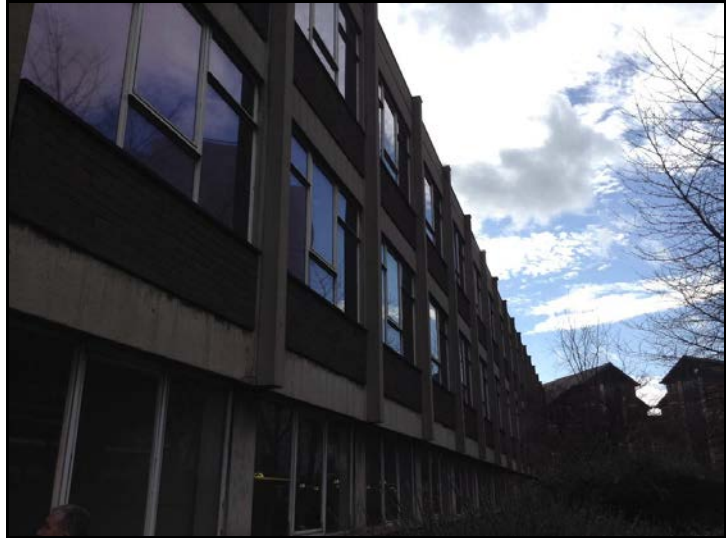
Site ID xxxxxx
 Location ID 401
 Building/Unit Site Name
 Floor 0 (Ground)
 Room / Area Throughout
 Description Putty to Windows
 Surveyed Yes
 Source of Information Name of Surveyor
 Last Inspection Date Xx/xx/xxxx
 Lab Reference Xxxxxx/xxxxxx
 Survey Type Refurbishment
 Demolition
 Sample Number xxxxxx/S48

Action	Priority	Notifiable	Licensed
Additional Comments	No asbestos was identified within the sample analysed.		
Recommendations

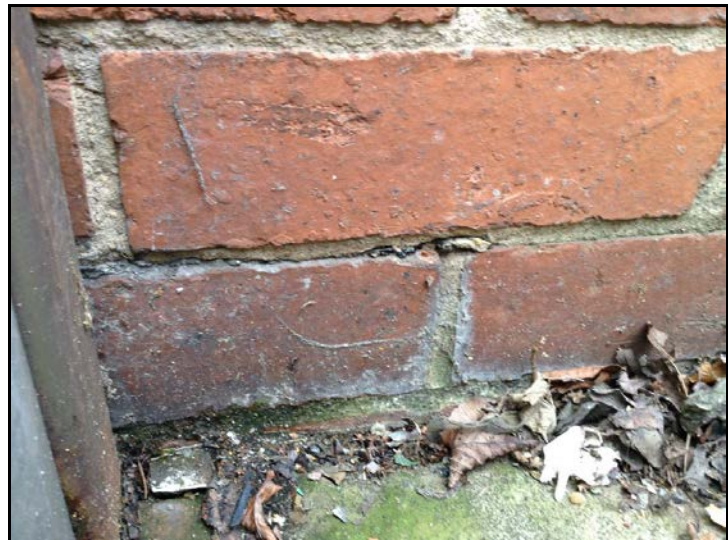
Site ID xxxxxx
Location ID 401
Building/Unit Site Name
Floor 0 (Ground)
Room / Area Throughout
Description Damp Proof Course
Surveyed Yes
Source of Information Name of Surveyor
Last Inspection Date Xx/xx/xxxx
Lab Reference Xxxxxx/xxxxxx
Survey Type Refurbishment
 Demolition
Sample Number xxxxxx/S47

Material	Bituminous Product (1)	Surface Treatment	Composite, reinforced or bonded (0)
Condition	Good Condition (0)	Sample Result	Chrysotile
Location	Outdoors	Amount	
Accessibility	Easily Disturbed

Recommendations **The asbestos damp proof course needs to be removed during the course of the works by suitably trained persons under controlled conditions using HSE Guidelines.**
