JAPAN P&I CLUB

P&I Loss Prevention Bulletin

Dragging Anchor

- Case Studies and Preventive Measures -

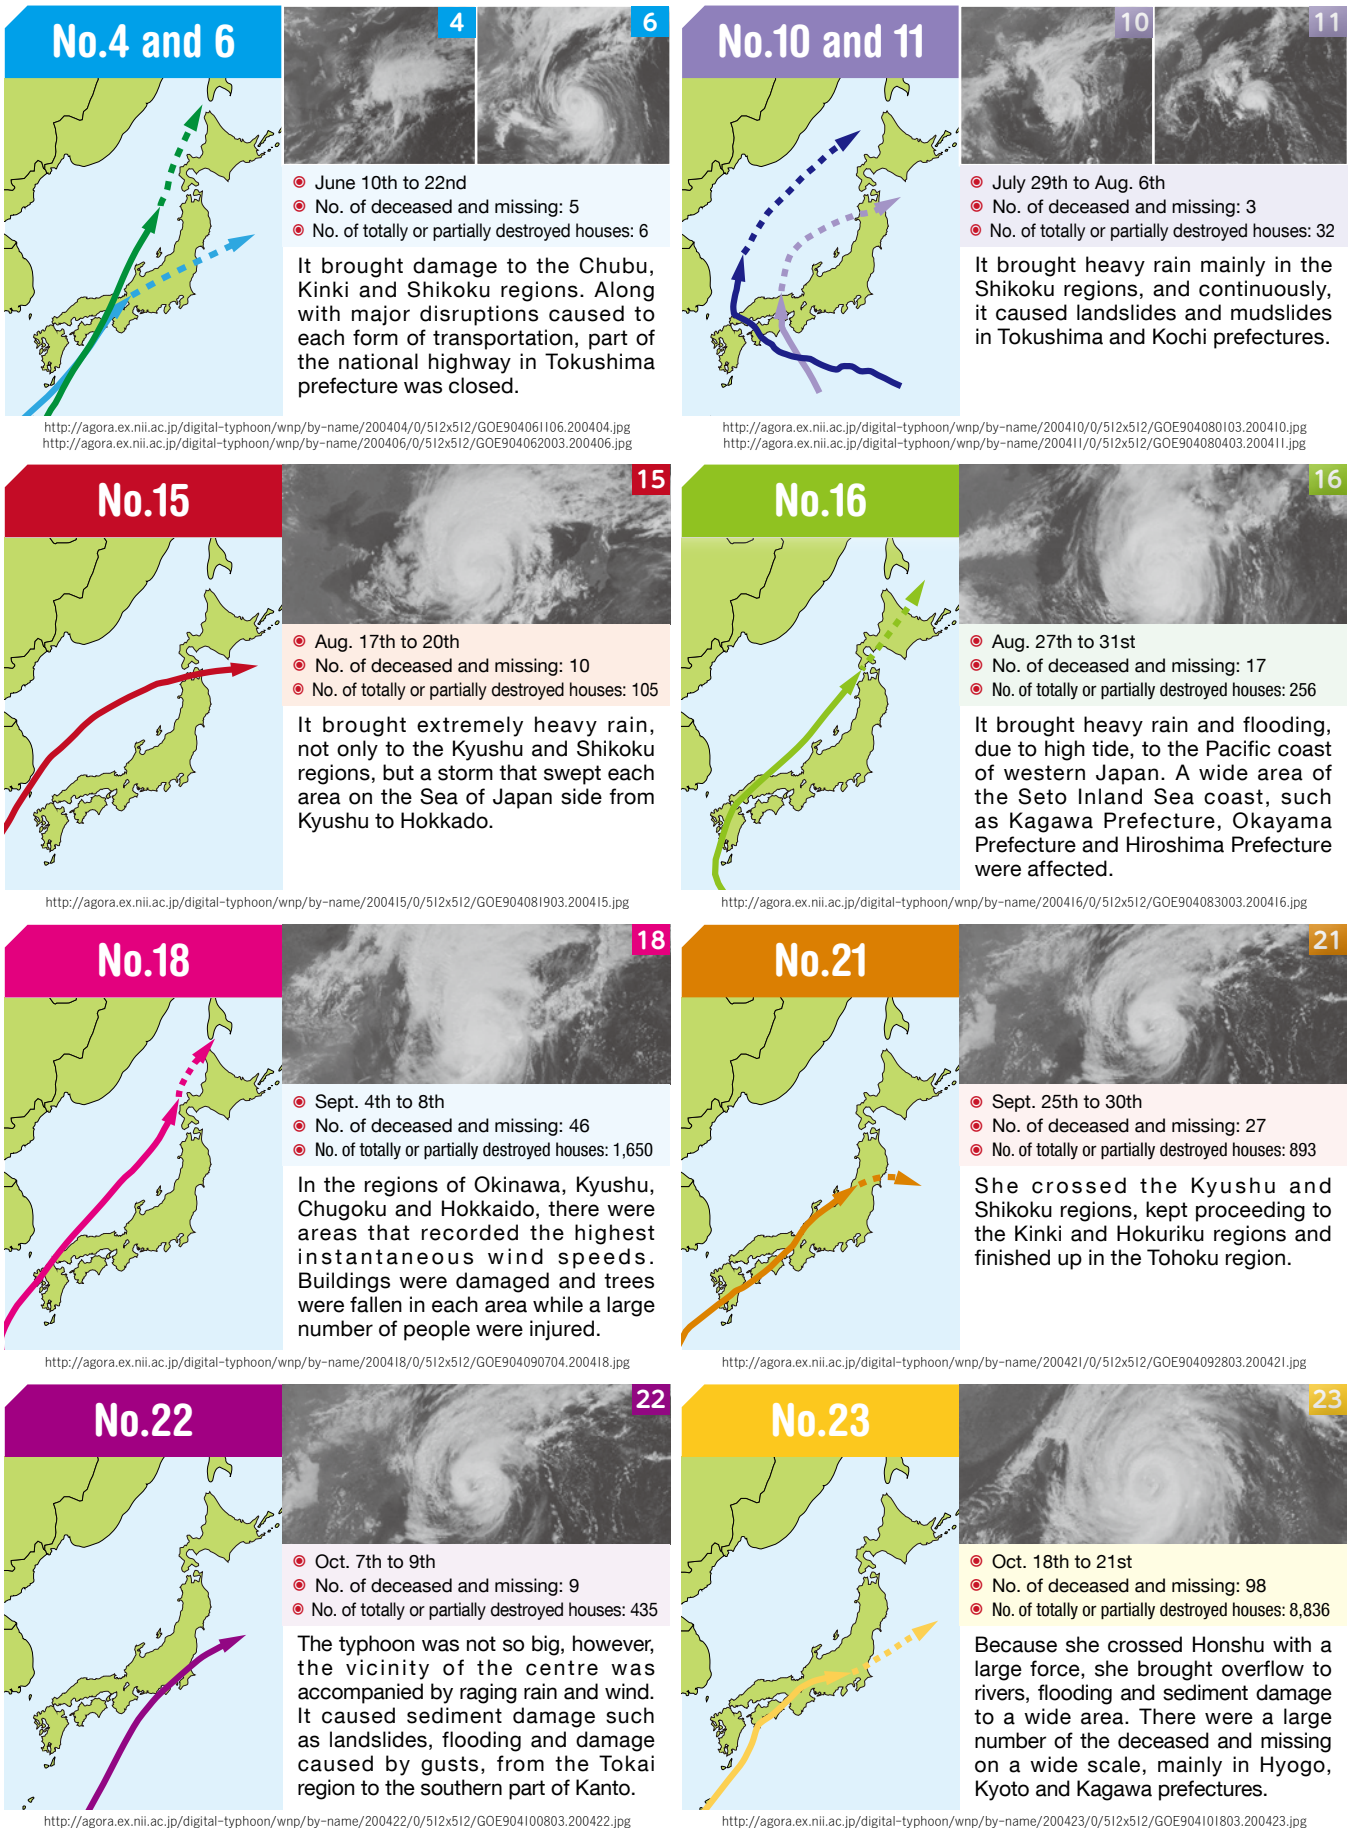
Fig. 16 ~ 23

Typhoons have caused large-scale disasters, not only for ships, but also on shore. Figs. 16, 17, 18, 19, 20, 21, 22 and 23 indicate damage statuses.

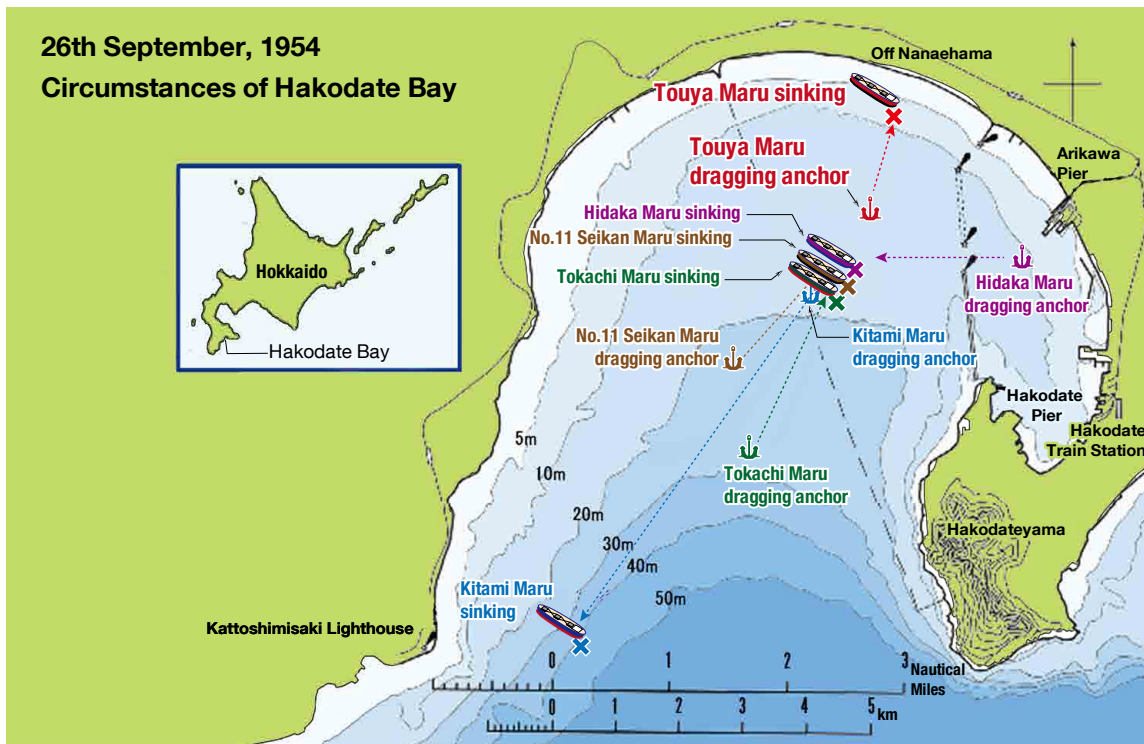
Fig. 30

The state of affairs at Hakodate Bay on the 26th of September in 1954 is shown in Fig. 30. Hakodate Bay has a land shape that makes it less influenced by wind and waves because it is shielded by high mountains, when there is a northwest wind.

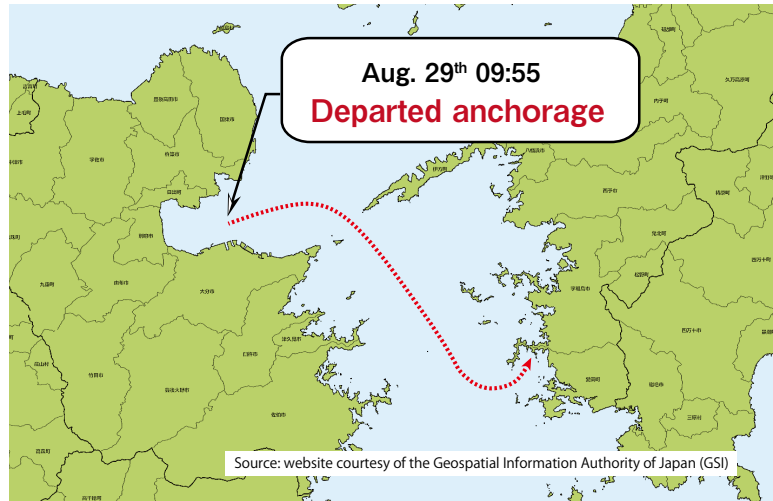
Fig. 46

deceased and three missing). The remaining 16 crew members including the Master were rescued by the helicopters of the Japan Coast Guard and the Self-Defense Force. Photograph 45, Figs. 46 and 47 show the path of Vessel B and its anchor being dragged.

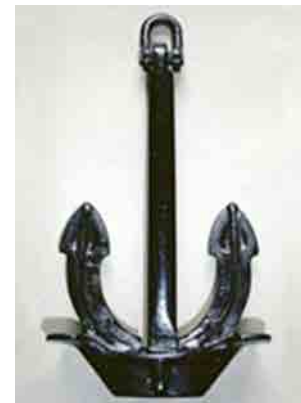
Anchor:	JIS type Weight 3,300kgs
Anchor cable:	1 shackle was at 27.5m × 9 shackles per side 248m

When tentatively calculating the minimum required length for an anchor chain, in 92m of water, an anchor chain with 513m (19 shackles) of length is required (at times of rough seas: $4 \times d + 145m$). Sheltering from stormy weather in a location which exceeds 50m in water depth is thought of as unsuitable.

Photograph 52
JIS type anchor

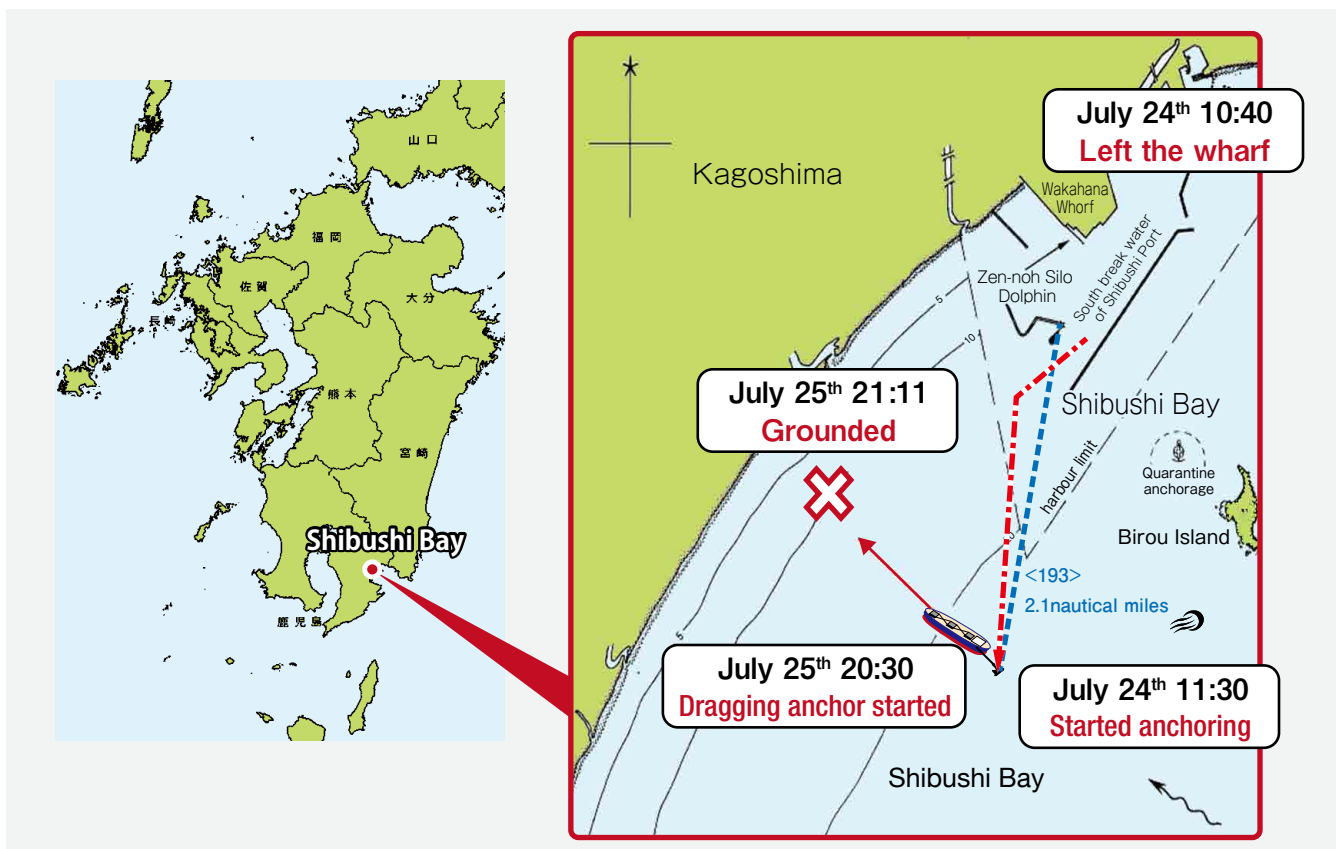
Fig. 54

The Master was thinking that he had not experience with entering Kagoshima Bay, it would take 11 hours as a round-trip and there was a risk of being close to the centre of the typhoon according to the forecast of the typhoon's path, then. He also judged that the force would decay judging by the information from NAVTEX. Because there was ample spare time until the typhoon approached, the Master decided to choose the anchorage according to the movement of the typhoon from the following three choices as his original plan: ① head for Kagoshima Bay, ② stay anchored at Shibushi Bay without navigating a direct course to Kagoshima Bay or ③ seek shelter offshore. As a result, at 11.30, the vessel dropped her starboard anchor at 6 shackles <056> 2.0 nautical miles off of Birou Island and 2.1 nautical miles off Shibushi south breakwater, light house <193>, where the sea bottom was sand with a water depth of around 25 metres.

Afterwards, partly because a similar size of ship, Vessel M started anchoring at Shibushi Bay, Vessel C also continued single anchor mooring with 6 shackles of anchor cable. However, contrary to expectation, the force of the typhoon did not decrease and Shibushi Bay gradually entered the storm area and the right semicircle of the typhoon. Due to
