# HOME REPORT

33A MAIN STREET  
CAIRNBULG  
FRASERBURGH  
AB43 8YJ

**DM HALL**  
CHARTERED SURVEYORS

# Energy Performance Certificate (EPC)

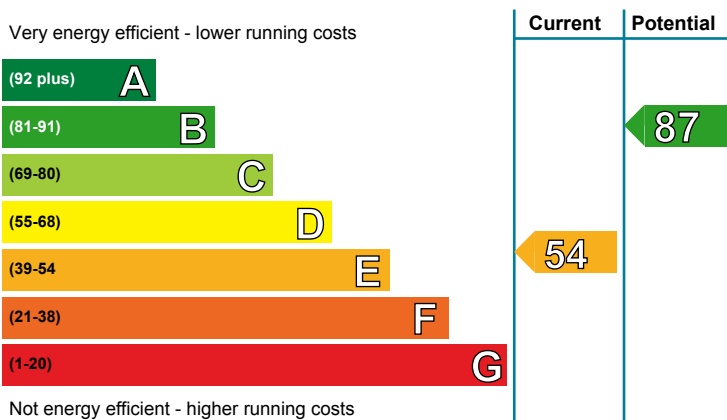
## Energy Efficiency Rating

This graph shows the current efficiency of your home, taking into account both energy efficiency and fuel costs. The higher this rating, the lower your fuel bills are likely to be.

Your current rating is **band E (54)**. The average rating for EPCs in Scotland is **band D (61)**.

The potential rating shows the effect of undertaking all of the improvement measures listed within your recommendations report.

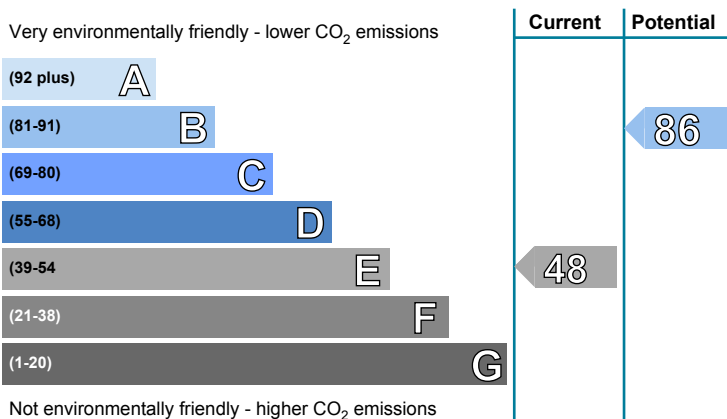
## Environmental Impact (CO<sub>2</sub>) Rating

This graph shows the effect of your home on the environment in terms of carbon dioxide (CO<sub>2</sub>) emissions. The higher the rating, the less impact it has on the environment.

Your current rating is **band E (48)**. The average rating for EPCs in Scotland is **band D (59)**.

The potential rating shows the effect of undertaking all of the improvement measures listed within your recommendations report.
