espc::home report

46 Willowbrae Road
Edinburgh
EH8 7HA
30/01/2020

Single Survey

Property address	46 Willowbrae Road Edinburgh EH8 7HA
Customer	Mr G Carmichale & Mr R Hastie
Customer address	
Prepared by	DM Hall LLP
Date of inspection	29th January 2020

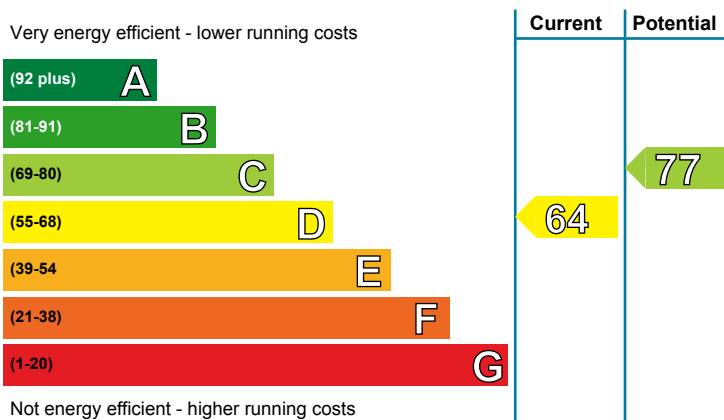
Energy Efficiency Rating

This graph shows the current efficiency of your home, taking into account both energy efficiency and fuel costs. The higher this rating, the lower your fuel bills are likely to be.

Your current rating is **band D (64)**. The average rating for EPCs in Scotland is **band D (61)**.

The potential rating shows the effect of undertaking all of the improvement measures listed within your recommendations report.

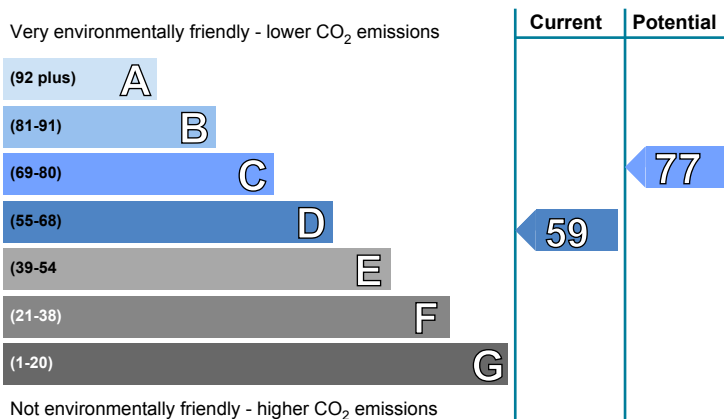
Environmental Impact (CO₂) Rating

This graph shows the effect of your home on the environment in terms of carbon dioxide (CO₂) emissions. The higher the rating, the less impact it has on the environment.
