Virginiatown-Kearns McGarry Township, Ontario

THE SITUATION

Unmanageable leakage from water and wastewater conveyance networks

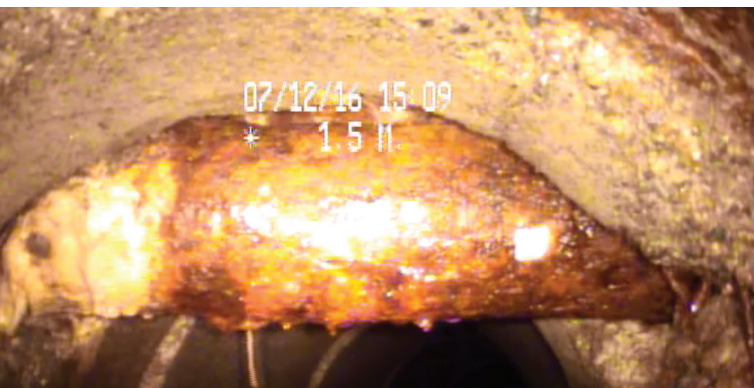
CCTV inspection showed several areas of concern in the sewers, including sections where water lines passed right through the sewer.

"About 13 percent of the sewer was in condition five; the worst possible," Semanuik says. "We found several holes, areas where root masses had penetrated the sewer, and a watermain that was crossing right through the sewer. In another section the water and sewer lines were so badly deteriorated, water was gushing directly from the leaking main into the sewer."
