Marshlands Park

Hal Brown Park at Creekside, Marin County Parks

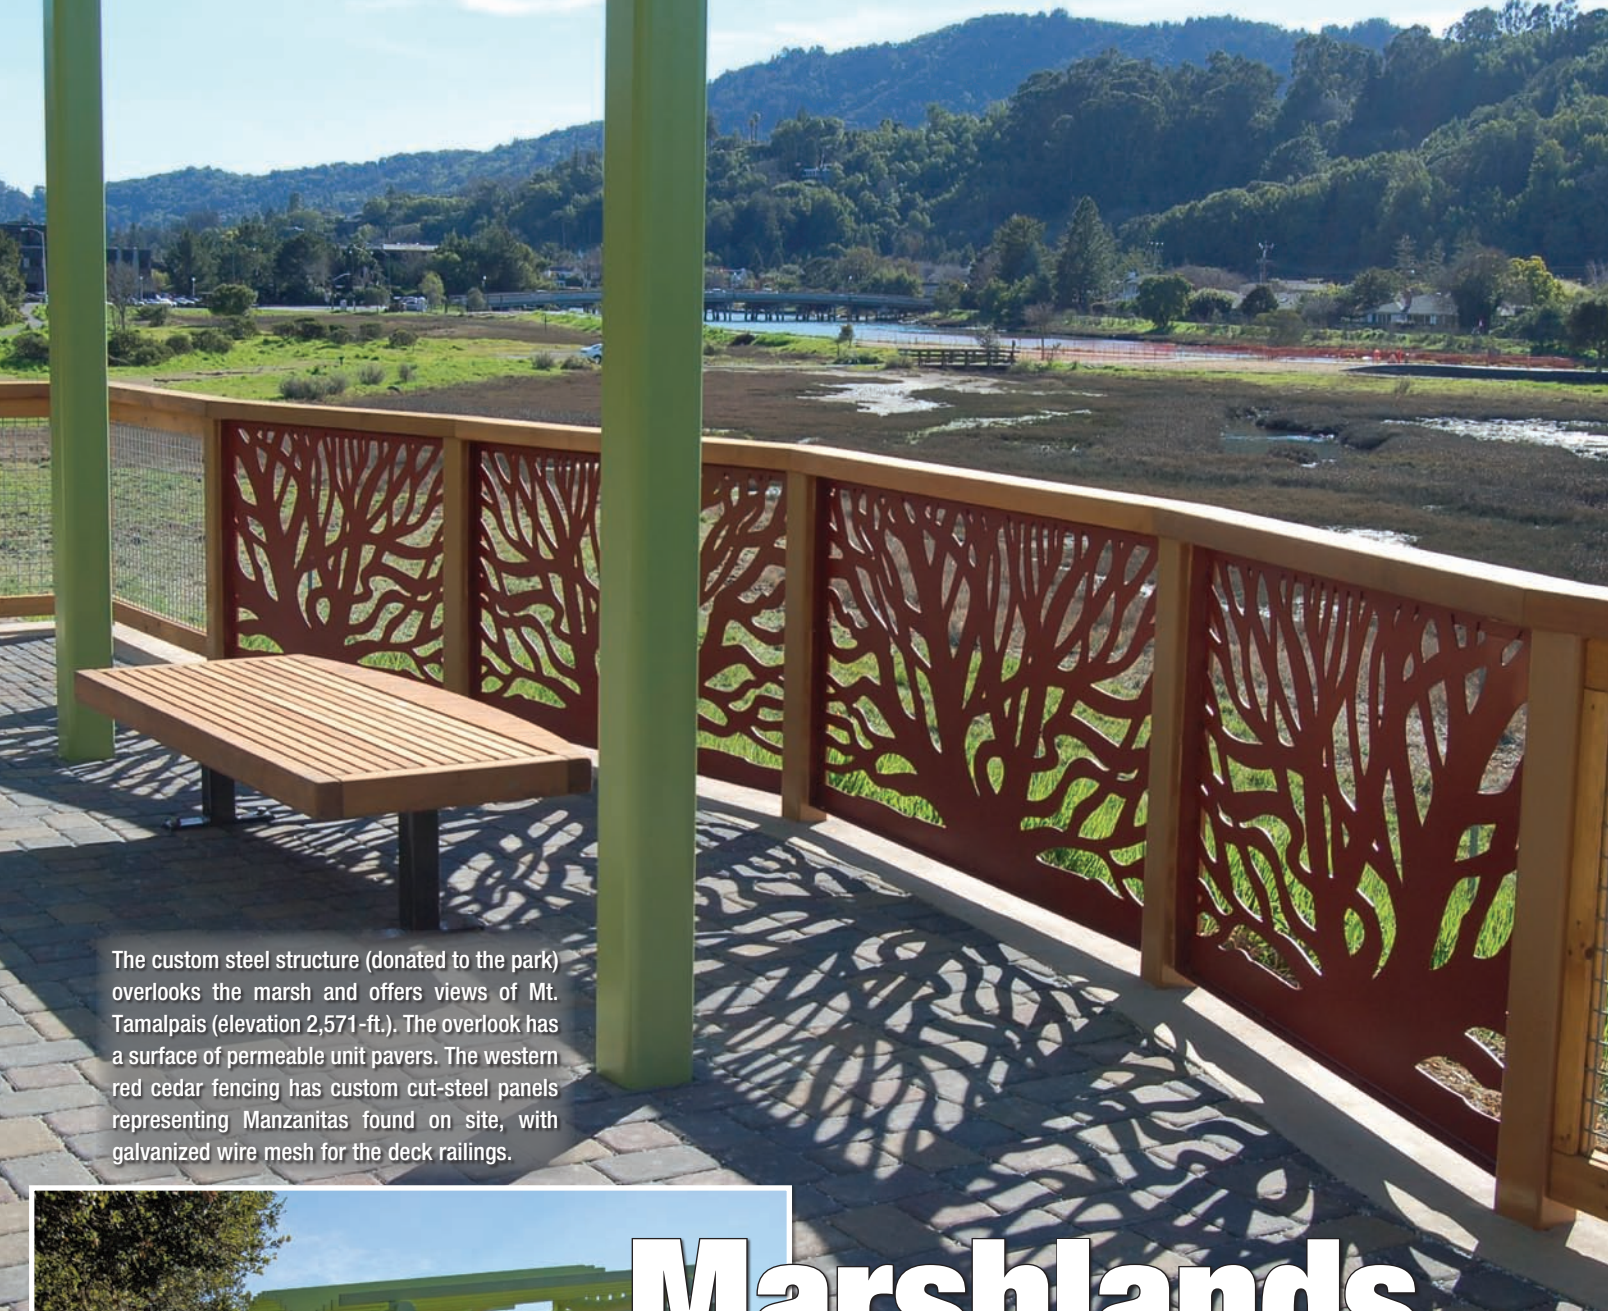
The custom steel structure (donated to the park) overlooks the marsh and offers views of Mt. Tamalpais (elevation 2,571-ft.). The overlook has a surface of permeable unit pavers. The western red cedar fencing has custom cut-steel panels representing Manzanitas found on site, with galvanized wire mesh for the deck railings.

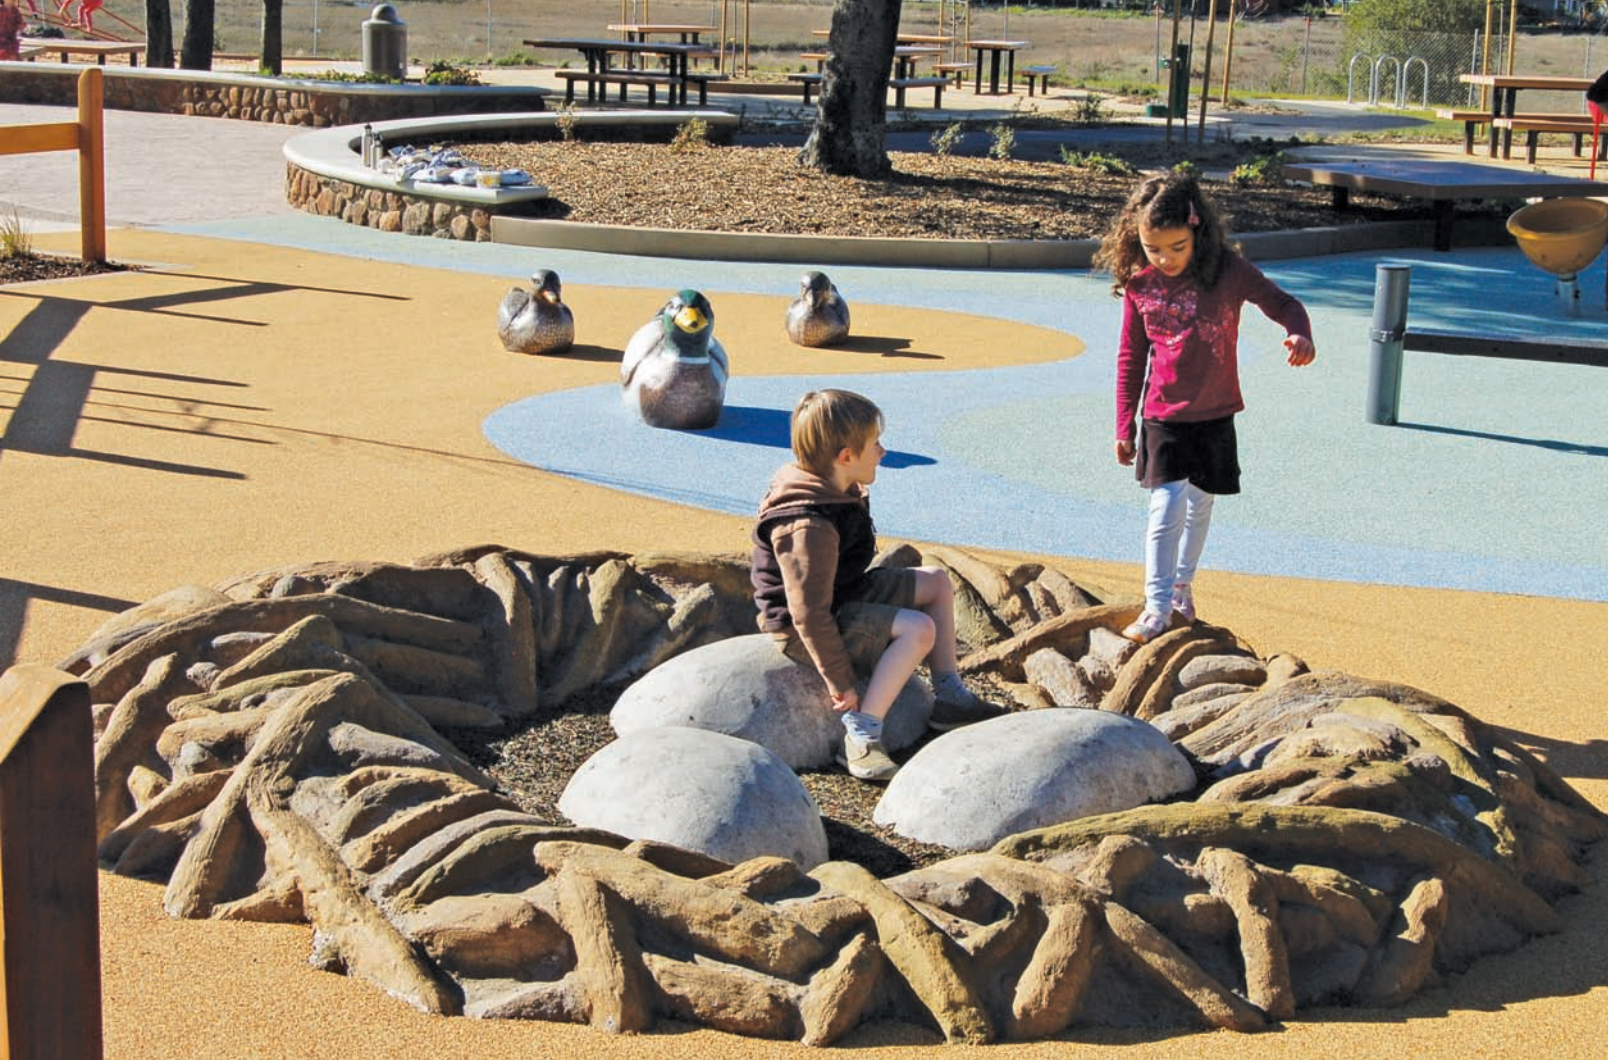
Above & Right: Clapper rails (*Rallus longirostris*), an endangered species, have nested in the adjacent marsh. The toddler play area includes shotcrete replicas of two clapper rail nests (Cemrock), and a custom precast concrete duck family floating on the rubberized surface. Ducks were frequent visitors to the construction site from the adjacent marsh.

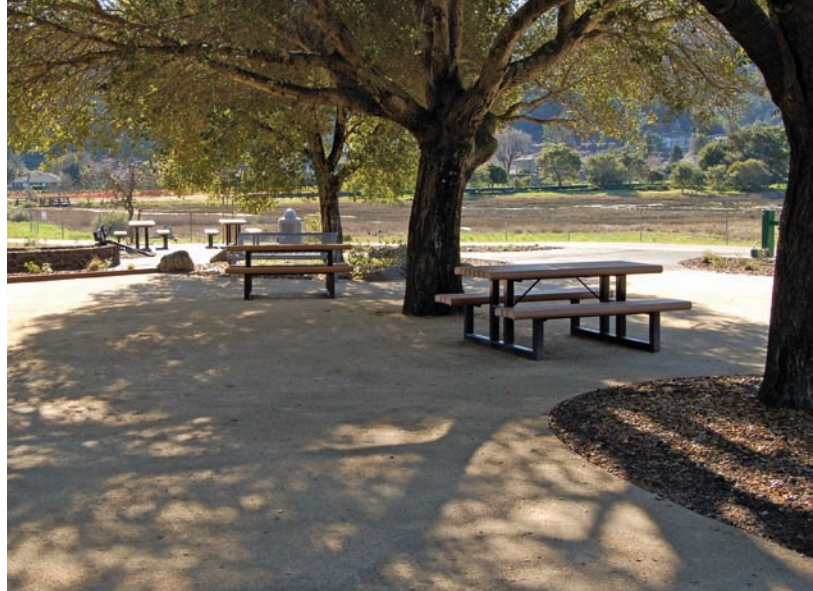
Above: An informal petanque area under existing oaks has decomposed granite without the binder for the playing surface. The tables (Dumor) are made from recycled plastic.

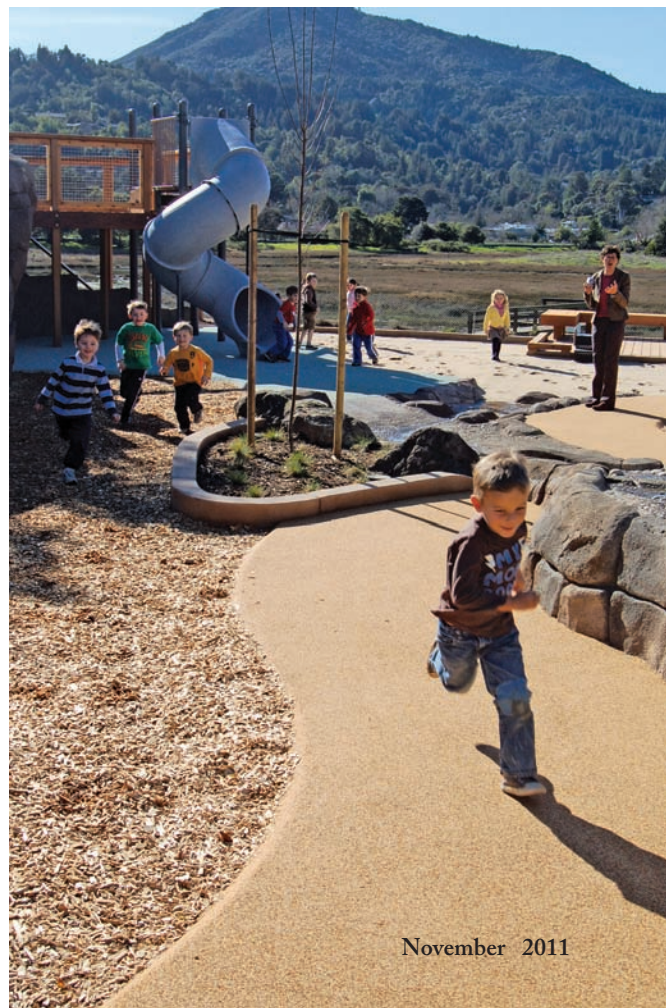
Above: The toddler makes a break for it! The renovated park includes expanded picnic areas with new recycled plastic picnic tables and steel trash receptacles (both from Dumor Site Furnishings). The surfacing is decomposed granite with a resin binder to create an accessible surface.

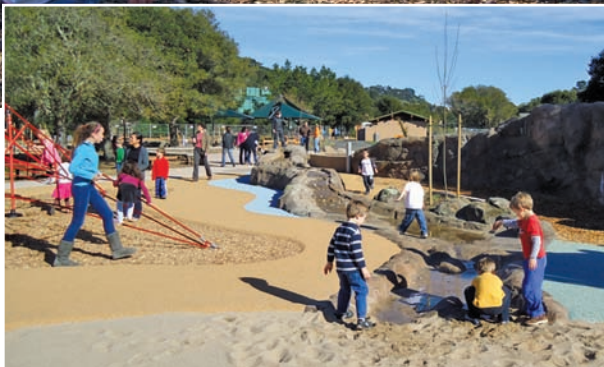
Left: A custom shotcrete play creek lets future dam builders explore water retention/flow engineering.
