## Case Study: 17486 Toilet Floor Refurbishment

**Location**  
Egham International School, Egham

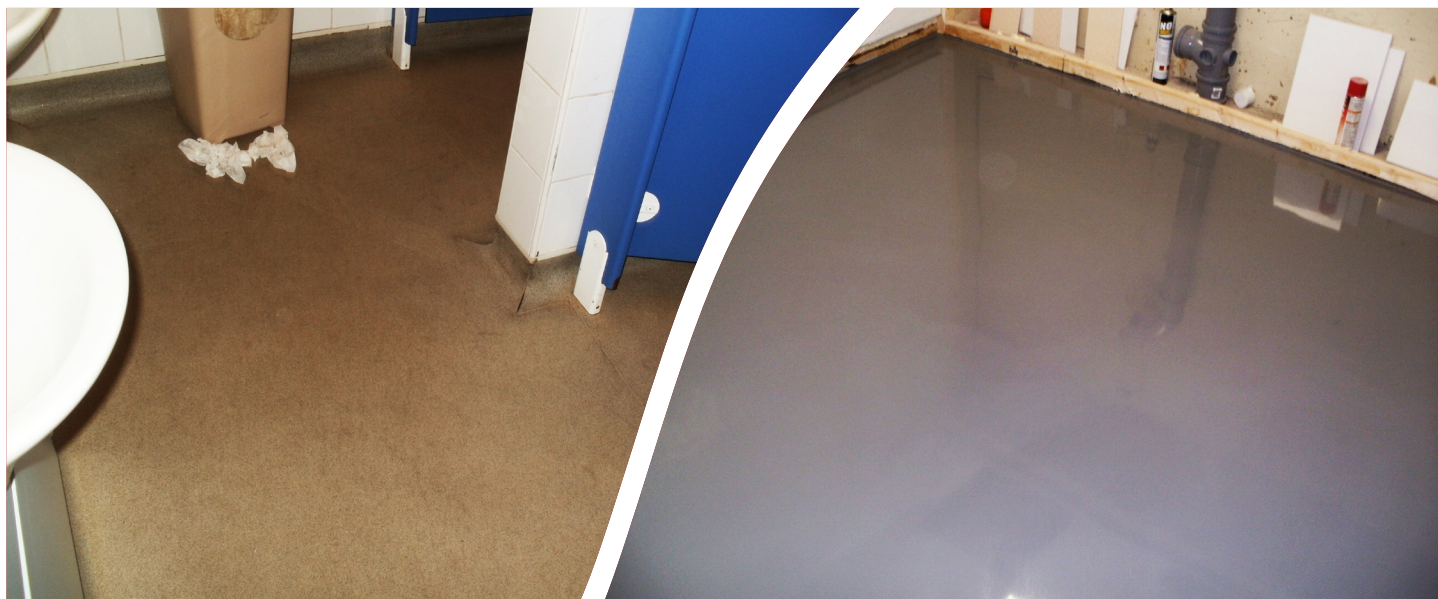
The existing sheet vinyl flooring had de-bonded allowing dirty water to penetrate the sub-floor causing foul smells and trip hazard issues.

Firstly the sheet vinyl flooring was removed. The Sub base was then scarified. When the floor was sufficiently prepared, a cement based latex was laid to level the sub-base. On top of this a tack coat primer was applied.

A quartz aggregate was then scattered onto wet primer to create a physical bond. This was then allowed to cure overnight and then a second tack coat primer was mixed and applied.

Finally the floor coating, a Flowcrete, Flowshield S/L, was mixed and applied at 4mm thick. This was applied using the back roll technique with spiked roller to remove air pockets.
